Dear David,  
Re: Proposed Remodelling of Chapel Hall.

**Long Rafter Length - Rear Roof over Toilets.**

### **Rear Roof over Toilets - Short Term Problem.**

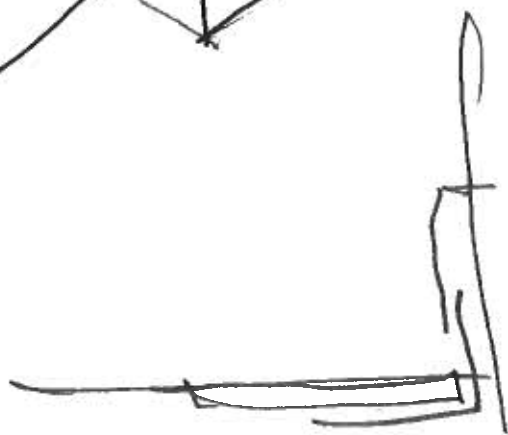
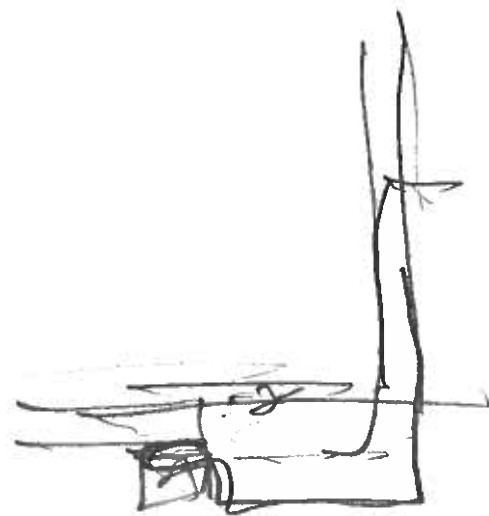
The tile problem is that the side grooves in the small tile lack the flow capacity to channel water at the lower end of the roof without it back flowing into the roof space. Possibly evidenced by the roof only leaking during heavy inclement rain.

I have today ladder access inspected the roof and confirm that it is probably a Mini Stonewold concrete tile suitable for use in a 17.5-degree roof pitch and laid at the recommended 100 mm head lap for low pitch and severe exposure. The roof is 16.95 degrees and although below 17.5 deg. ~~but that should not prove an issue.~~

The water entry looks to be windblown entry driven up the head lap. There is an area of slightly cocked / rocker tiles which would cause water entry in a storm. Saying that with continuous felt it should not appear. There are however old roof lights which would have previously penetrated the felt line and it is probable that water is dripping through at the old roof light junction.

Although 8.9 m rafter length on a south west storm facing roof in Merthyr is still to close the maximum allowed 10 m rafter length. I advise that the existing 16.9-degree roof be replaced and there are two alternatives:
