## INSTALLATION OF NEW SKYLIGHTS/VELUX WINDOWS

JAH-JIREH CARE HOME, A465 MERTHYR

### BUILDING INSPECTION REPORT

Document Ref: E25136001 Doc 01 September 2025

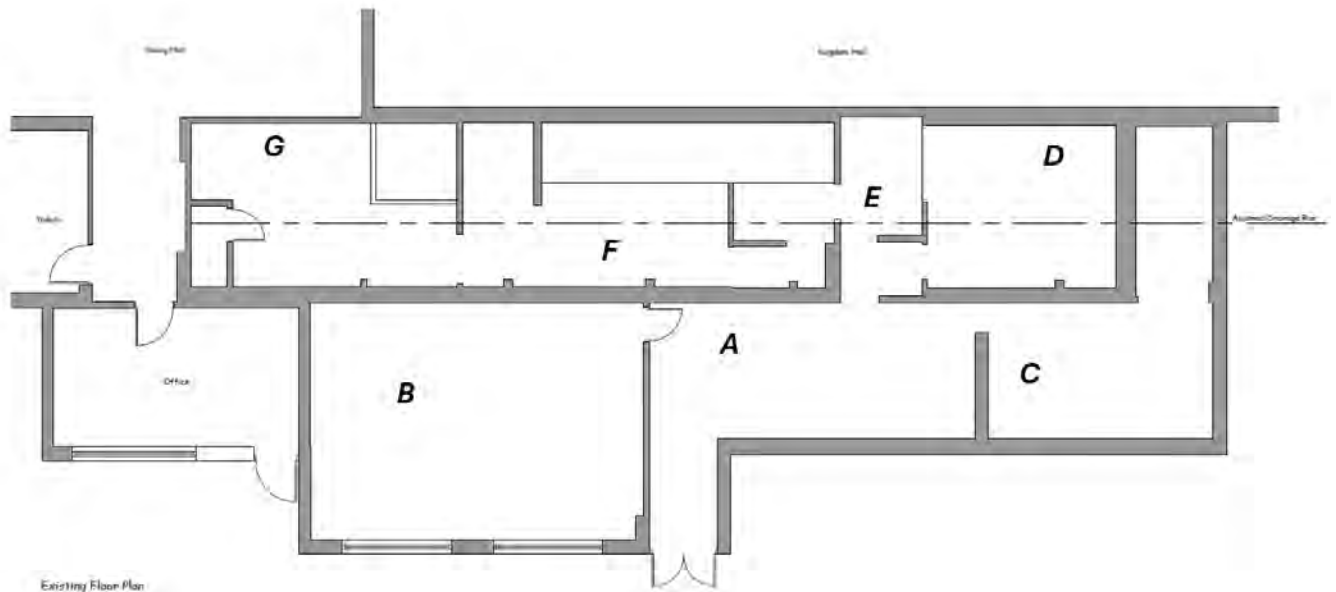
**Figure 1-Existing Internal Room Layout-Area Surveyed**

3.9 The section of the building that is included in the proposed works area was previously used as toilets/bar area. Figure 1 illustrates the internal room layout of the surveyed area. There are 7 separate rooms (referred to as A-G).

3.10 The door was locked upon entry and the window located in room B was open. Rooms A-C are largely located within the flat roof area and no accessible roof space is present (Room C is partially located in the pitched roof section of the building). Recent works include the installation of ceiling insulation boards in room A,B and C. There were no signs of bat droppings on any surfaces within these rooms.

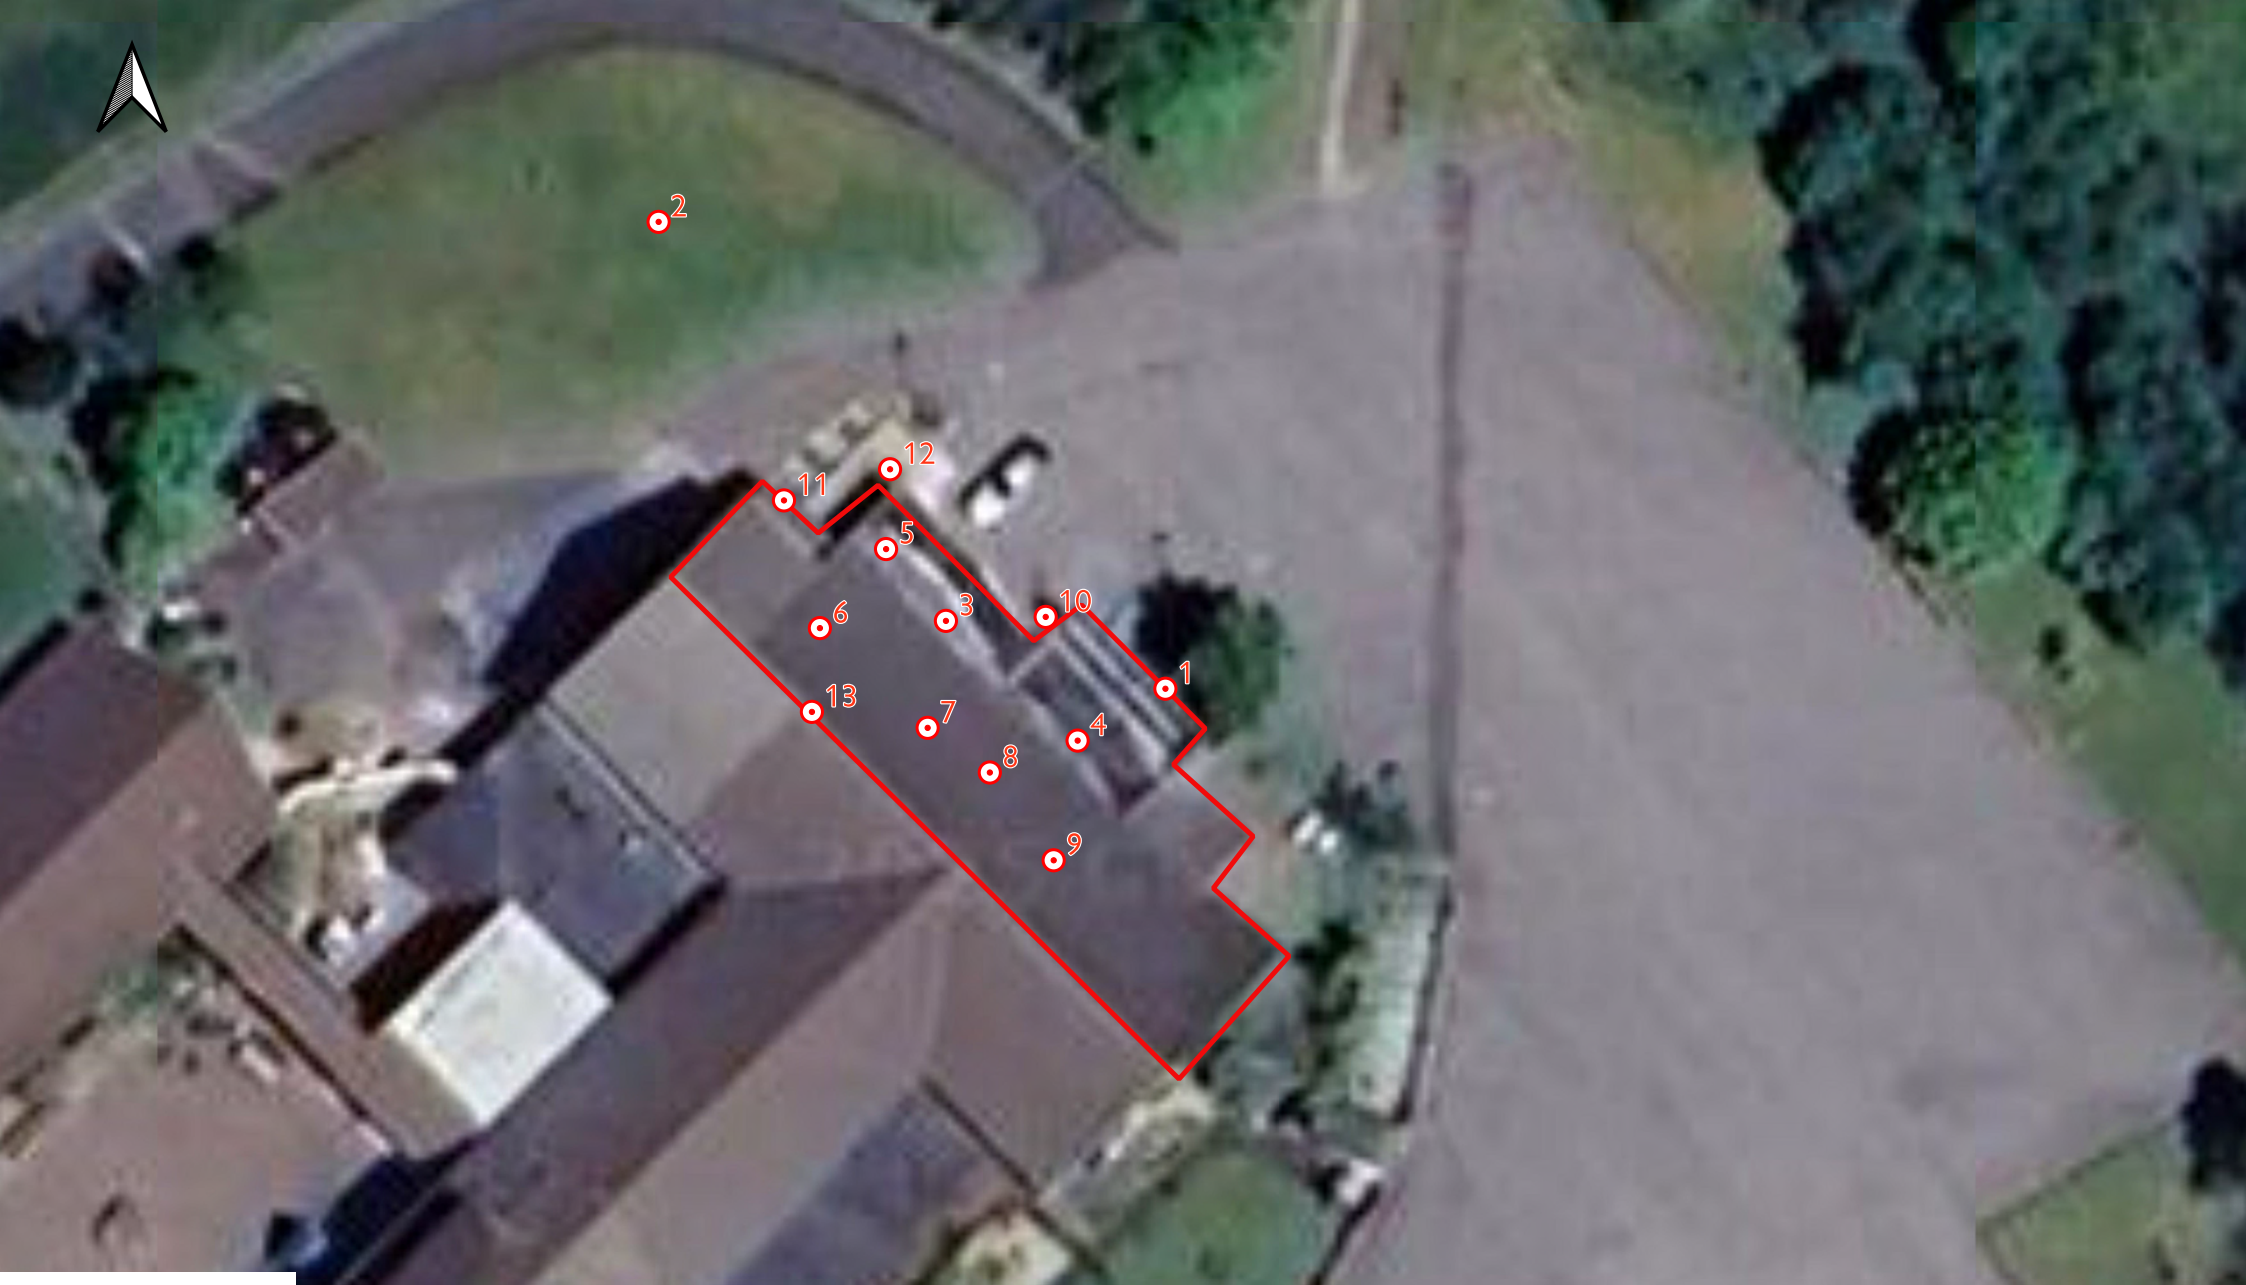
## APPENDIX I     Site Location Plan (with target notes)

- 3.6 The walls are a combination of red brick and render and are in a good state of repair i.e. no obvious cracks damage (with the exception of the one area identified in TN 5). The roof is well sealed and new fascia's and bargeboards have been installed recently (within last 12 months<sup>4</sup>). (Plate 1 and TN 10, 11, 12& 13).

- 3.7 There appeared to be some missing cement along the ridge of the main roof away from the proposed development area although it was not clear (from ground view with binoculars) if this created any access points(TN13).
- 3.8 There are two security lights and a street light present in the location with the damaged render was noted (red circle).
