CANOLFAN SOAR, MERTHYR TYDFIL  
CURRENT CONDITION  
FEBRUARY 2026

## CURRENT CONDITION & FABRIC ISSUES

This section outlines the observations obtained from the assessment of the fabric to the lower ground floor of the Canolfan Soar building undertaken on Friday 3rd February and Friday 17th February 2023.

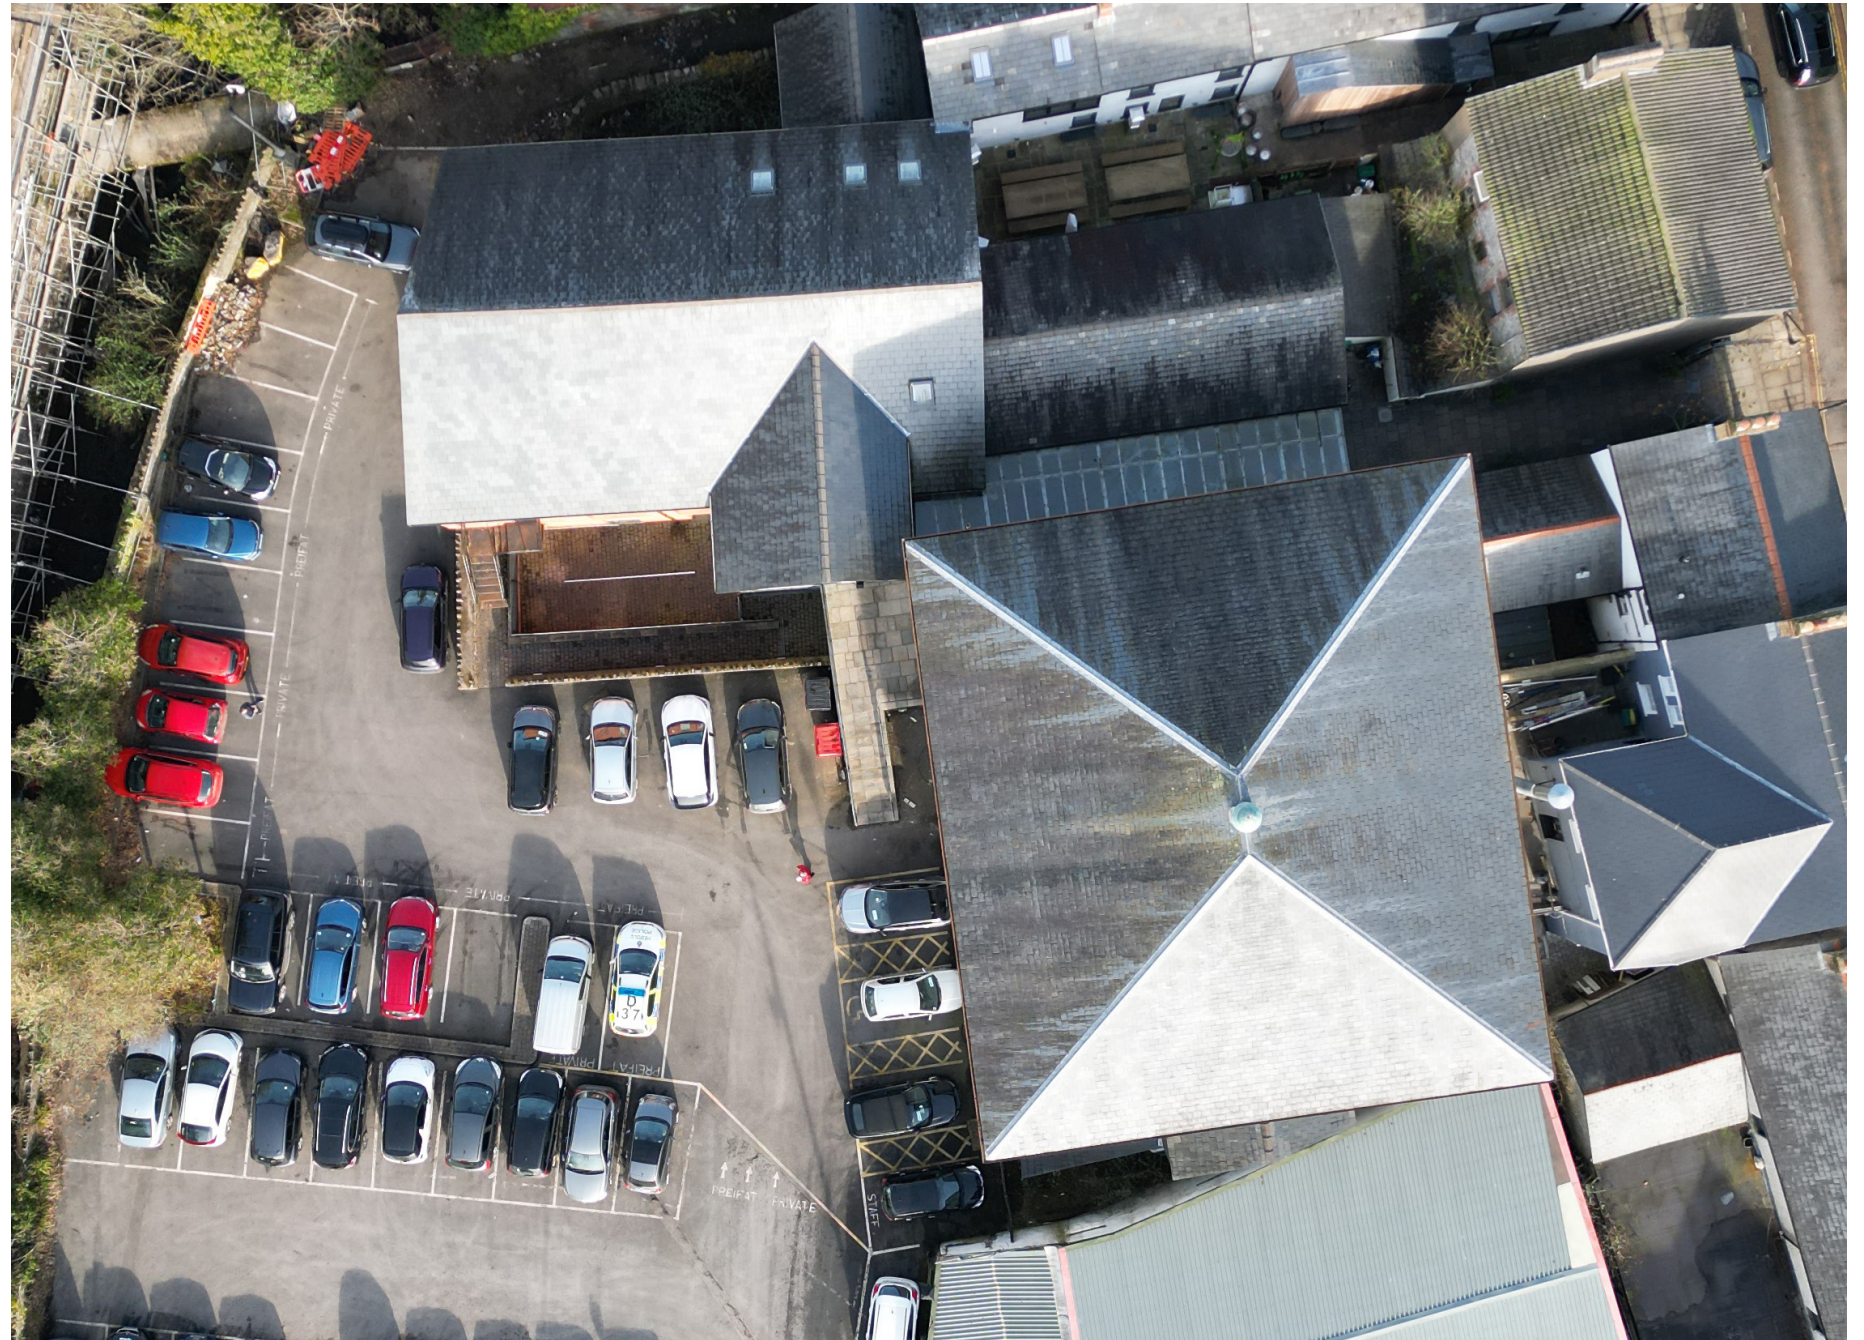
The south wall to the external foyer is showing signs of salt migration and defective finishes to the rendered areas.

The south terrace which is linked to the Meithrin is a sunken yard with stone boundary walls formed to the west and south. The south accommodates the ramped approach, which provides means of level access from the car park to the upper ground floor level, which passes through the internal lobby to obtain access to the lift.

There is a large tarmacadam car park which wraps around the south-west of the site which provides vehicular parking at the lower ground floor levels as illustrated on the adjacent aerial image.
