**Heritage Impact Assessment**

**Proposed Replacement Windows**

5 Chapel Row, Georgetown, Merthyr Tydfil, Cf48 1BN

October 2023

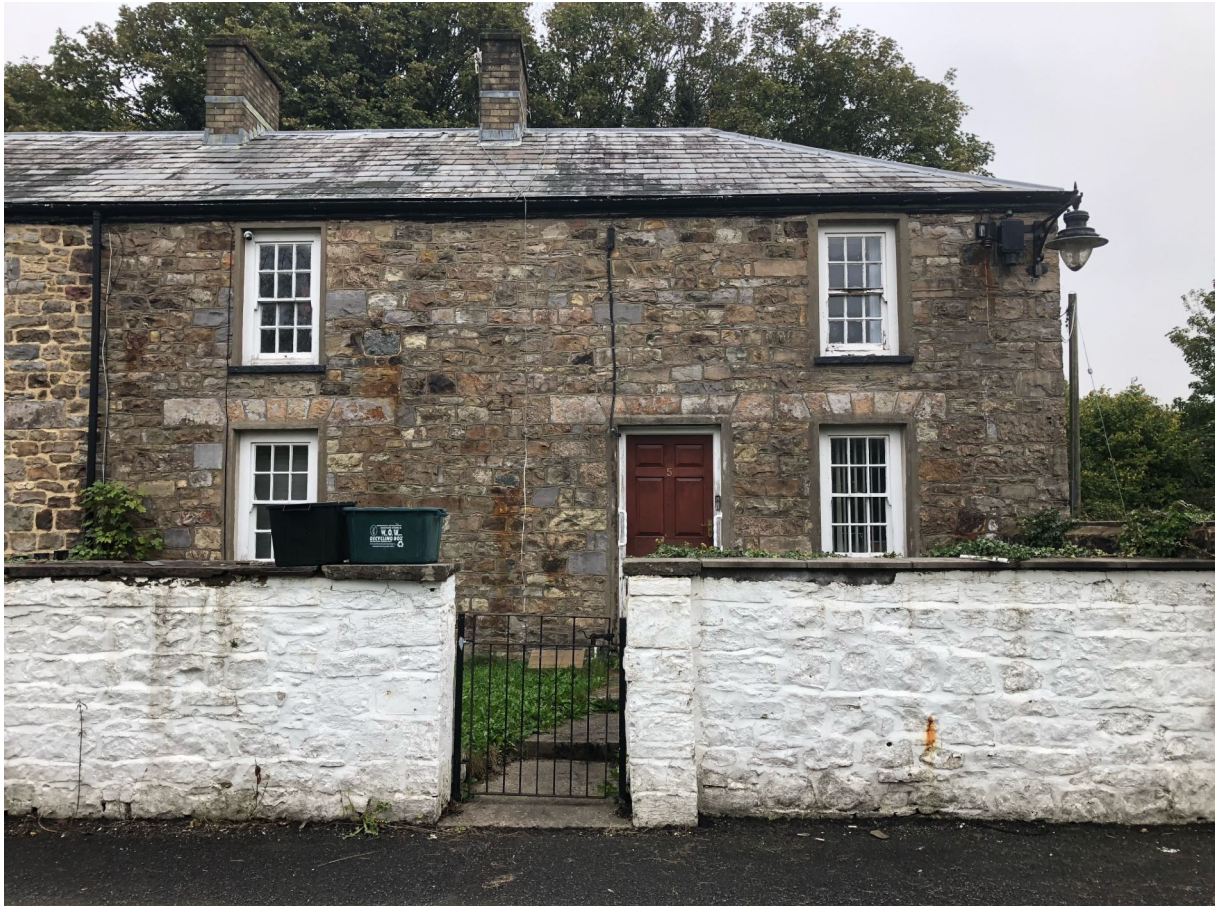
Photo 2 – front elevation

With regard to evidential value, from the exterior, the building appears to retain much of the original layout of the stone walls under a slate roof, (Photo 2) although there is a modern extension to the rear elevation with smooth-rendered walls but retaining the slate roof. (Photo 3)
