*Report No. BC/MB/09.17.02/2.*

# **Site Investigation Report: Land at Goatmill Road, Dowlais, Merthyr Tydfil.**

**M. DeLacey and Sons (Holdings) Ltd.**

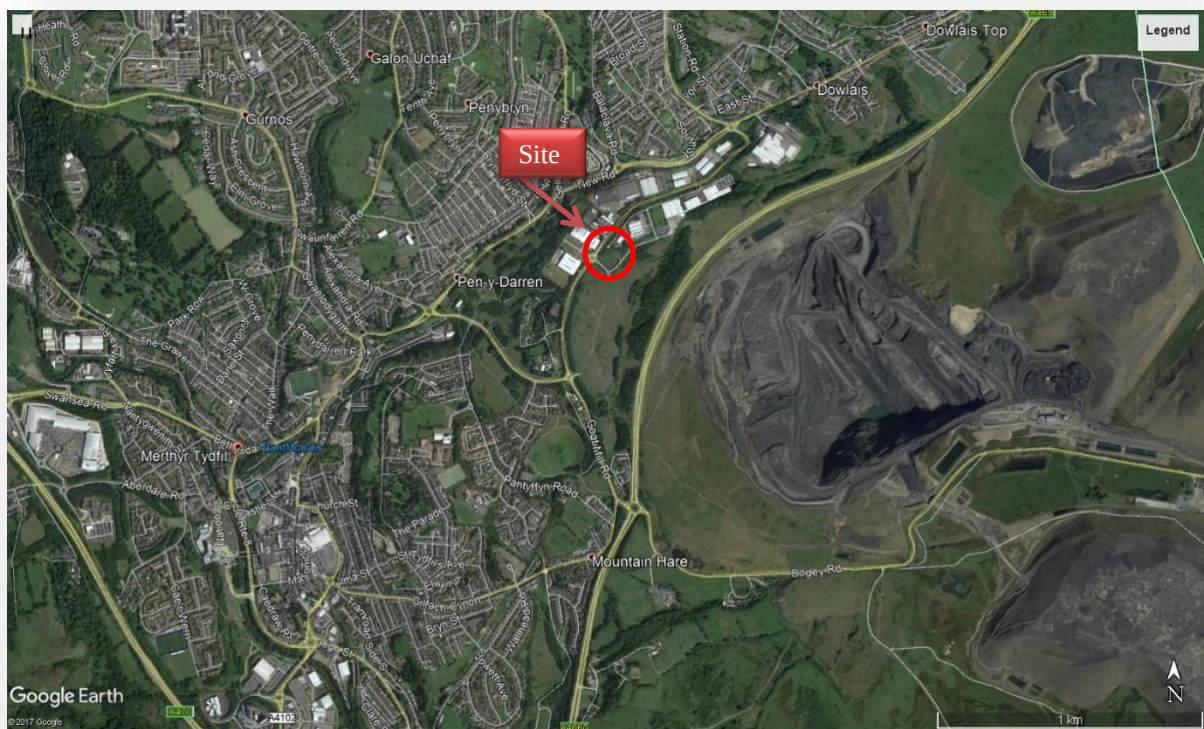
**Figure 1**  
**Aerial View of the Site**

estate. Buildings on the industrial estate occupy land to the north and west of the Site; to the east and south is a relatively level area that is unoccupied in readiness for industrial development. The Site, itself is on the north-west corner of the land designated for industrial development. The Site is irregular in outline and occupies an area of approximately 0.65 hectares. Figure 1 Aerial View of the Site.

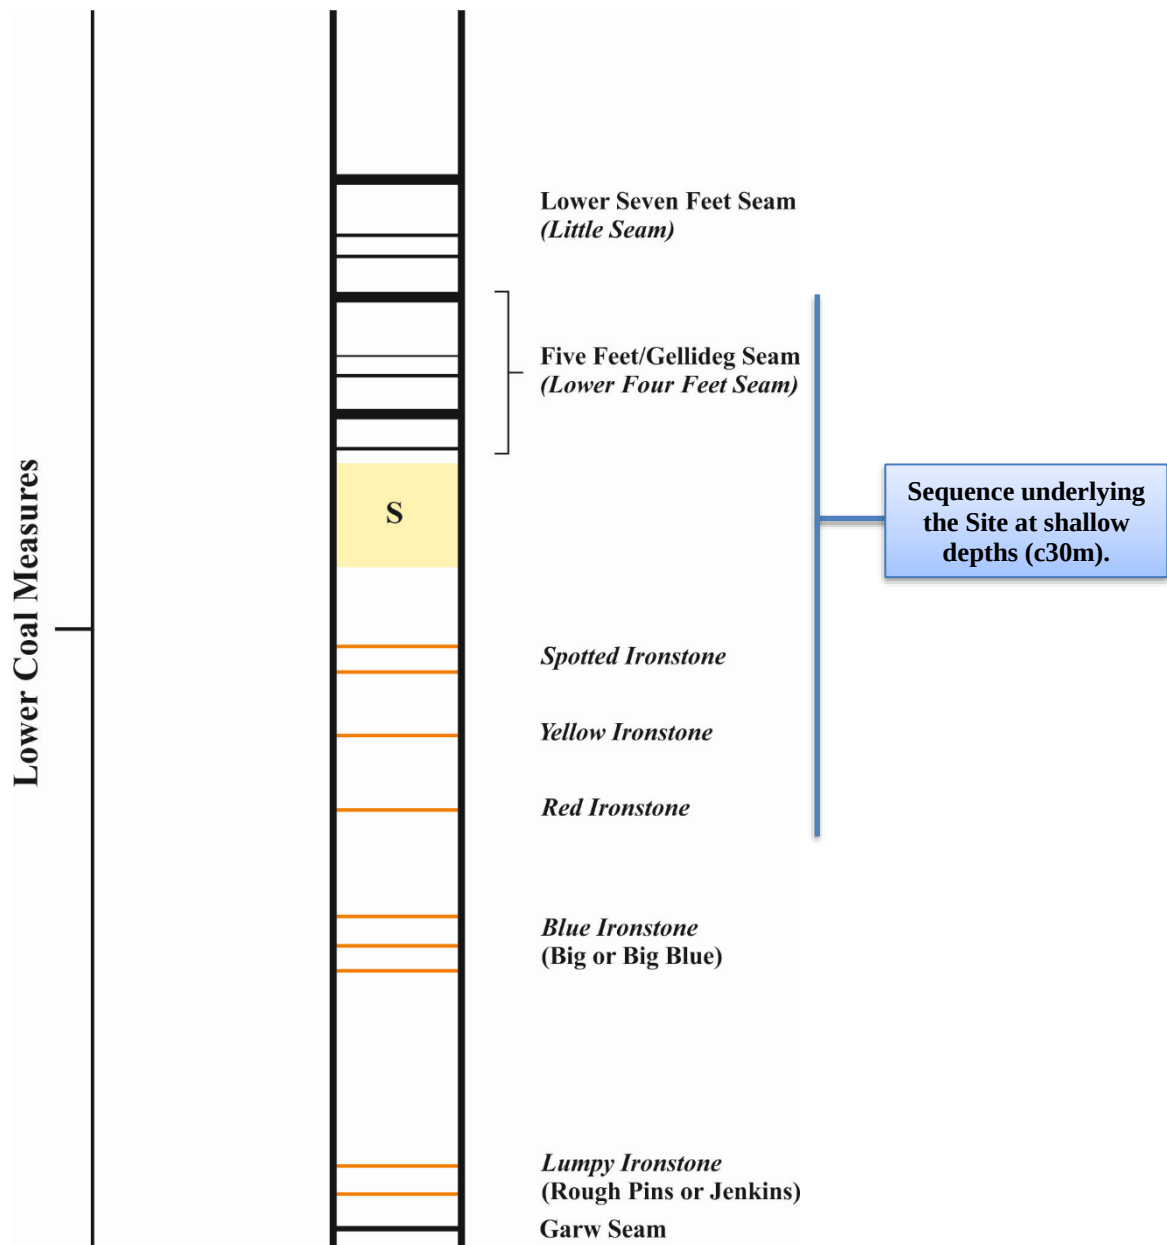
**Figure 2**  
**Part of the Stratigraphic Column.**  
 (Based on BGS Published Data)

The Site is underlain at shallow depths with strata assigned to the Lower Coal Measures, a sub-division of the Upper Carboniferous Period. The inferred position of the outcrop of the Gellideg Seam is shown, on the published 1:10,560 scale geological sheet (SO 00 NE), to pass through the Site with a north-eastern trend (see *General Geology Plan, drawing no. BC/MB/09.17.02.02*). Beneath the Gellideg Seam there are a number of ironstone veins and the Garw Seam of coal (see Part of the Stratigraphic Column below), that together with the Gellideg Seam, all underlie the Site at relatively shallow depths. Mining records further suggest that the

Lower Seven Feet Seam, locally known as the Little Seam and which overlies the Gellideg Seam, may also underlie at least part of the Site at shallow depth.

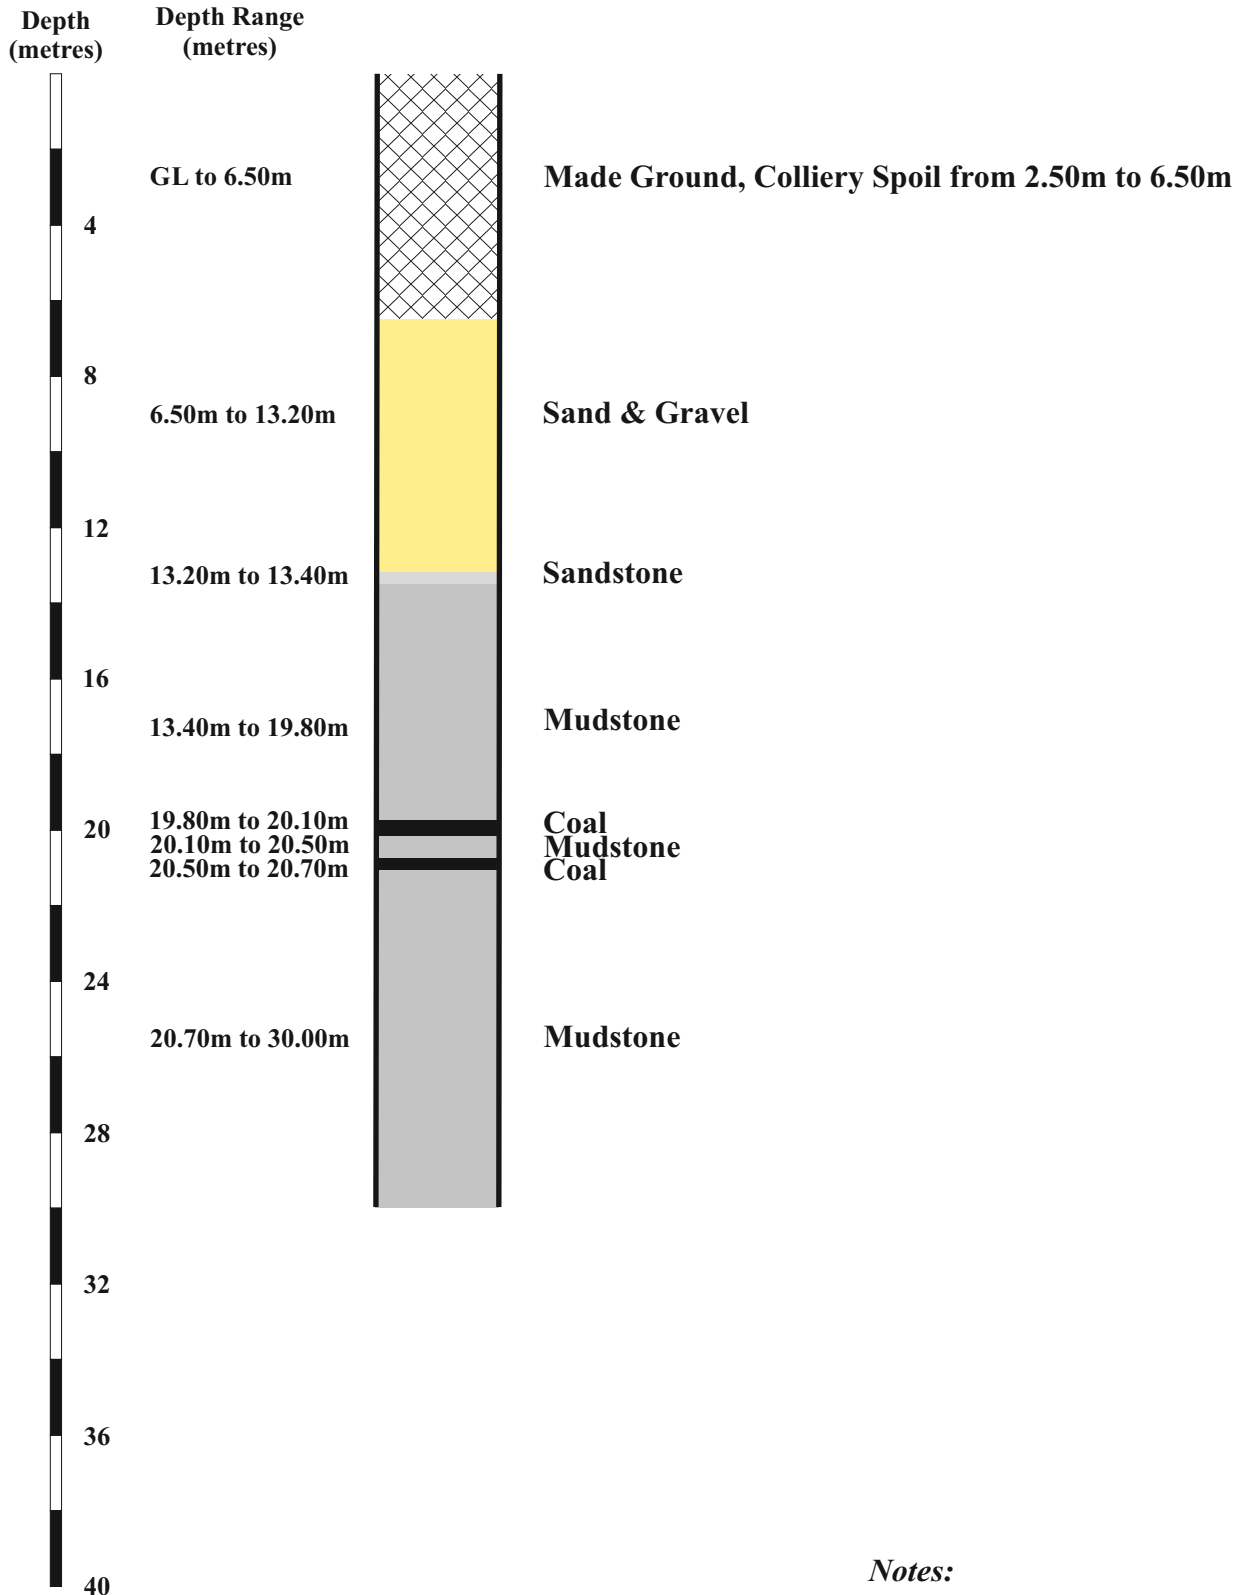
### *Borehole No. 1*

1. *Driller's Descriptions.*
2. *Borehole dry.*
3. *Total depth of borehole, 30.00m.*
4. *Cased 14.00m.*

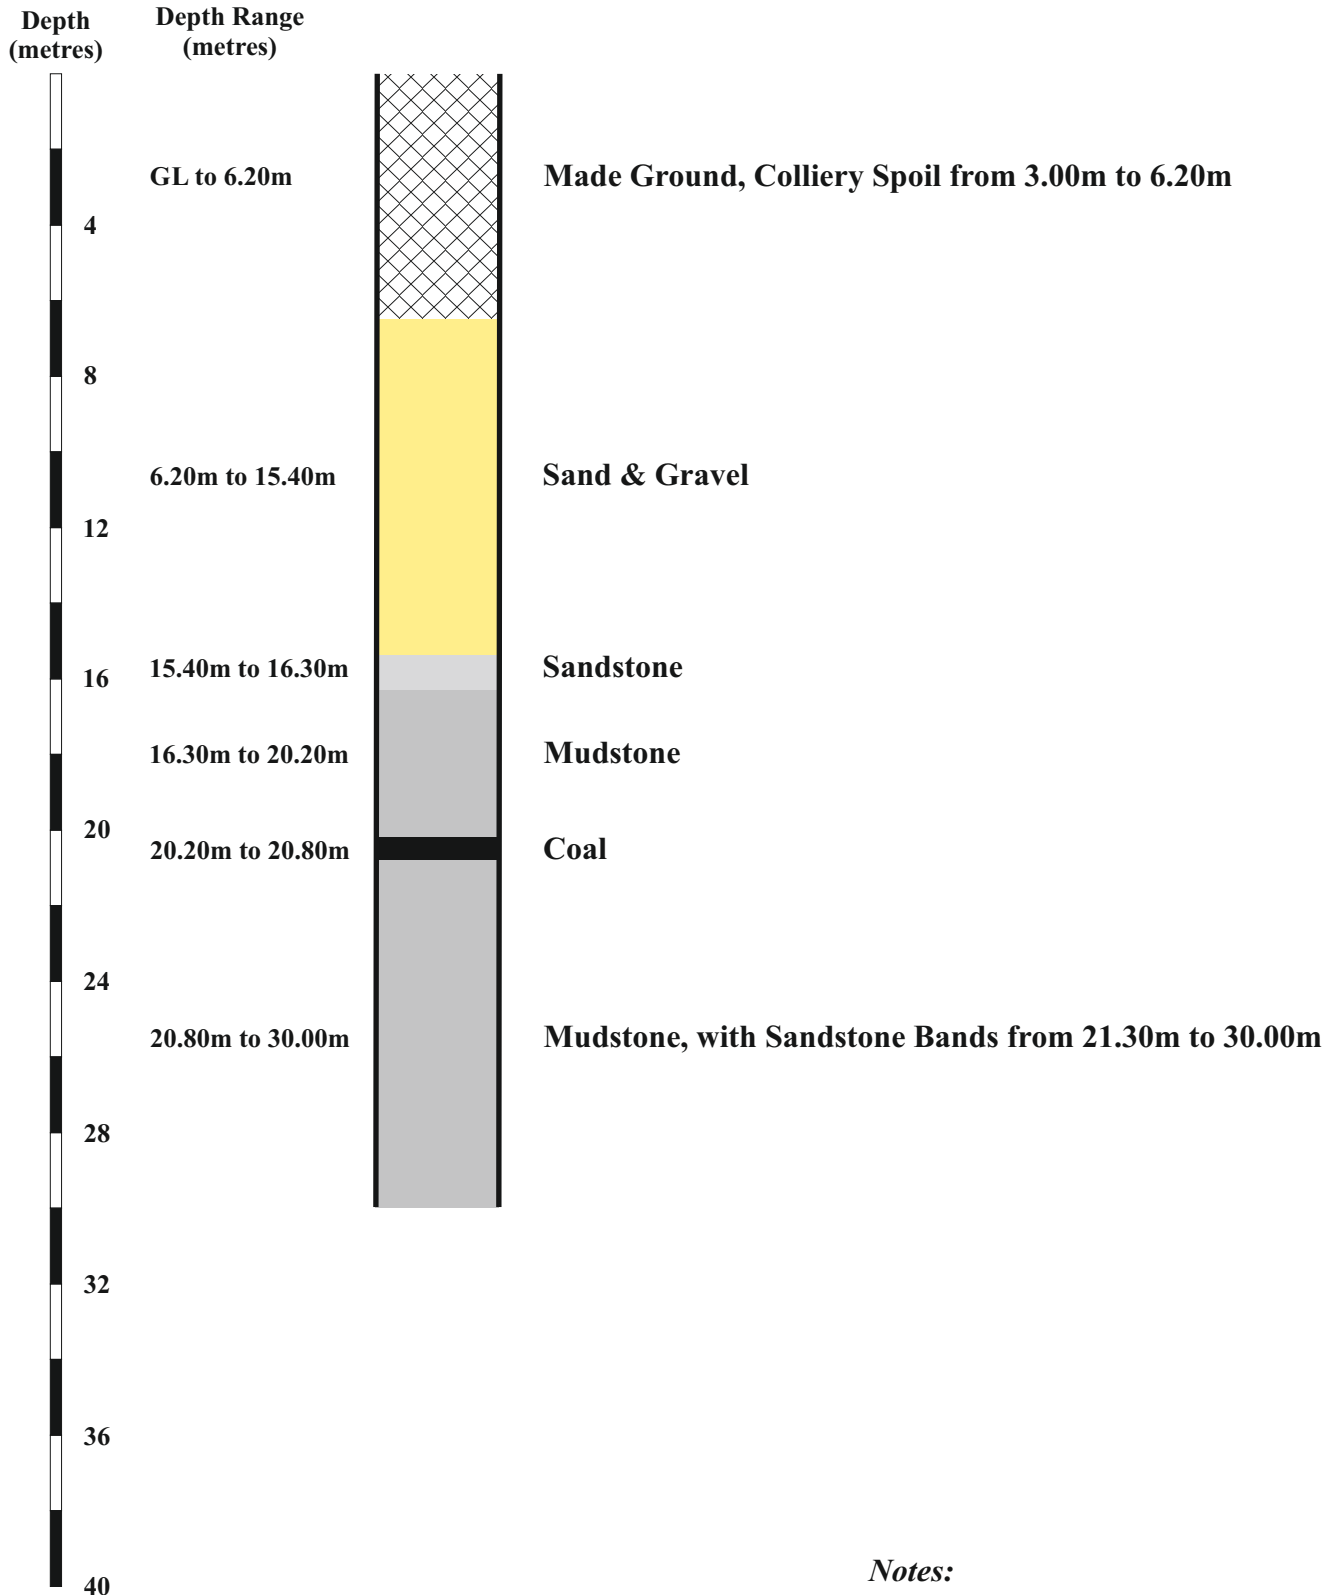
### *Borehole No. 2*

1. *Driller's Descriptions.*
2. *Borehole dry.*
3. *Total depth of borehole, 30.00m.*
4. *Cased 16.00m.*
