# MERTHYR VALLEY HOMES

## DEMOLITION OF 6 GARAGES AT PINE CLOSE, GURNOS ,MERTHYR TYDFIL

### BUILDING INSPECTION REPORT (PROTECTED SPECIES)

October 2023

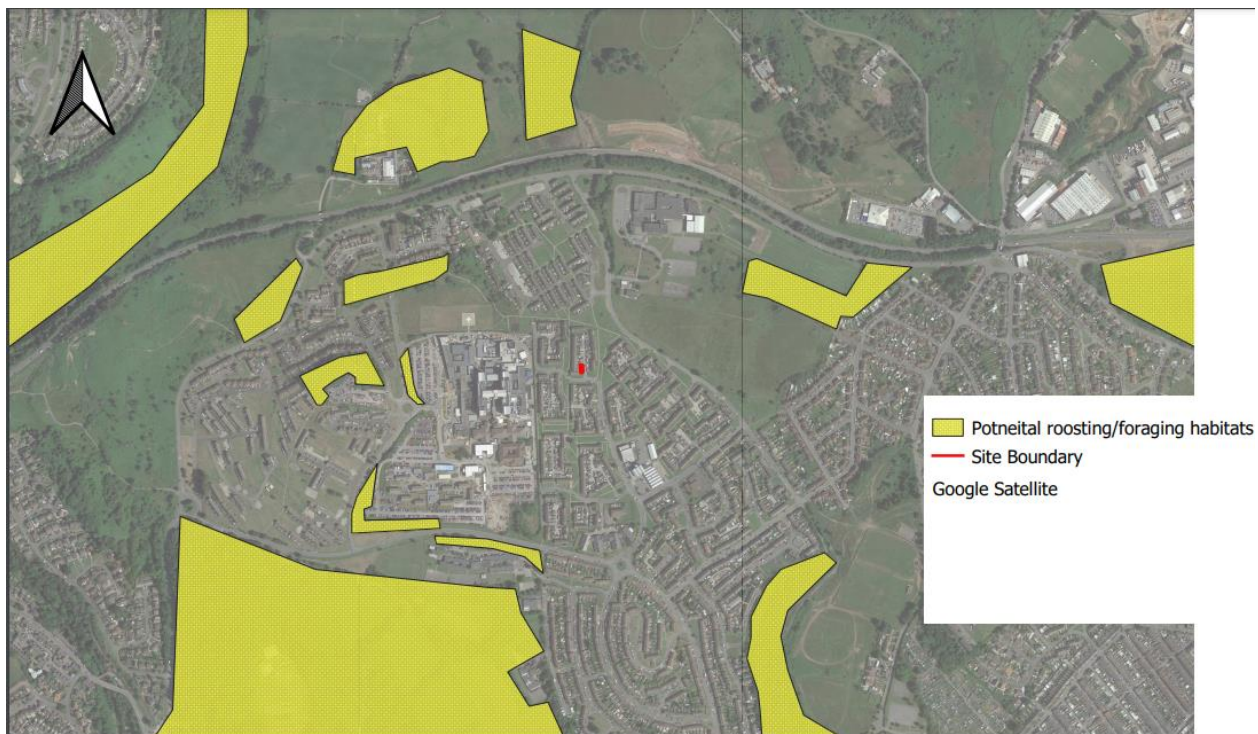
**Figure 1-Habitats potentially suitable for foraging/roosting.**

- 3.1 Figure 1 shows potential suitable habitat for commuting/foraging/roosting bats in the locality.<sup>5</sup> The nearest optimum habitat-woodland/scrub was approximately 300m north east of the site adjacent to Pen Y Dre School. There is a large area of amenity/short grassland (this may provide a food resources e.g. insects for foraging bats), houses and a road (Goitre Lane) separating the garages to the nearest site.
