## Pandy Farm, Merthyr Tydfil

### Bat Report

Report Ref: 1703 / 02e

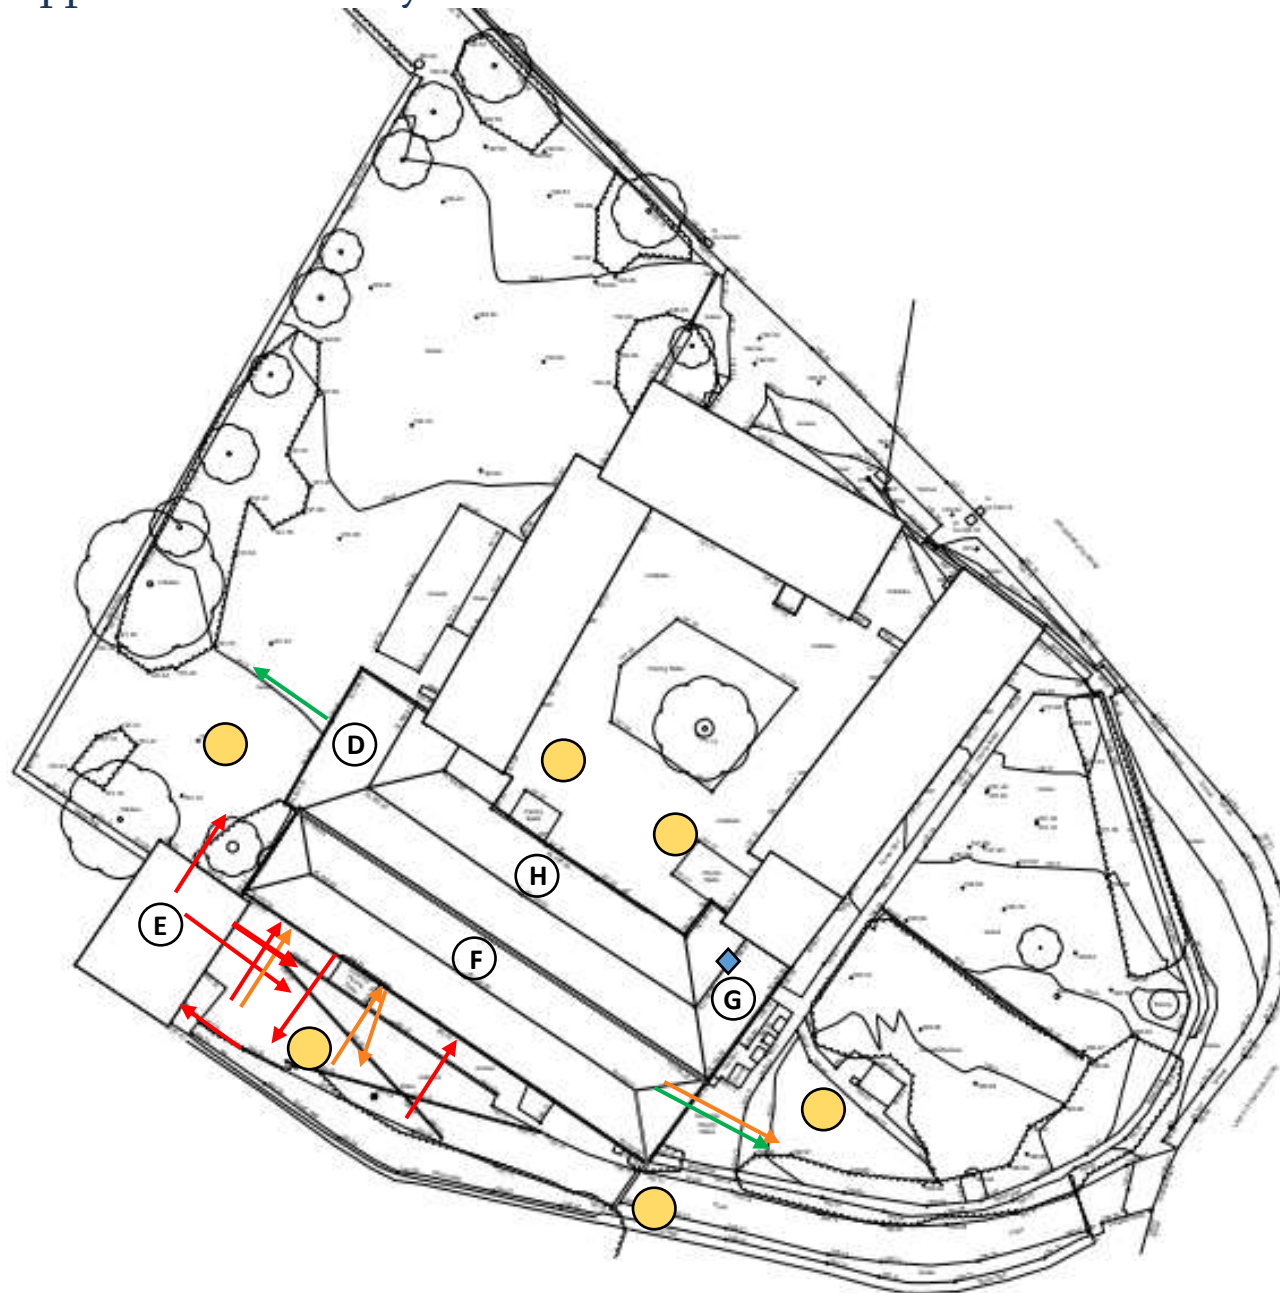
## Appendix 2 – Survey Results

- 2.10 **Appendix 2** illustrates surveyor locations, although these were strategically located during different surveys and were not necessarily covering one building per survey. This means some elevations were surveyed on more than one occasion as they were visible from surveying a different section of the complex. Surveys were well spaced during the 2022 maternity period. A minimum of three surveys were carried out of Buildings E-H and two surveys of Building D.
- 2.11 The dates and weather conditions were suitable for all surveys, as detailed in **Table 1.** below.
