*Report No. BC/MB/11.20.04.*

# **Preliminary Site Investigation: Land at Colliers Row, Merthyr Tydfil.**

**Maxiom Developments Ltd.**

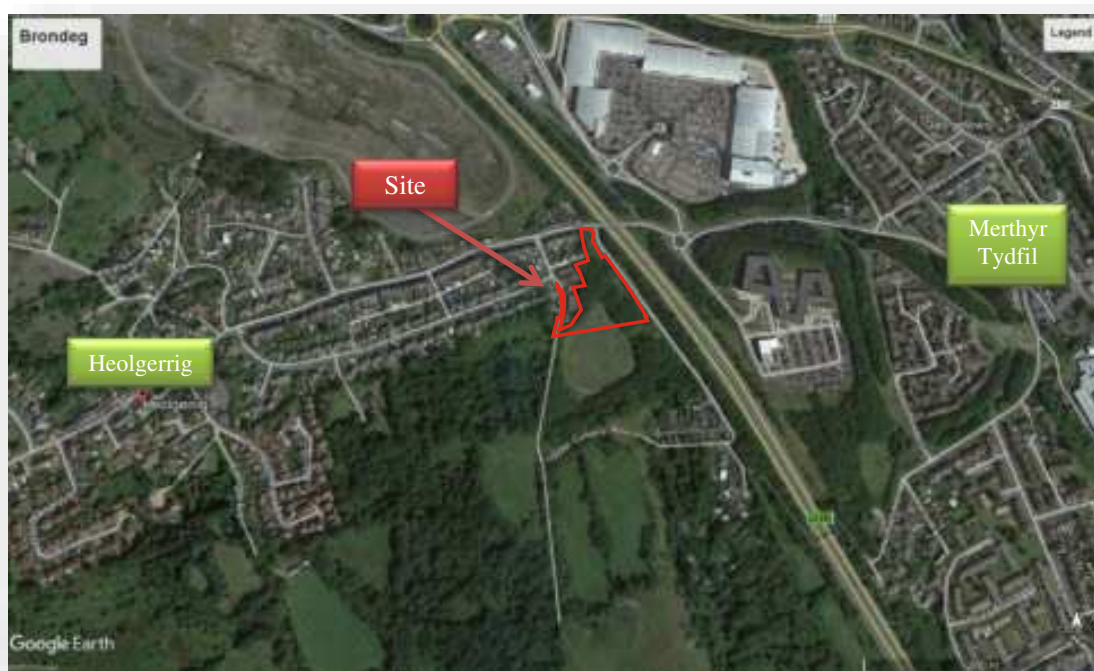
**Figure 1**  
**Aerial View of the Site**

The plot of land that is the subject of this report, 'the Site' is located on the western fringes of Merthyr Tydfil, approximately 700m west of the town centre; it is irregular in outline and occupies an area of approximately 0.82 hectares (see Figure 1 and *General Location Plan, drawing no. BC/MB/11.20.04.01*). The Site is located in a residential area on the fringes of the town and is bounded on its western side by residential dwellings and a lane; to the north is Aberdare Road and beyond it the Trago Mills retail site; to the east is the public highway serving Colliers Row, beyond which is the A 470 (T), and to the south there are a mixture of agricultural enclosures and open countryside.

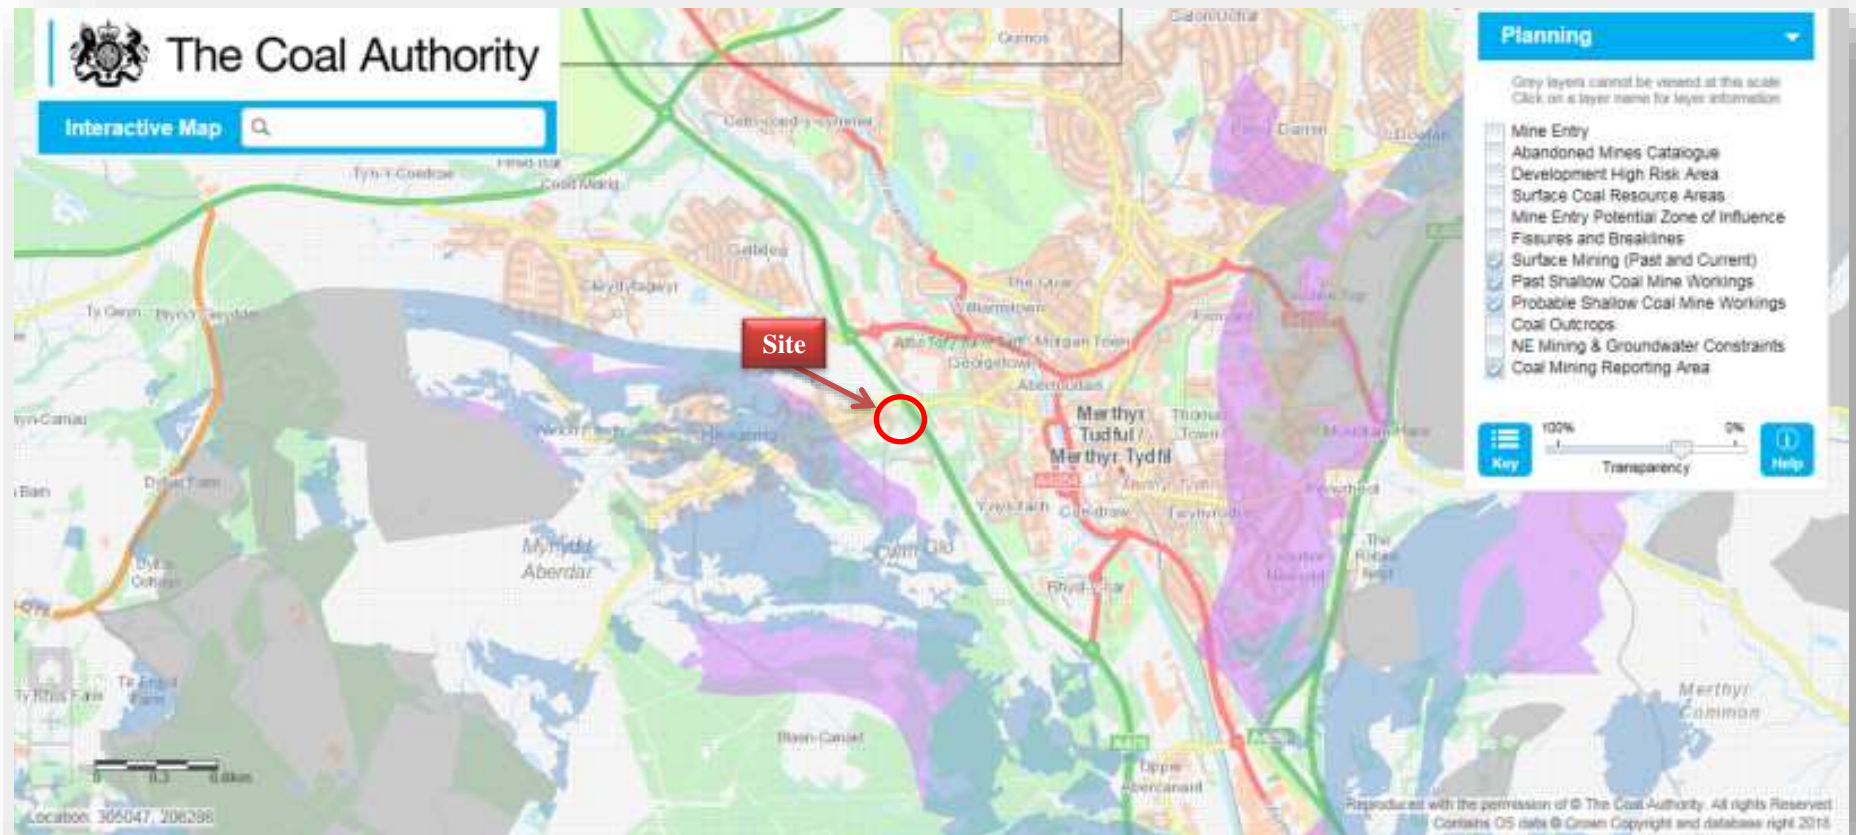
**Figure 3**  
**Print from The Coal Authority's Interactive Map**  
(accessed 21<sup>st</sup> August 2019)

Coal Authority's interactive map identifies that the inclusion of the finger of land along the lane does not alter any of the findings of The Coal Authority's report.

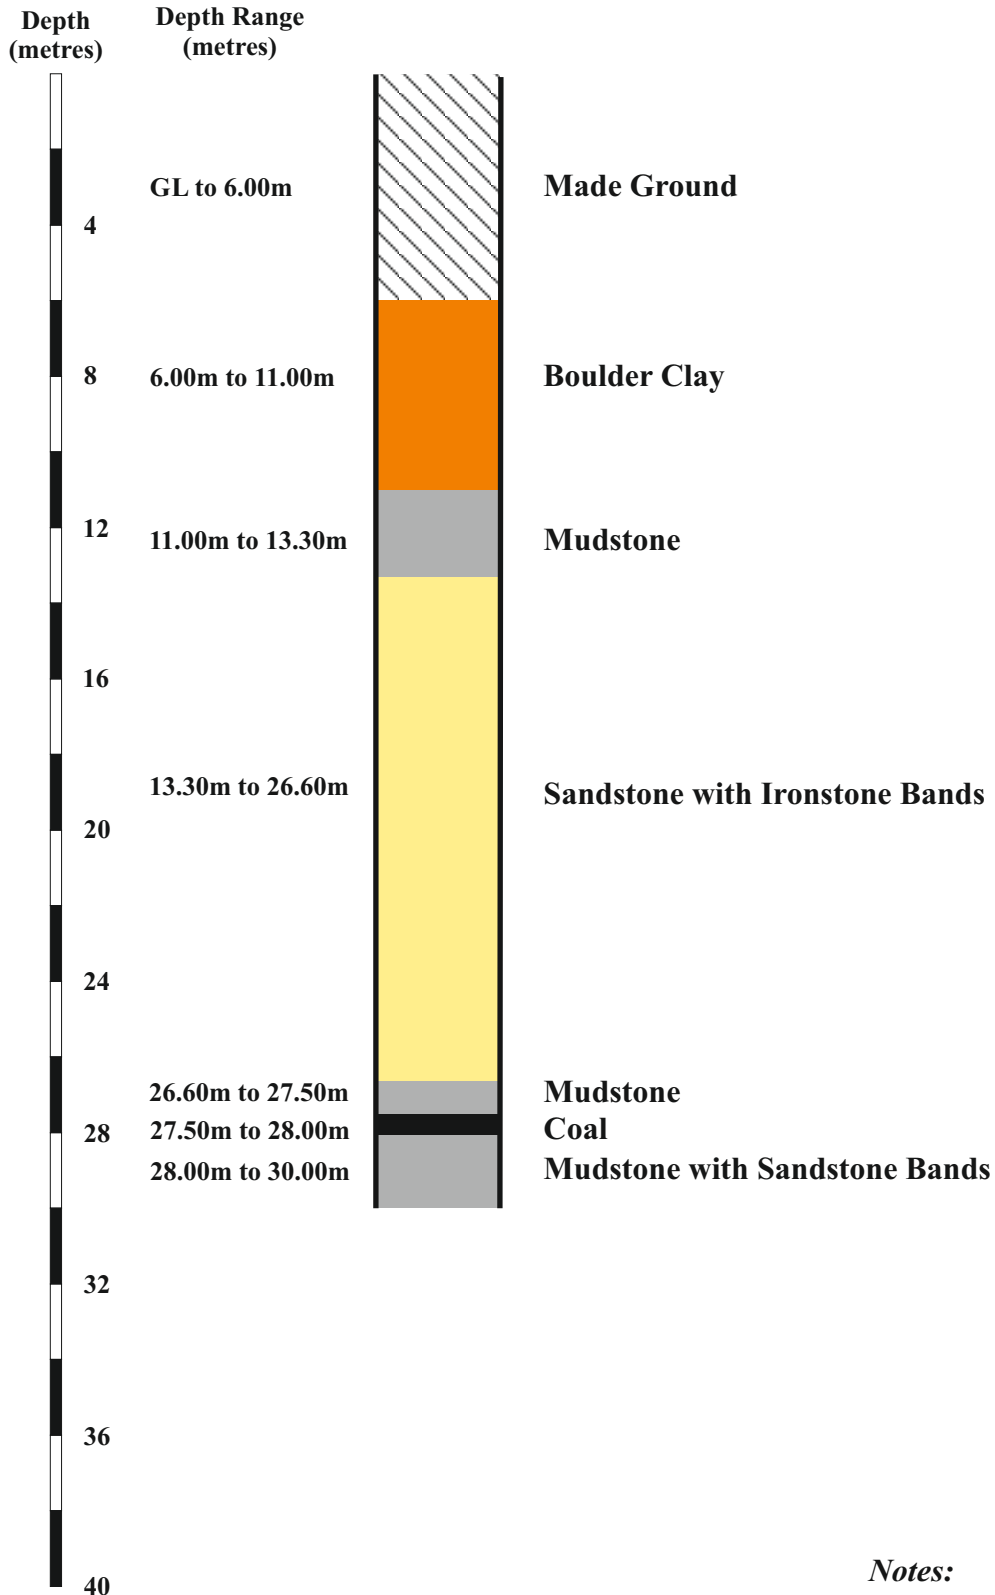
### *Borehole No. 1*

1. *Driller's Descriptions.*
2. *Borehole dry.*
3. *Total depth of borehole, 30.00m.*
4. *Cased 10.50m.*

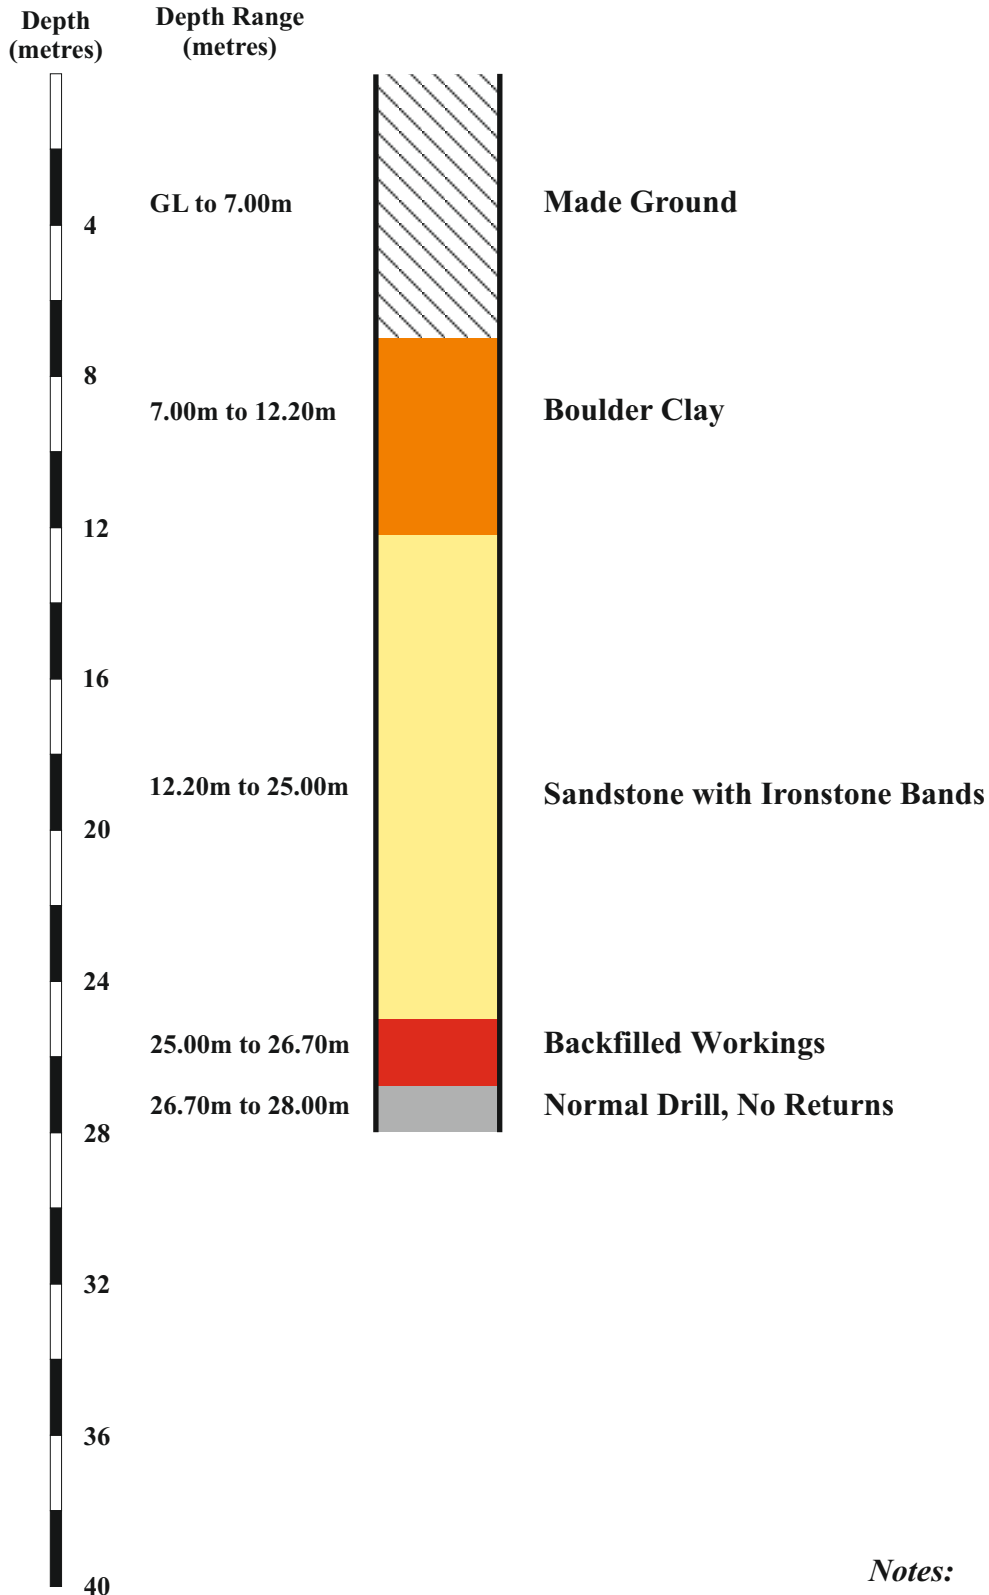
### *Borehole No. 2*

1. *Driller's Descriptions.*
2. *Borehole dry.*
3. *Total depth of borehole, 28.00m.*
4. *Cased 12.00m.*

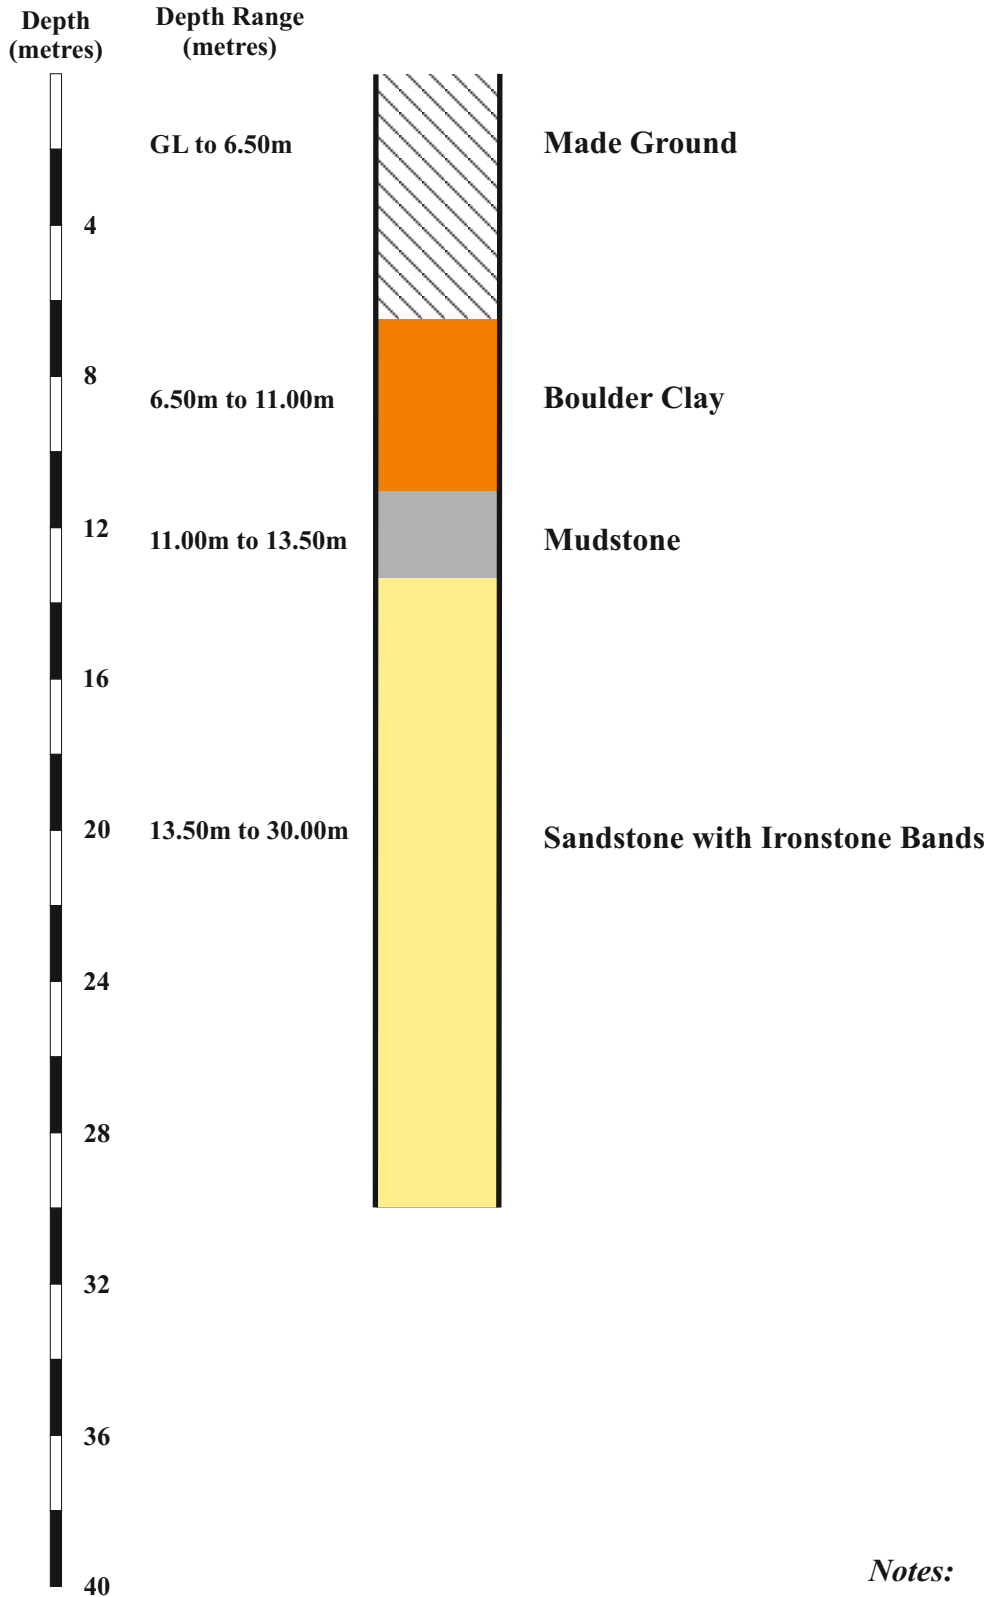
### *Borehole No. 3*

1. *Driller's Descriptions.*
2. *Borehole dry.*
3. *Total depth of borehole, 30.00m.*
4. *Cased 10.50m.*

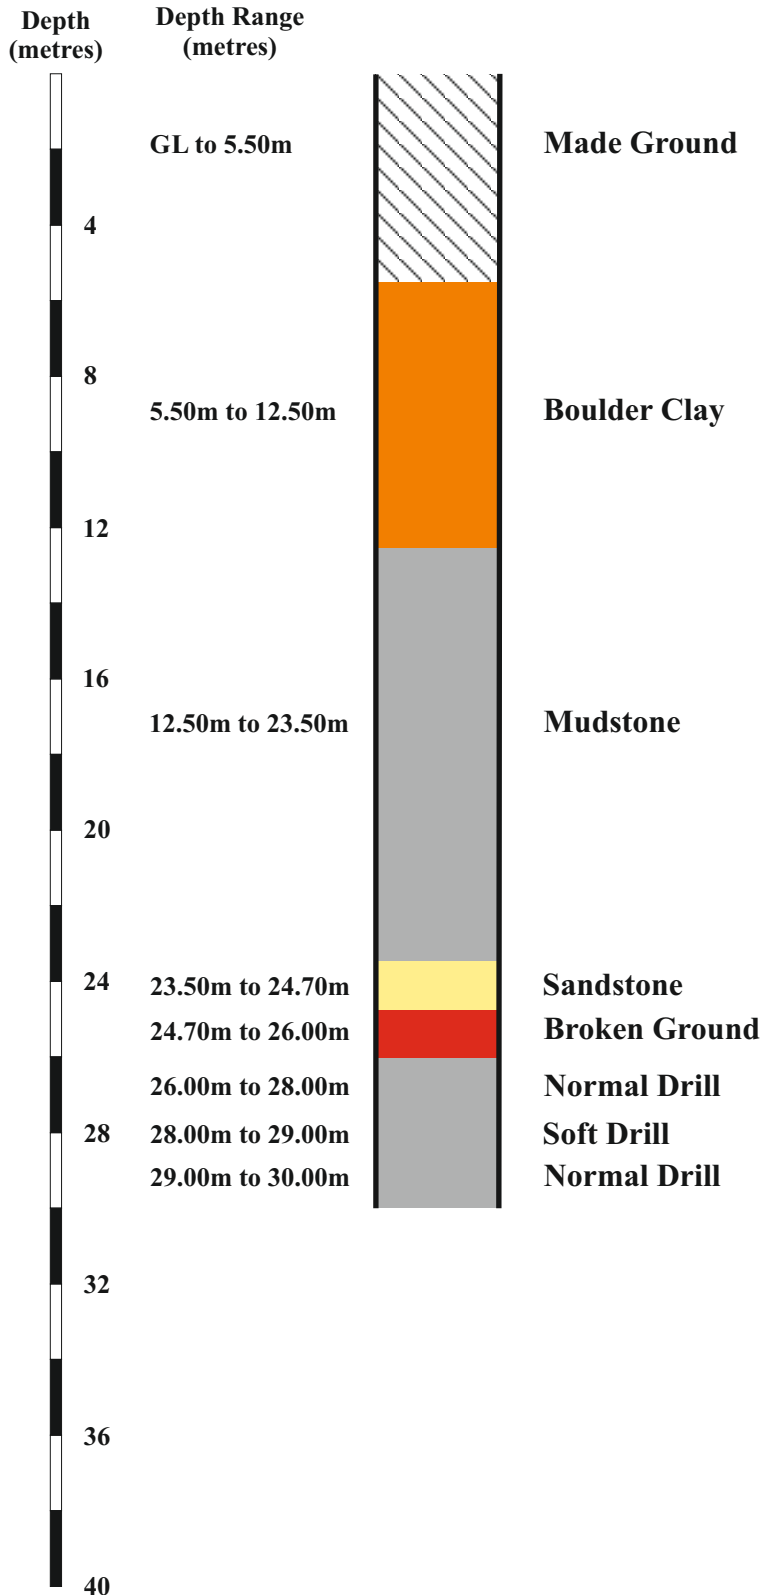
### *Borehole No. 5*

1. *Driller's Descriptions.*
2. *Borehole dry.*
3. *Total depth of borehole, 30.00m.*
4. *Cased 12.00m.*

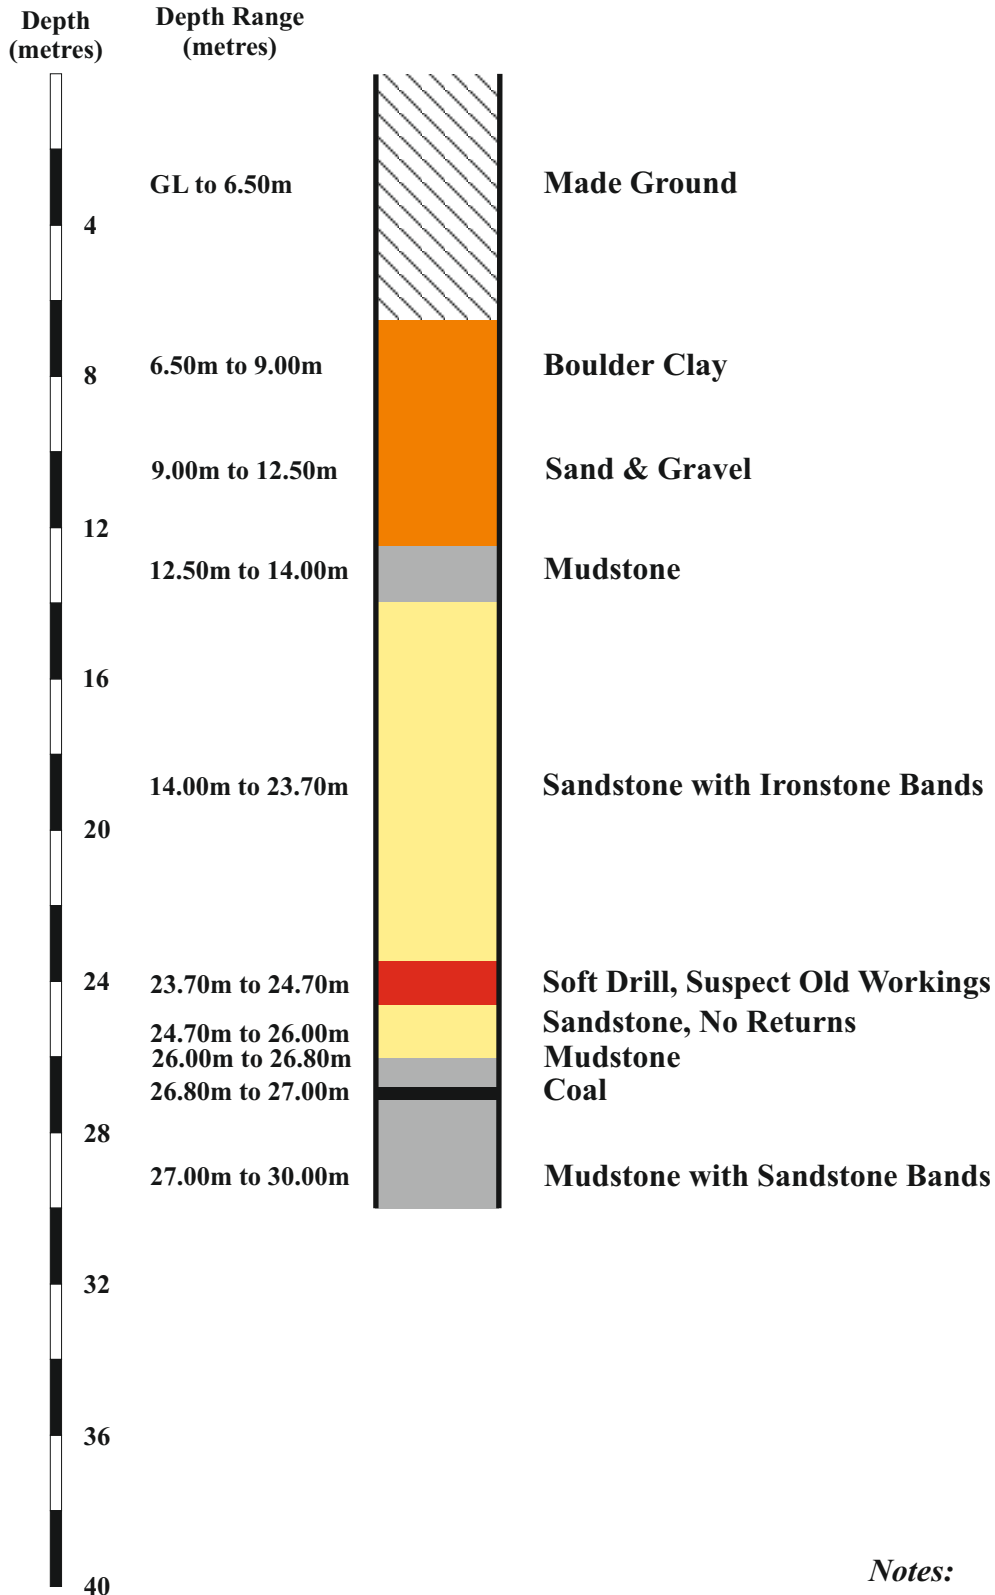
### Borehole No. 6

1. Driller's Descriptions.
2. Borehole dry.
3. Total depth of borehole, 30.00m.
4. Cased 13.00m.

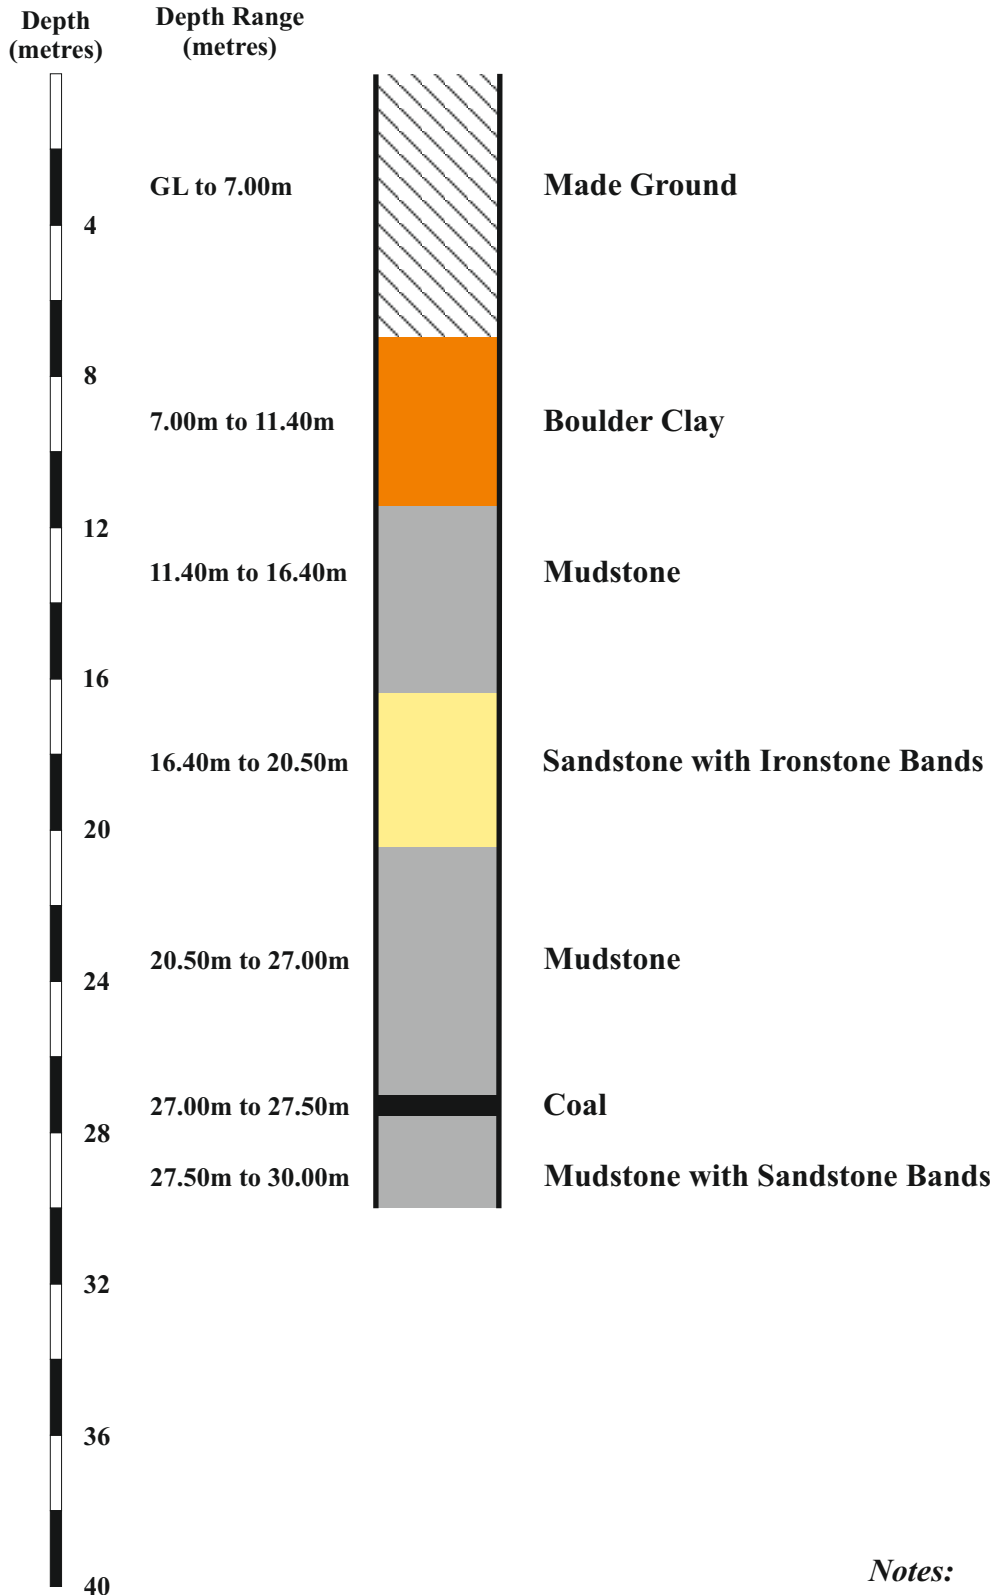
### *Borehole No. 7*

1. *Driller's Descriptions.*
2. *Borehole dry.*
3. *Total depth of borehole, 30.00m.*
4. *Cased 10.50m.*

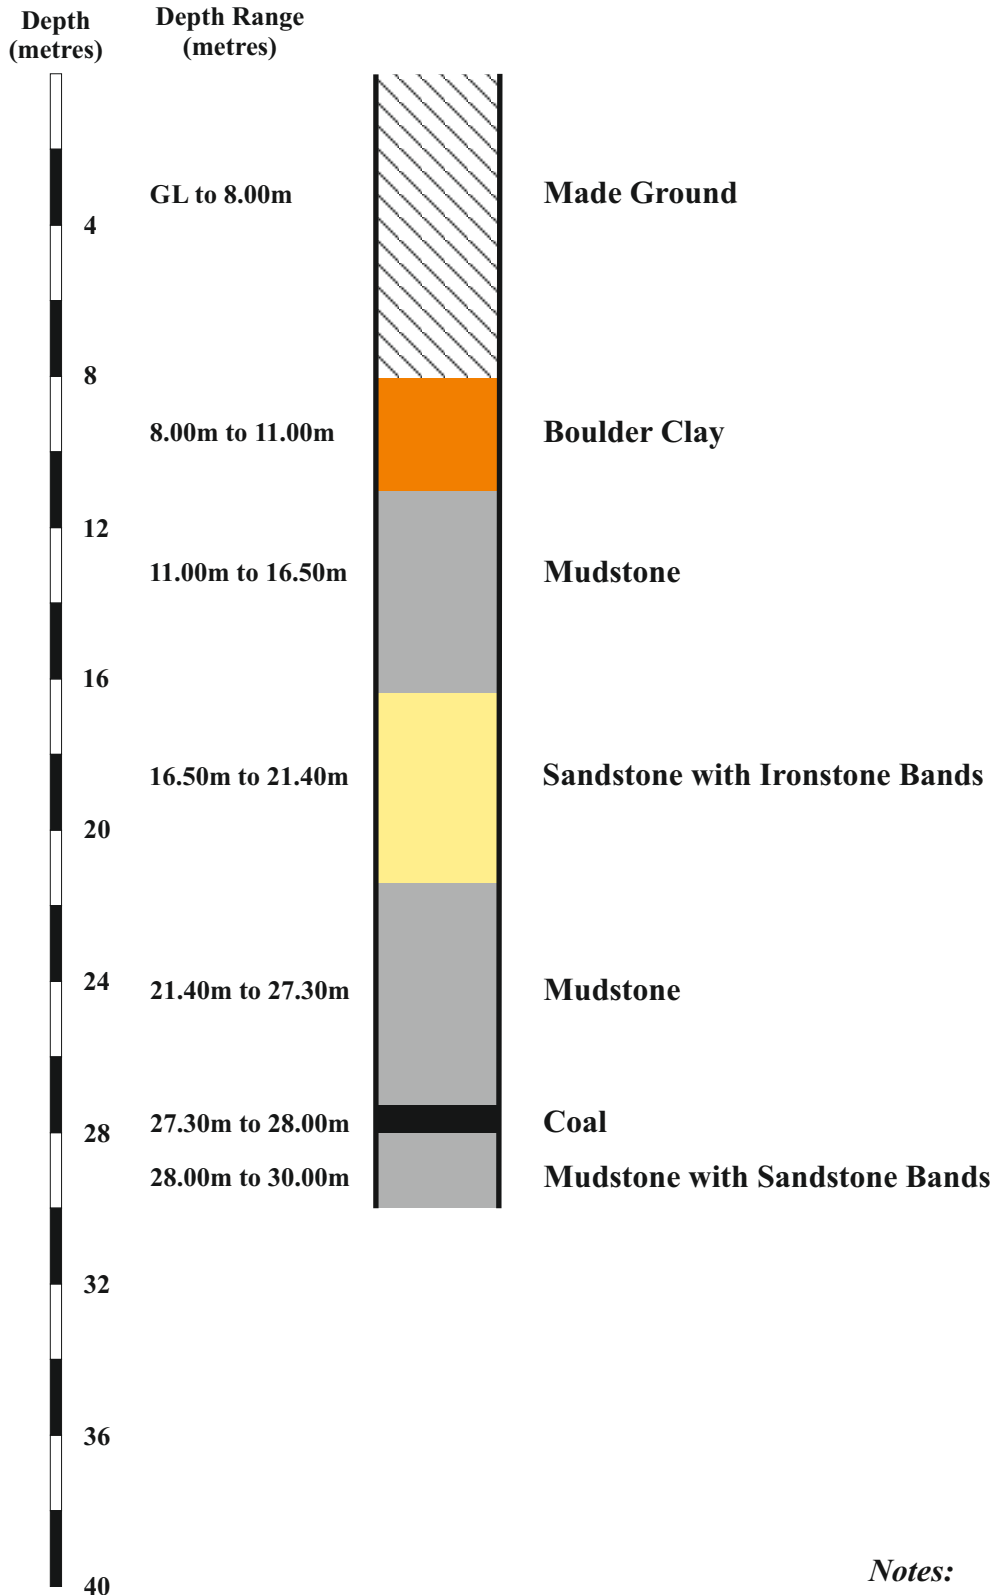
### *Borehole No. 8*

1. *Driller's Descriptions.*
2. *Borehole dry.*
3. *Total depth of borehole, 30.00m.*
4. *Cased 10.50m.*

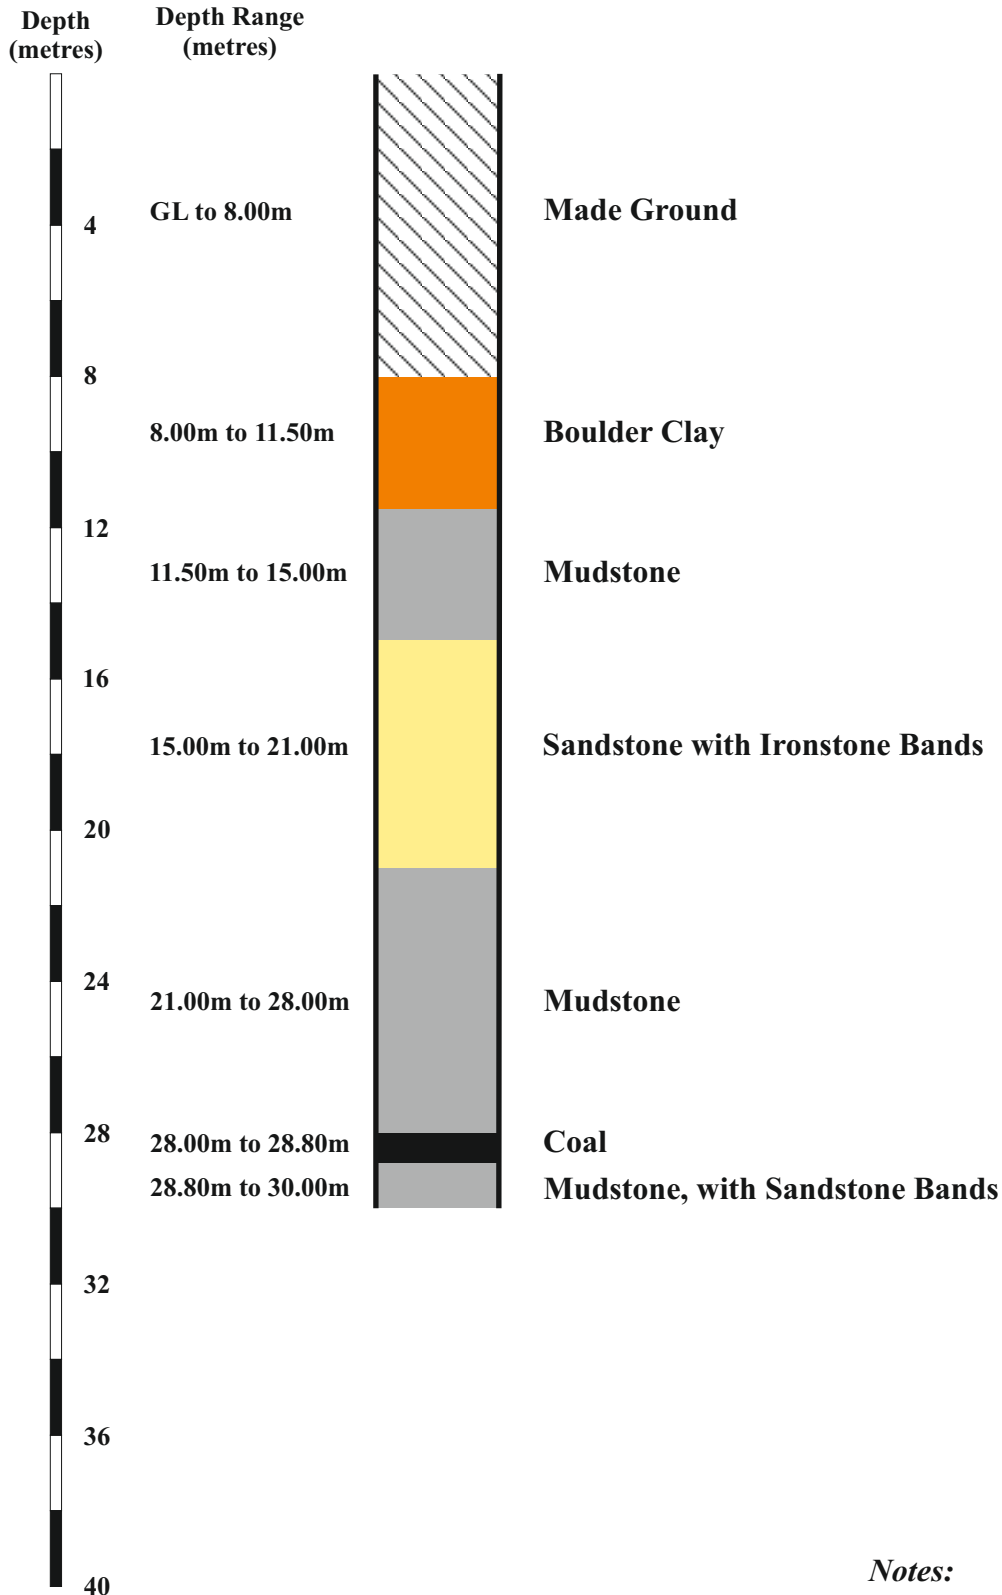
### *Borehole No. 9*

- 1. Driller's Descriptions.*
- 2. Borehole dry.*
- 3. Total depth of borehole, 30.00m.*
- 4. Cased 10.50m.*
