*Report No. BC/MB/03.17.02.*

# **Mining Risk Assessment: Land at Gelligaer Road, Trelewis**

**Ms J Creese**

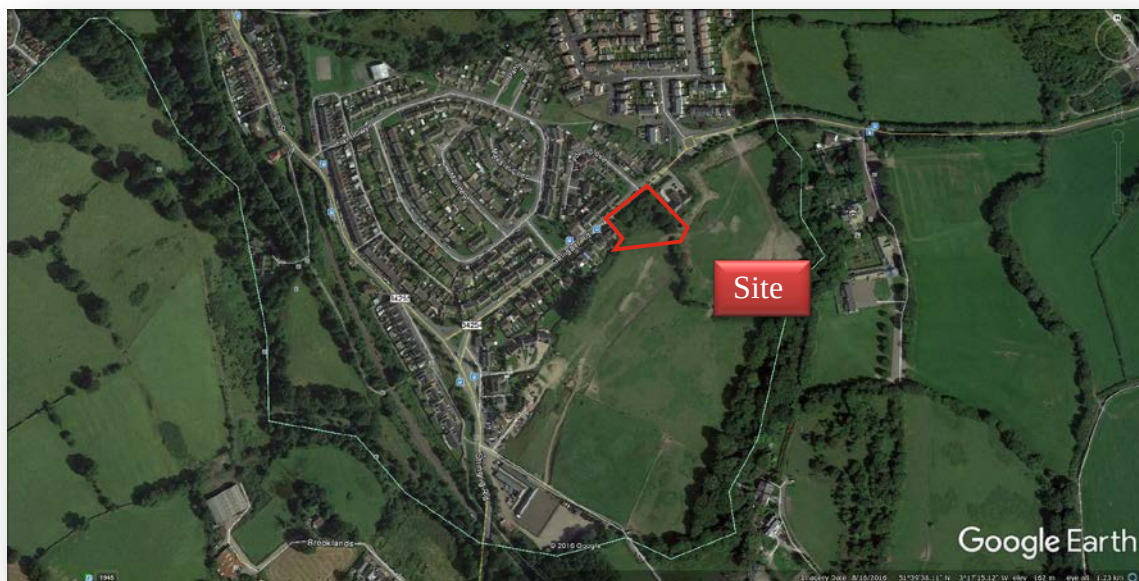
**Figure 1**  
**Aerial View of Site**

The parcel of land that is the subject of this report ('the Site') is located at the south-eastern fringes of the settlement of Trelewis and is approximately 2km south-east of the centre of Treharris (see *General Location Plan, drawing no. BC/MB/03.17.02.01*). The Site is located on the south side of Gelligaer Road, the B4254, on southerly facing slopes where average ground slopes are 1 in 12. The Site is irregular in outline and with maximum dimensions of approximately 50m by 43m; it is at an approximate elevation of 168m above ordnance datum. The Site lies between a housing estate comprised of semi-detached and detached dwellings and a single, detached dwelling. To the south of the Site there are agricultural enclosures. (see Figure 1 and *Detailed Location Plan, drawing no. BC/MB/03.17.02.03*).
