# BAT SURVEY REPORT

HOOVER SITE,  
MERTHYR TYDFIL

| <b>Project: Hoover Site, Merthyr Tydfil</b> | | |
| <b>Title</b> | Bat Survey Report | |

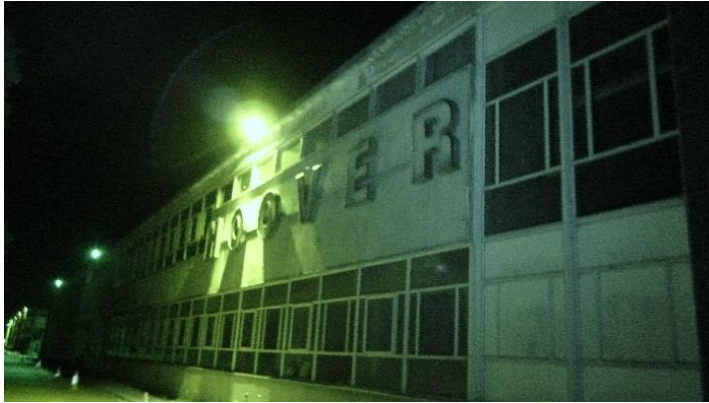
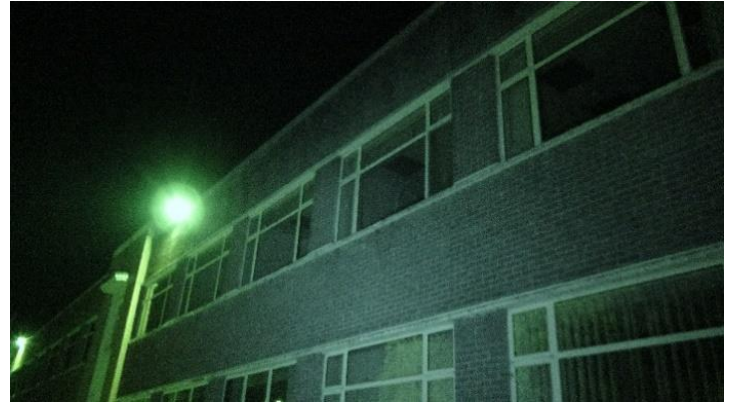
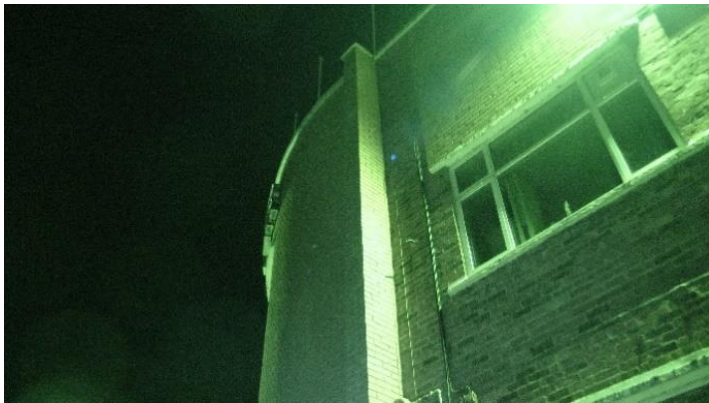
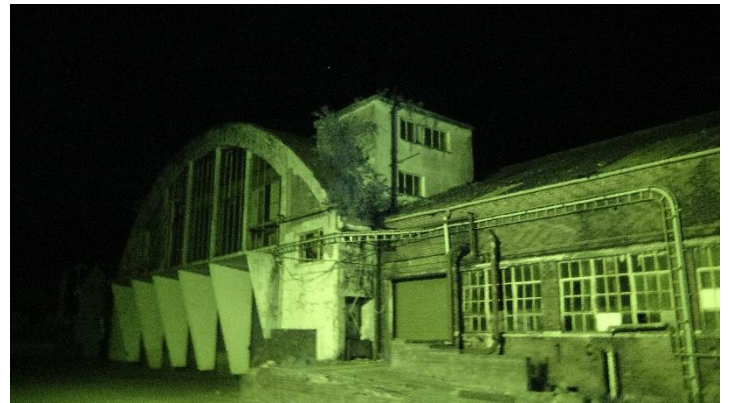
Building 1a.

The screenshots from the IR cameras are shown below; the high levels of light on site are clearly visible.
