# Tynycoedcae Farm, Merthyr Tydfil

## Historic building survey

A report for Ray Gee Construction  
By Johnny Crawford BSc MA MCIfA

GGAT report no. 2019/039  
Project no. P2022  
National Grid Reference:  
SO 01457 07480

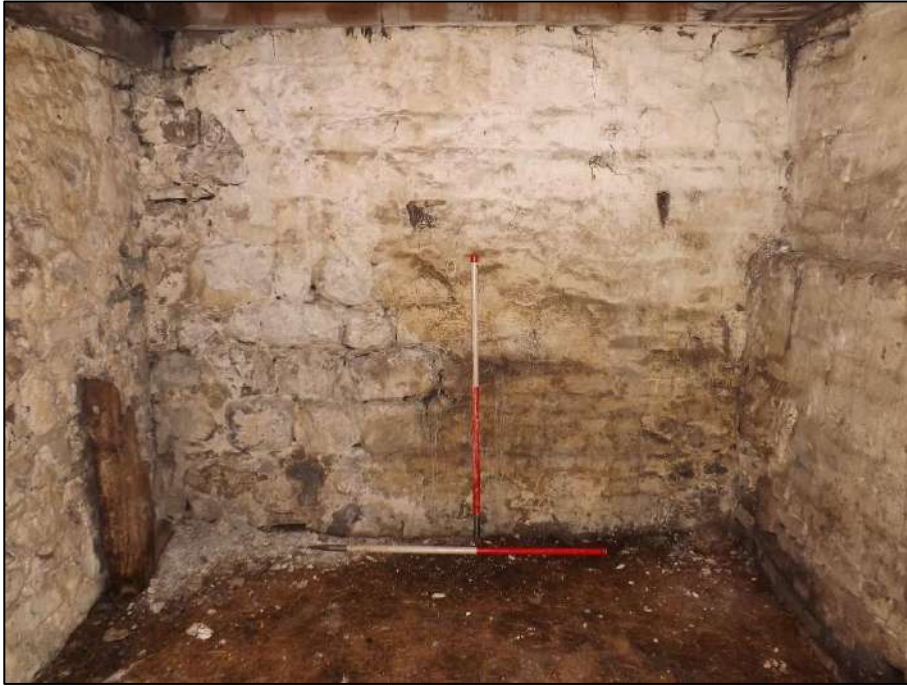
**Plate 24. West elevation of barn as seen from inside Annexe 3. Scale 1m.**

This was the smallest of the three annexes, measuring 2m by 4m and had been built by utilising the north wall of Annexe 2, the west elevation of the barn and building an 'L' shaped wall to enclose the room. The annexe featured a combination of brick and stone in the construction but stone predominated. The interior was whitewashed and featured a brick and cobble floor. The doorway had originally been wider, perhaps being 1.6m wide but had been partially blocked with brick and stone to narrow the entrance and create a window. The roof was intact, consisting of slates supported by timber joists.

Annexe 3 appeared to have been used as a store room or similar but may have initially been built as a small animal pen. The floor sloped to the west possibly to aid drainage, and the wide door as was initially constructed would aid the passage of animals or larger equipment.

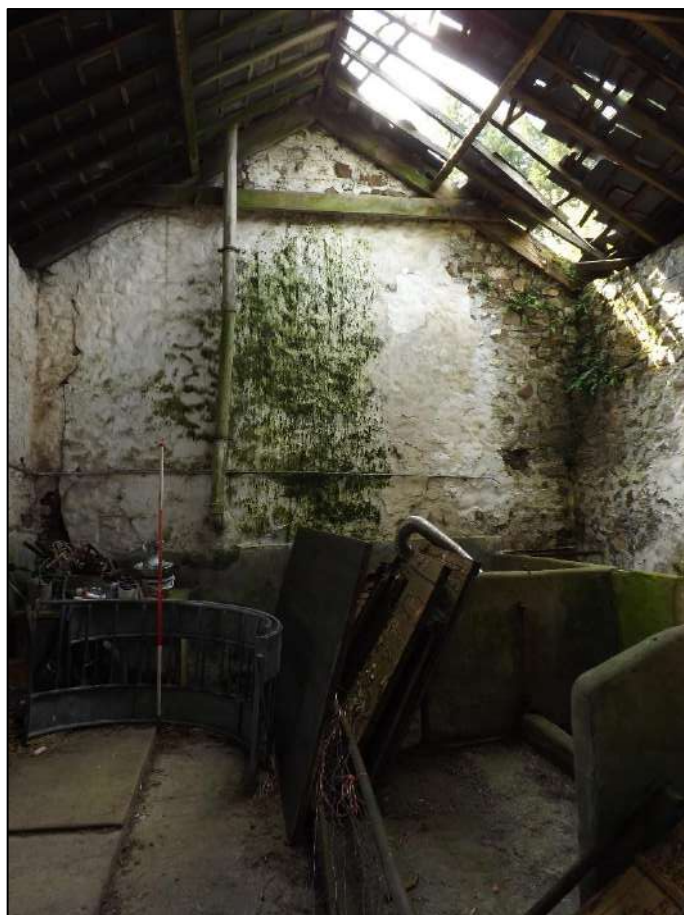
**Plate 27. Interior of the south wall showing stored farm items and part of the byre. Scale 2m.**

The original roof line of the barn was visible in the walls as a linear break in the stonework, particularly within the western wall. The extant roof was likely to have been the one built following the raising of the roof, consisting of timber joists and purlins with the slates directly attached to timber slats.

Although it was possible to see where the roof line had been raised, there was no evidence to suggest that the barn had ever possessed an upper floor.

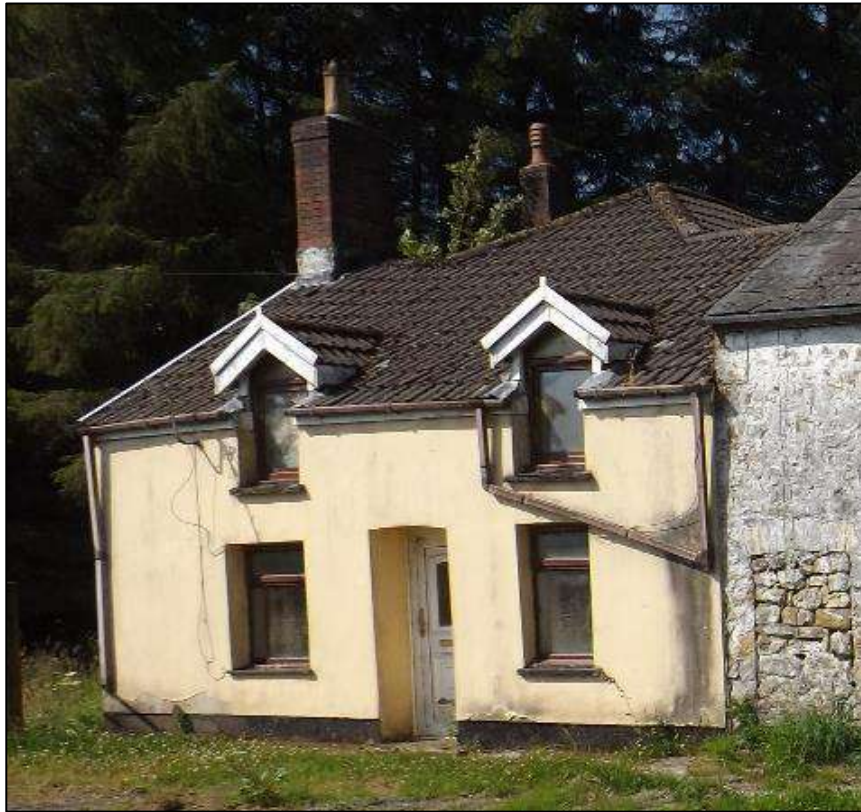
The east elevation formed the main entrance into the cottage and was furnished with two windows on the ground floor, each located either side of the front door and two dormer type windows to the first floor. The roof line was situated at the same height as the original roof line for the barn and there is a possibility that the cottage was built to incorporate the south end of the barn. This is supported by the similarity of the arch over the cottage front door to those over the barn doors. The entire elevation was rendered with concrete and the cottage possessed a roof made of ceramic tiles. The roof was furnished with lead flashing, wooden soffits and a modern gutter system.

**Plate 31. Oblique view of the east elevation of the cottage. No scale but the doorway measured 2m in height by 1m in width.**

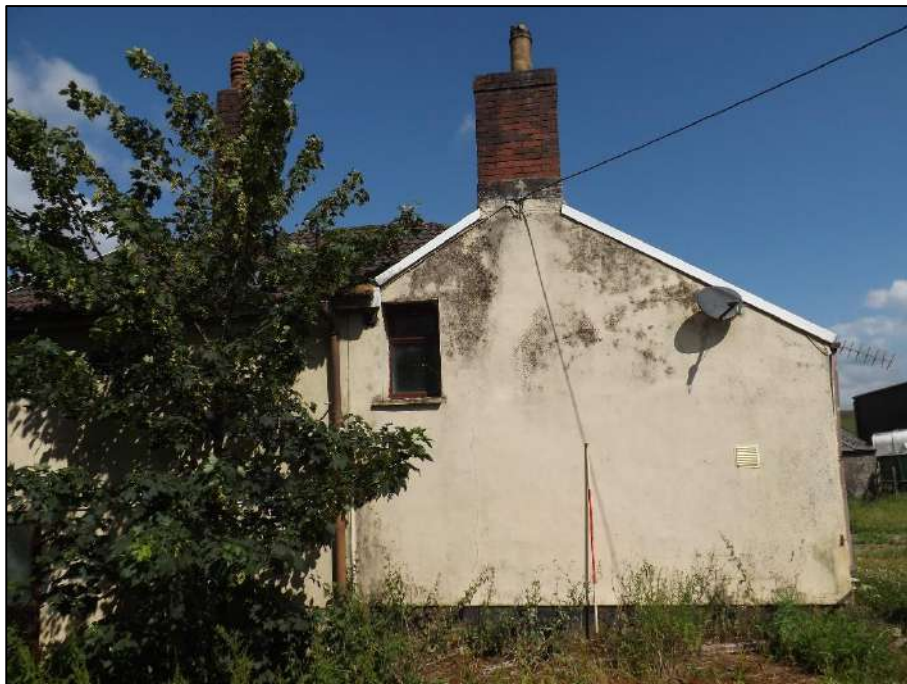
The south elevation was partly obscured by trees but was, in any case rendered with concrete. A single window for the first floor bathroom was located to the west of the chimney stack. Little else can be said regarding the elevation.

**Plate 32. South elevation of the cottage. Scale 2m.**

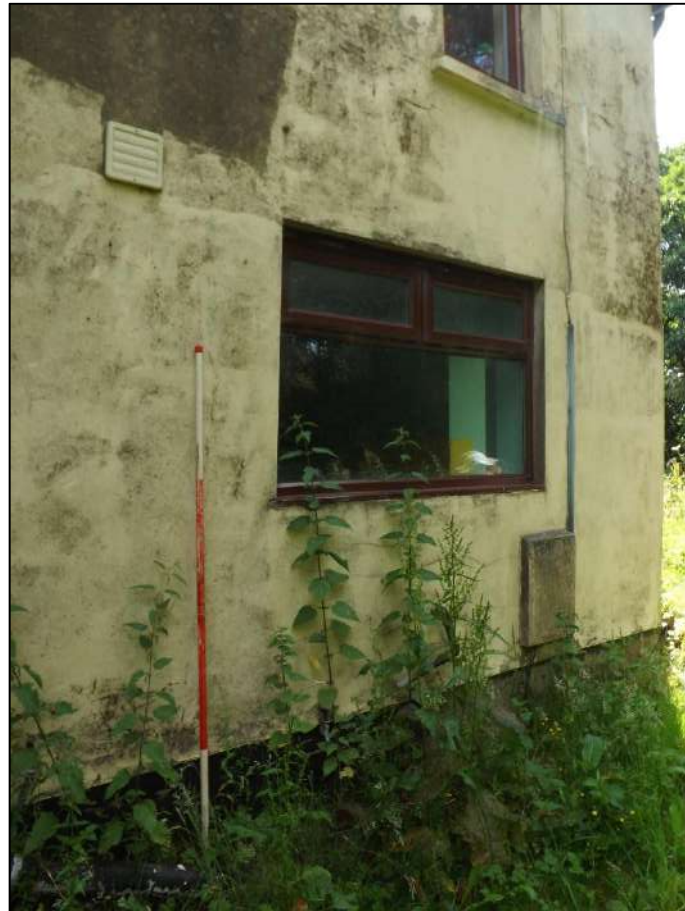
It was not possible to obtain a satisfactory photograph of the cottage west elevation due to the presence of trees. However, the elevation was pierced by four modern windows, two on the ground floor and two on the first floor. The northernmost ground floor window was somewhat recessed and may once have been a doorway that had been converted to a window for the ground floor bathroom.

**Plate 33. Ground floor kitchen window in the west elevation of the cottage. Scale 2m.**

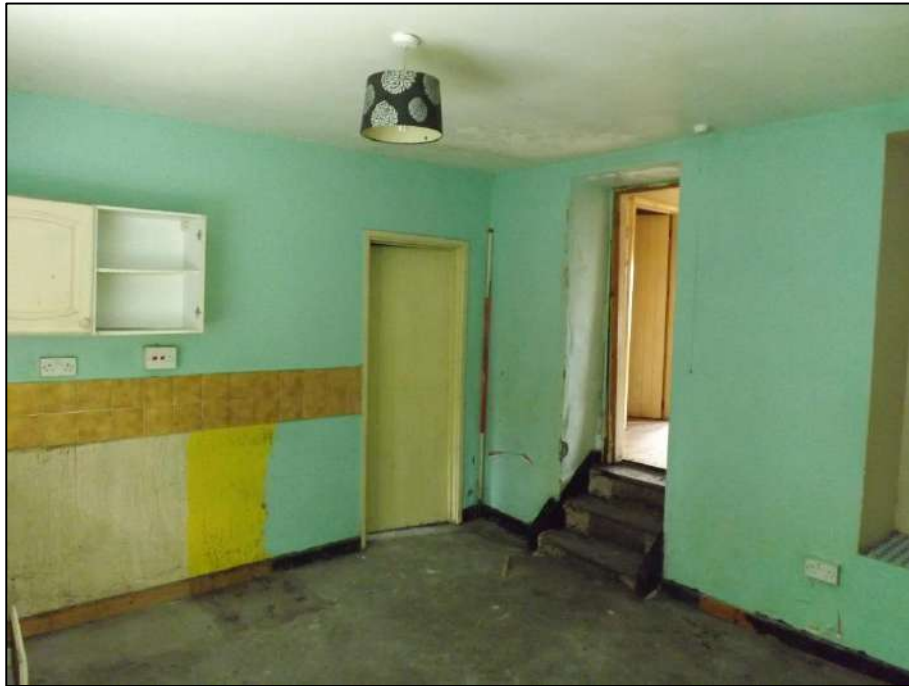
The kitchen area floor was a concrete screed and that of the living room was overlain by a wood effect material. The ceiling in the kitchen area was rendered and that of the living area had exposed but heavily painted beams. The appearance and therefore relative age of these beams was obscured by the paint.

**Plate 34. North east corner of the kitchen showing the steps into the living room and doorway (closed) into the bathroom. Scale 2m.**

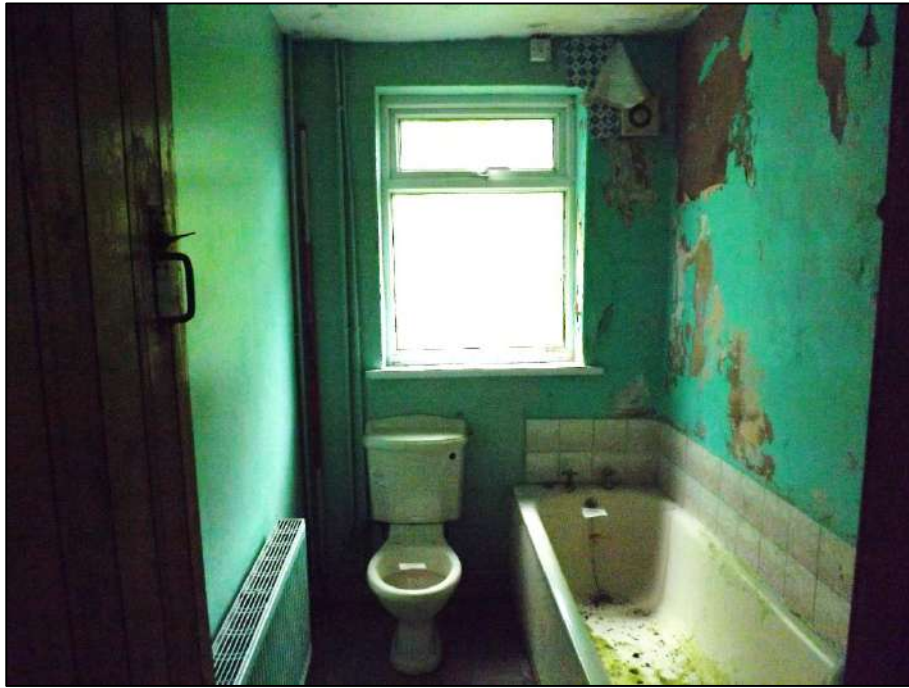
Fittings in the kitchen included a modern sink unit, with the bathroom being an unremarkable modern example.

Plate 36. Modern bathroom on the ground floor. Scale to the left of the toilet 2m.

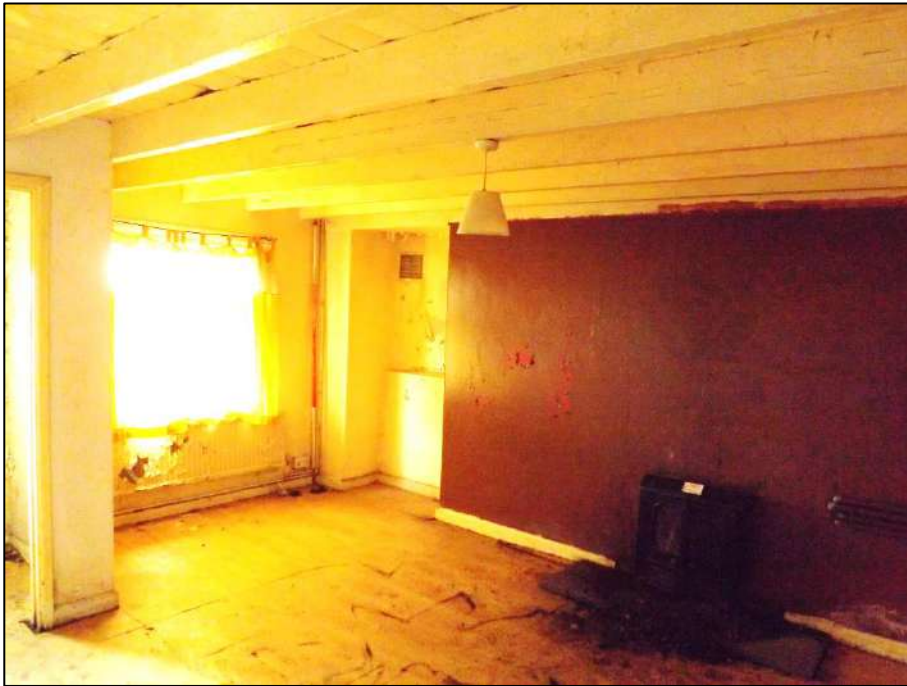
An unusual semi-circular recess, measuring 1m in width by 0.5m in depth was noted in the south east corner which had no apparent function. It was initially thought that this recess was another blocked doorway but as the feature extended to the first floor bedroom above (see below). It is possible that the feature was simply a niche but some thought must be given to the idea of the feature being part of a circular stairway.

**Plate 37. South east corner of the living room. Scale 2m.**

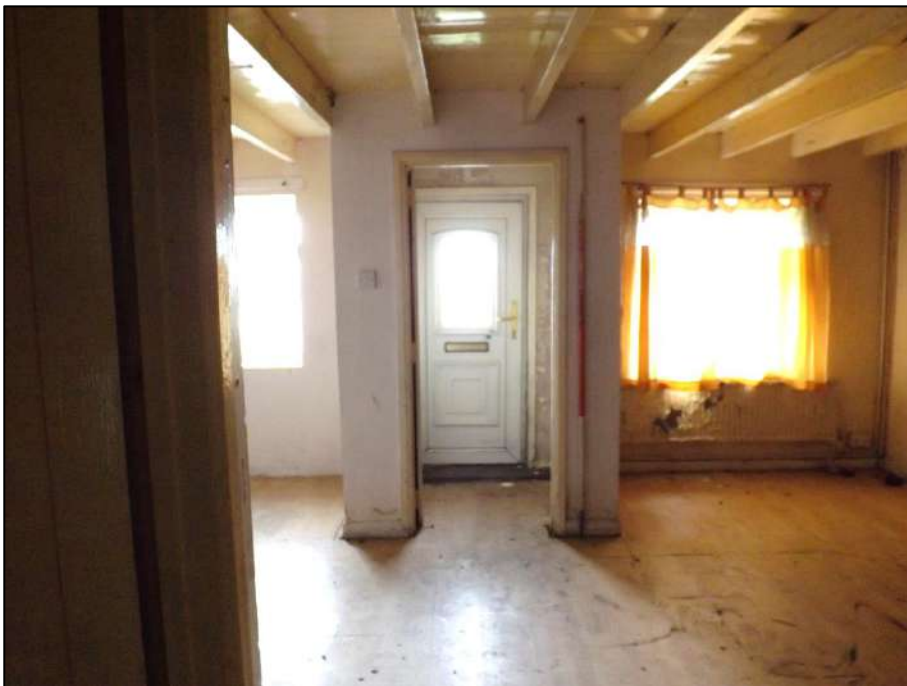
**Plate 38. Internal porch and exposed ceiling beams in the living room. Scale 2m.**

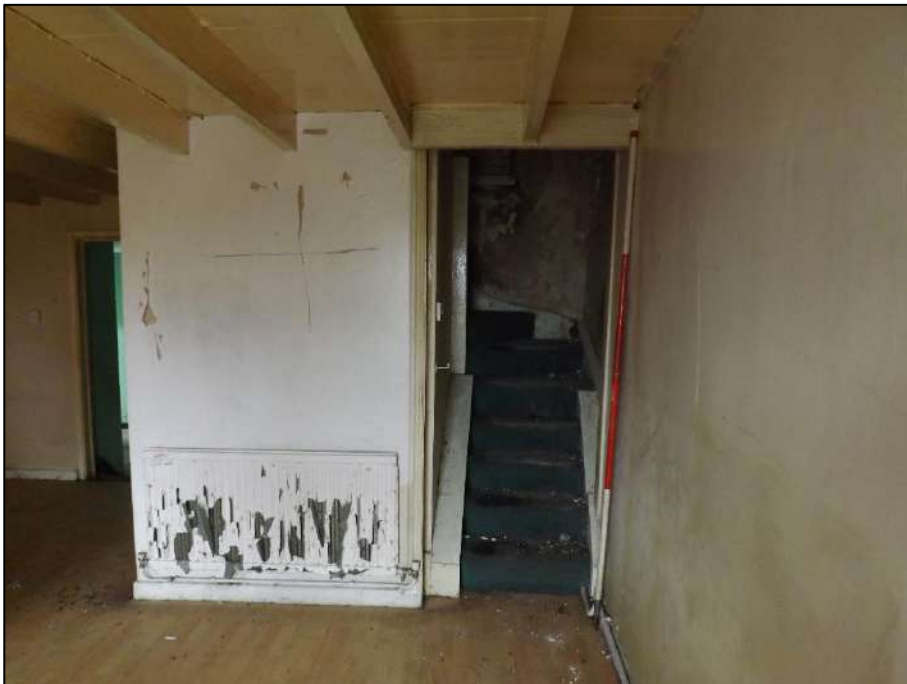
**Plate 40.** View of the stairwell leading to the first floor. Scale 2m.

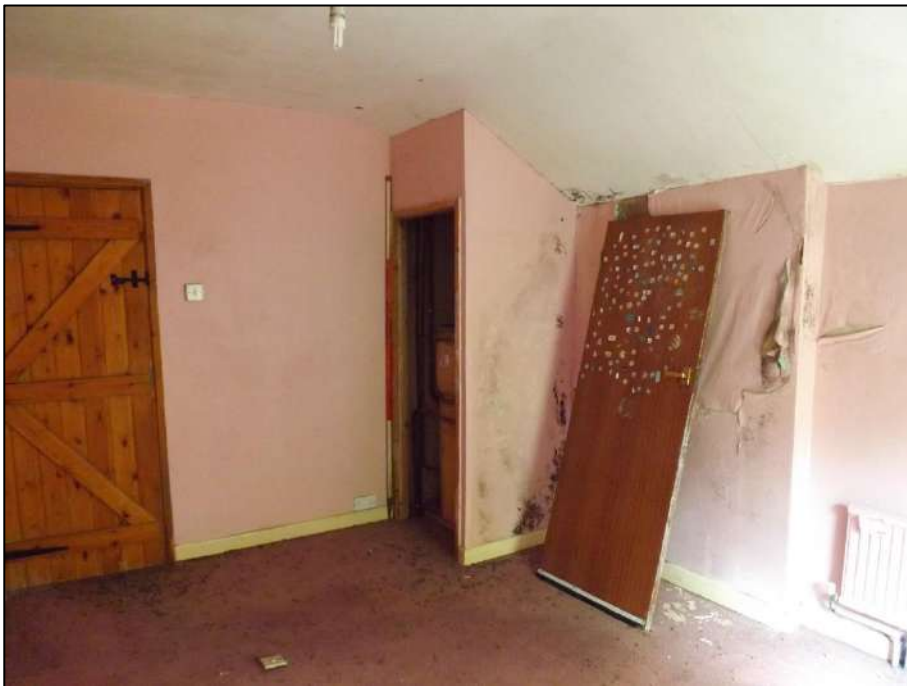
**Plate 43.** Plasterboard boiler cupboard within the south west bedroom. Note the childrens' stickers on the door, the only sign of personalisation within the entire cottage. Scale 2m.

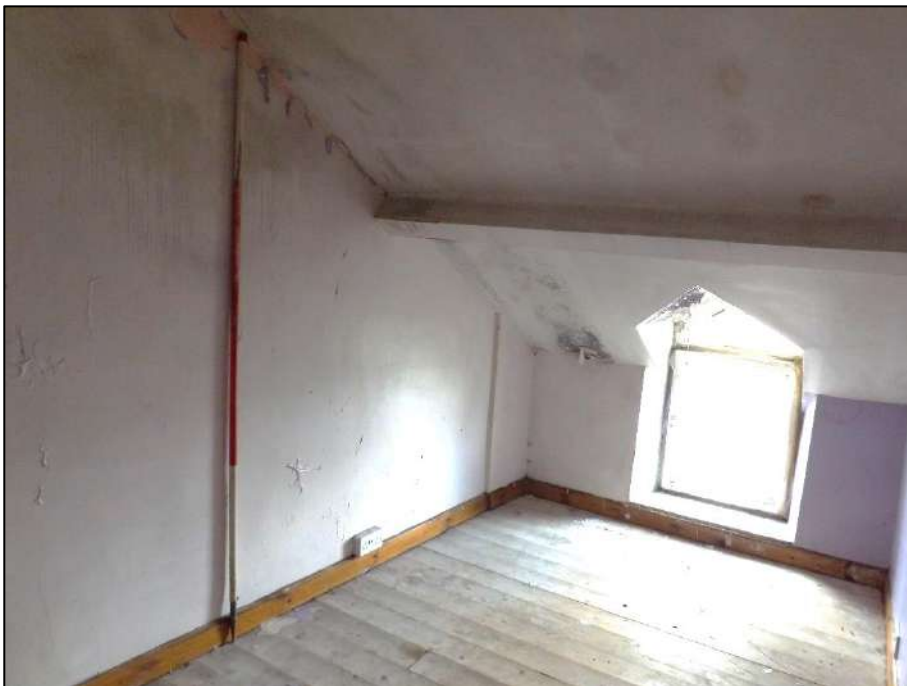
Plate 45. View into the north east bedroom showing dormer window arrangement and plasterboard ceilings.

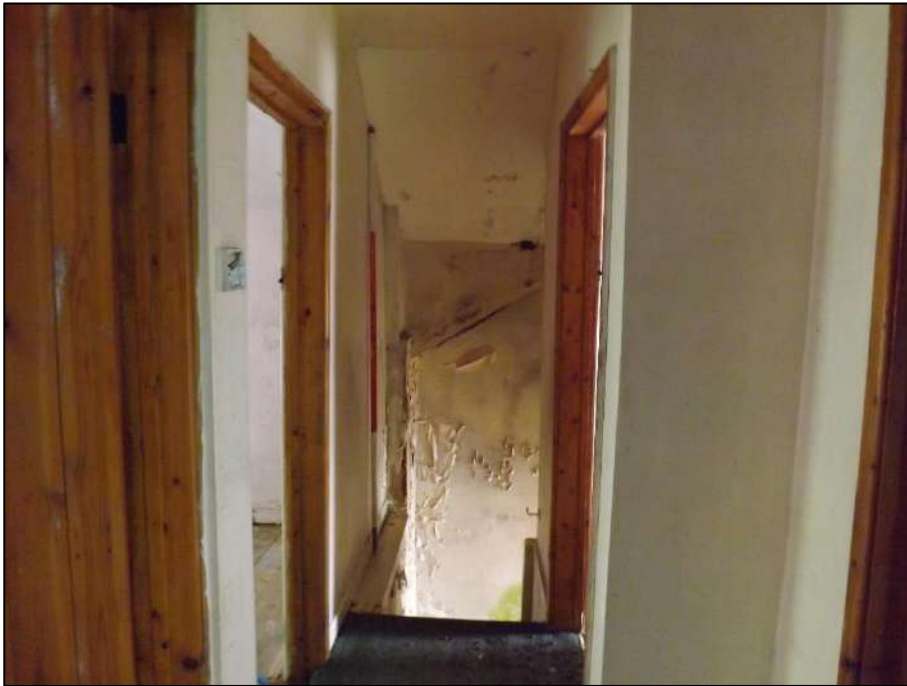
Plate 46. View along the landing towards the stairwell. Scale 2m.

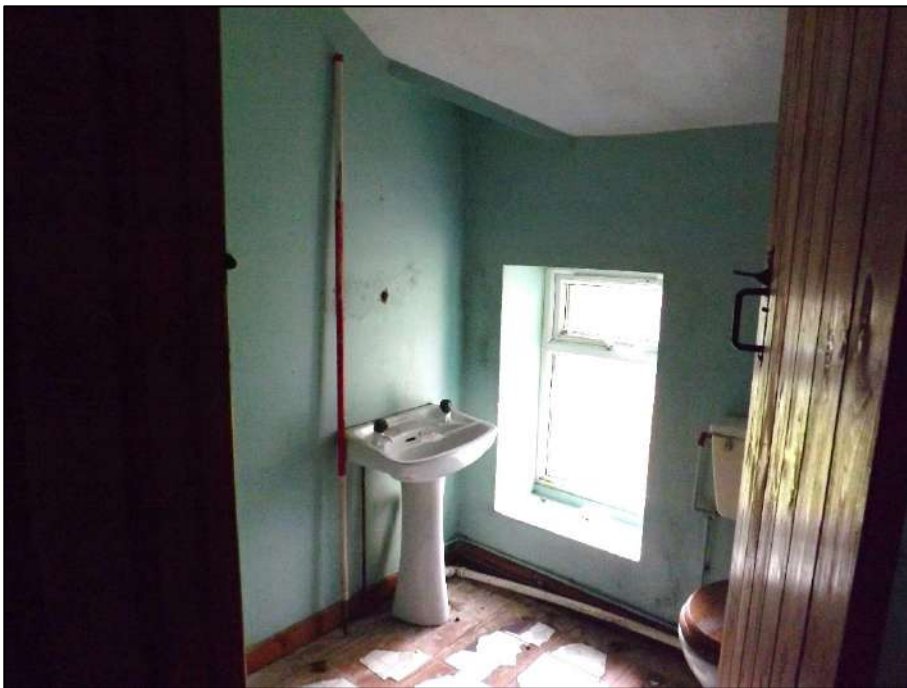
Plate 47. General view of the upstairs toilet and sink. Scale 2m.

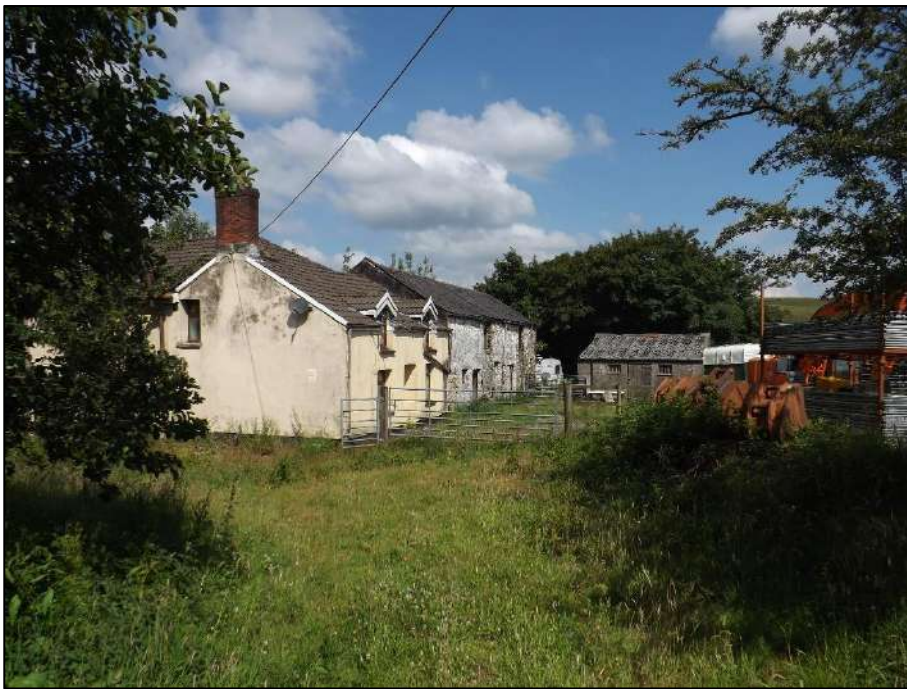
**Plate 49. General view of Tynycoedcae Farm from the original access track.**
