GEOTECHNICAL REPORT  
ON SLOPE STABILITY  
AT  
MERTHYR MOTOR AUCTIONS  
PANT ROAD  
DOWLAIS  
MERTHYR TYDFIL  
CF48 3SH  
10/11/2020

## **INTRODUCTION**

### **1. SITE DESCRIPTION**

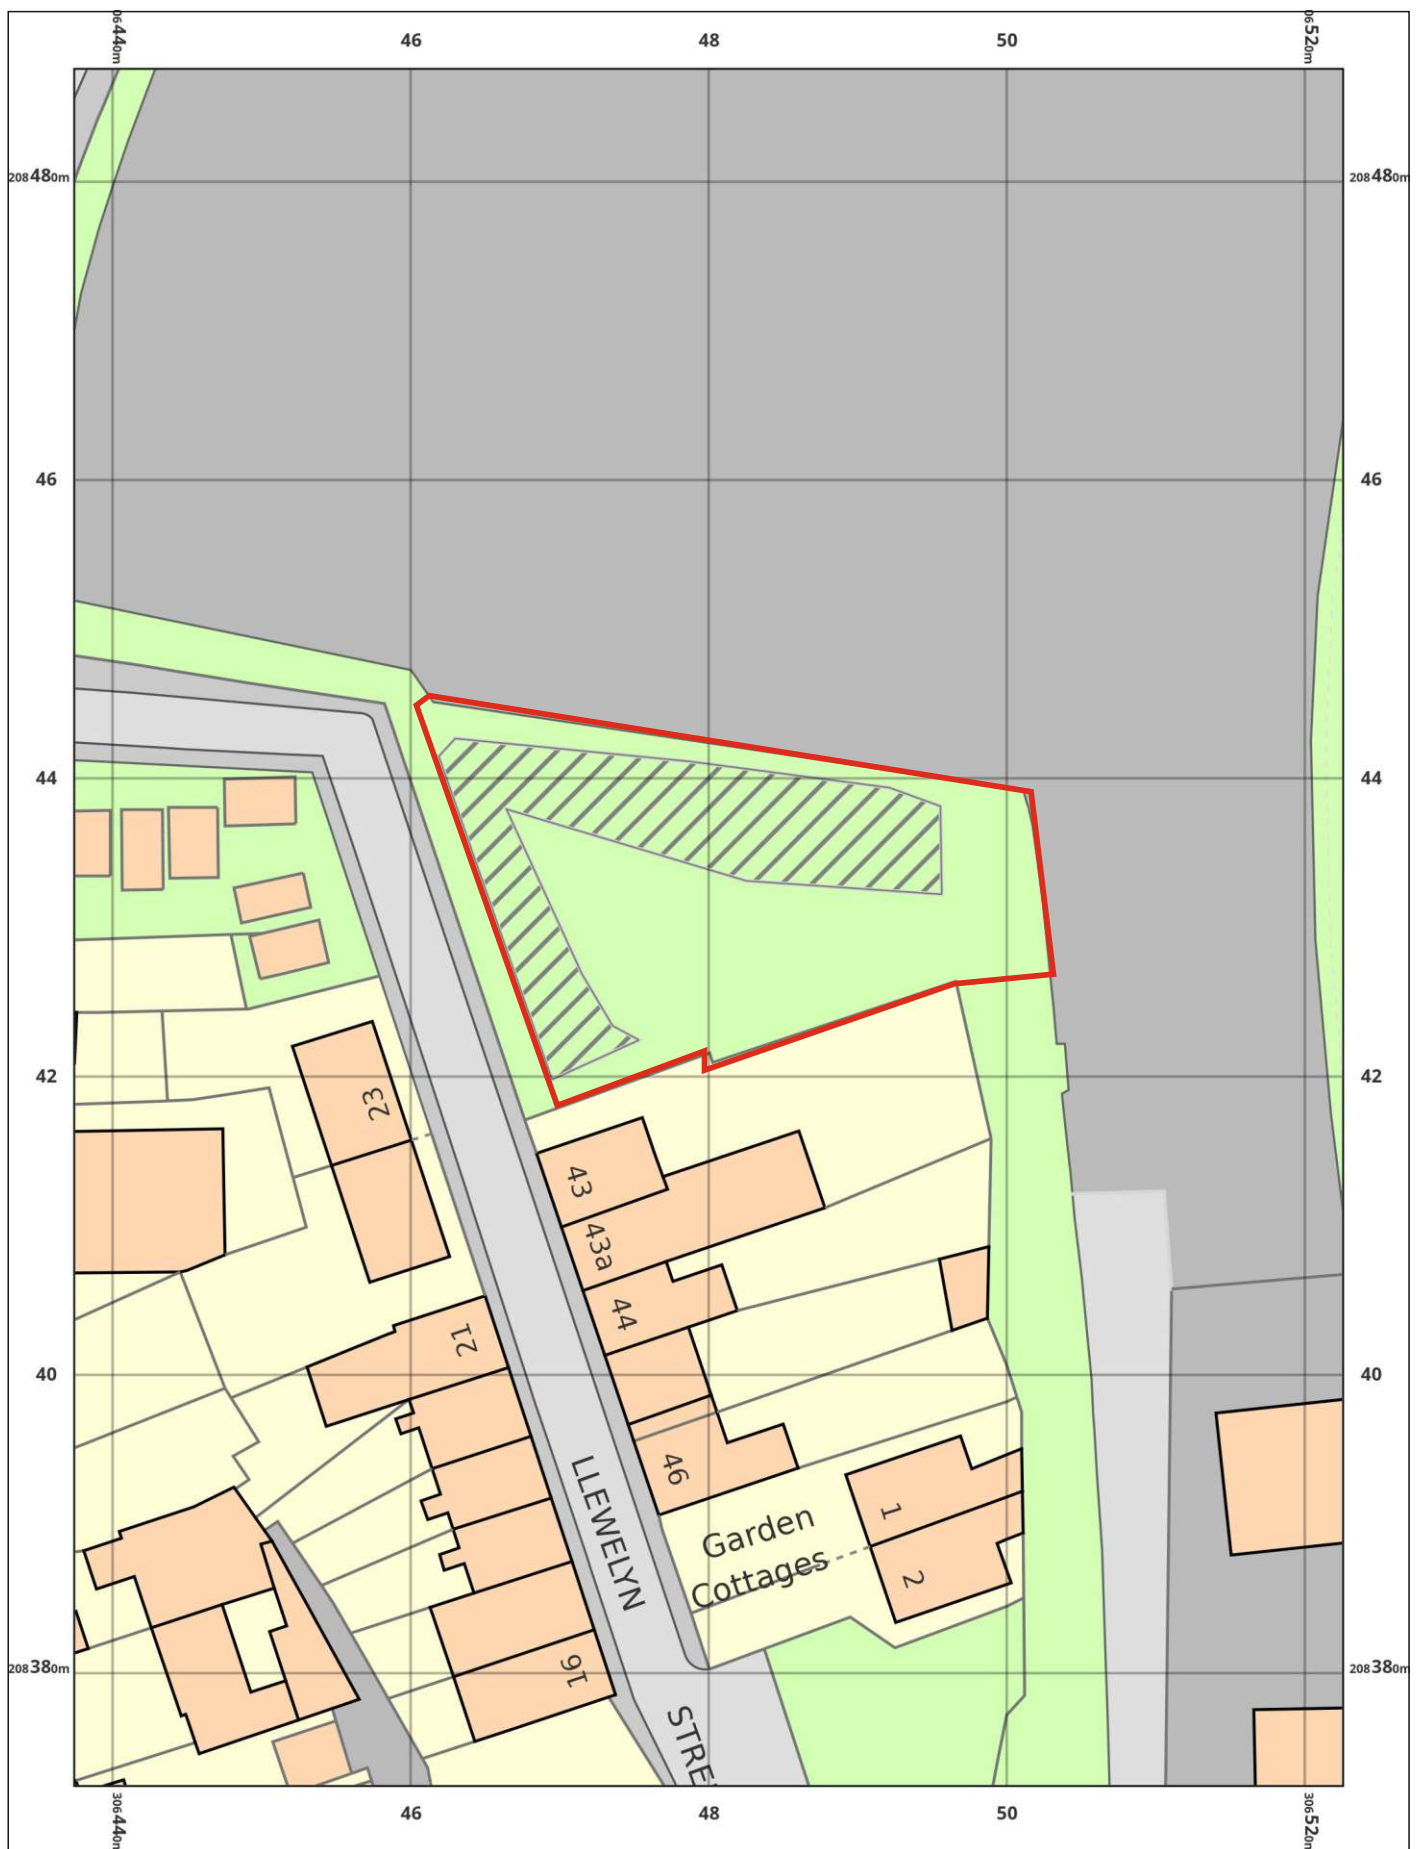
FIGURE 2

THE EMBANKMENT (HIGHLIGHTED) AND SURROUNDING AREA.  
GRID SQUARES ARE TWENTY METRES ACROSS.

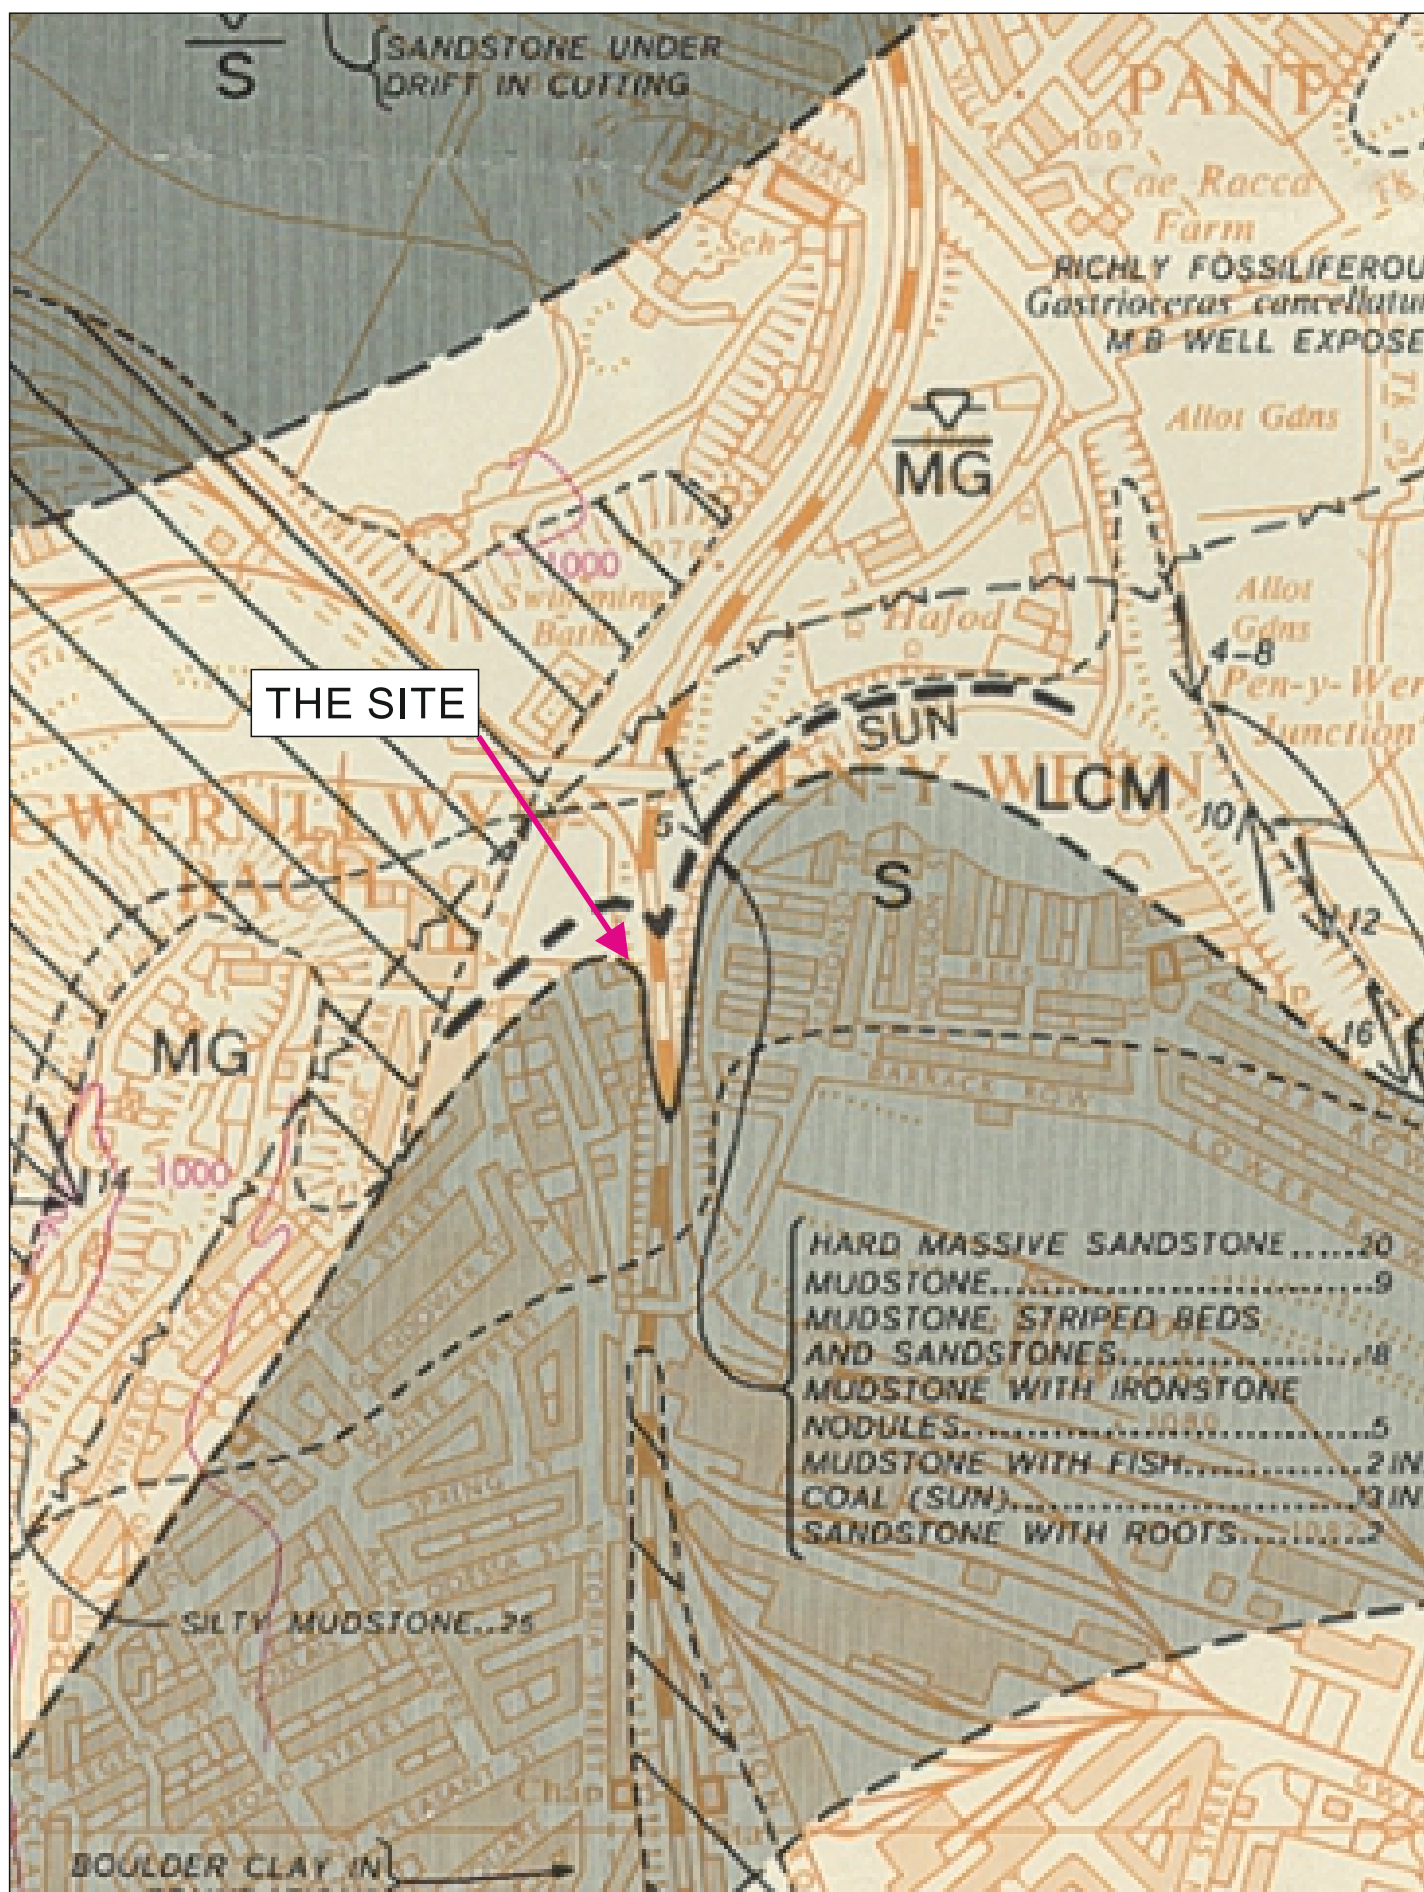
FIGURE 7  
EXTRACT OF GEOLOGICAL SURVEY SHEET SO 00NE. THE O.S. BASE MAP IS FROM 1965 AND THE RAILWAY SERVING THE IVOR WORKS IS STILL IN EXISTENCE.
