**A HERITAGE IMPACT ASSESSMENT**  
*in support of a*  
**RETROSPECTIVE LISTED BUILDING APPLICATION**  
*for*  
**EMERGENCY WORKS**

**at**  
**THE YMCA, MERTHYR TYDFIL**

Pontmorlais West,  
Merthyr Tydfil  
CF47 8UU

**Merthyr Tydfil County Borough Council**

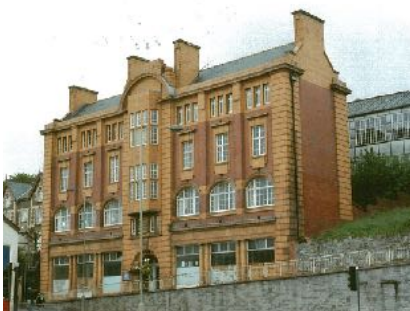
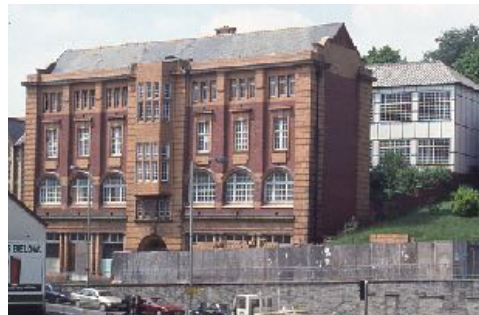
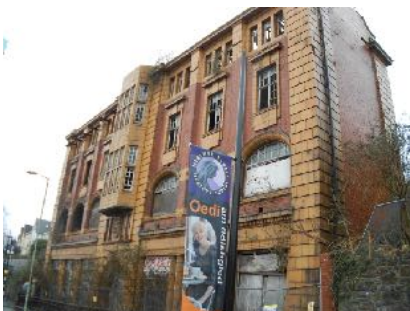
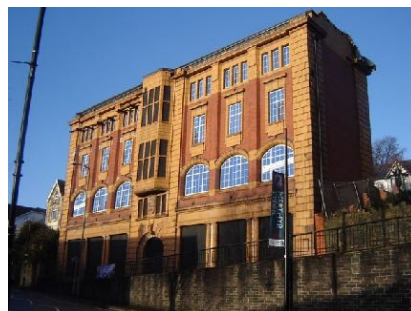
- Above-left: In the late 1980's, the building retaining much of its original appearance.
- Above-right: In the 1990's, various high-level masonry having been removed (to the Front Building side elevation's and the feature arch over the central south oriel window).
- Below-left: Circa 2013, following a devastating fire.
- Below-right: In 2015, following an initial programme of emergency repairs.
