*Report No. BC/MB/07.22.04.*

# **Geo-Environmental Report: Land at The Wern Sports Ground, Ynysfach, Merthyr Tydfil.**

## **Stage 1 Site Condition Report: Land at The Wern Sports Ground, Ynysfach, Merthyr Tydfil.**

and relates to a parcel of land at the Wern Sports Ground, Cae'r-Wen, Ynys Fach Estate, Merthyr Tydfil, where it is proposed to construct a new changing room building ('the Site'). This report is a Coal Mining Risk Assessment and a Stage 1 (Desk Study) Land Condition Assessment that discusses the geology, mining history, and environmental setting of the Site and supports a planning application for the new changing rooms.

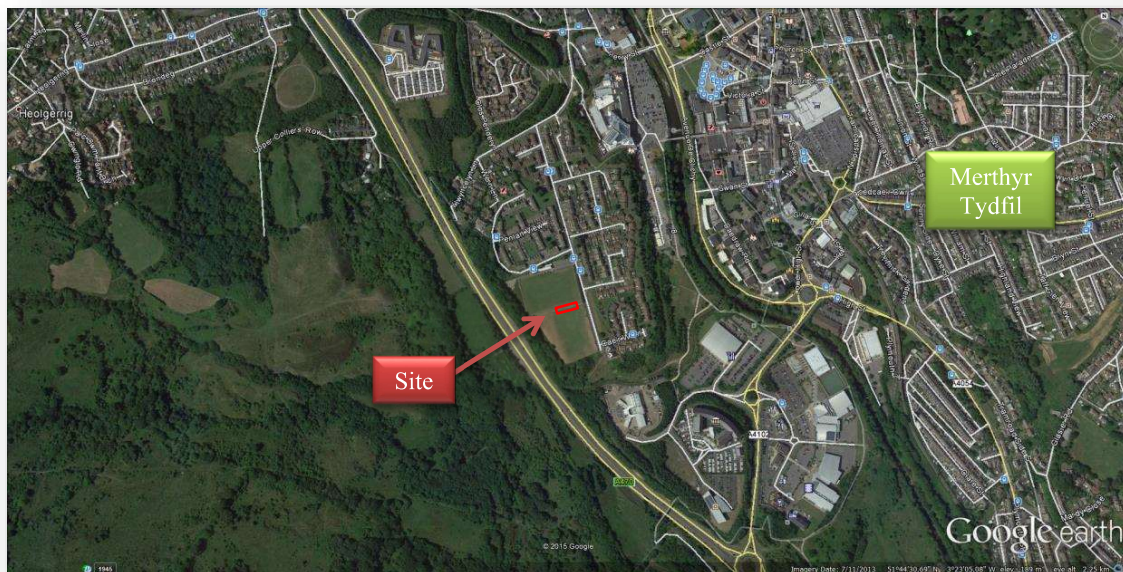
**Figure 1**  
**Aerial View of the Wern Sports Ground**

The Wern Sports Ground is located on the western fringes of Merthyr Tydfil, approximately 600m south-west of the town centre; it is irregular in outline and occupies an area of approximately 0.26 hectares (see Figure 1 and *General Location Plan, drawing no. BC/MB/07.22.04.01*). The plot of land that is the subject of this report, 'the Site' is a rectangular area located fairly centrally within the Wern Sports Ground; it has approximate maximum dimensions of 25m by 6m. The Wern Sports Ground is located in a residential area on the fringes of the town and is bounded on its western side by the A 470 (T), beyond which is open countryside. It is situated close to the floor of the Taff Valley and the Site is at an approximate elevation of 187m aod.
