Welsh Jewish Heritage Centre, Merthyr Tydfil

THE EXTERNAL AREAS

at the Former Synagogue & Primrose Hill

THE PROPOSALS

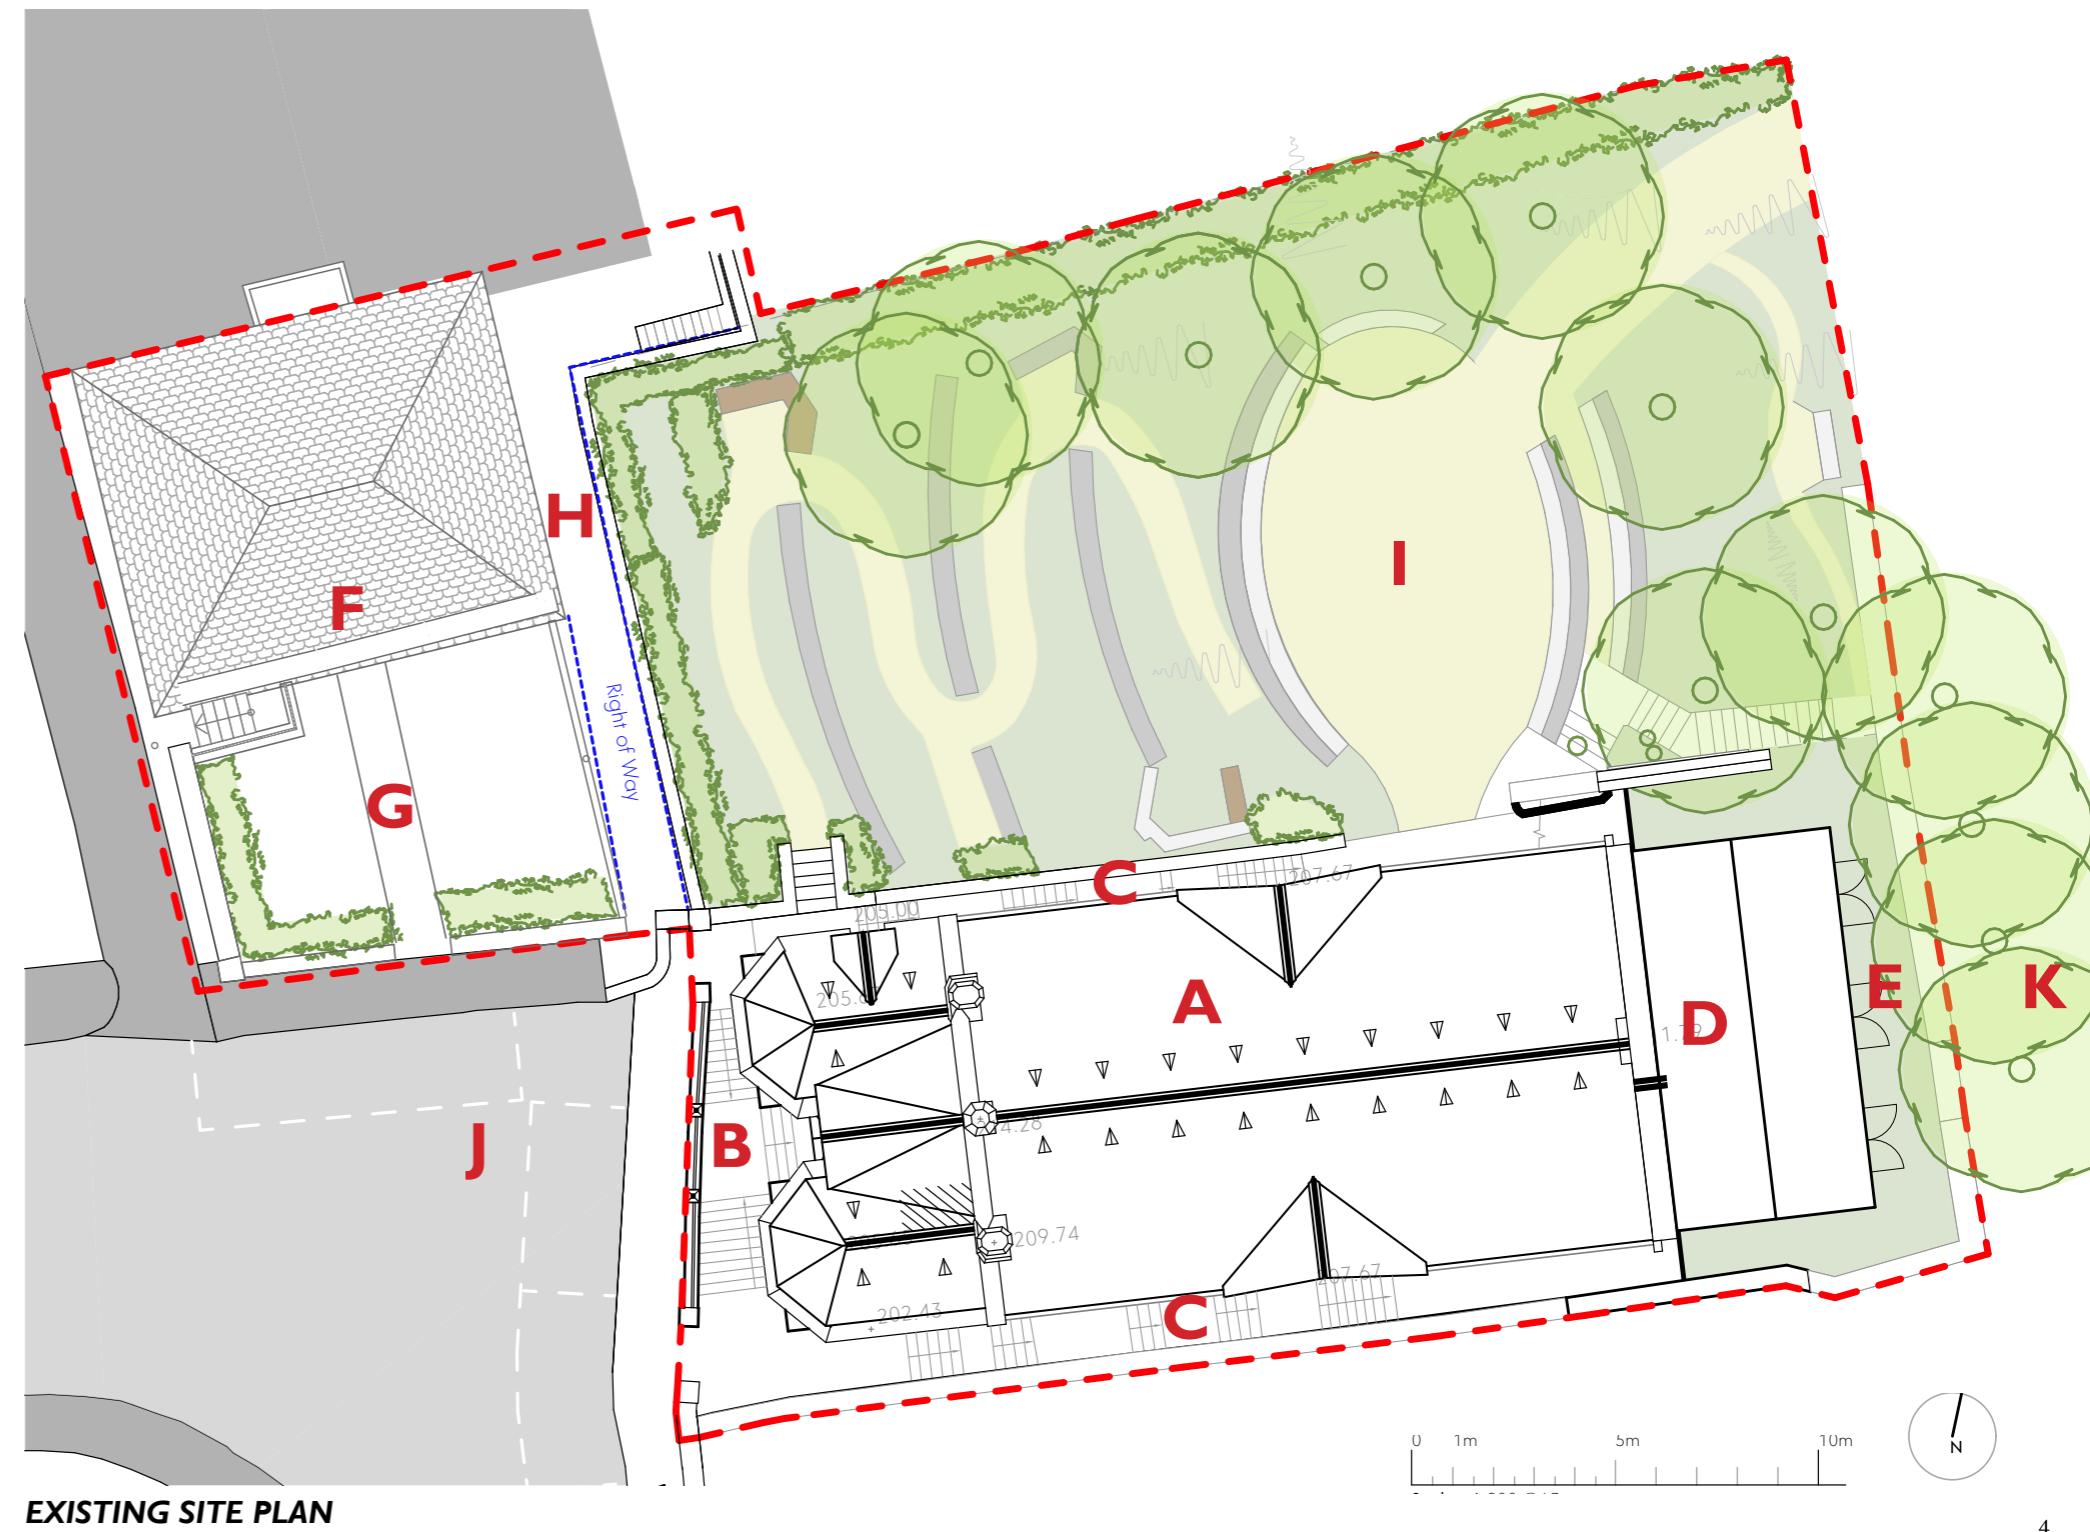
EXISTING SITE PLAN

The Welsh Jewish Heritage Centre comprises the following aspects, for which the letters below relate to the existing site plan to the right:

- A The Former Synagogue
- B Entrance Steps at the Front of the Former Synagogue
- C Two runs of Steps & Retaining Walls to the Sides of the Synagogue
- D Steps and a Retaining Wall at the Rear of the Former Synagogue
- E A narrow strip of derelict land beyond the rear steps
- F Primrose Hill House
- G The Front Garden to Primrose Hill House
- H A 'Right of Way' Path to the east of Primrose Hill House
- I A large area of Derelict Woodland to the North of the Synagogue

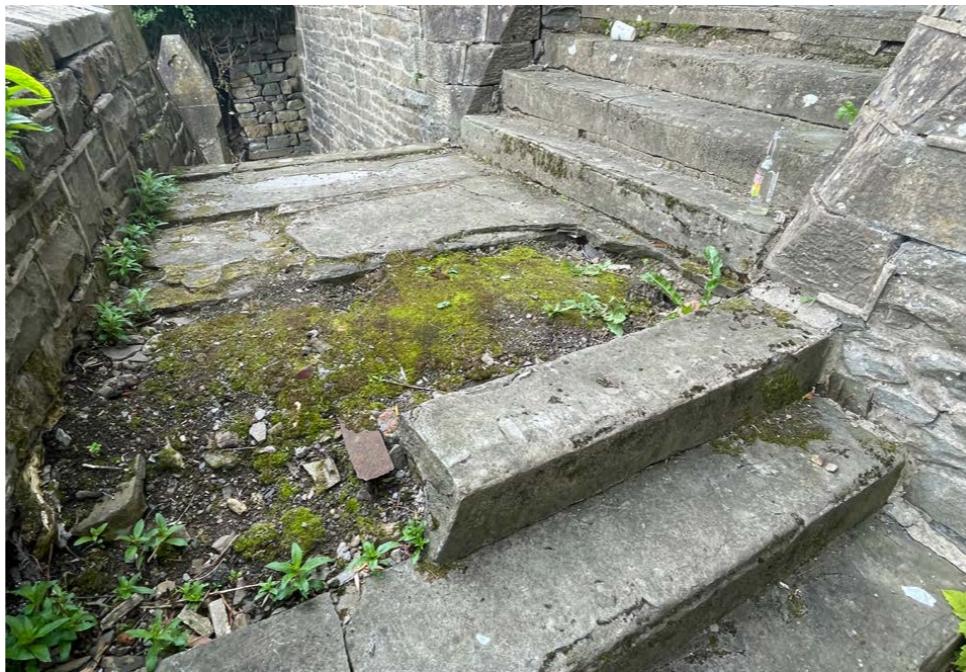
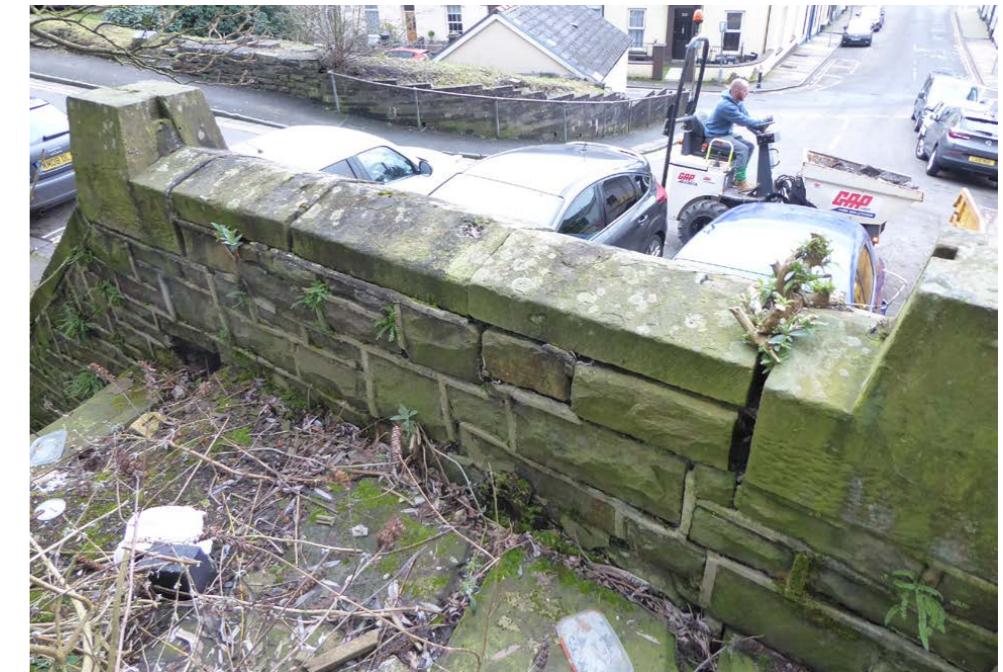
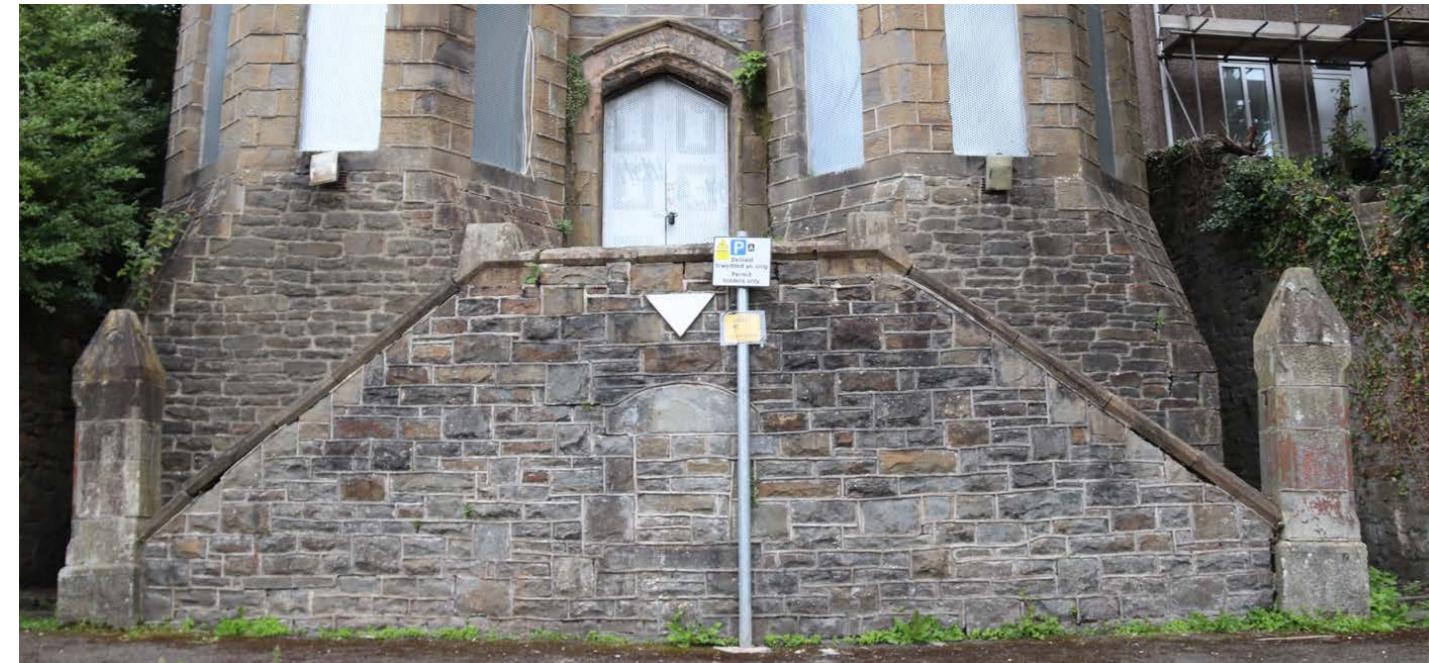
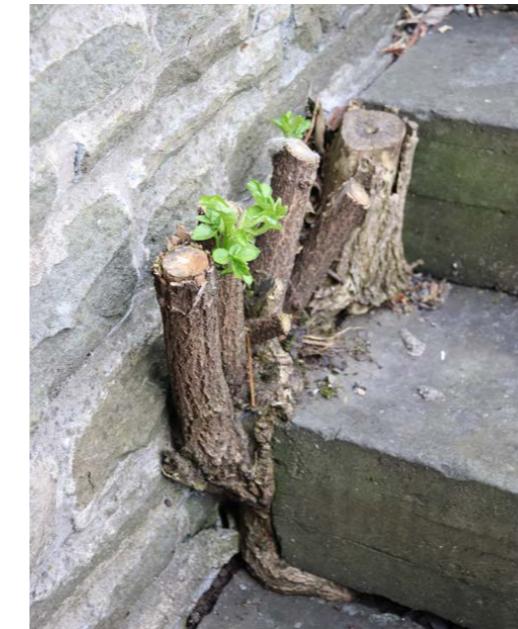
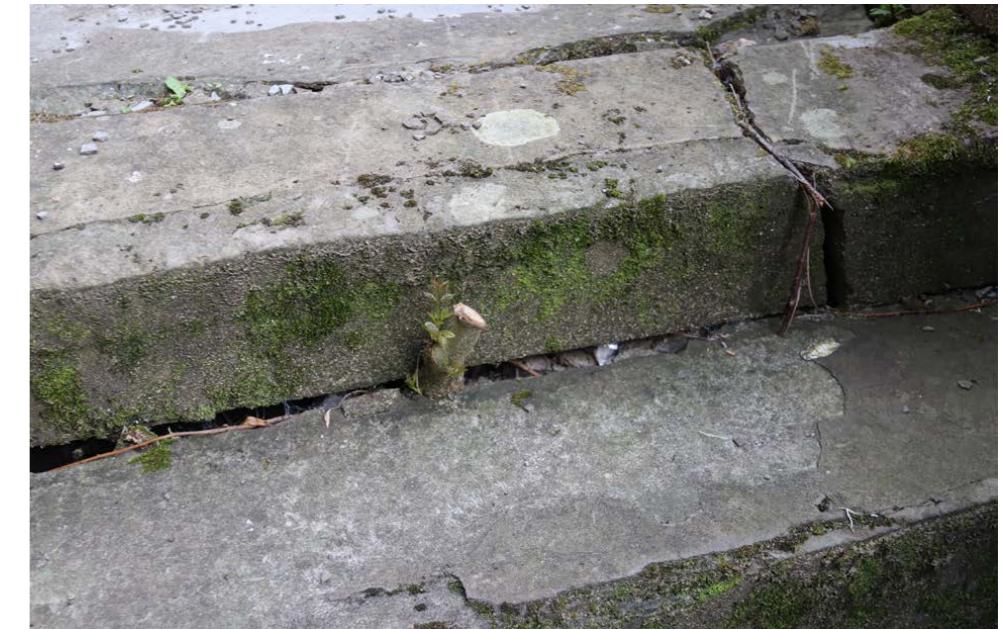
Retaining wall and pillars currently

The stone steps, retaining wall and pillars to the front are in an extremely poor condition; having been pulled apart by buddleia roots and other damage. Steps are partially missing or fractured, the landing has lost much of its surface and the wall and pillars are misaligned. The proposals involve the wall being taken down to level steps; and re-built once all the roots are removed. The stone pillars are to be taken down and re-built straight, once all the roots are removed.

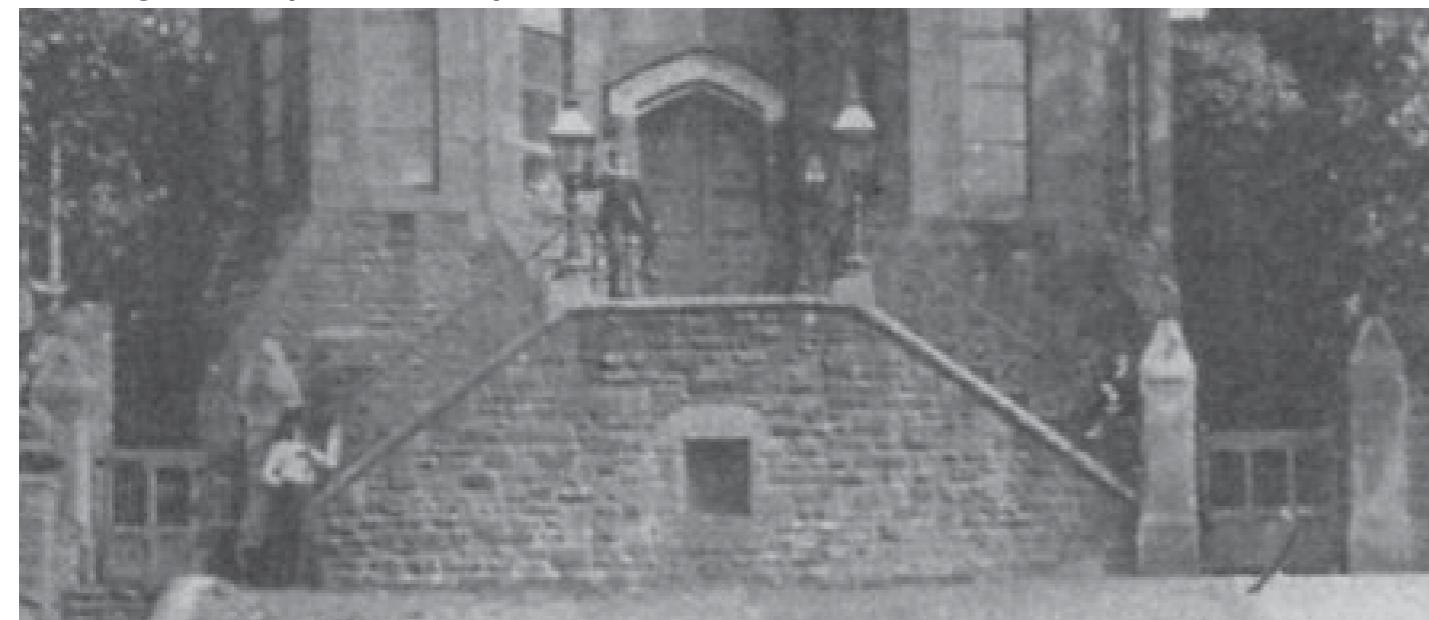
Historical view of Synagogue frontage showing railings and lamps (source: 'alangeorge.co.uk' website)

As the bottom image shows, there used to be decorative iron railings on top of the wall and iron lamp posts with copper heads on the two inner pillars. The proposals reinstate / replicate both the decorative iron railings and the two iron lamp posts with copper heads, which would be pinned down with stainless steel bars, with an electrical supply provided underneath the steps; all as shown in the bottom right hand elevation.

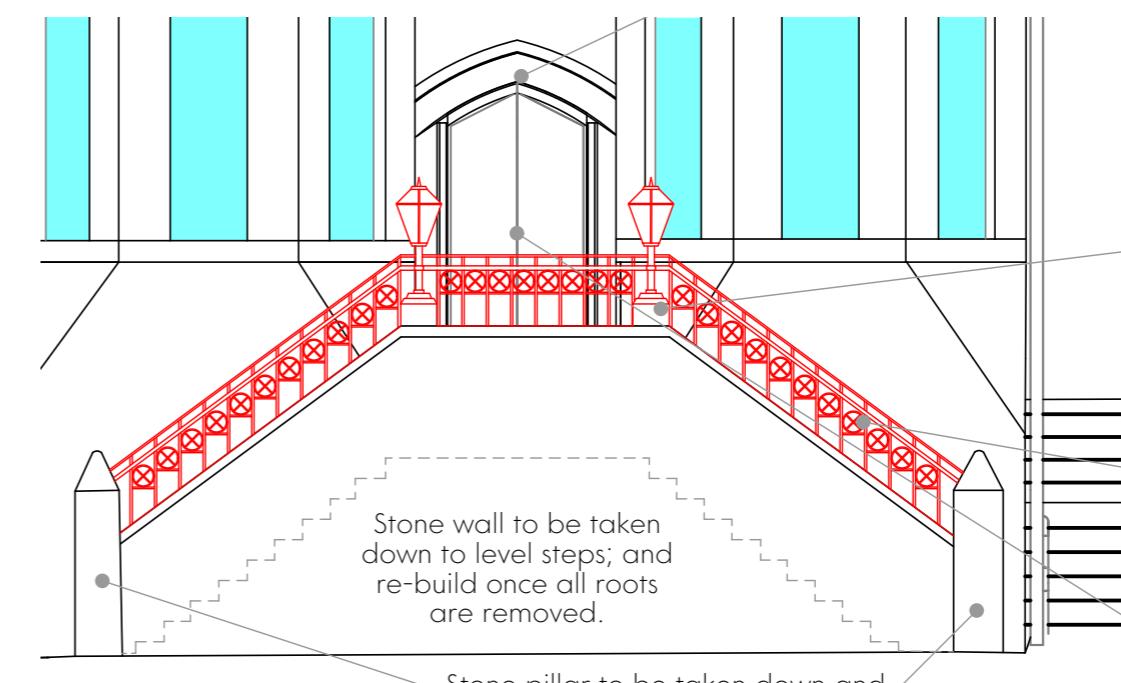
Part Proposed Elevation, showing replica railings & lamps

Replica iron lamp posts with copper heads to be installed on the 2no. inner stone piers, pinned down with stainless steel bars. Electrical supply needed to both.

Install new decorative iron railings, as original on top of wall between piers.

Stone wall to be taken down to level steps; and re-build once all roots are removed.

Stone pillar to be taken down and re-built straight, once all roots removed.

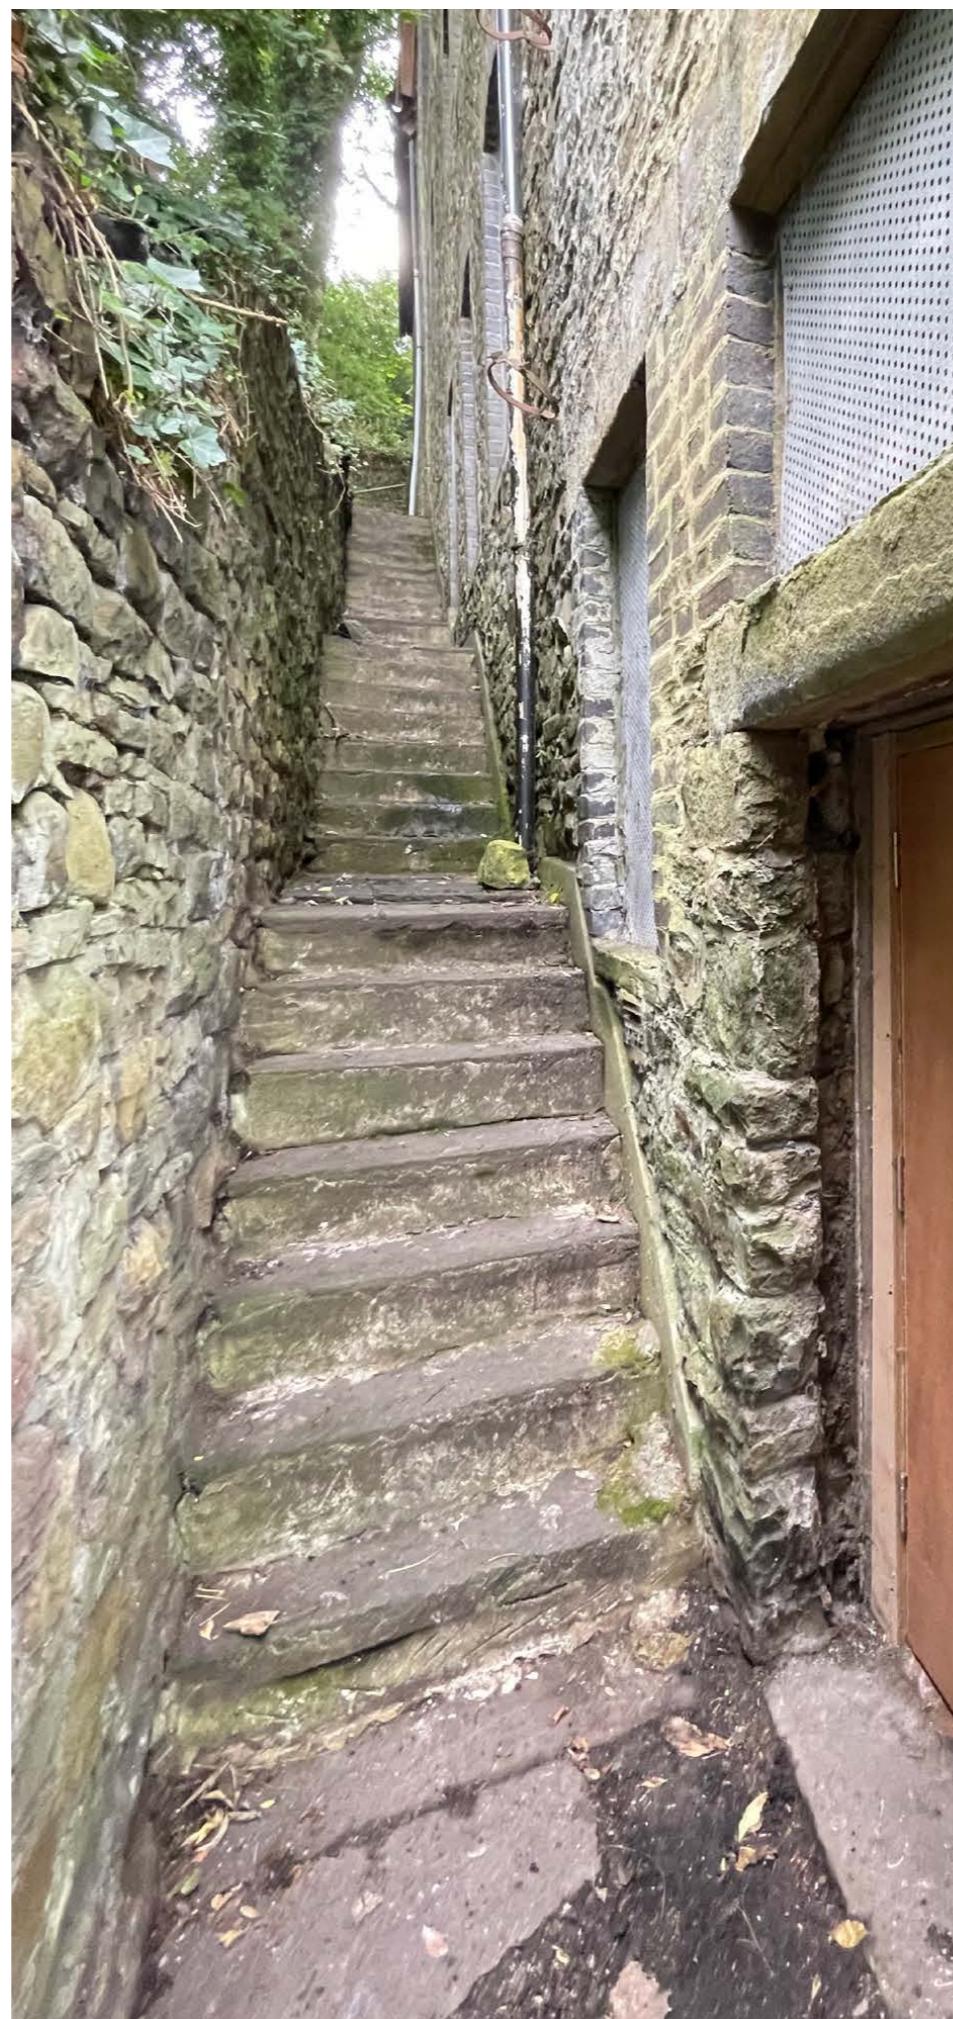
North side steps up the side of the Synagogue

To both sides of the Synagogue, there is a long, steep set of stone steps leading to the rear, with some brick inner body. Both are flanked by a stone boundary wall. Apart from one location on the north wall, the Structural Engineer believe that these walls are either built up from the step level or have a single course below the steps. Also, the steps appear to be embedded into the external wall of the building. Therefore, it is not possible to remove and replace the steps without taking down the walls completely; which is not desired. As a result, it is proposed that these steps are repaired, like-for-like, as best they can in situ. This would likely comprise a step by step repair undertaken from the bottom of the flight to the top. The southern steps are generally in a reasonable condition however there are localised areas in poor condition with degraded treads and landing slabs, and some minor vegetation growth. The northern steps are in poorer condition, with most of the treads failing or locally missing leaving ground material under exposed and vulnerable. The proposals also involve localised repairs to the south wall. A new opening is proposed within the north wall to provide access into the garden, opposite the door into the building.

The rainwater drainage pipework appears to run within these steps, for their full length. These 225mm diameter pipes are encased in concrete on 3no. sides and sit approximately 200mm off the face of the building. They terminate at the bottom of the site. The north pipe appears to be in reasonable condition and in relatively clear; whilst the south pipe is blocked along its lower half. The proposals involve the clearance and in situ repair of these pipes, as far as can be done; and the in situ repair of the steps around the pipes. If possible, a sleeve may be inserted along the length of the pipes to improve their operation and to address any areas of damage which cannot be suitably repaired.

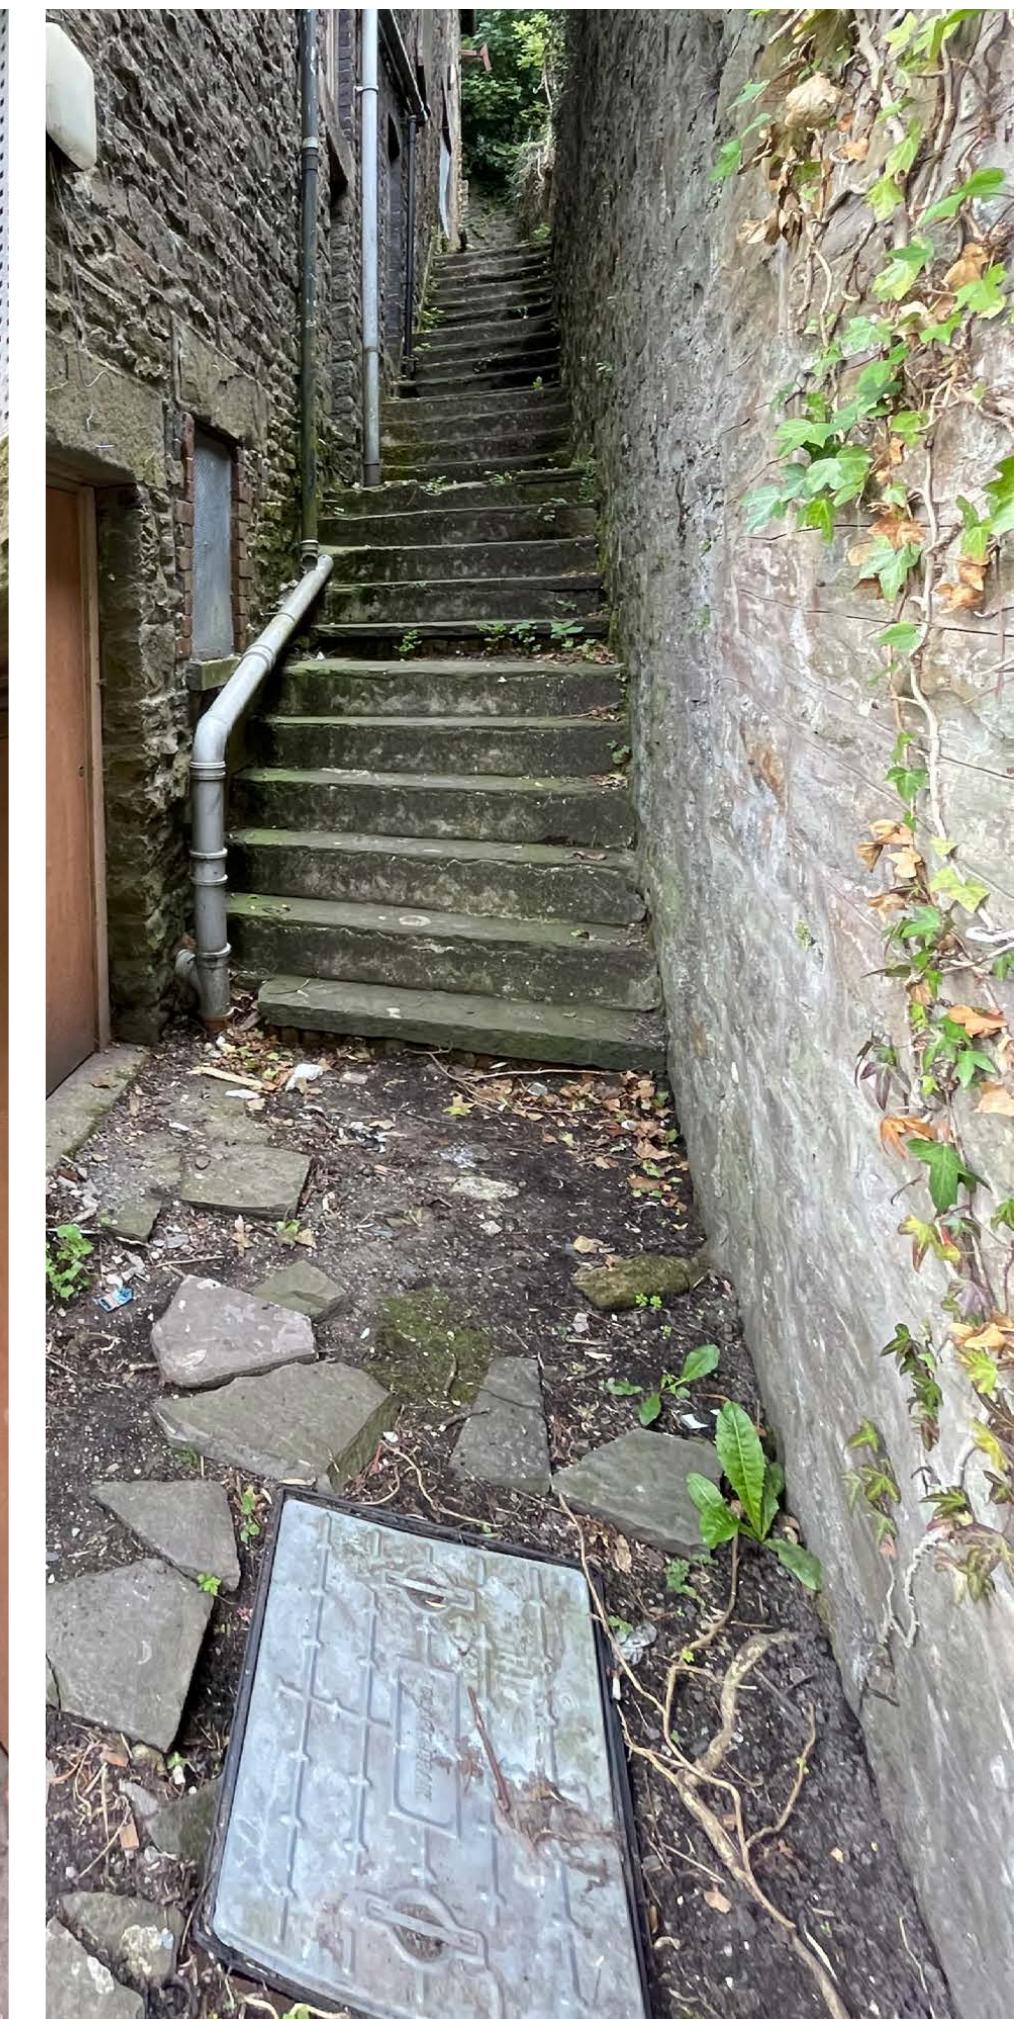
South side steps up the side of the Synagogue
