# Feeder Pipe Bridge

## OTTER SURVEY REPORT

Doc Ref: GC3880-RED-74-XX-RP-C-0001

Feeder Pipe Bridge  
 Otter Survey Report

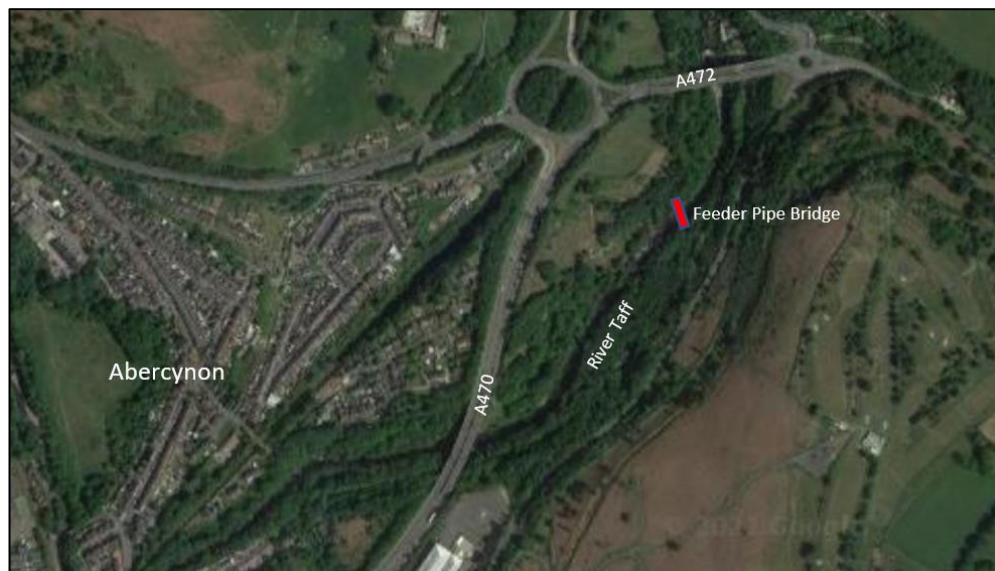
**Figure 1:** Aerial image adapted from Google Earth showing location of Feeder Pipe Bridge. (Central Grid Reference ST 09208 95484).

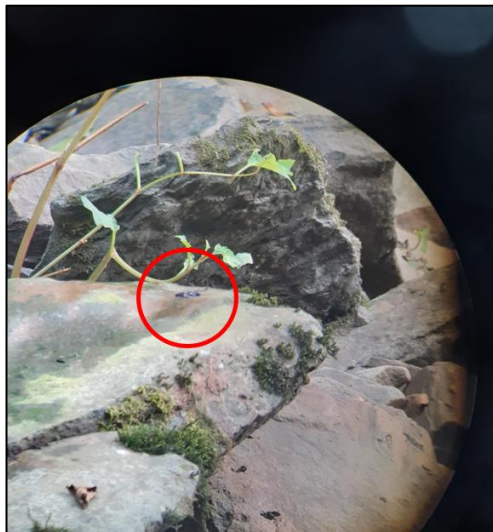
**Photograph 1:** Fresh otter spraint on rock at ST0926695538. Image taken using phone camera through telescope lens from opposite bank.

Evidence for the presence of otter, in the form of fresh spraint, was recorded 85 m upstream of Feeder Pipe Bridge at approximate grid reference ST0926695538 (photograph 1, Target note [TN] 1) and 115 m upstream at approximate grid reference ST 0928495561 (photograph 2, TN2). All spraint was located on the south-east bank of the river. The location of spraint sites are presented in Drawing GC3880-RED-74-XX-DR-C-0004.

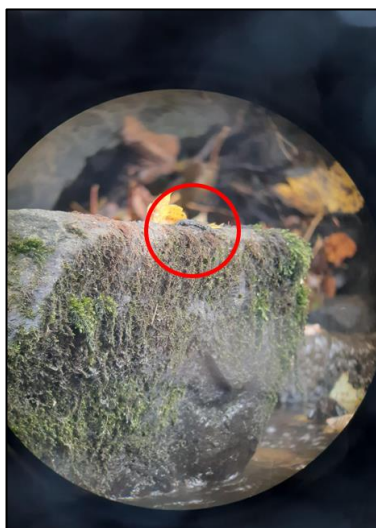
**Photograph 2:** Fresh spraint on rock within watercourse at ST0928495561. Image taken using phone camera through telescope lens from opposite bank.

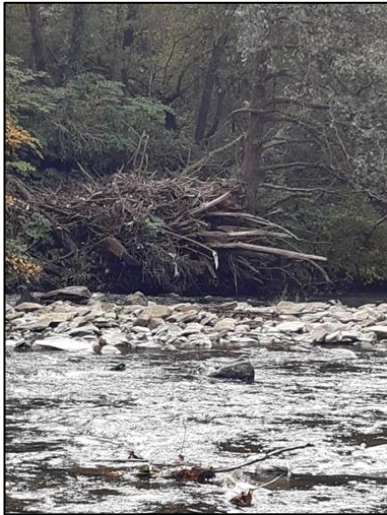
**Photograph 3:** Potential holt site at ST 0924995515. Image taken using phone camera through telescope lens from opposite bank.

There was a log/ debris pile 55 m upstream of the bridge on the south -east bank at approximate grid reference ST 0924995515 (Photograph 3, TN3). The debris provided a potential site for an otter holt to be established. A section of redundant concrete pipe was noted on the riverbank at approximate grid reference ST 09270 95557 (photograph 4, TN4) and the natural rock face at this location appeared to have gaps which could provide an opportunity for otter to establish resting sites or holts (TN4). Target note 3 was the closest site to Feeder Pipe Bridge with potential to support an otter holt.

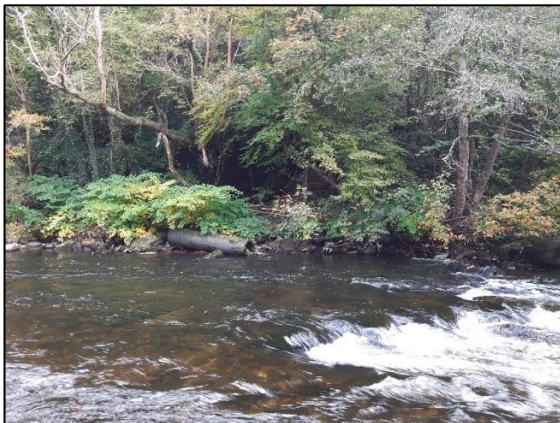
**Photograph 4:** Concrete pipe section and potential holt sites in natural cliff face at approximate grid reference ST 09270 95557.

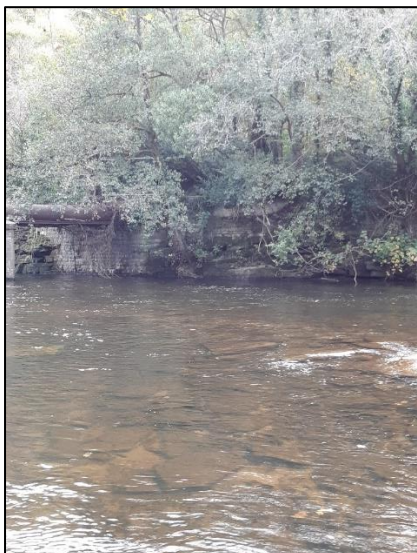
**Photograph 5:** Stone built abutments and steep sided natural outcrop on upstream and downstream side of the south-west bank of River Taff; unsuitable for otter to establish holts

There were no holt sites, or potential for holts to be established within 30 m of the bridge on either side of the river due to the presence of steep sided natural outcrop and stone walls associated with the original bridge structure (photographs 5 and 6, TN5 and TN6)

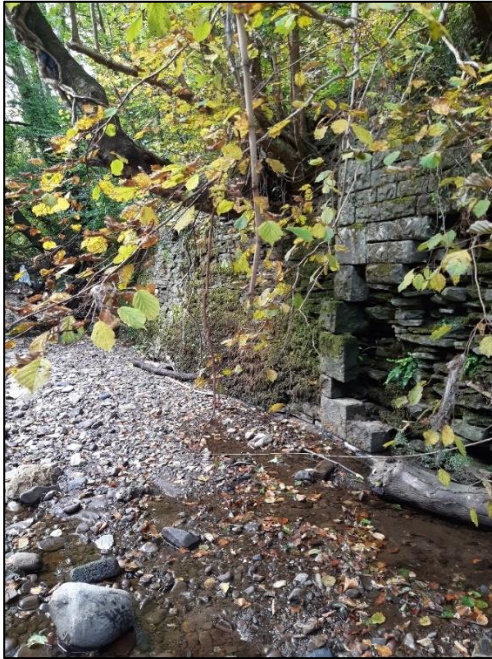
**Photograph 6:** Stone wall at least 2 m high on upstream side of the north-east side of feeder pipe bridge; unsuitable for holts to be established and preventing otter from accessing bankside vegetation.
