# **A HERITAGE IMPACT ASSESSMENT**

## **LISTED BUILDING APPLICATION**

## **THE REFURBISHMENT, ALTERATION & EXTENSION**

## **THE YMCA, MERTHYR TYDFIL**

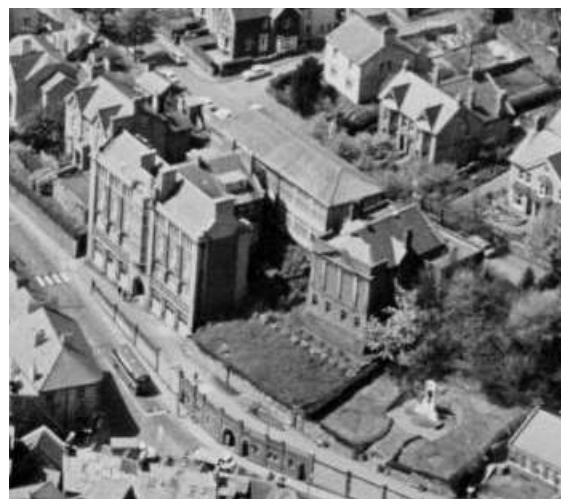
Left: A diagram illustrating the arrangement of the YMCA's component parts

- 2.4 When completed the building originally comprised 3 distinct elements:
  1. Front (Main) Building: Part of the original design, the extant terracotta and facing brickwork walls providing the YMCA with its main character. Its roof, top floor and central pediment are now missing, further walls also having to be removed to enable its repair.

2. Middle Building: Part of the original design, this face brickwork building is a much plainer 'link' originally intended to connect adjoining Front and Rear Buildings. The roof finishes, structure and the top third of the northwest wall are now missing, further walls also having to be removed to enable its repair.

3. Rear Building: A later and much poorer quality building located on an 'upper plateau', its floor being at first floor level of the Front Building to accommodate the sloping site. This building has been demolished, a cleared and hard-cored informal 'car park' remaining.

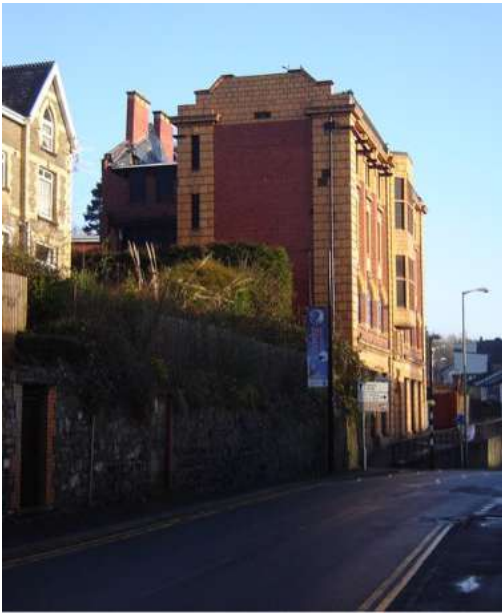
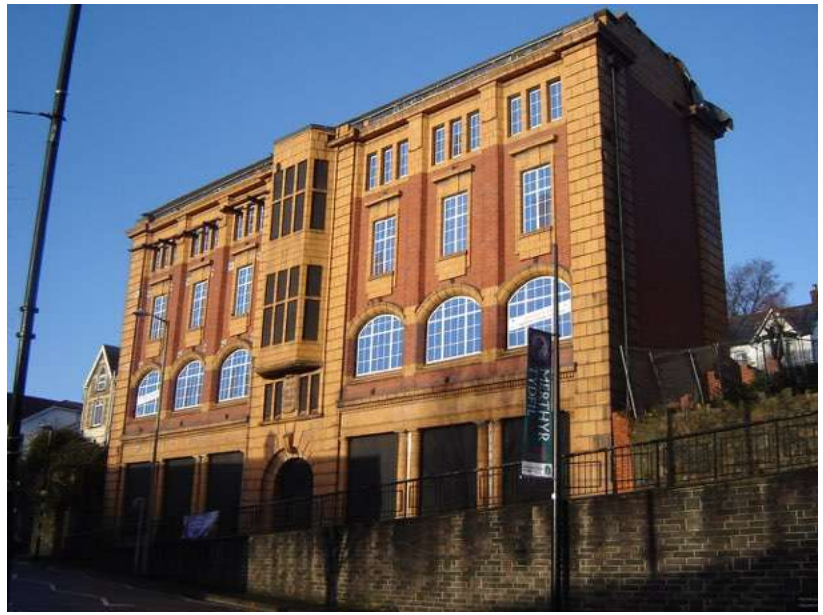
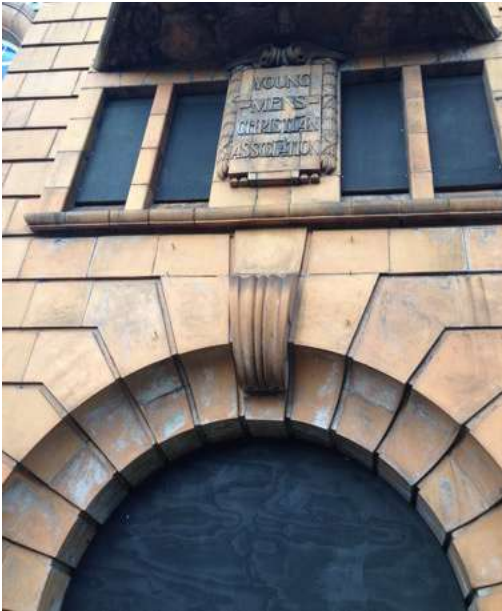
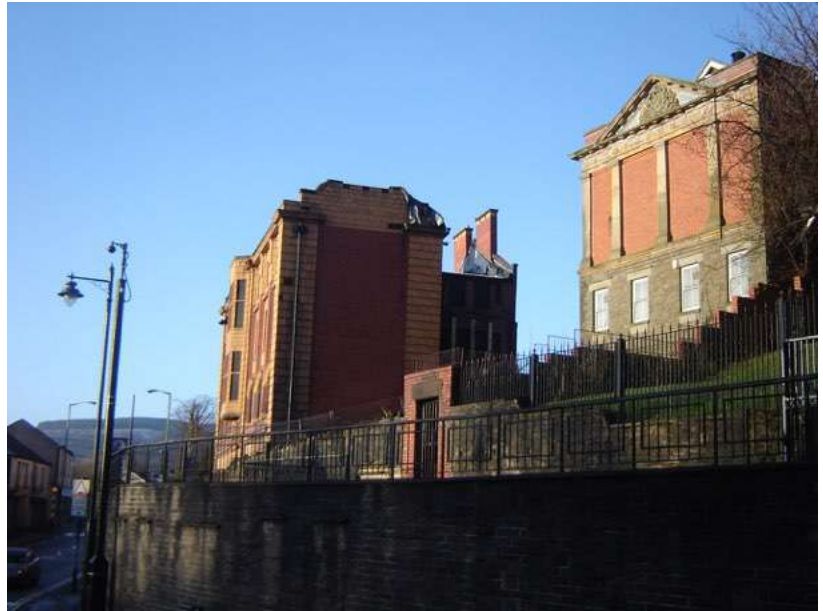
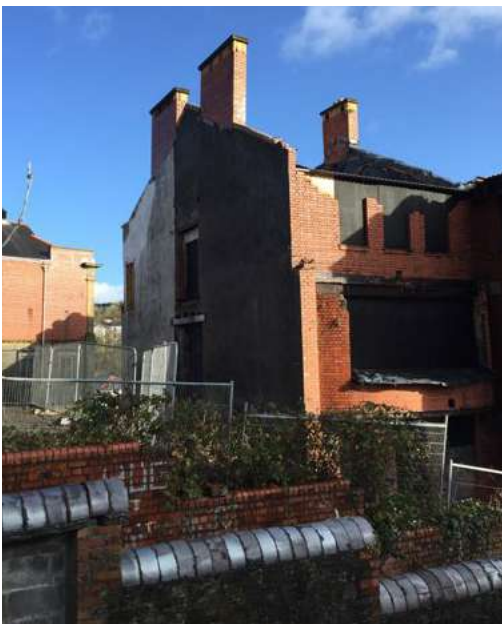
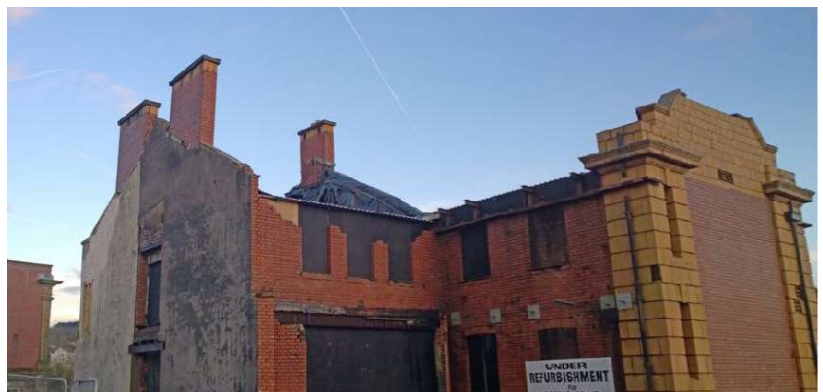
*Various views of the buildings current exterior, following completion of the 'emergency' works. Prior demolition of a building constructed on the upper plateau has left the Middle Building's unsightly north elevation in full view, though 'Jones & Thomas' original design for this area was never completed.*

The N elevation was never originally intended to be seen, a rear 'Theatre' Building, being planned for the Upper Plateau. This was never built, a 'prefab' Gymnasium subsequently being constructed in lieu. The poor quality materials and seemingly random openings (given the demolition of the Gymnasium) within the current N elevation reflecting its status.

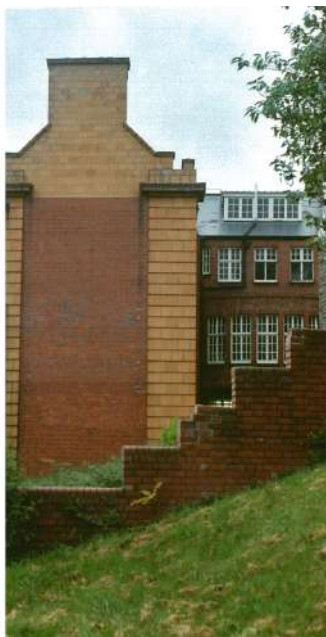
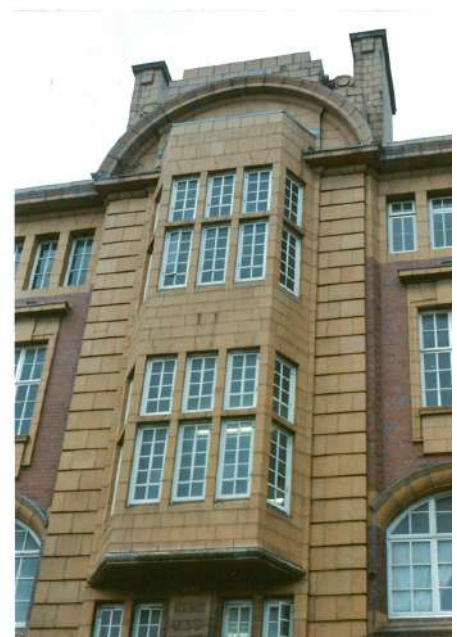
*Right: Images of the YMCA in 1990 and illustrating the front pediment, chimneys and dormer windows, all now missing. The proposals include the reinstatement of these missing historic features, this enhancing and preserving the buildings special architectural character.*

5.3 The roof of the building is completely missing, including the terracotta central pediment, both side gables and all chimney's. The Conservation Statement confirms the capacity for change of these roofs as moderate, primarily due to their prominence. They are therefore proposed to be reinstated to their original profile and (slate) finish, the missing pediment, gables and chimneys also being reinstated. The following alterations are proposed within this reinstatement:

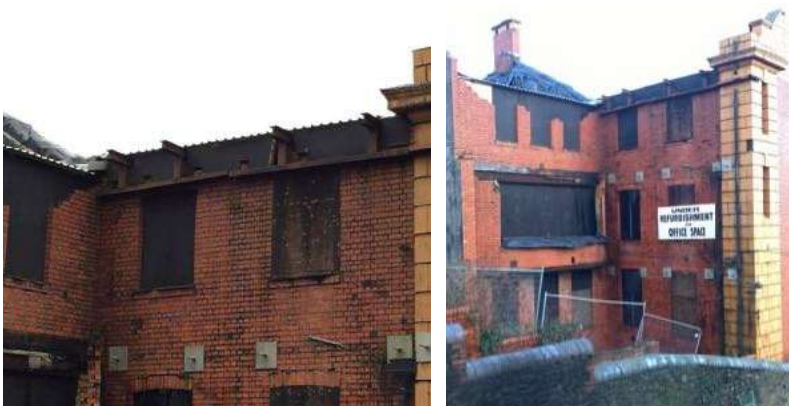
*Above: The location of the 'penthouse' dormer proposed within the recreated 'Rifle Range', the original historic fabric being entirely missing. Note also the condition of the original curved oriel windows, new steel 'props' being introduced to provide required support beneath.*

2. **The 'Rifle Range':** The missing roof and top floor will be replaced in exactly the same location as the original. To maximise internal lettable floor space however, flat roofed dormer windows are proposed to the rear, its height being determined by the need to

2. **The 'Rifle Range':** The existing roof is entirely missing, the new roof being finished in slate in deference to its prominence and significance. The new dormer windows proposed to the rear are clearly contemporary in appearance, simultaneously maximising the potential lettable area within.

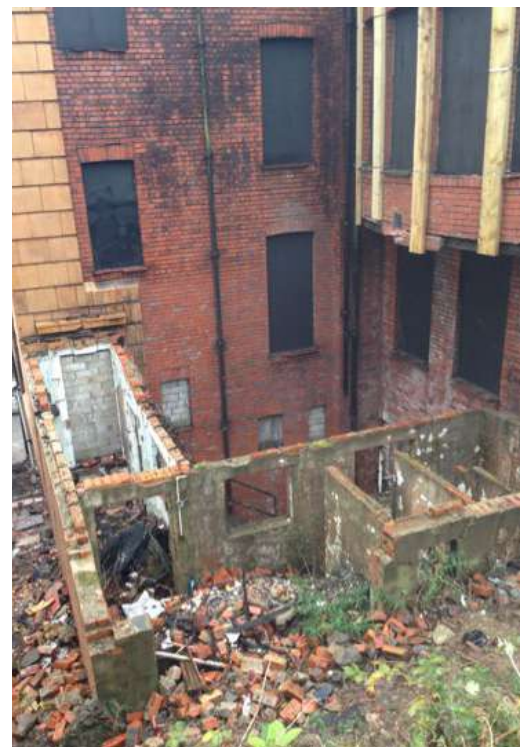
*Right: The location of the proposed bat mitigation, within a re-roofed range of existing outbuildings. The Conservation Statement confirms this area as low significance with medium~high capacity for change.*

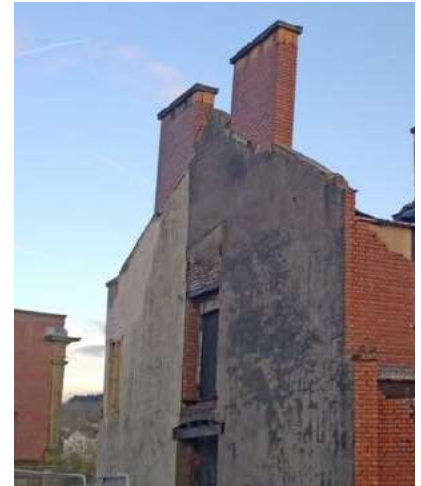
*The existing rear elevation of the Middle Building.*

4. **The Middle Building:** The Conservation Statement confirms the low significance and high capacity for change of this building generally, the following alterations being proposed:
1. Roof: The existing roof is entirely missing, its new replacement being finished with slate so as to match the Front Building. Dormer windows will be reinstated, a new glazed roof light also introduced to enable natural light to penetrate the heart of the building beneath, directly over the new stair.
  2. Northwest (rear) Elevation: This is currently a visual jumble of elements and materials due to the failure to complete the building in accord with the original design, together with subsequent piecemeal repair. This entire elevation is therefore reordered and using higher-quality materials, the whole elevation being enhanced in the process.

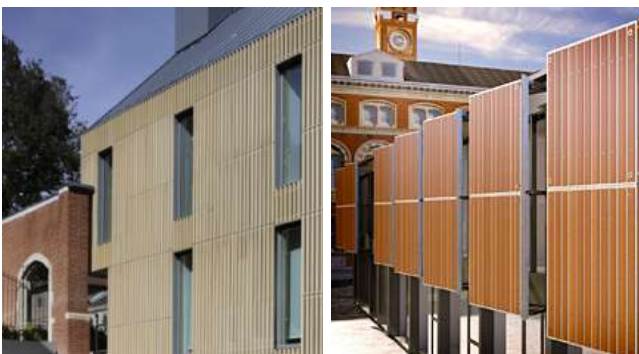
*Left: Examples of contemporary use of terracotta cladding, both in an historic setting. Terracotta is used as a rain screen cladding in such situations and enabling a high level of insulation to be introduced behind.*

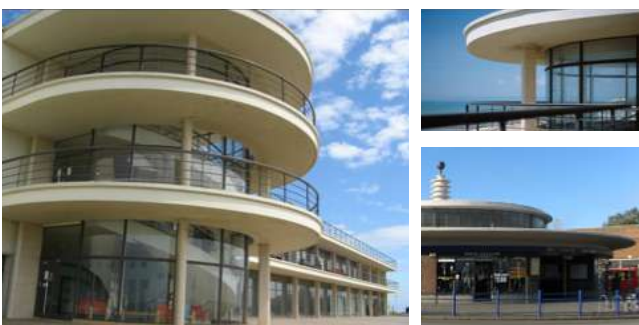
*Left: When designing the YMCA, the Conservation Statement highlights that 'Jones & Thomas' were clearly influenced by the many artistic movements that were emerging at the beginning of the C20th, including Art Deco. This period has consequently similarly influenced the appearance of the proposed C21st extensions, fundamentally solid roofs 'hovering' over glass walls beneath.*

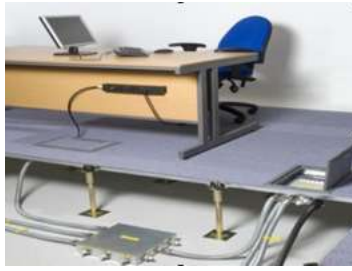
*The adopted philosophy for this latest phase in the YMCA's history is that 'new work should express modern needs in a modern language'. The new services required to enable the YMCA to become a fully C21st building will be used to most evidently demonstrate this philosophy internally.*

*In a typical commercial office (top left), services are distributed horizontally via voids below the floor slab and hidden by suspended ceilings. This approach however is entirely inappropriate for the YMCA, due to its negative impact upon the buildings historic character. Also, all the original floor finishes have either already been removed or need to be, due to their condition. Consequently it is proposed that they be replaced with a new raised floor void above the slab (top right), this enabling:*

- 1. primary horizontal service routes to be hidden, and*
- 2. extant ceilings and walls to simply be repaired, where required.*
