*Report No. BC/MB/08.19.04.*

# **Geo-Environmental Report: Land at Colliers Row, Brondeg, Merthyr Tydfil.**

**Maxiom Developments Ltd.**

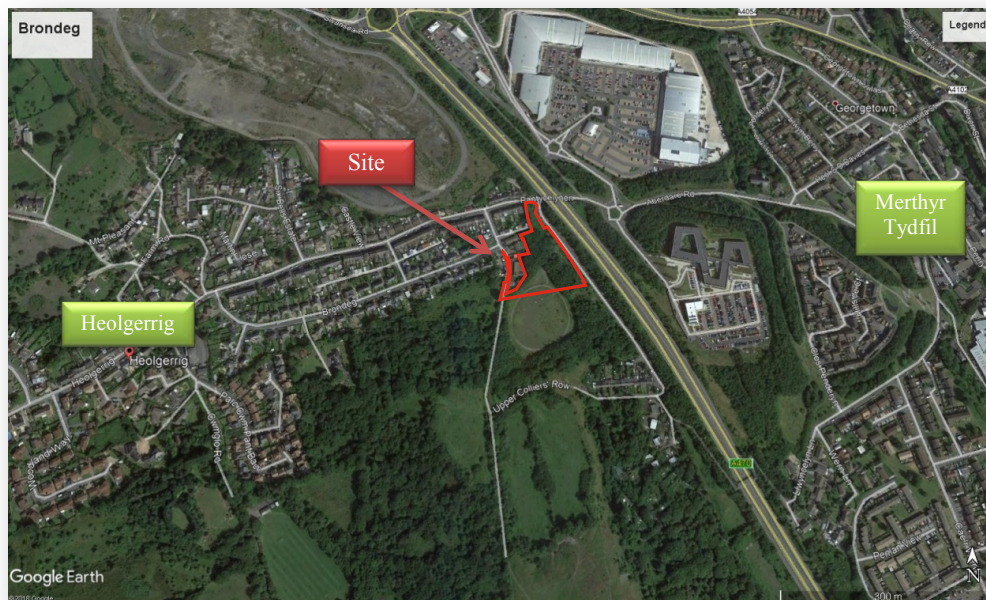
**Figure 1**  
**Aerial View of the Site**

The plot of land that is the subject of this report, 'the Site' is located on the western fringes of Merthyr Tydfil, approximately 700m west of the town centre; it is irregular in outline and occupies an area of approximately 0.82 hectares (see Figure 1 and *General Location Plan, drawing no. BC/MB/08.19.04.01*). The Site is located in a residential area on the fringes of the town and is bounded on its western side by residential dwellings and a lane; to the north is Aberdare Road and beyond it the Trago Mills retail site; to the east is the public highway serving Colliers Row, beyond which is the A 470 (T), and to the south there are a mixture of agricultural enclosures and open countryside.

The northern two thirds or so of the site is overgrown with immature trees and saplings and the southern part is an enclosure with what appears to be a trotting track on it. The Site is situated close to the floor of the Taff Valley.

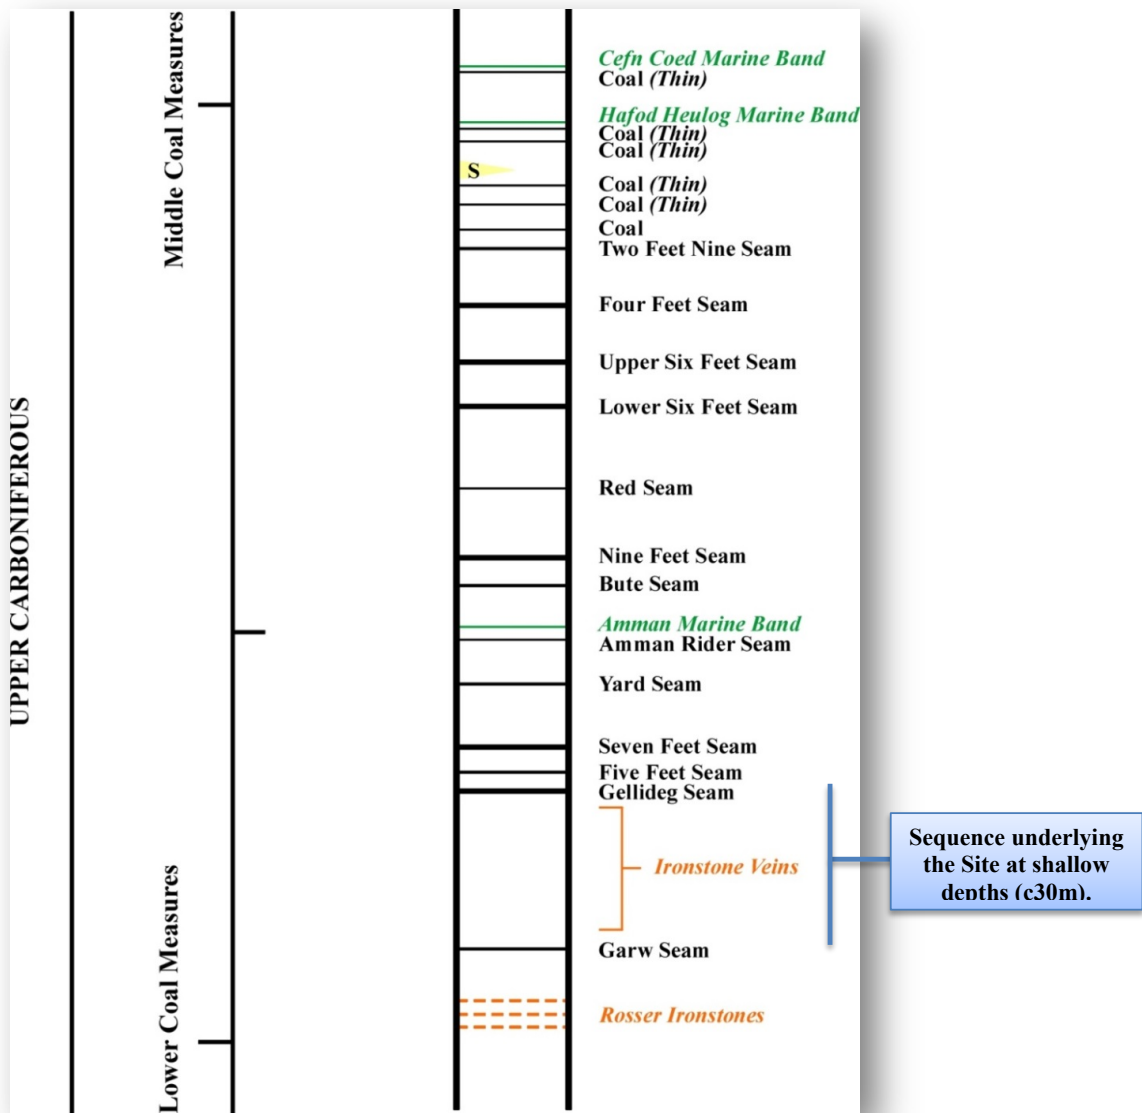
Figure 2  
Part of the Stratigraphic Column.

The Site is situated near the northern margin of the South Wales Coalfield and is underlain at shallow depths by strata assigned to the Lower Coal Measures, a sub-division of the Upper Carboniferous Period. The most recently published geological sheet at 1:10,560 scale (SO 00 NW) shows the inferred positions of the outcrop of the Garw Seam to pass through the Site (see *Geology Plan, drawing no. BC/MB/08.19.04.02*). However, mining records indicate that the outcrops are south-east of the positions shown on the published geological sheet such that the outcrop of the Five Feet/Gellideg Seam passes through the south-west corner of the Site (see *Plan of Old Workings in the Five Feet/Gellideg Seam, drawing no. BC/MB/08.19.04.04*). A number of ironstone bands are present within the coal measures, occurring above and below the Garw Seam (see Figure 2, Part of the Stratigraphic Column).
