8.3.1 Existing Steps at the Rear - Options Assessment

**Design Note**
 53 Mount Stuart Square, Cardiff CF10 5LR
 T: 02920 480333 www.mannwilliams.co.uk
Project No: **Merthyr Synagogue**Project: **9684**
 Report No: **9684_DN_01**
 Page: **4 of 8**
3.0 Proposed Options

8.3.2 Existing Steps at the Rear - Agreed Approach

8.4 Proposed New Structure to Rear

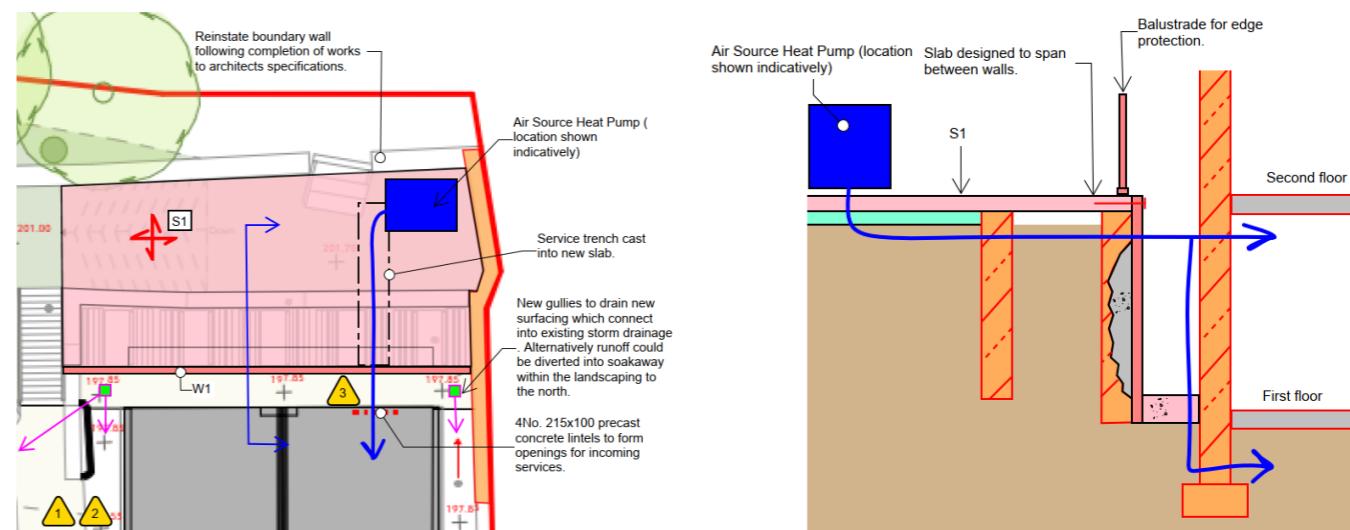
Option 2

**Plan View****Section**

3.3.1 This option which has been detailed further in Mann Williams drawing 9684-MWC-XX-XX-SK-S-90.0010 comprises the construction of a new sheet piled retaining wall in front of the existing masonry wall and a new insitu concrete ground bearing and partially suspended slab at the upper level. This option would encase the existing steps and walls and loads from the slab are proposed to be taken by the sheet pile wall and the ground (where ground bearing) only, and not taken by the existing walls.

3.3.2 The upper level could be utilised to support a new Air Source Heat Pump sited in an enclosure, be utilised as external circulation or seating for visitors. The upper level would be accessed via a new staircase located on the west of the slab.

- ✓ Minimal impact to the existing structural fabric as the existing steps and walls will be encased within the new structure.
- ✓ Forms a large usable area at the rear of the site with several potential uses, with space for MEP plant areas as required.
- ✓ Minimal requirement for excavations and removal of debris from site.
- ✓ Likely the cheaper of the options apart from Option 1.
- ✗ Potentially complex sequence of works including elements of temporary propping to the sheet pile wall. Associated health and safety concerns for operatives working in the gap between the front wall and the synagogue wall.
- ✗ Access for lifting equipment and concrete pumps likely difficult as noted in previous sections.
- Will require mechanical lifting equipment however this equipment may only be required to lift in the sheet piles, reinforcement cages, and potential temporary works.

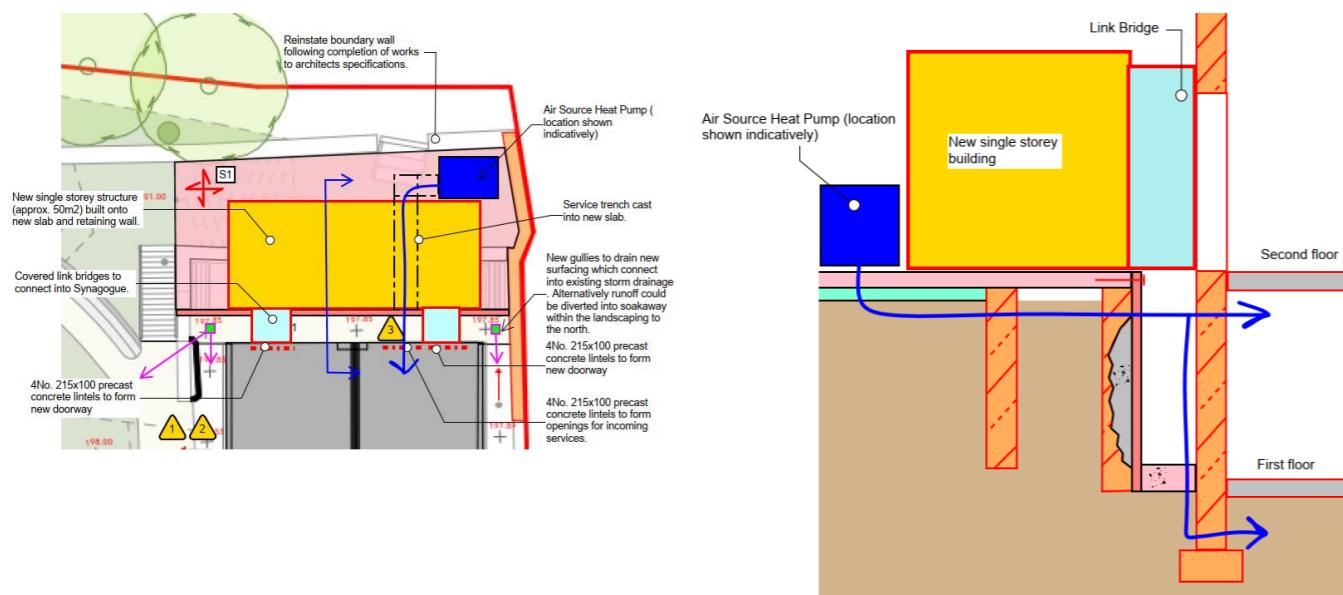
3.4 Option 3

Plan View

Section

3.4.1 Option 3 comprises the same as Option 2 described previously however with an additional consideration for adding a single storey structure on the upper level with link bridges back into the Synagogue.

3.4.2 The new single storey building could comprise a timber or steel superstructure with a lightweight roof construction and cladding to the Architect's details and specifications. The link bridges could comprise cantilevering steel beams connected to the existing gable wall of the synagogue which support the walls and roof structure. The link bridges are proposed to not load the retaining wall.

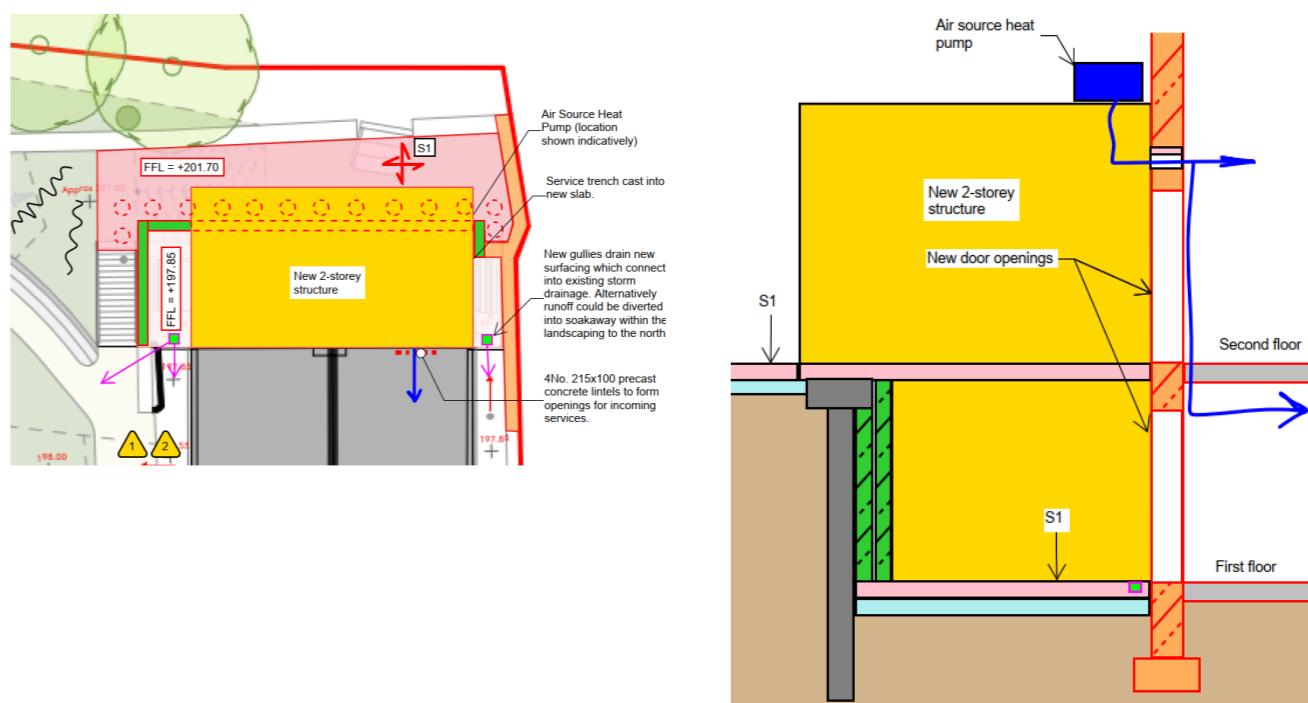
3.5 Option 4

Plan View

Section

- ✓ Potentially safer to construct than the other options as this option limits time operatives have to spend in proximity to the failed retaining wall and on the existing steps in poor condition.

5.4.1 We also recommend beginning discussions with a specialist piling contractor to understand the viability of Option 4. Mann Williams can undertake these discussions if instructed.

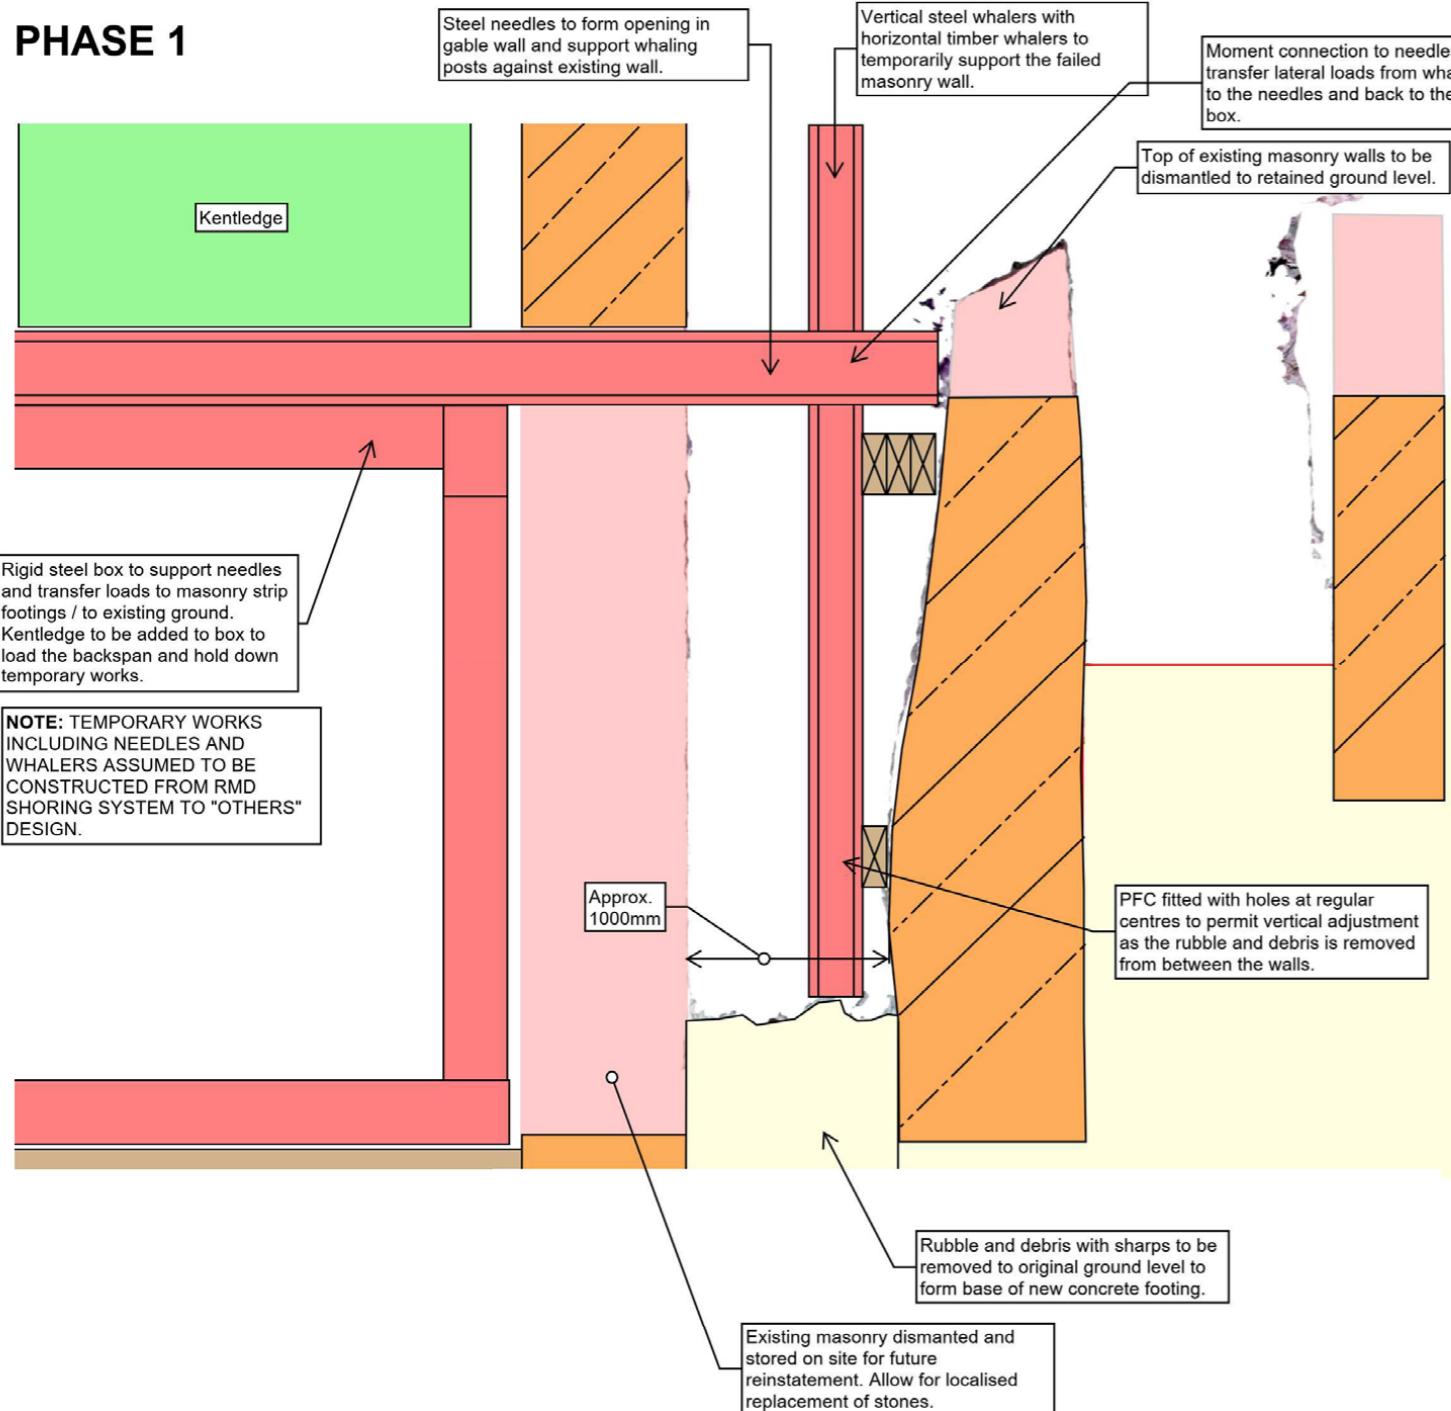
PHASE 1

Phase 1 would involve the careful dismantling of two sections of the external stone gable wall of the Synagogue at first floor level, to form openings in order to access and work on the rear wall and steps. Each section would be approximately 1.2m wide x 2.2m high. The stones are to be numbered before dismantling and set aside for later reinstatement. The masonry above is to be steel needled for temporary support. A series of vertical steel whalers are to be installed in front of the existing failed retaining wall, with timber whalers set between the steels and the wall. The tops of the masonry retaining wall and the partly retaining wall behind would be taken down to the level which will be the underside of the new slab over. The rubble and debris within the 1 metre gap between the building and retaining walls will be removed to the original level of this gap.

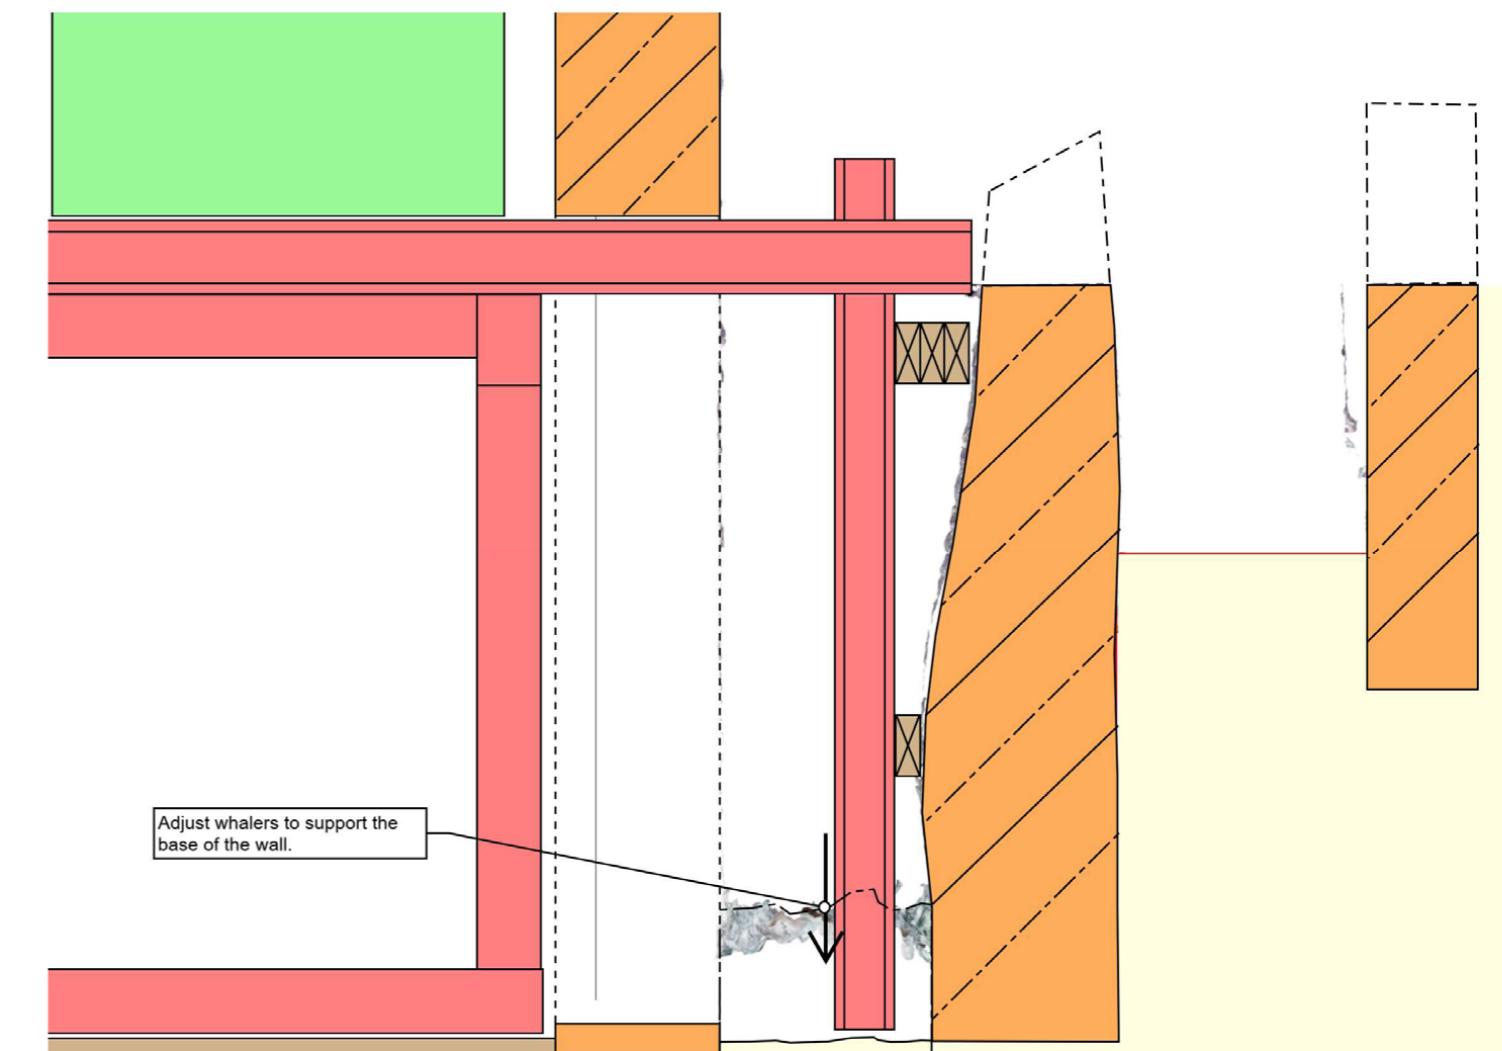
PHASE 2

Phase 2 would involve the vertical steel whalers being dropped and adjusted to support the base of the retaining wall.

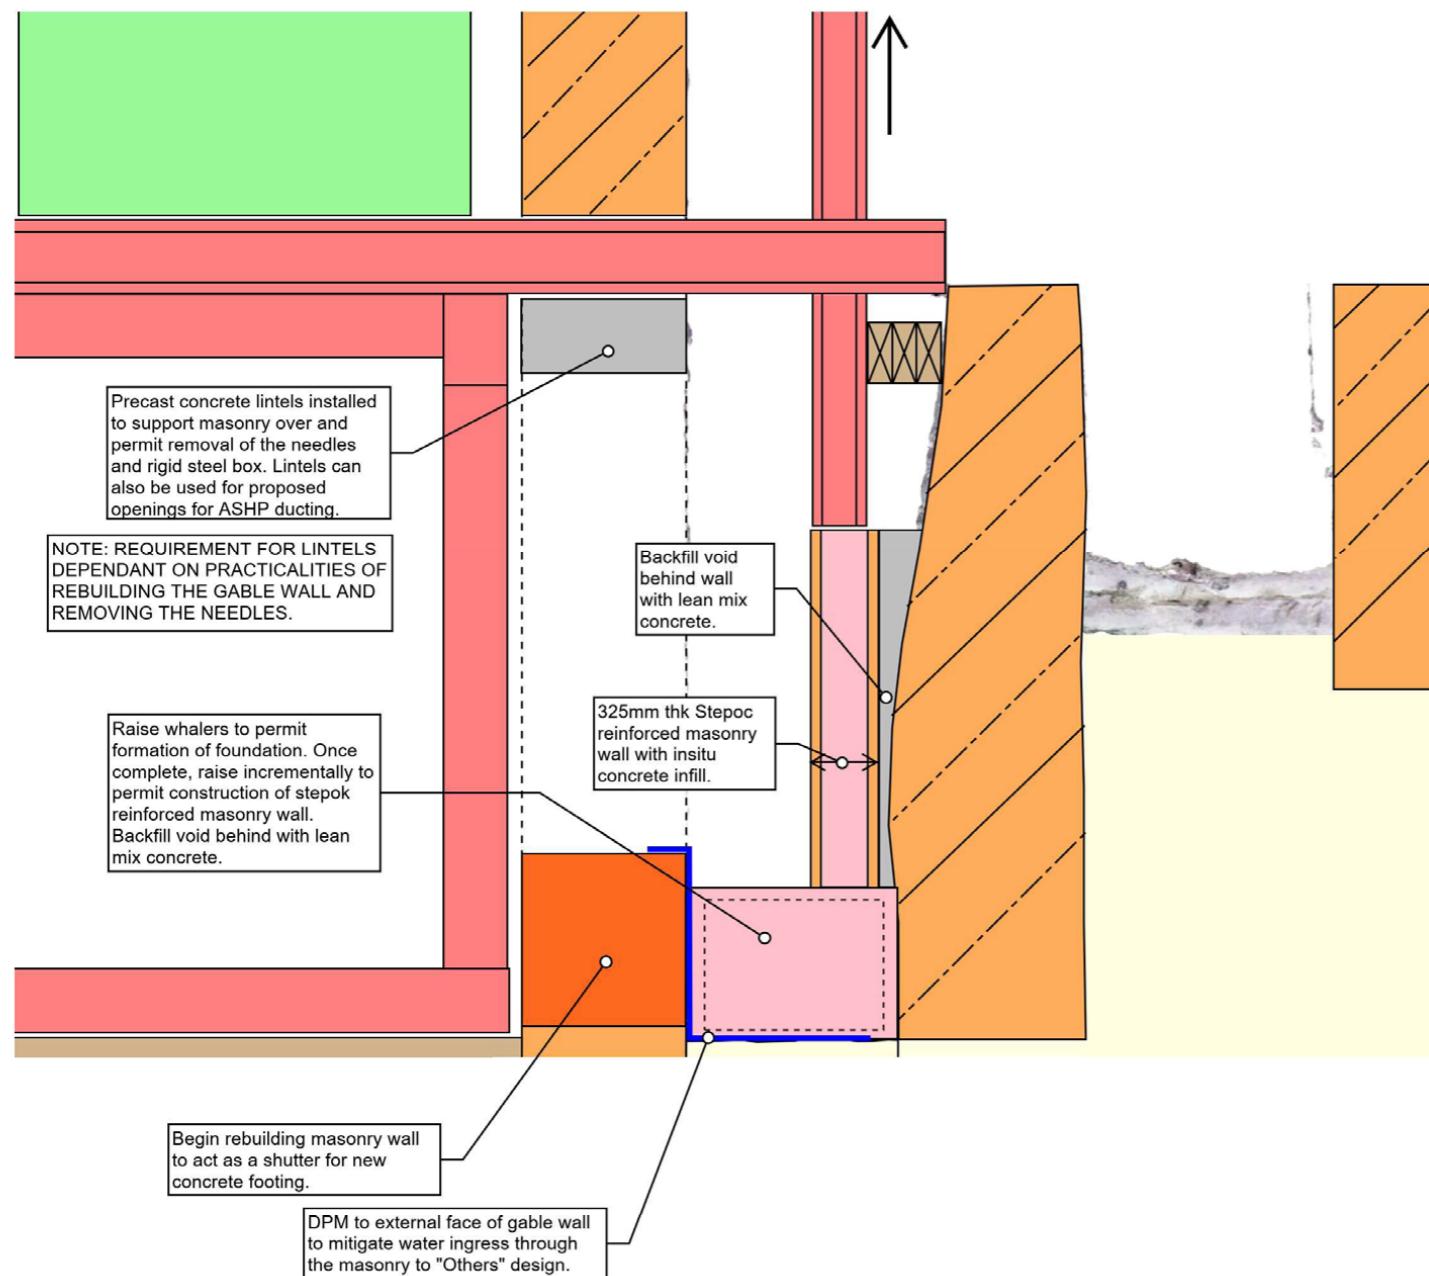
PHASE 3

Phase 3 would involve the vertical steel whalers being raised as a concrete foundation strip is formed at the base of the retaining wall. The bottom of the two temporary openings in the gable wall would be laid with the retained stones to act as shuttering for this foundation strip. A damp proof membrane would be laid between the two parts to control water ingress to the building fabric, and partly to avoid the concrete 'sticking' to the stone, thereby making the installation potentially reversible. Off this strip, a 325mm thick reinforced masonry wall would be constructed with insitu concrete infill. As this happens, the space behind would be backfilled with a lean mix concrete.

As stated, the zone between the existing steps and the underside of the new slab is to be offered as a compensatory bat hibernation roost. This would mean that, whilst not shown on the drawing below, the reinforced concrete capping beam would extend over the steps and sit on the outer original masonry wall, thereby forming a void.

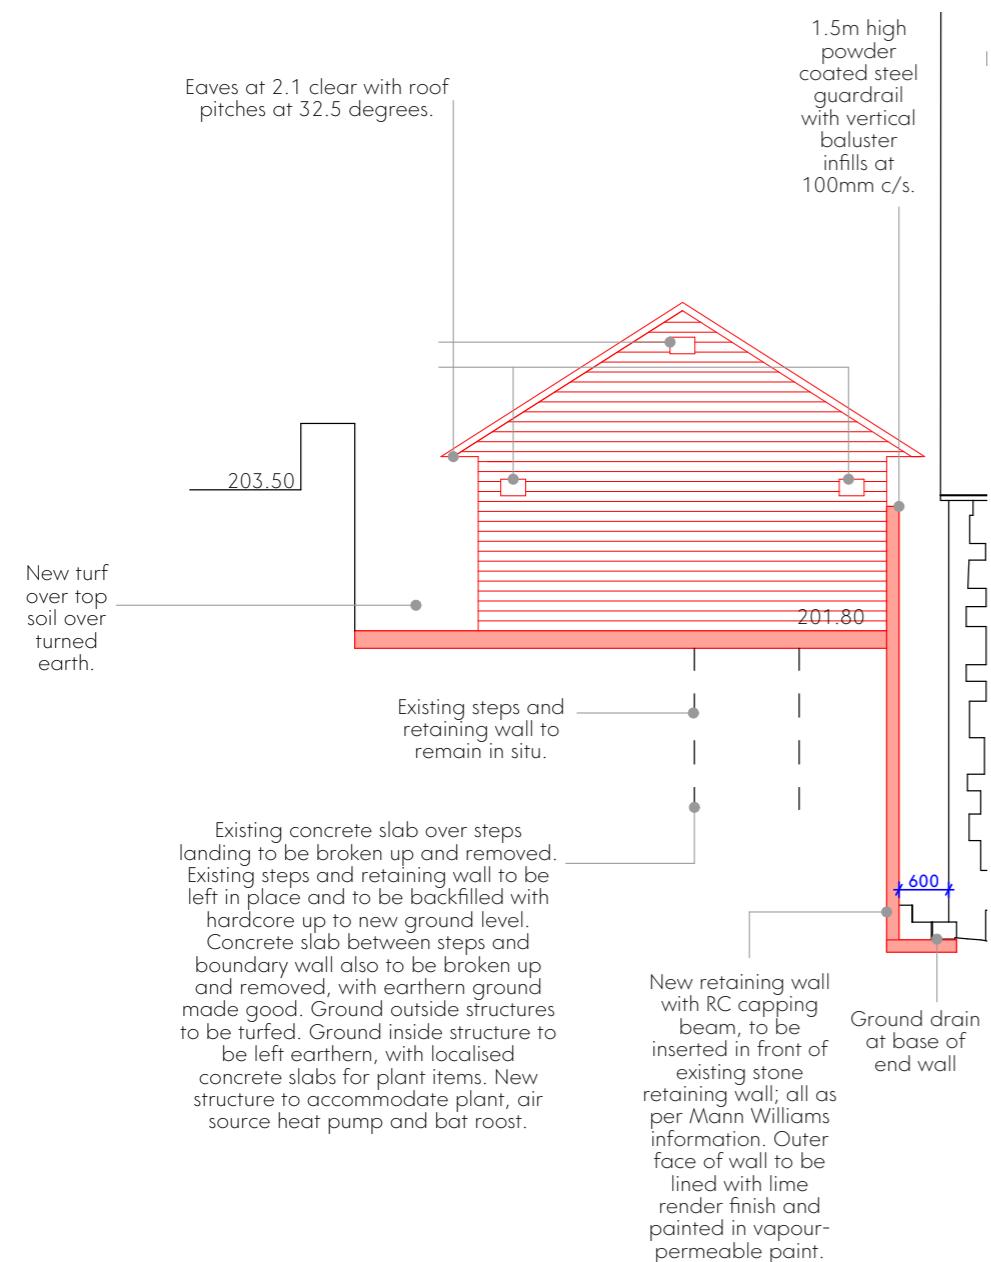
However, with the agreed approach to retain the steps and walls and build a new retaining wall in front and a slab over (with the space below acting as a bat hibernation space); this provided a level external area (at second floor level), incorporating the area above the steps and the narrow strip of derelict land beyond the steps.

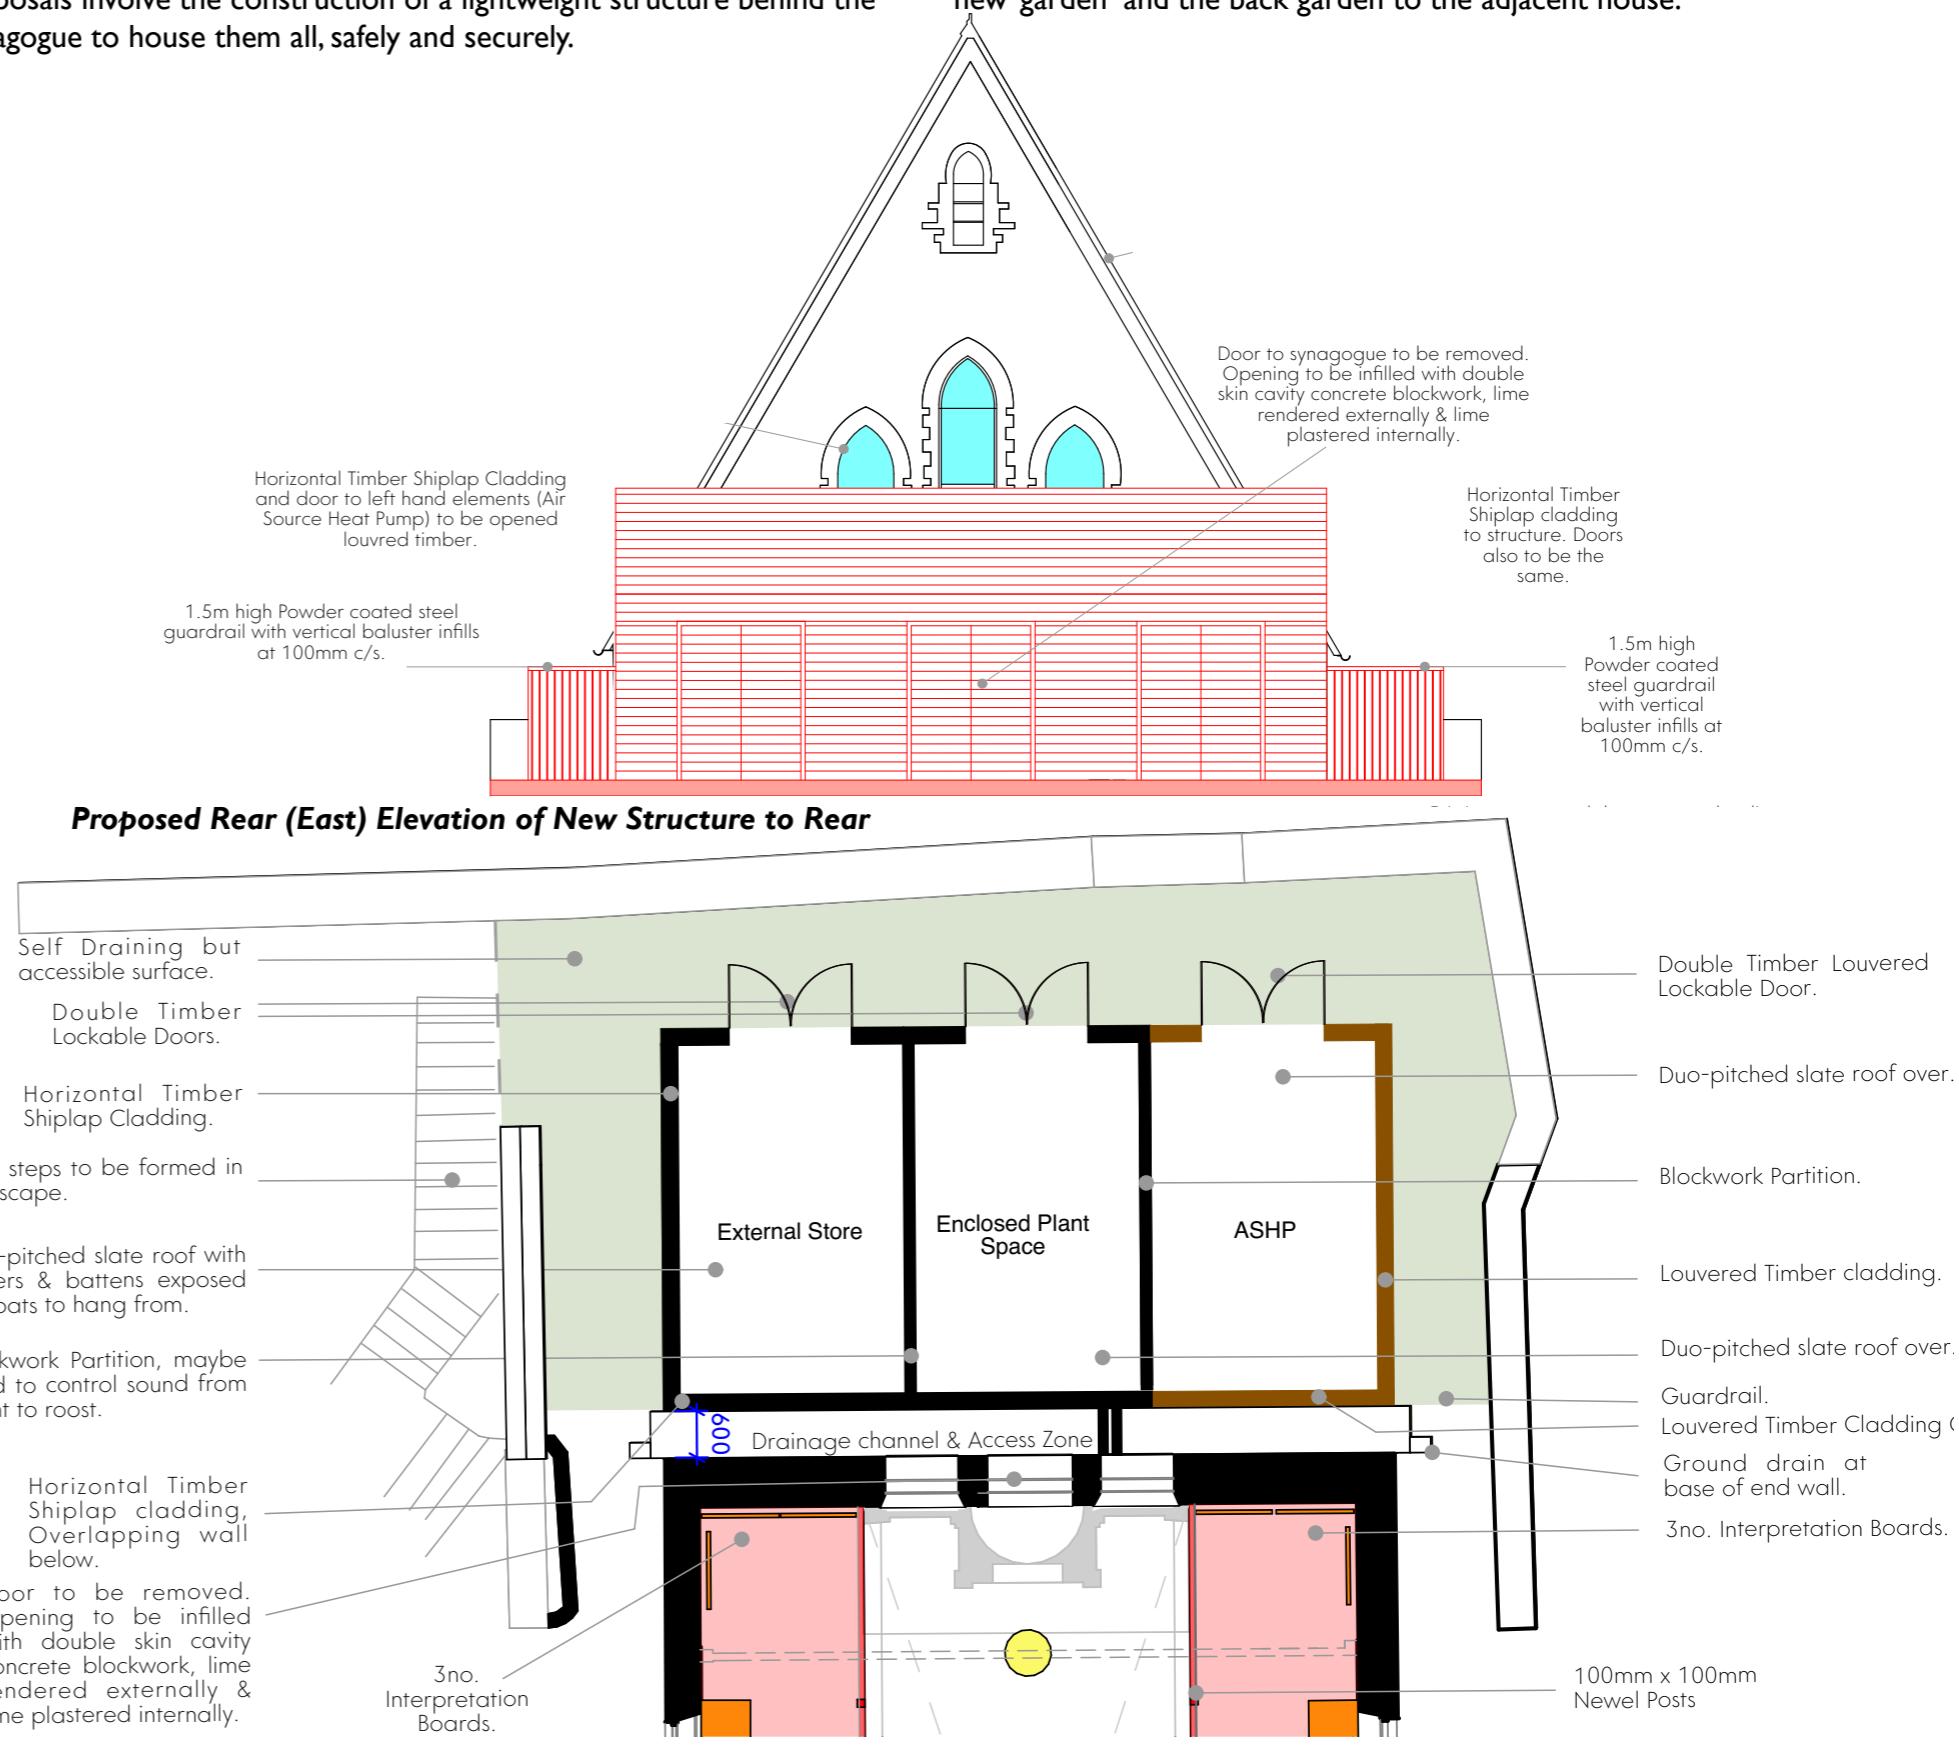
On this page are the proposed plan and elevations for this structure, which would be a lightweight structure clad in horizontal timber shiplap cladding, which will sit well within the wooded environment here. The form would be simple, with a duo-pitched roof with a natural slate covering, as the Synagogue. The roof pitch would be shallower, to minimise visual impact. Given its location, this structure would not be visible from the public road; only visible from the private road behind, the new 'garden' and the back garden to the adjacent house.

Proposed Side (North) Elevation of New Structure to Rear

Proposed Plan showing New Structure to Rear

With the rear of the site being the only suitable location for the external Air Source Heat Pump, this provides the obvious location for it, and its enclosure. Given the lack of space inside the building, and the desire to restore the original 'Prayer Hall' back to its original volume, there is nowhere to locate the necessary Plant provision, apart from out the back. This also needs to be enclosed. On top of this, the large 'garden' area will require equipment to be safely stored. With these three requirements, the proposals involve the construction of a lightweight structure behind the Synagogue to house them all, safely and securely.

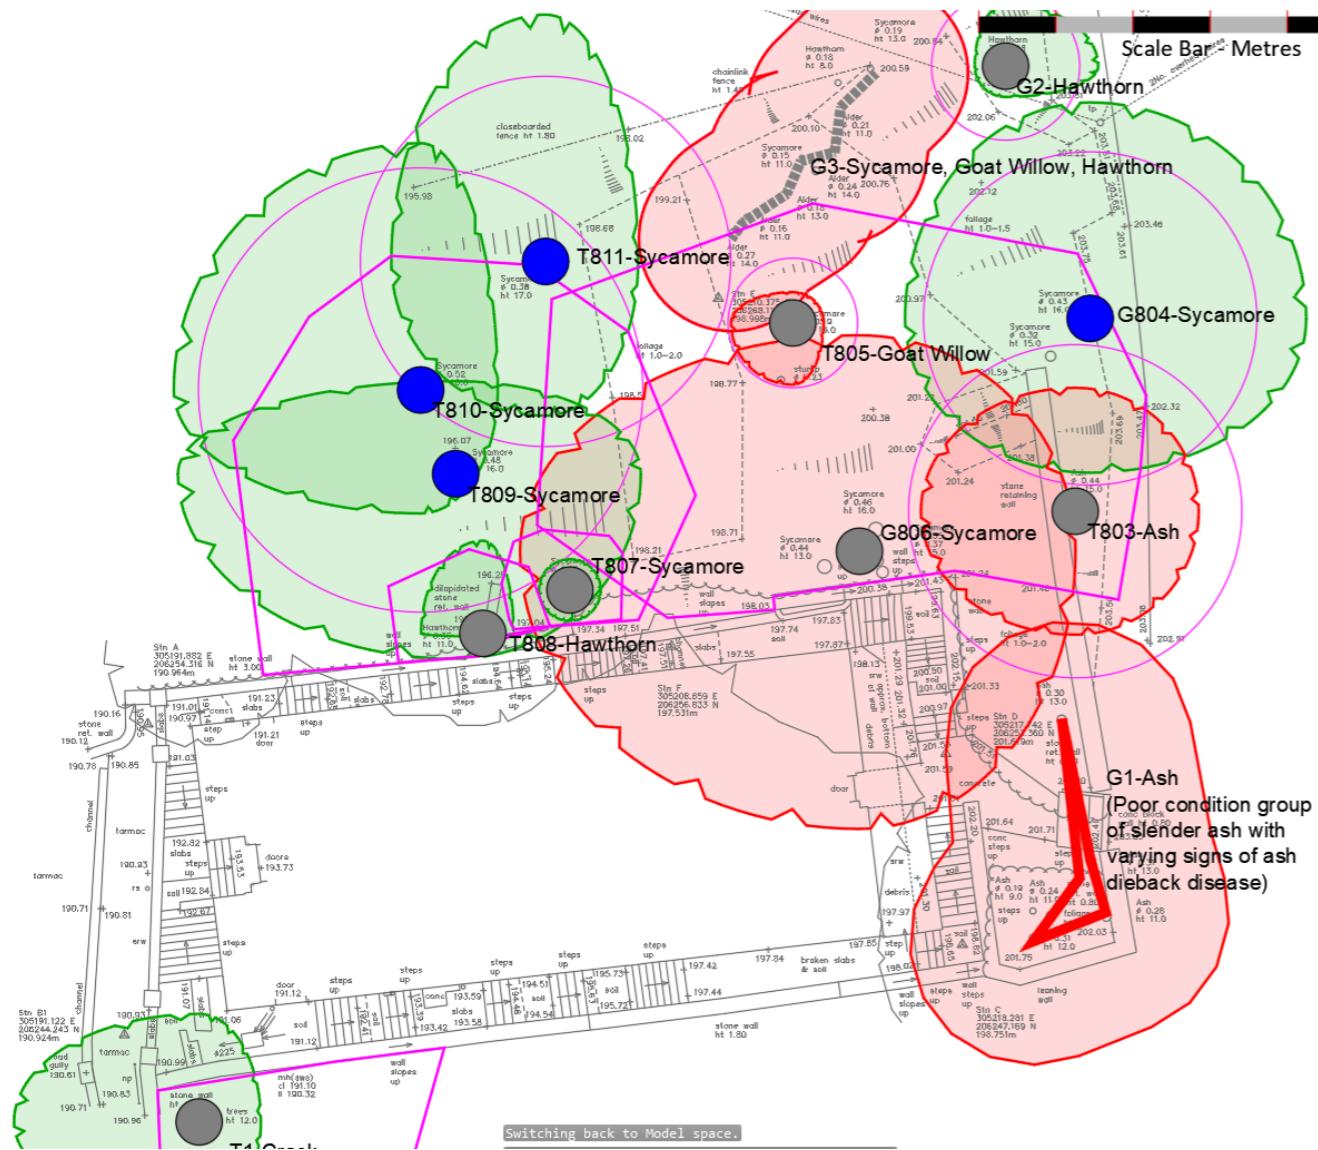
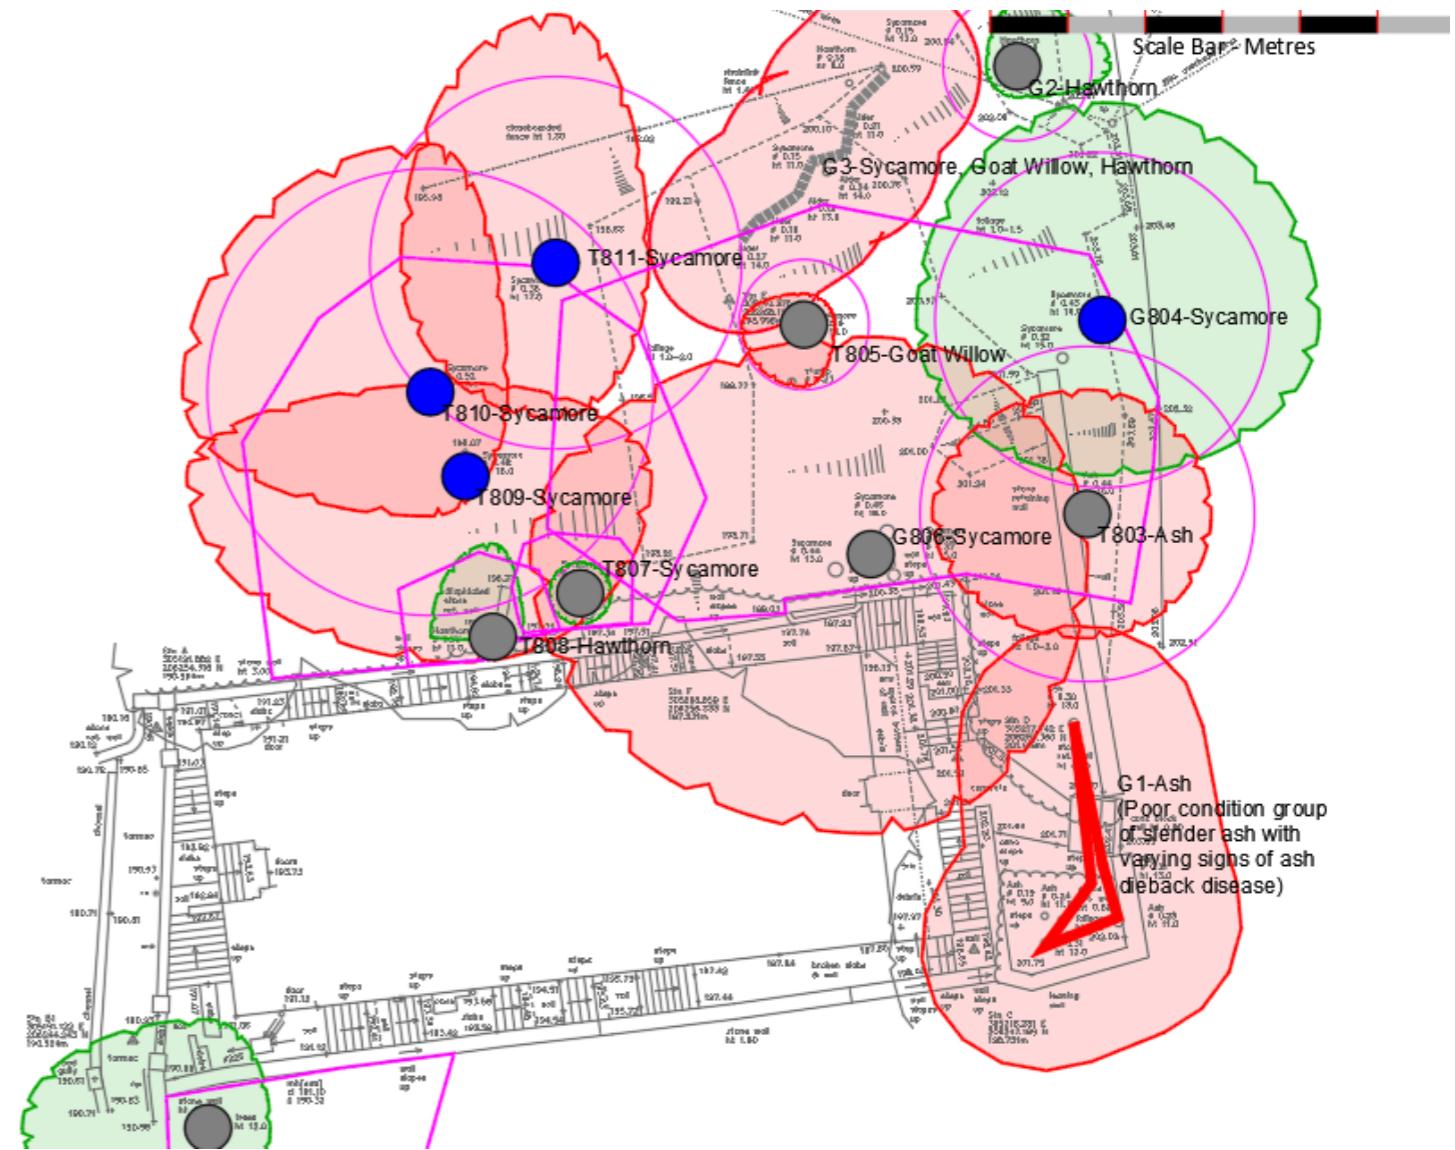
TREE CONSTRAINTS PLANS below

- Trees with Blue trunks in 'Moderate' Condition
- Trees with Grey trunks in 'Low' Condition
- Trees within Red shape in 'Poor' Condition

An Arboricultural Report was produced by Arboricultural Technician Services Ltd (Tree Consultancy) to assess the nature and condition of the trees within the derelict land to the rear (east) and side (north) of the Synagogue. The results of this assessment would guide any thoughts on how the existing wooden area could be best approached, i.e.:
