**FFOS-Y-FRAN  
FINAL RESTORATION STRATEGY**

**Supplementary Environmental Information (SEI)  
SEI Appendices**

**MERTHYR  
(SOUTH WALES) LTD**

**GGAT report no. 2002/075  
Project no. A788  
National Grid Reference: SO 089 066**

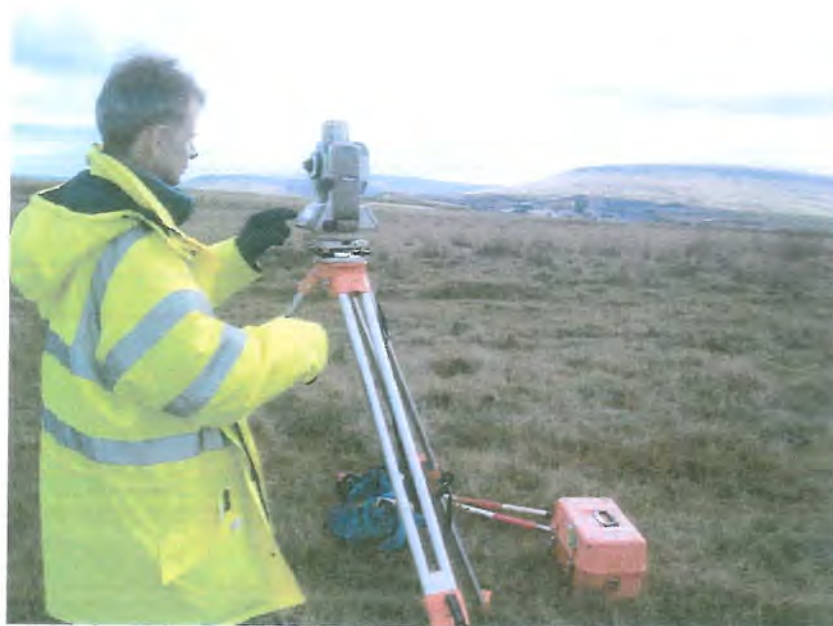
*Field survey on part of the Dowlais Free Drainage System in October 2002 © GGAT*

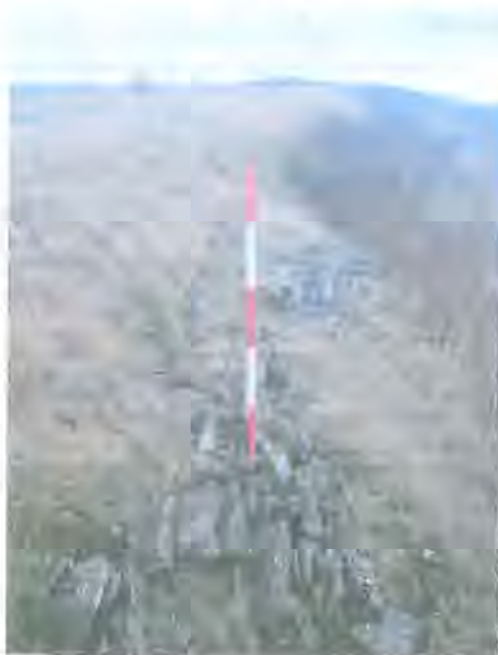
*Plate 1: Pond 85523, showing detail of stone revetment on inner south wall, looking SW*

The dam measures almost 200m northeast to southwest, and 130m northwest to southeast; the dam walls are stone-revetted on their inner edge, most noticeably on the long south side. The two sluice positions on the west side of the dam lead to Leat 88014 (north sluice) and Leat 88020 (south sluice).

The larger of the Twynywaun ponds consists of a three-sided dam fed by leats to the north and northeast, with outfall sluices on its west side. Like the other dams, it was open on its northern (upslope) side, attracting flow from small streams. Air photographs suggest that it may have been sited on the line of a natural stream line from the northeast, though the position in relation to a natural stream bed was much less apparent than at Shepherd's Pond (85526) to the south, or the small dam 85592 to the southwest.

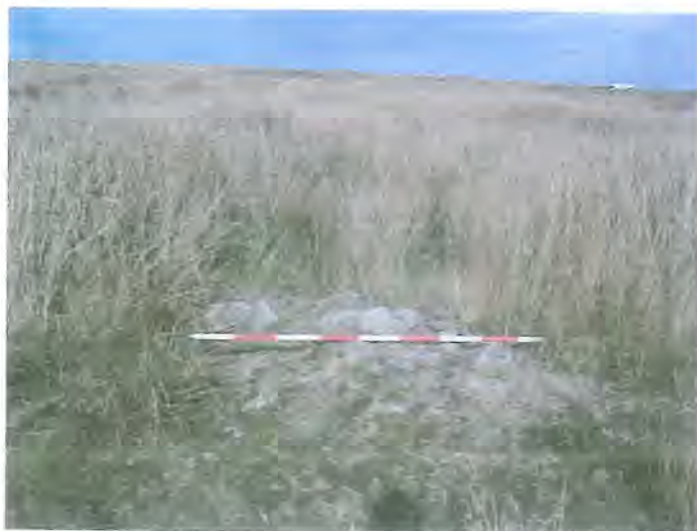
*Plate 2: A rubble mound in 'Area B', looking NW*

To the north of the dam is a group of features including parallel trackways (interpreted as cart tracks), small mounds of rubble and shallow linear earthworks and a irregular earthen/rubble platform. These features are described collectively as 'Area B' for the present survey. It is possible that they relate to the construction of the dam; the rubble mounds alongside the trackways suggest the collection of material for the stone revetting. Alternatively, these features may be the remains of some form of stock enclosure.

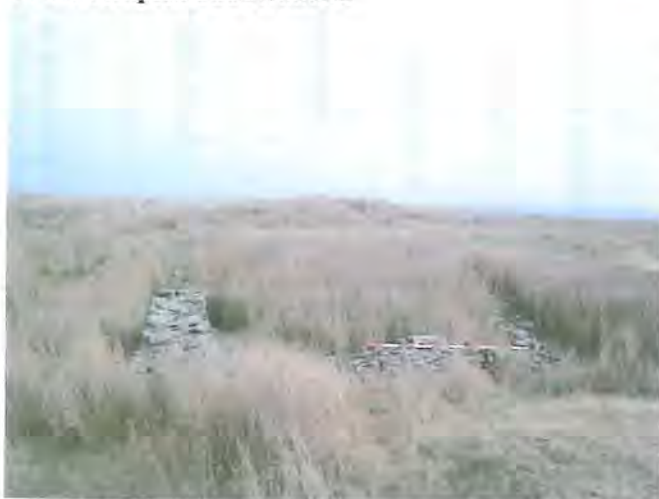
*Plate 3: Rectangular structure 88021 with Pond 85523 in background, looking NW*

This site lies to the southwest of the dam, at the junction of Leats 88020 and 88014. The pit is an oval shaft (88022), 17.5m x 13.4m, now filled with water, with some rough stonework visible on its northeast and southeast sides. A channel extends from the shaft southwest to Leat 88014, and seems to be respected by the adjacent tips. Occupying a platform on the northwest side of the shaft is a rectangular structure of drystone walling (88021), open on its southeast side, but with an enclosed room in one corner. This is presumably a balance pit, with a general arrangement similar to that of Pit 85558 near Soap Vein Pond. The small scale of the tips, notably close to the shaft itself, suggests that it may have been a short-lived operation.

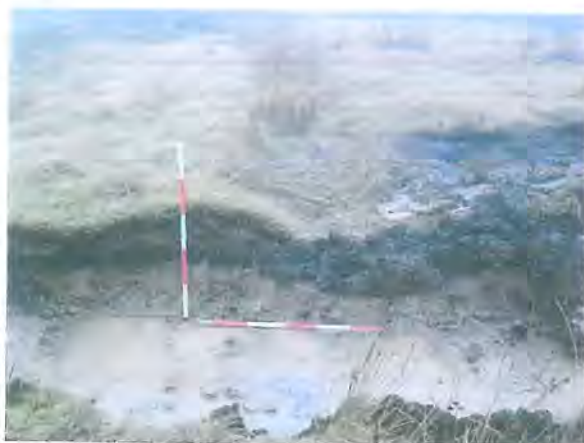
Plate 4: Machine-cut section of Leat 88023, looking W

RECORD: The line of the leat was traced from GPS spot co-ordinates and the air photograph. A drawn profile of the leat was recorded near its west end at SO 08634 07096. A machine excavation through the leat was undertaken at approximately SO 08654 07092. See Appendix 1 for details of photographs.

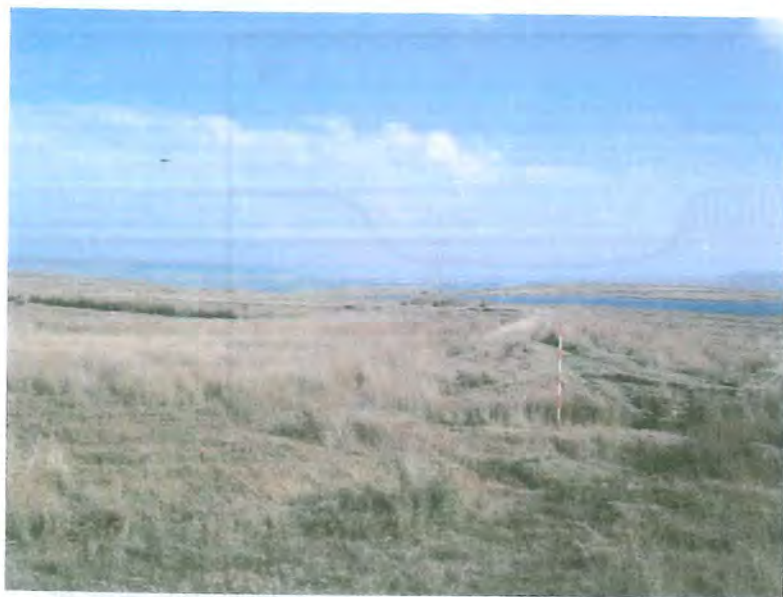
*Plate 7: Pond 85524, S end, with Leat 88014 on right, looking NE towards Rhaslas Pond*

The southern of the two Twynywaun ponds lies adjacent to the present road. It will not be affected by the proposed scheme, and was not included in the present survey. The pond is an extensive feature, with earthen dam walls on its east and south-east sides and an open west (upslope) side. It is fed by leat 88014 from its south corner.

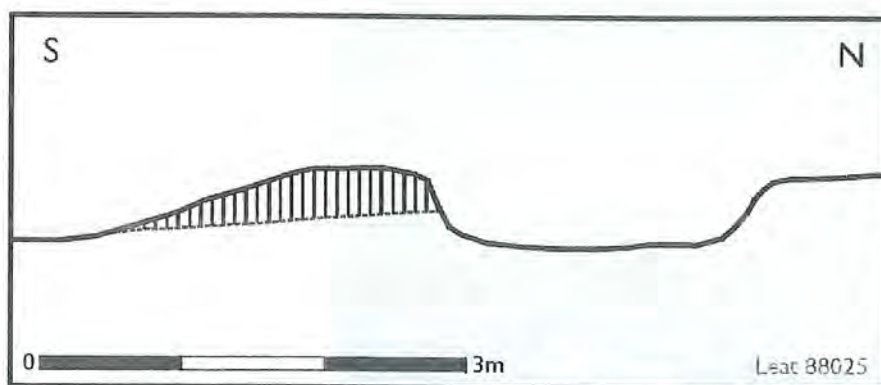
*Figure 11: Profile of Leat 88025 at SO 08667 06861*

The leat profile varies somewhat along its length. At SO 08682 06866, to the east of the major natural stream junction, the leat is 2.4m in width and 0.45m in depth, with a bank 0.9m in width on its south side. A similar (but deeper) profile was recorded to the east of the junction with Leat 88014 (where the leat is described as 88020). At SO 08548 06856, immediately to west of a crossing point for a track shown on the 1<sup>st</sup> ed OS, the leat is considerably wider, 5.70m in width and 0.75m in depth, with rubble along its lower (south) side but no distinct bank.

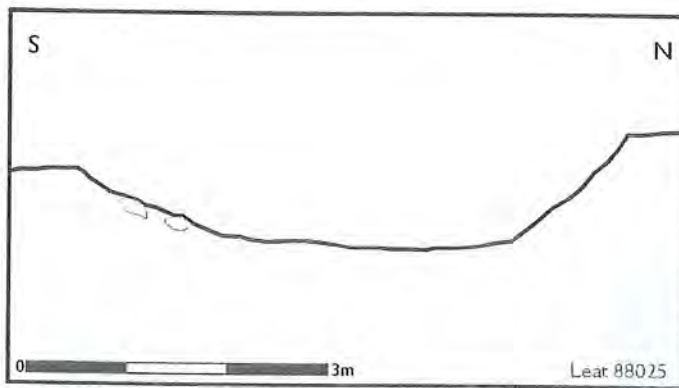
Figure 14: Profile of Leat 88025 at SO 08548 06856

**RECORD:** The eastern section of the leat (described as Leat 88020) was recorded in detail by total station survey. A second area of detailed survey was undertaken on the junction with the natural stream course. The remainder of the leat was plotted from spot GPS co-ordinates and the air photograph.. Three drawn profiles were recorded at SO 08760 06929, SO 08682 06866 and SO 08548 06856. A machine-cut section was recorded at SO 08690 06875. See Appendix 1 for details of photographs, under Leats 88025 and 88020.

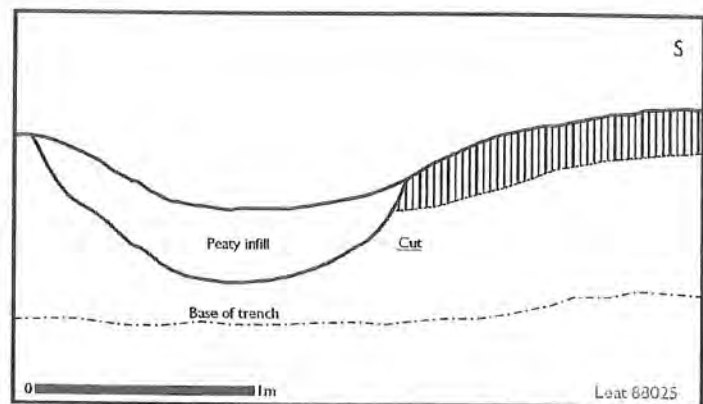
Figure 15: Machine-cut section through Leat 88025 at SO 08690 06875

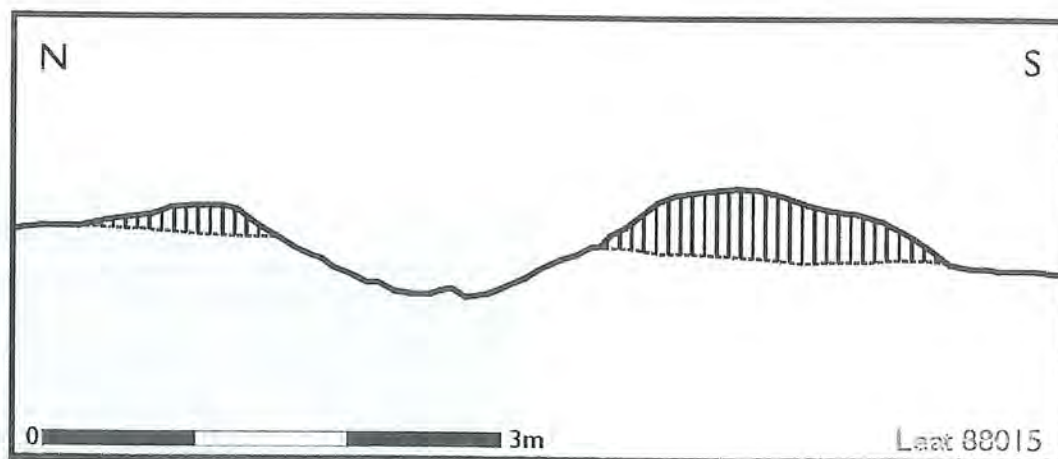
Figure 16: Profile of Leat 88015 near Pond 85526 at SO 08804 06642

The second of the two main leat courses extends east from a point to the west of the survey area (now reclaimed) and extends to Pond 85526, where it becomes Leat 85575. In practice, Leats 88015 and 85575 appear to be the same feature; the pond marks the point where the west-east leat is carried across the north-south stream line by an embanked aqueduct. At its western end, Leat 88015 is quite broad, ranging from 3.75m to 5m in width and 1.5m in depth; it becomes a narrower feature, 2.6m in width and 1.5m in depth where it reaches the pond.

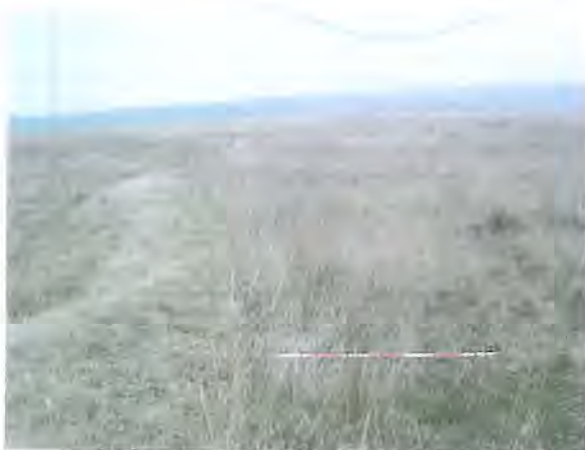
Figure 19: Profile across Leats 88015 and 88029 at SO 08475 06809, to west of Figure 18 (above), showing central ditch between the leats

RECORD: The leat was recorded in detail by total station survey. Drawn profiles were recorded at SO 08611 06718 and SO 08475 06809 (both of these including the upper leat line 88015). See Appendix 1 for details of photographs.

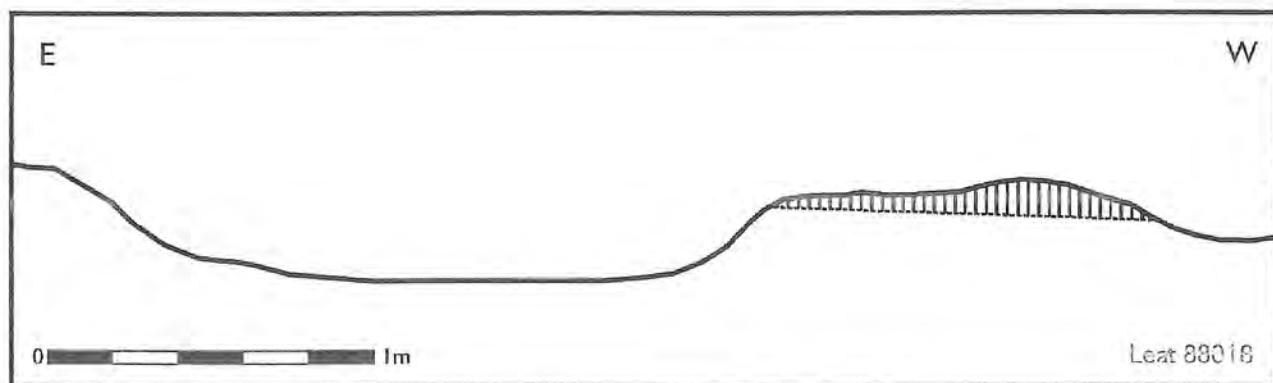
Figure 20: Profile of Leat 88018 at SO 0897 06813

**RECORD:** The south half of the leat was recorded in detail by total station survey. The course of the north half was defined by GPS spot co-ordinates and air photograph plots. A drawn profile was recorded as SO 08797 06813. See Appendix 1 for details of photographs.

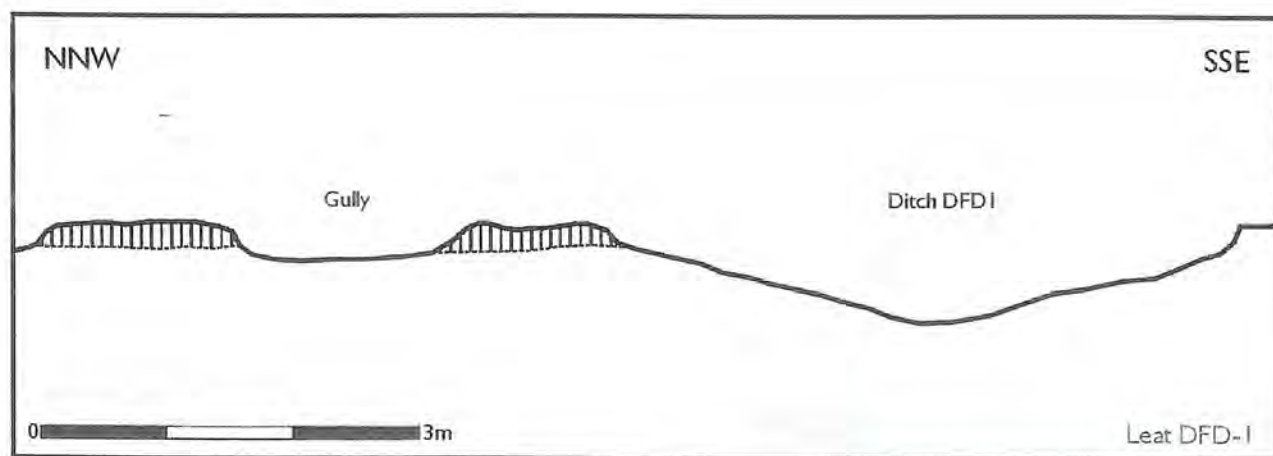
This previously unrecorded feature runs south between Leat 88025 and 88015, occupying what was probably the line of a natural stream course. It consists of a broad, flat ditch, 5.2m in width and 0.7m in depth, becoming narrower to the south. A smaller gully with banks extends from Leat 88025 to join DFD1 on its west side.

Figure 21: Profile of Leat DFD1, with smaller gully to left, at SO 08601 06843

**RECORD:** The course of the leat was plotted from GPS spot co-ordinates and the air photograph. A drawn profile through the leat and the smaller accompanying ditch was recorded at SO 08601 06843. See Appendix 1 for details of photographs.

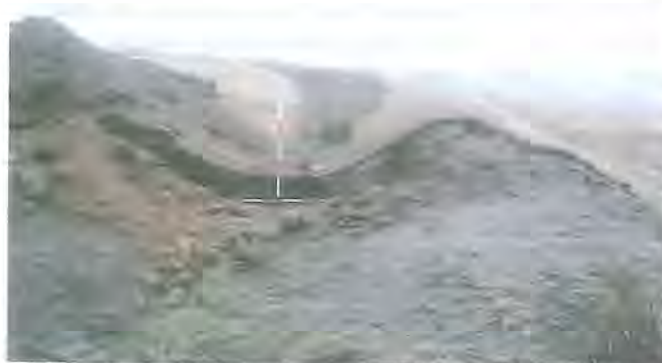
Plate 12: Machine-cut section across Leat 85575 at SO 08871 06581 (as Figure 23 above), looking E

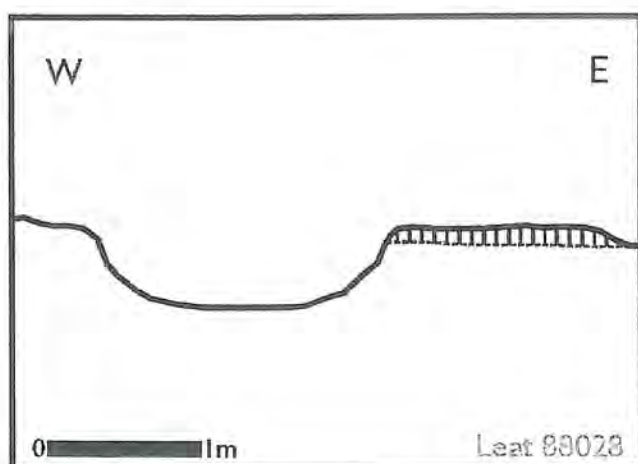
This is a short leat extending south from Leat 88015 to Leat 88027. It is not shown on the 1<sup>st</sup> or 2<sup>nd</sup> ed OS plans, but appears on the 3<sup>rd</sup> ed OS sheet of 1915. The leat follows the line of a natural stream course, and is probably a rationalization of an existing natural feature. It is a shallow ditch, 1.9m in width and 0.5m in depth.

*Figure 24: Profile across Leat 88028 at SO 08758 06612*

**RECORD:** The south part of the leat was recorded in detail by total station; the north end was plotted from GPS spot co-ordinates and an air photograph. A profile was drawn across the leat at SO 08758 06612. See Appendix 1 for details of photographs.

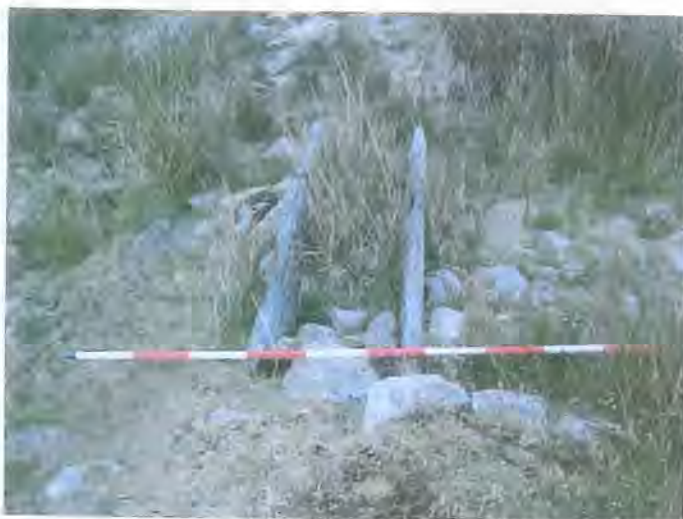
*Plate 13: Stone-lined outfall sluice 88030 at NW corner of Pond 85525, looking W*

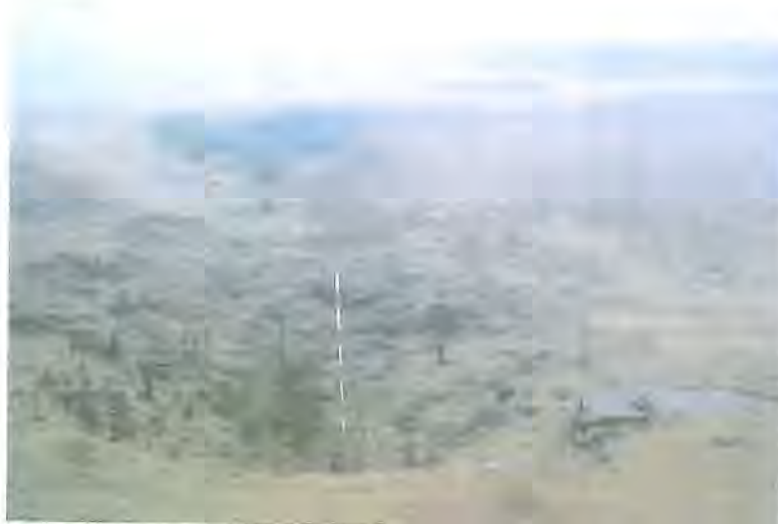
The pit is set within a level hollow, 43m x 23m in area, surrounded by levelled tips and embanked leats. The shaft is oval, 6.7m x 5.15m, with lining stonework on its northwest and northeast sides. An aperture in the stonework on the northwest side is in line with the position of a track shown on the 1<sup>st</sup> ed OS plan. Holding-down bolts mark the position of part of the superstructure, probably for the frame of a balance wheel.

*Plate 14: Pit 85558, looking NW towards tramroad terrace. Note stone lining at back and right of shaft*

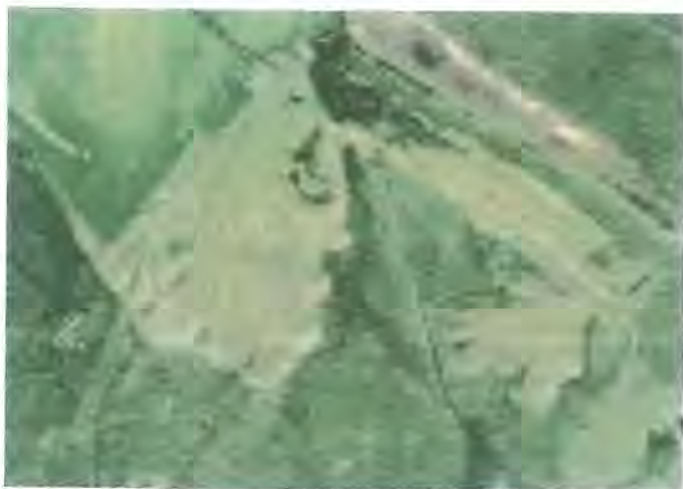
Plate 15: Detail of air photo showing Area 6. Pond 85525 is at the top right, with the tramroad terrace to the SW of it. Waste tips 88035 are on the left and tips 88032 on the right. Compare with 1<sup>st</sup> ed OS plan in Figure 29 (below)

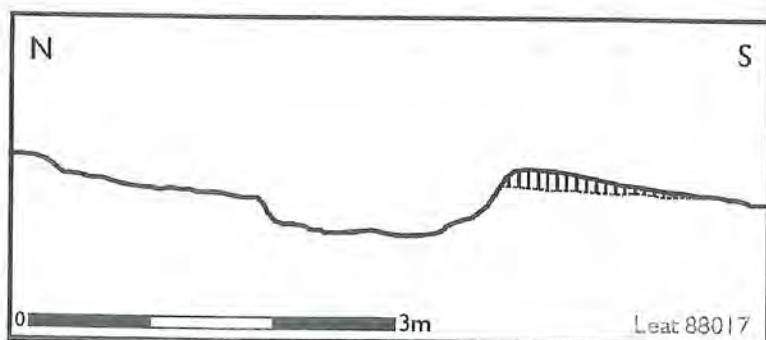
Figure 31: Profile of Leat 88017 at SO 09110 06598, to the west of the junction with Leat 88016

RECORD: The course of the leat was plotted from GPS spot co-ordinates and the air photograph. Drawn profiles were recorded at SO 08937 06632, SO 09110 06598 and SO 09158 06597. A machine-cut trench was excavated at SO 09050 06597. See Appendix 1 for details of photographs.

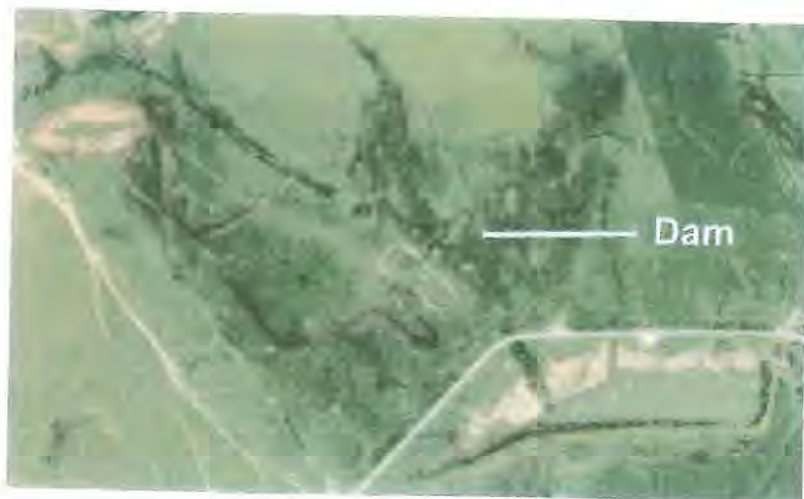
Plate 19: Detail of air photograph, with similar view to Figure 38 (above), showing position of dam for Pond 85992

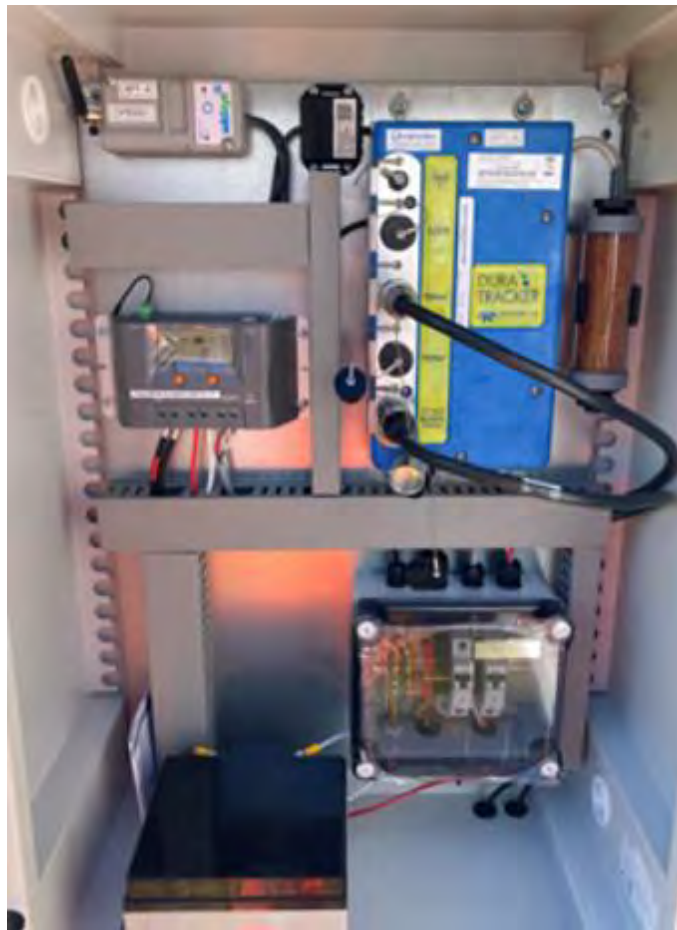
Ratings curves would be generated for each site using a temporary installation, consisting of a **Duratracker** portable logger unit (Figure 4) and **AV (Area Velocity) meter** (Figure 5). These will be kept in place sufficiently long to characterise the rating curve over the full stream flow regime. The length of time required for this will depend on climatic conditions. It is recommended that monitoring for rating curve development would start during the winter period to capture high flow conditions, and continue into the spring and early summer to capture low flow conditions however this is dependent on when planning approval is received.

*Figure 4: ISCO DuraTracker area-velocity flowmeter and Wildeye 4G Telemetry Datalogger assembly*

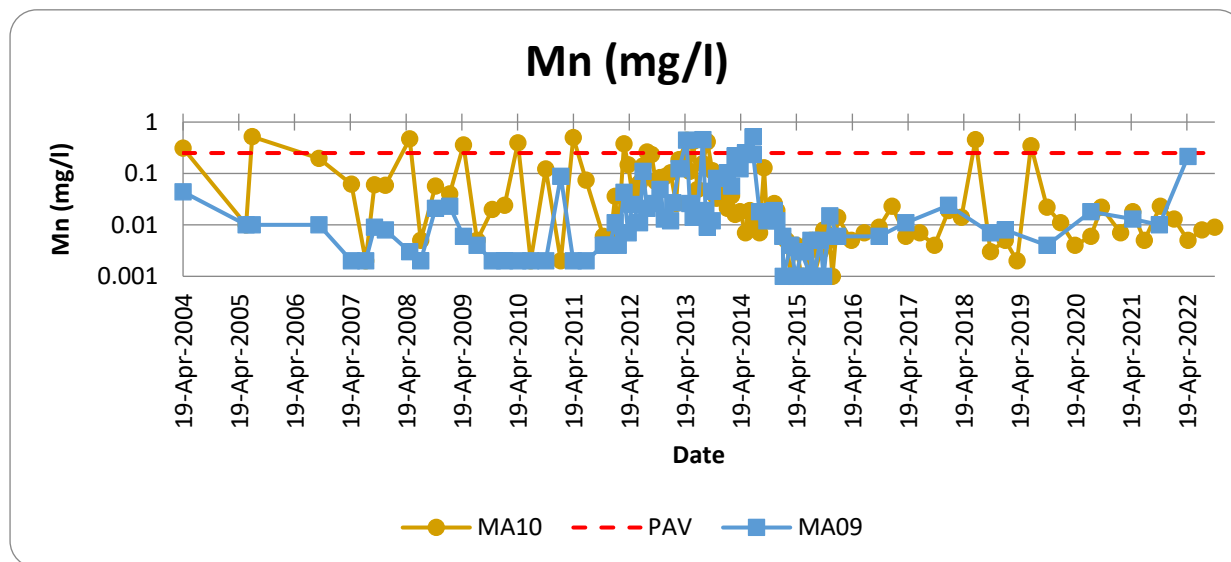
Figure 9 Manganese at MA09 and MA10

Given the improved water quality for manganese over the monitoring period, particularly over the last six years of monitoring (2017-2022), see Figure 9, the results could be considered as achieving water quality objectives for manganese.

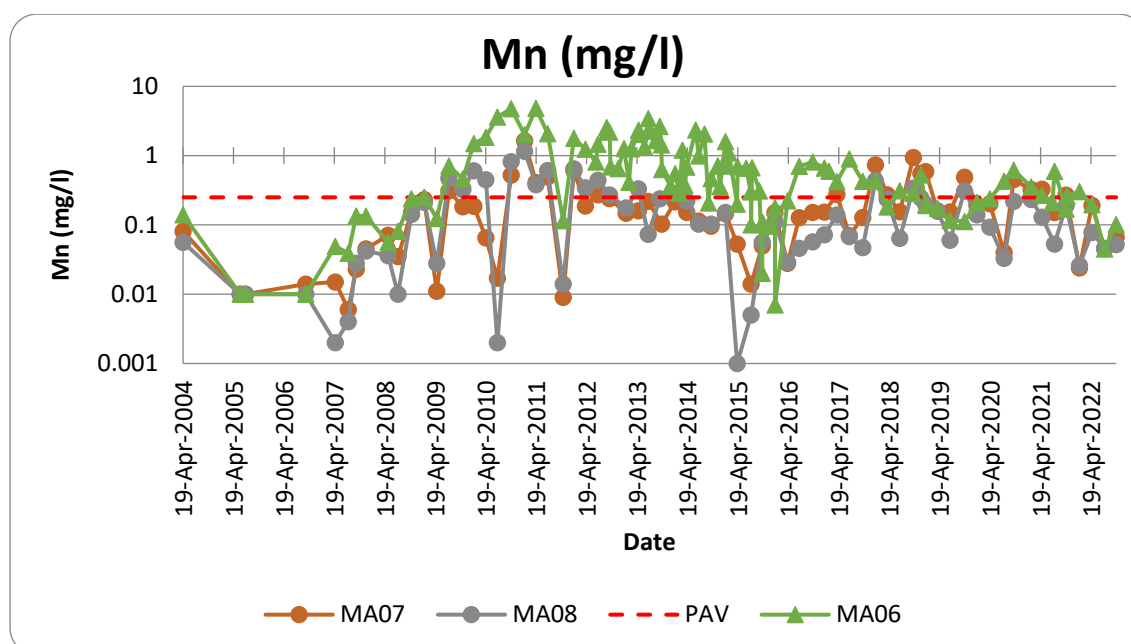
Figure 17 Manganese at MA06, MA07 and MA08

For locations MA06, MA07 and MA08 an elevated Mn concentration is seen (averages greater than the PAV) and thus it can be concluded that the water quality objectives for Manganese are not being reached. Again, as these are the locations downgradient of seepage from OB3 the mitigation measures described in the AMD assessment (MEM, 2025) should be implemented and then monitored to continue to manage any potential risks. Mn is one of the indicator parameters for seepage at these locations.

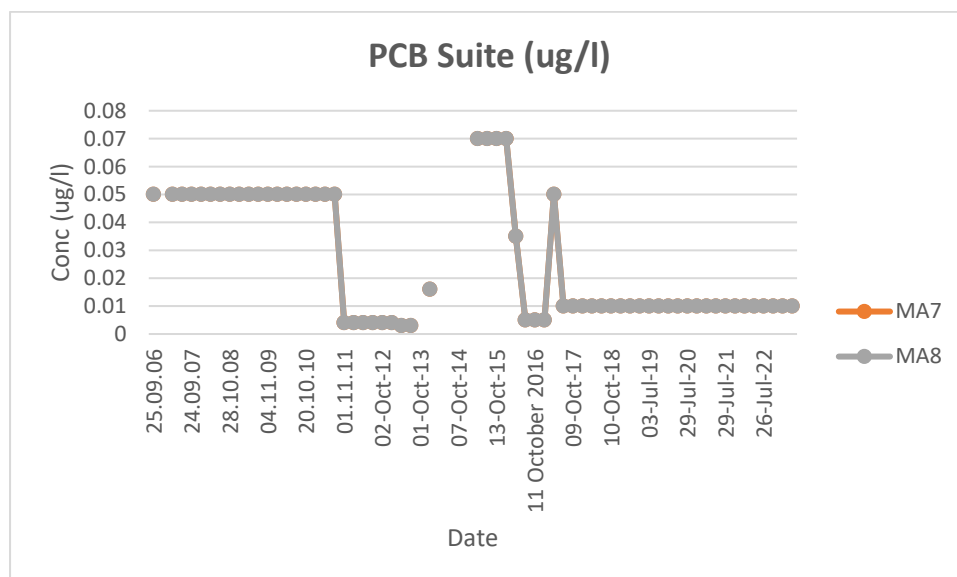
Figure 23 PCB Suites at MA07 and MA08

The results from the two locations, MA07 and MA08 are identical to each other, see Figure 23. This appears to reflect the LOD of each analysis, and variations to the usual LOD by the laboratory so suggests no PCB detected at these locations. The elevated results prior to 2017 are likely to be a combination of changes in LOD and inconsistency in methods of calculating the values from combining the results from the individual species. The methodology seems to be overly conservative resulting in values that are greater than the PAV, when in reality this may not be the case. MEM would consider that samples that returns at below the LOD are complaint. The most recent 2025 result returned <0.01ug/l for all species. All phenol and PCB results at MA06, MA07 and MA08 were below PAV for the period 2004-2023.

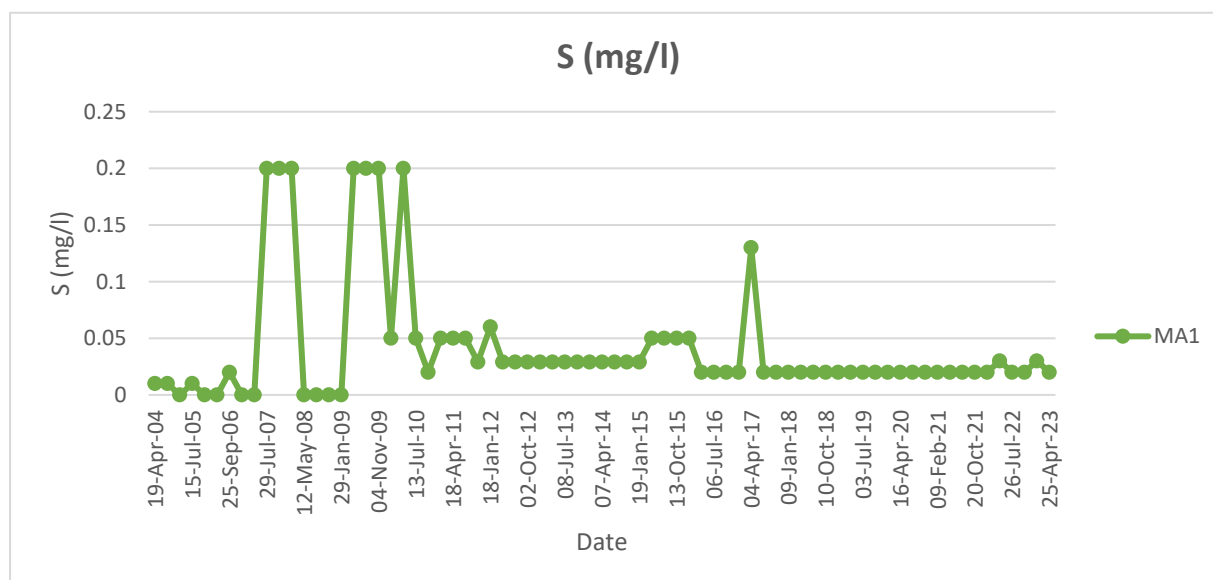
Figure 27 Sulfur at MA01

Given the two elevated result above PAV (0.03 mg/l) since 2020 and the concentration average over the last six years, see Figure 27, it should be considered that water quality objectives are being achieved for sulfur, particularly as sulfate has not been found to be above the PAVs in the monitoring dataset at this location.

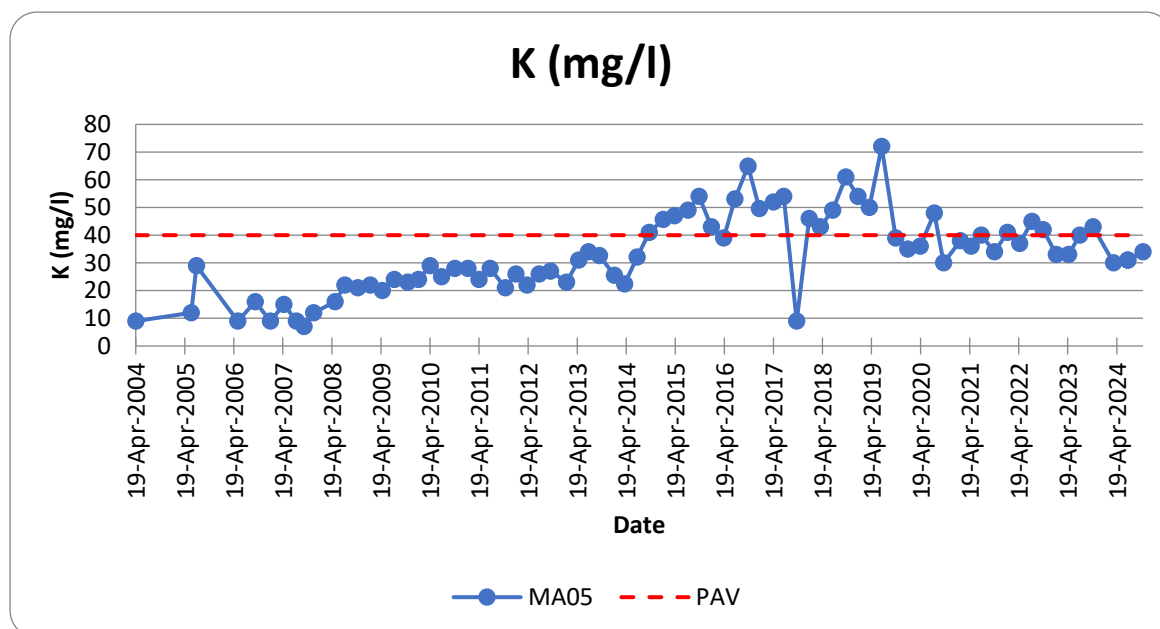
Figure 28 Potassium at MA05

The average of the periods 2014-2018 is greater than the overall average, and above the PAV. Following 2018 the average remained relatively high and occasionally above PAVs, see Figure 28. As

such it could not be concluded on the data alone that the water quality objectives for Potassium has been reached.

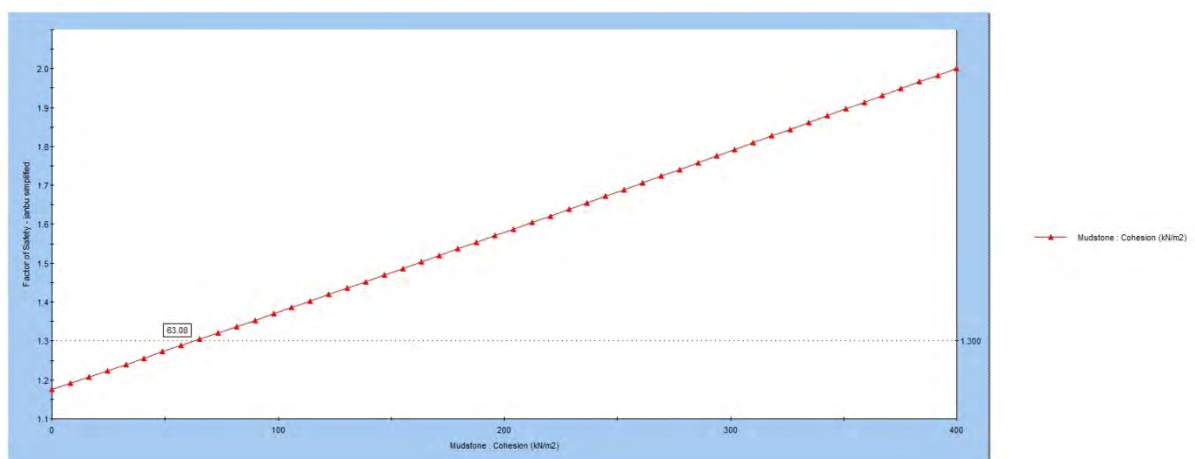
**Fig 5 - Section D, Variation of Factor of Safety with Cohesion in Coal Measures**

Due to the uncertainty of the strength parameters, a sensitivity analysis looking at the effect of variations in the cohesion has been considered, the results of which are presented in Figures 2 to 7.

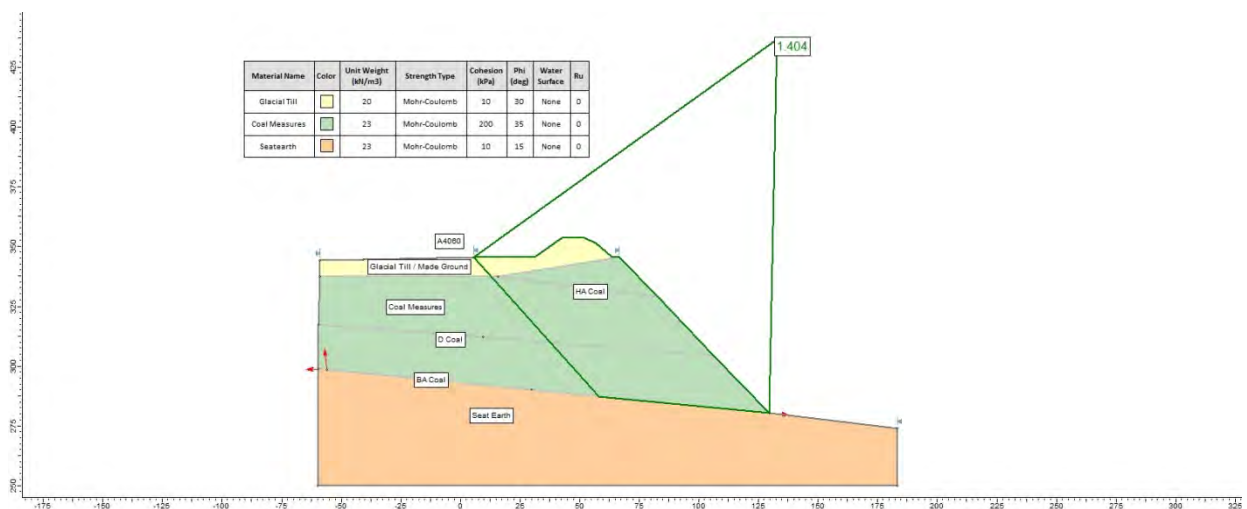
**Fig 6 - Section E, Sensitivity - Cohesion in Coal Measures 200kPa**  
**Factor of Safety = 1.40**  
 (Note this is the average cohesion of the range considered)

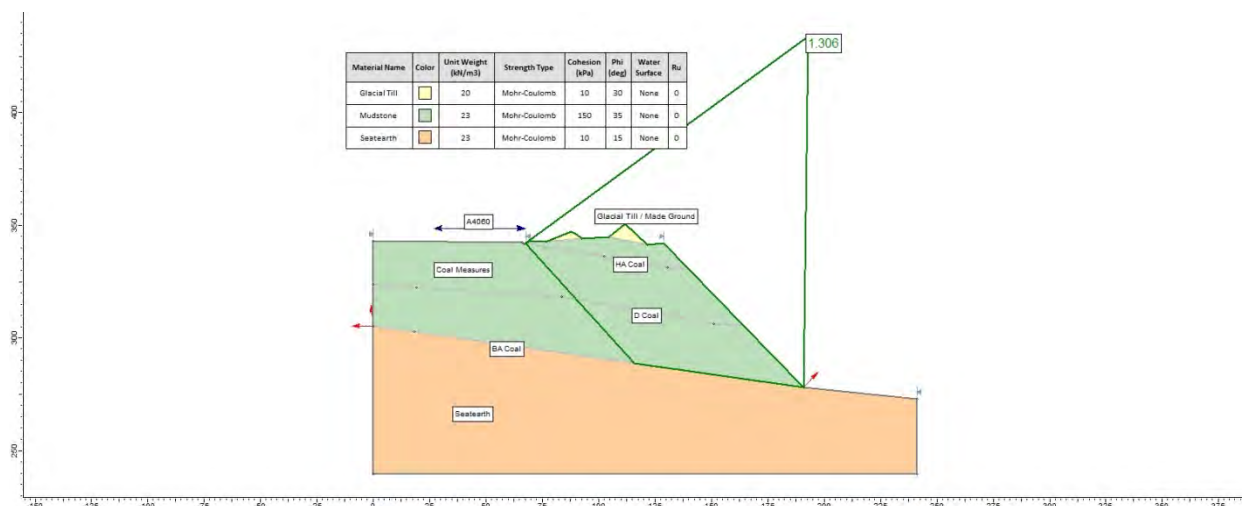
**Fig 8 - Section C, Cohesion in Coal Measures 150kPa  
Factor of Safety = 1.31**

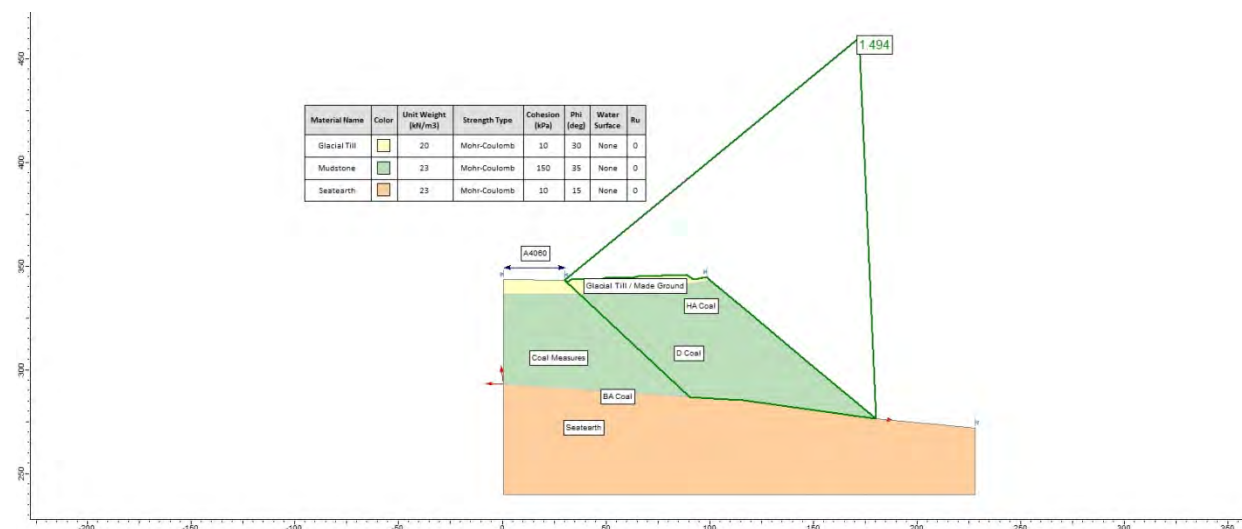
**Fig 9 - Section D, Cohesion in Coal Measures 150kPa  
Factor of Safety = 1.49**
