*Report No. BC/MB/04.19.04.*

# **Coal Mining Risk Assessment: Proposed New Club House at the Wern Sports Ground.**

**Merthyr Rugby Club.**

## **Mining Risk Assessment: New Club House, Land at the Wern Sports Ground.**

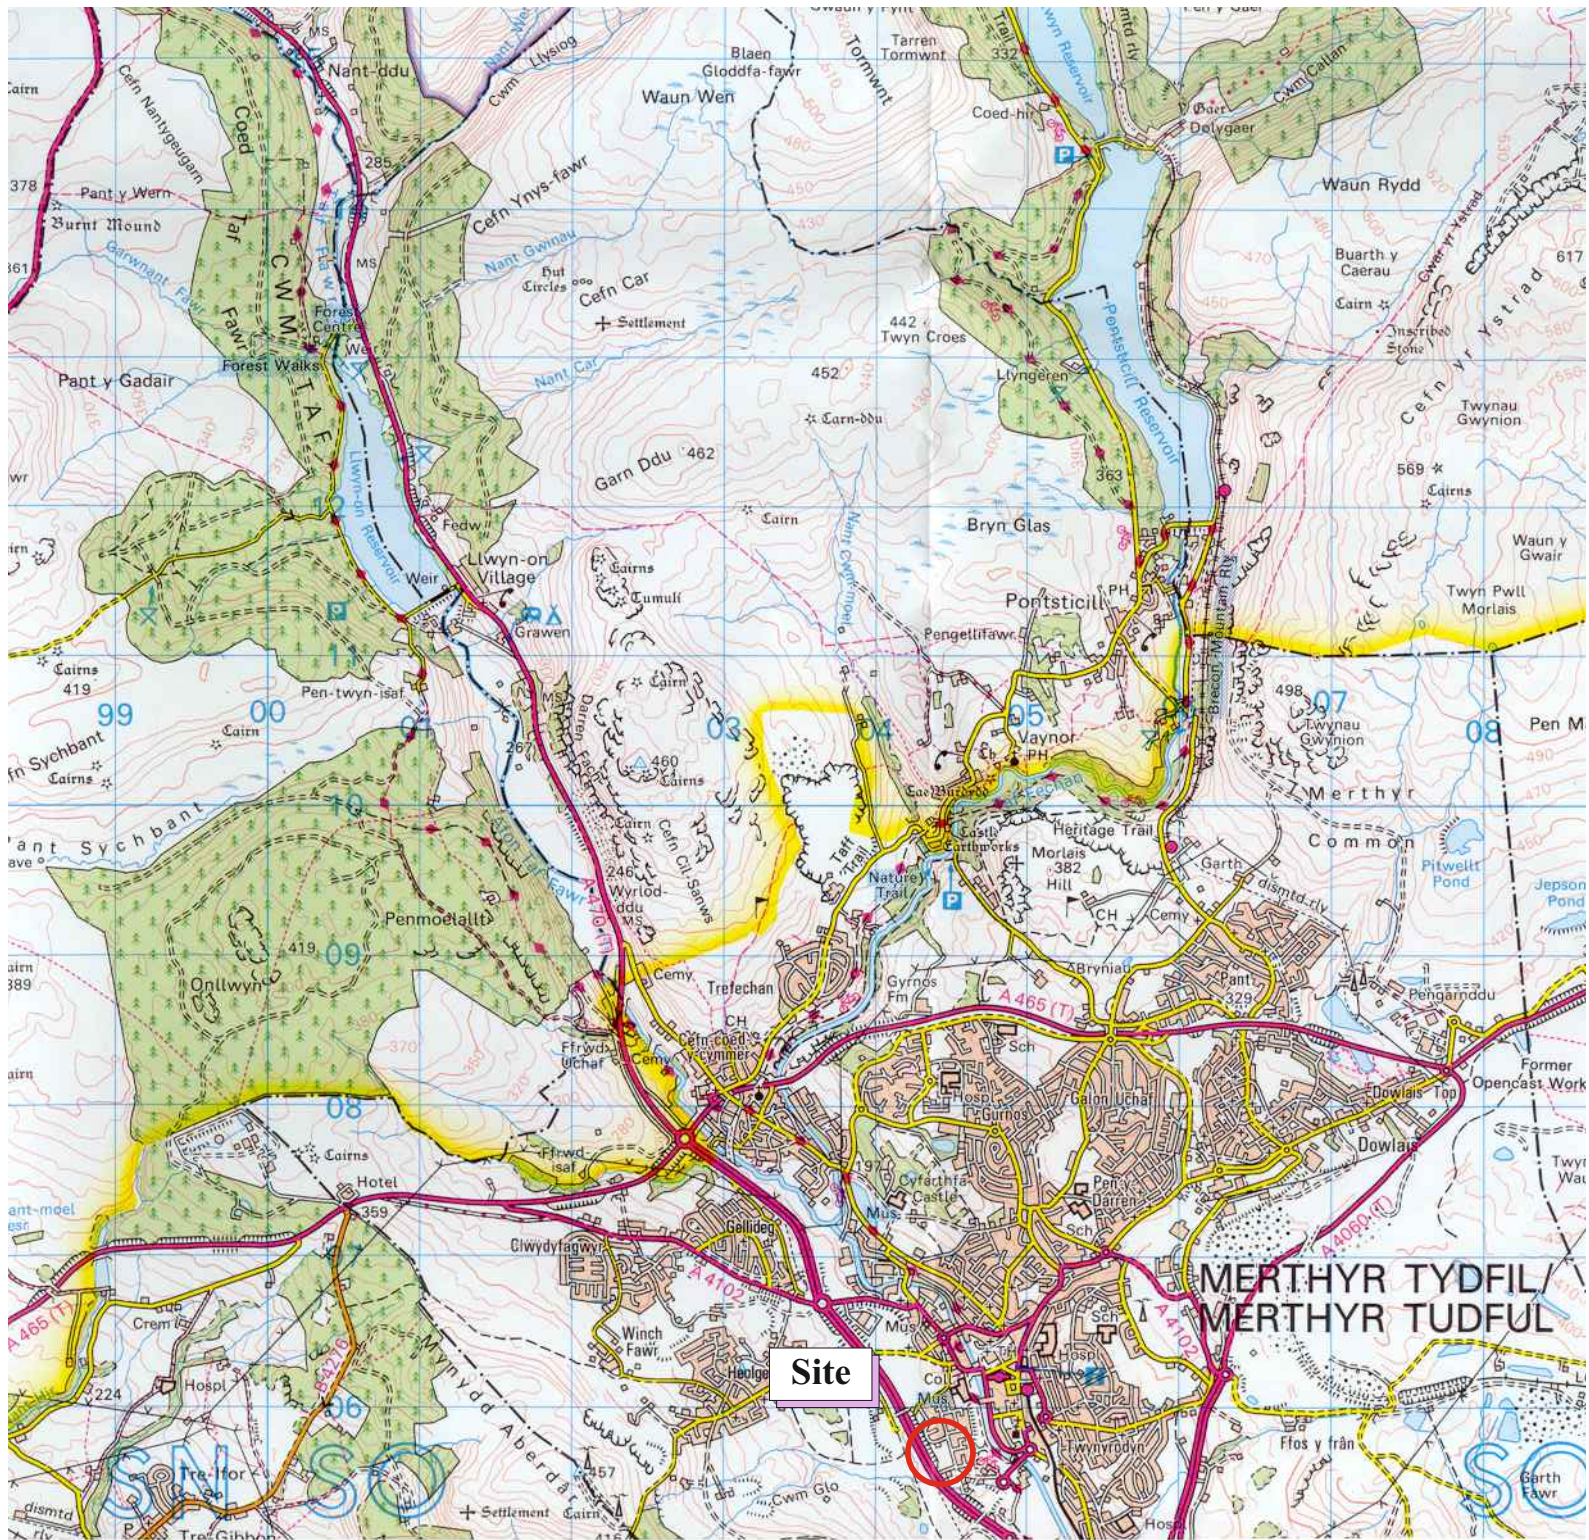
Drawing No: BC/MB/04.19.04.01.

Study on Land at Merthyr Rugby Club Ground.

Geology Plan.

| <b>Drawing No:</b> | | <b>Scale:</b> |
|---|---|---|
| <i>BC/MB/04.19.04.02.</i> | <i>Geology Plan.</i> | <i>1:10,560.</i> |
