*Report No. BC/MB/12.19.02*

# **Mining Risk Assessment: Land at Crophorne Stables, Trelewis.**

**AW Properties Ltd.**

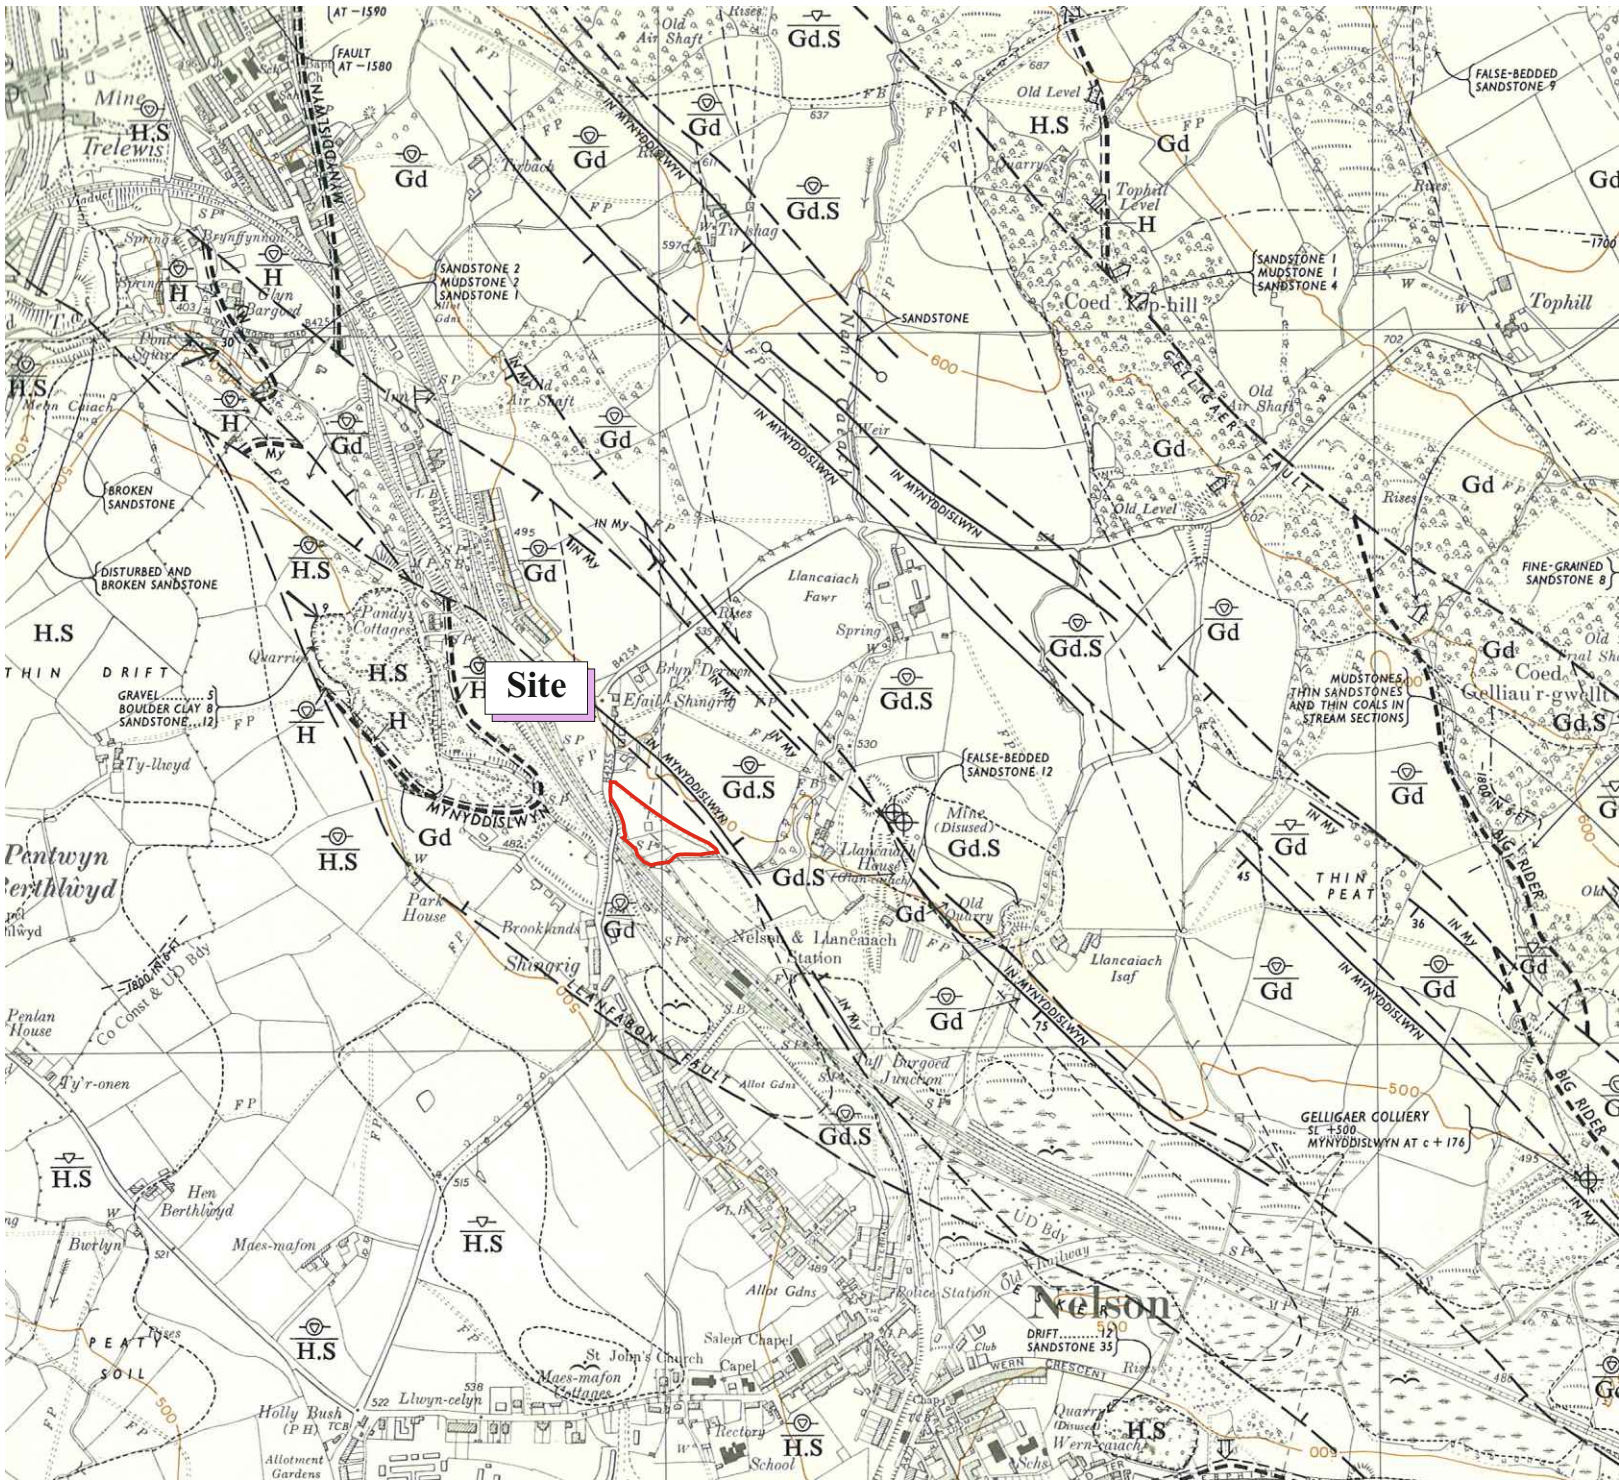
## *Detailed Location Plan.*

Study on Land at Crophorne Stables, Trelewis.

The parcel of land that is the subject of this report ('the Site') is located at the southern margins of the settlement of Trelewis and is approximately 2km south-east of the centre of Treharris (see *General Location Plan, drawing no. BC/MB/12.19.02.01*). The Site is located on southerly facing slopes where average groundslopes are 1 in 12. The Site is irregular in outline and occupies an area of approximately 0.7 hectares; it is at approximate elevations of 147m above ordnance datum. Residential dwellings and agricultural enclosures form the north-eastern boundary of the Site, agricultural enclosures and woodland the south-eastern and the B 4255 the western boundary (see Figure 1 and *Detailed Location Plan, drawing no. BC/MB/12.19.02.03*).
