| Reference | 179 | <p>This Design Statement supports the planning application for the proposed reconfiguration, alterations, and restoration of the South Stables, Cow Housing, former Forge, and Threshing Barn at Pandy Farm, Merthyr Tydfil.</p> <p>This document should be read in conjunction with the accompanying general arrangement drawings and plans, the Heritage Statement, Heritage Impact Assessment (HIA), and other supporting documents, which together evaluate the proposal’s potential effects on the site’s heritage significance.</p> <p>The farmstead comprises a group of buildings statutory listed Grade II in 1973:</p> <ul style="list-style-type: none"><li>• Reference 11406 – Barn at Pandy Farm (Grade II, Designated) agricultural and subsistence class</li><li>• Reference 11407 – L Plan Stable Ranges at Pandy Farm (Grade II, Designated) domestic class</li><li>• Reference 11405 – Clock Tower at Pandy Farm (Grade II, Designated), gardens, parks and urban spaces class</li><li>• Reference 11404 – Pandy Farmhouse (Grade II, Designated), domestic class</li></ul> <p>A series of site visits and workshops pertaining to a previous scheme, have previously been hosted at Pandy Farm during Oct

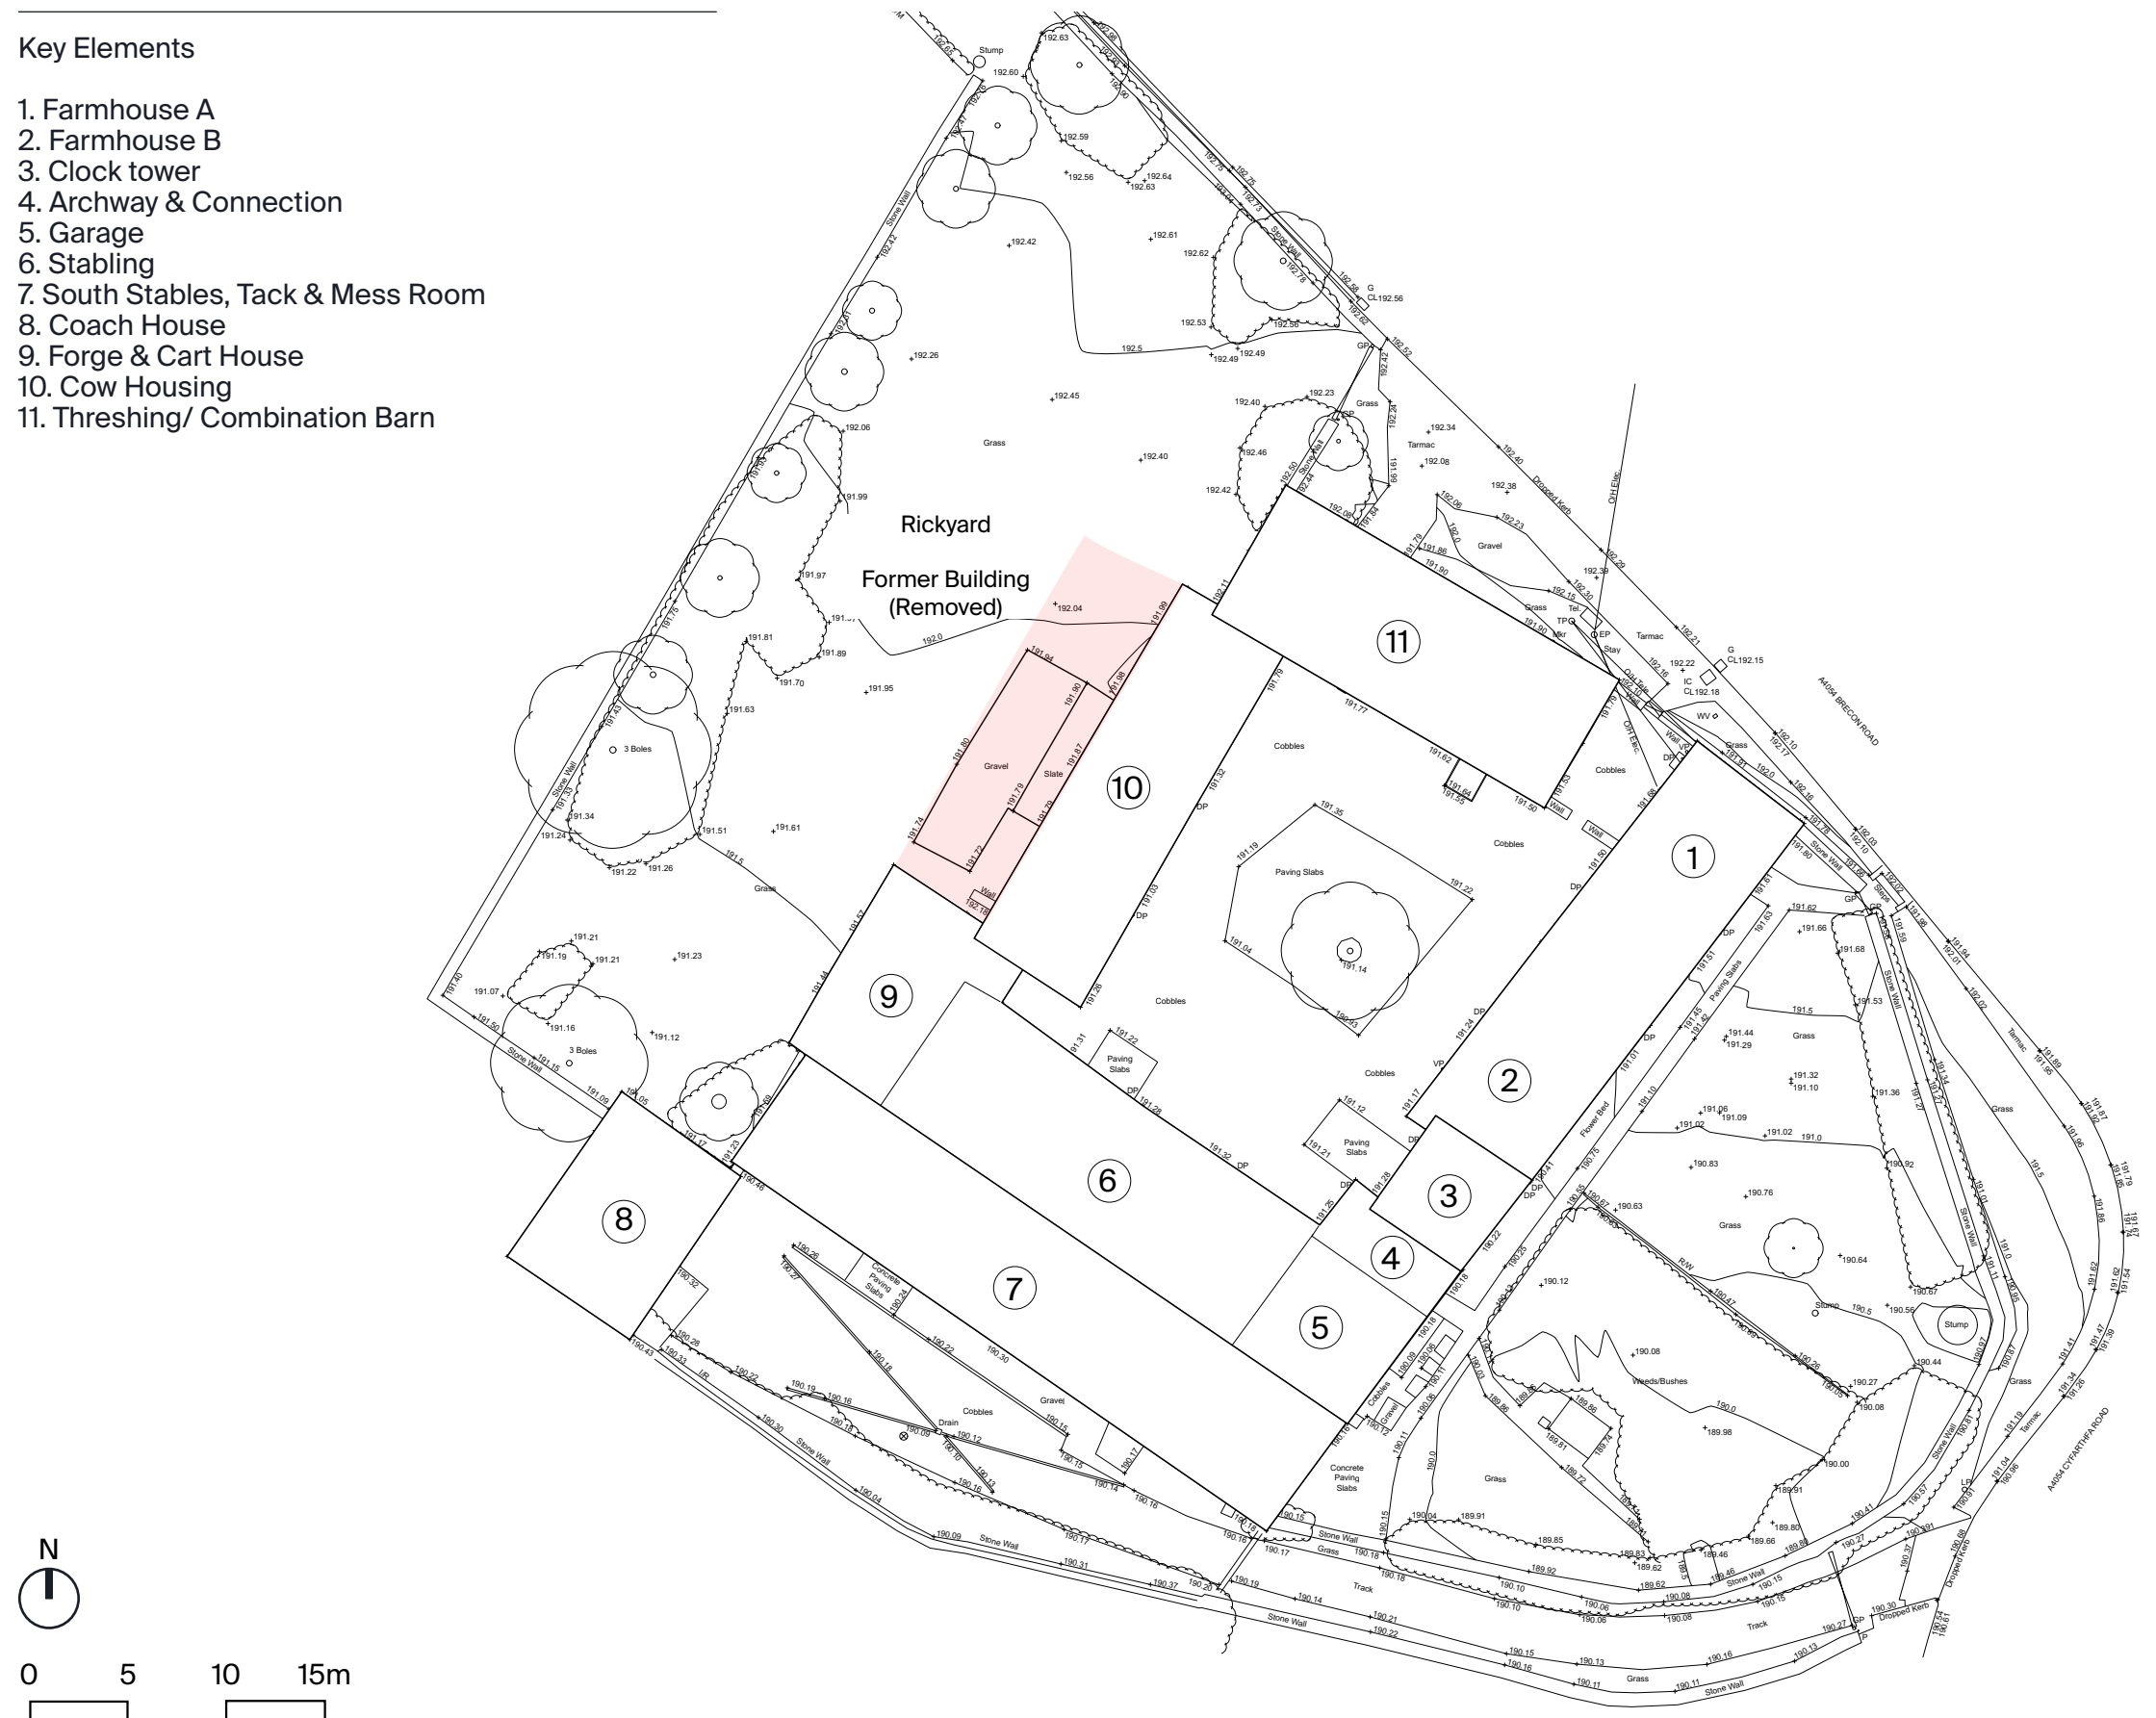
# Pandy Farm Historic Elements

## Key Elements

1. Farmhouse A
2. Farmhouse B
3. Clock tower
4. Archway & Connection
5. Garage
6. Stabling
7. South Stables, Tack & Mess Room
8. Coach House
9. Forge & Cart House
10. Cow Housing
11. Threshing/ Combination Barn

- The threshing/combination barn (11) appears to have been built before the cow housing (10) as inside the building (10) you can see the threshing barn wall and the cow housing butting up to it.

- It is uncertain, but seems as if 4, 5 and 6 were built at the same time as cow housing and stabling for working horses. The dividing wall between 5 and 6 seems to be a later insertion and they share the same back south wall.

- The cart shed facing the rickyard and forge (9) could be later.
- The stables (for riding and coach horses) and carriage house 7 & 8 appear to be built after 5, 6 and 9. It looks as if there is a visible junction at low level between 7 & 5 on the east gable before the stonework is tied in further up. In the south-west end of 7 the rear wall appears to be the wall of the cart shed, 9 above.

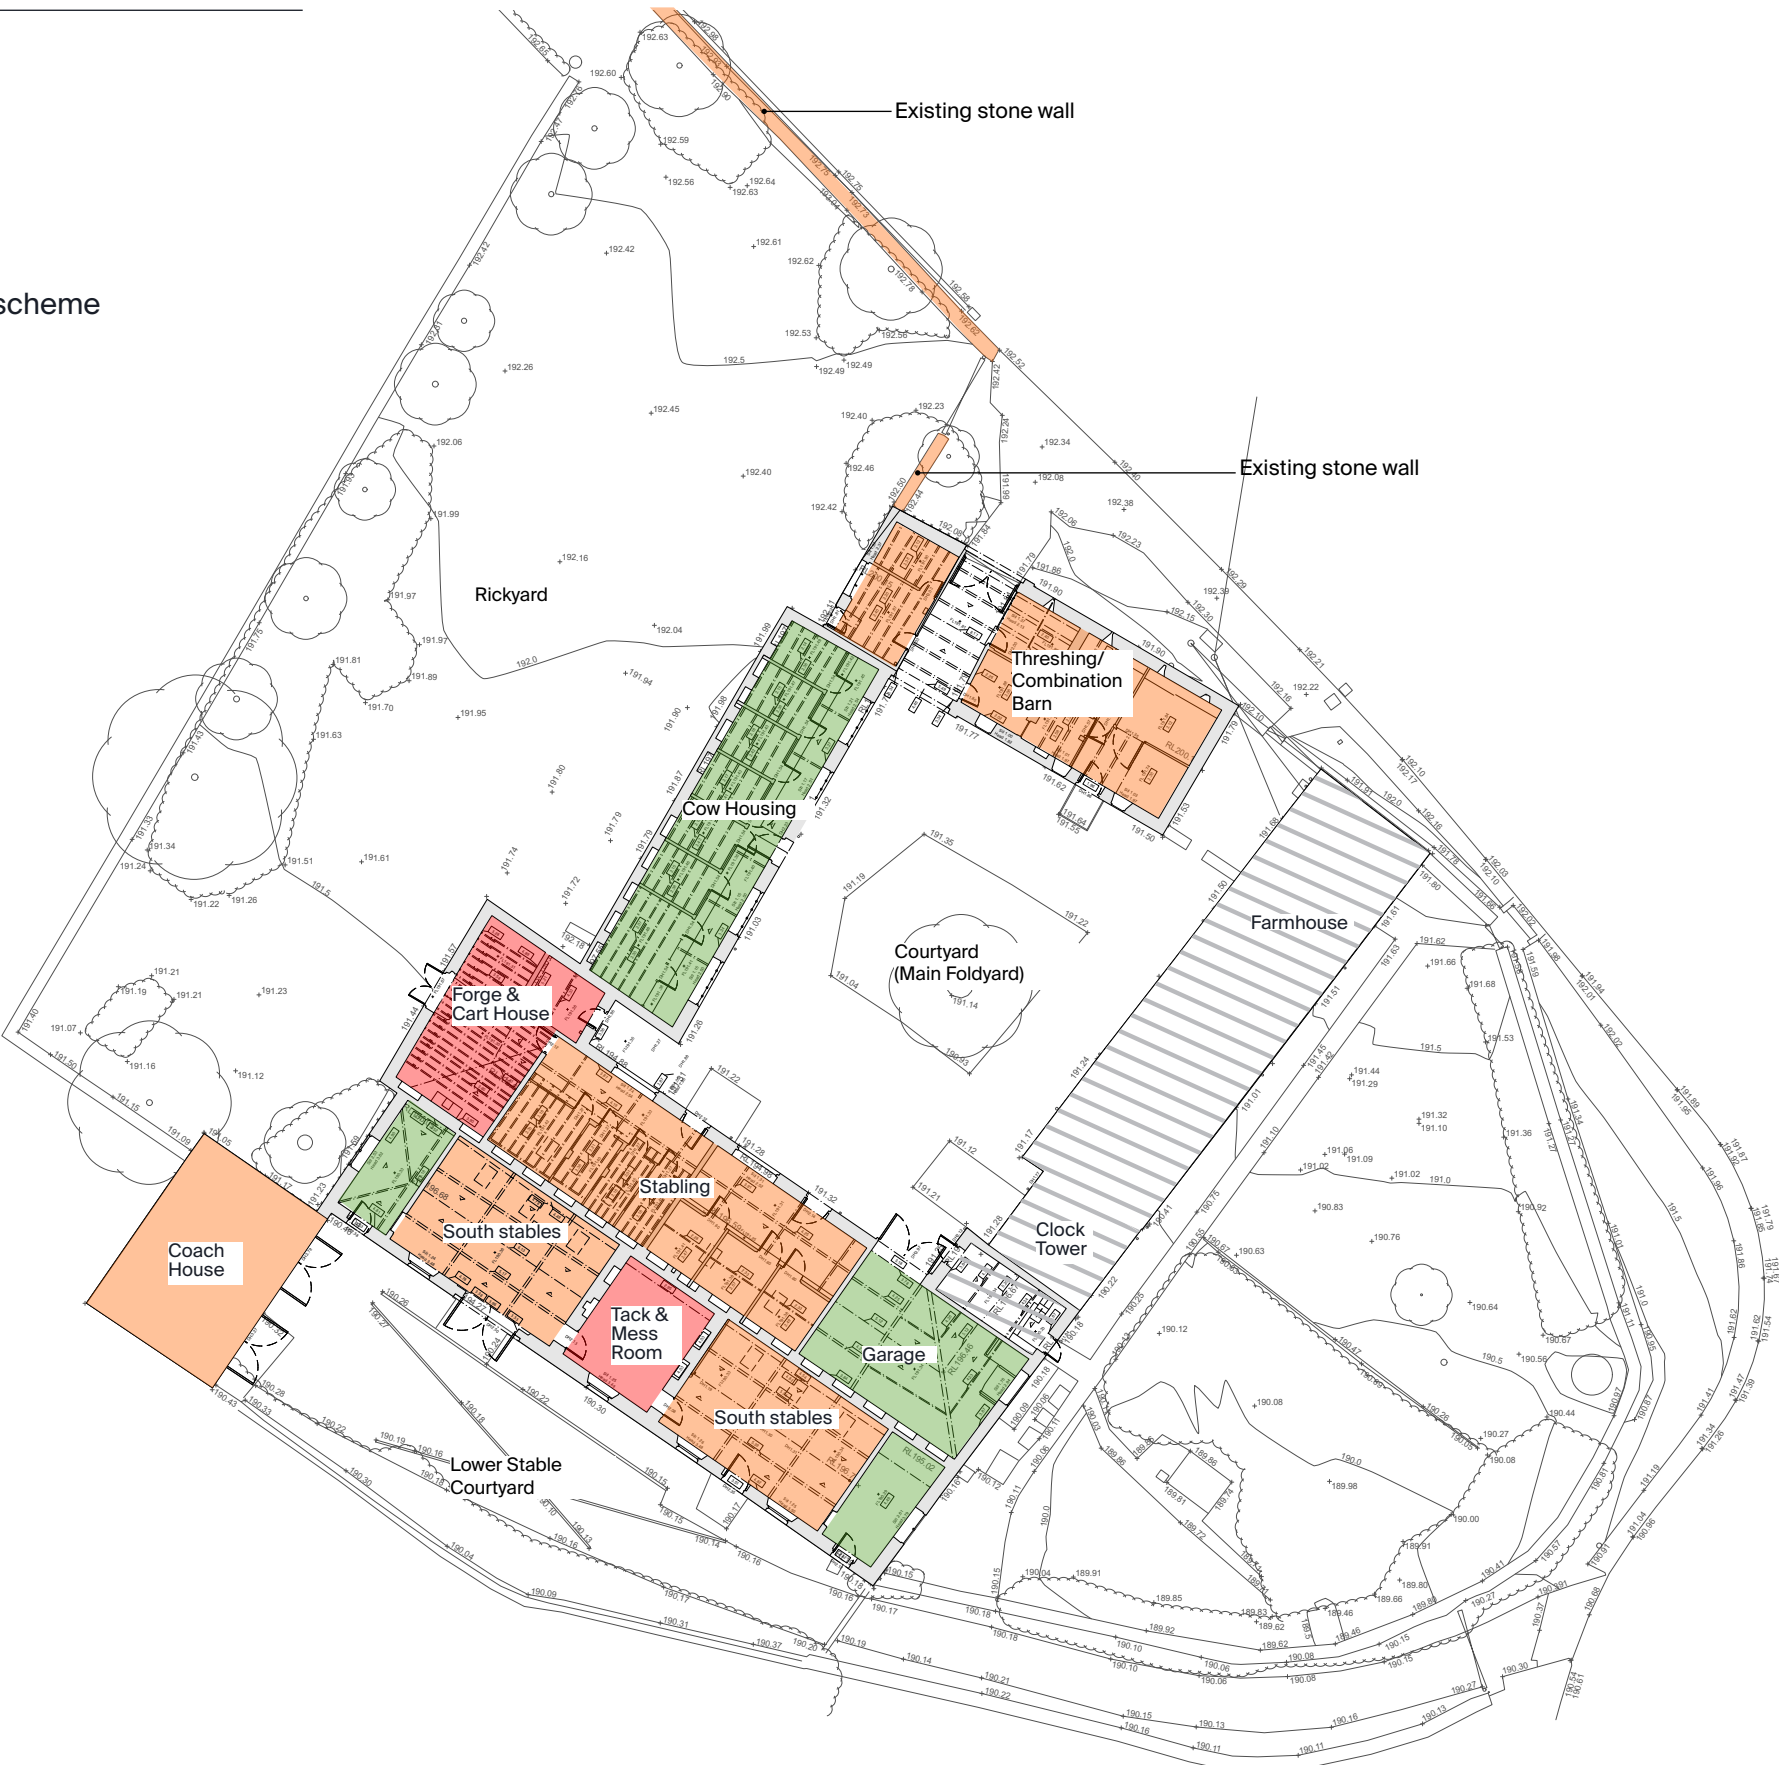
A comprehensive Statement of Significance has been prepared within the Heritage Statement, outlining the site’s overall heritage importance in relation to the four recognised heritage values.

While the site as a whole has been assessed as having high significance, it is composed of individual buildings, each with their own distinct heritage value. Recognising these differences is essential for understanding the varied contribution each structure makes to the character, development, and historic function of the farmstead.

The accompanying plan illustrates both the distribution and the combination of heritage values across the site. It also demonstrates that significance can vary even within a single building. The south stable offers the clearest example of this, where high, moderate, and low levels of significance are assigned to different rooms within the same structure.

Key

- High
- Moderate
- Low
- Not part of the proposed scheme

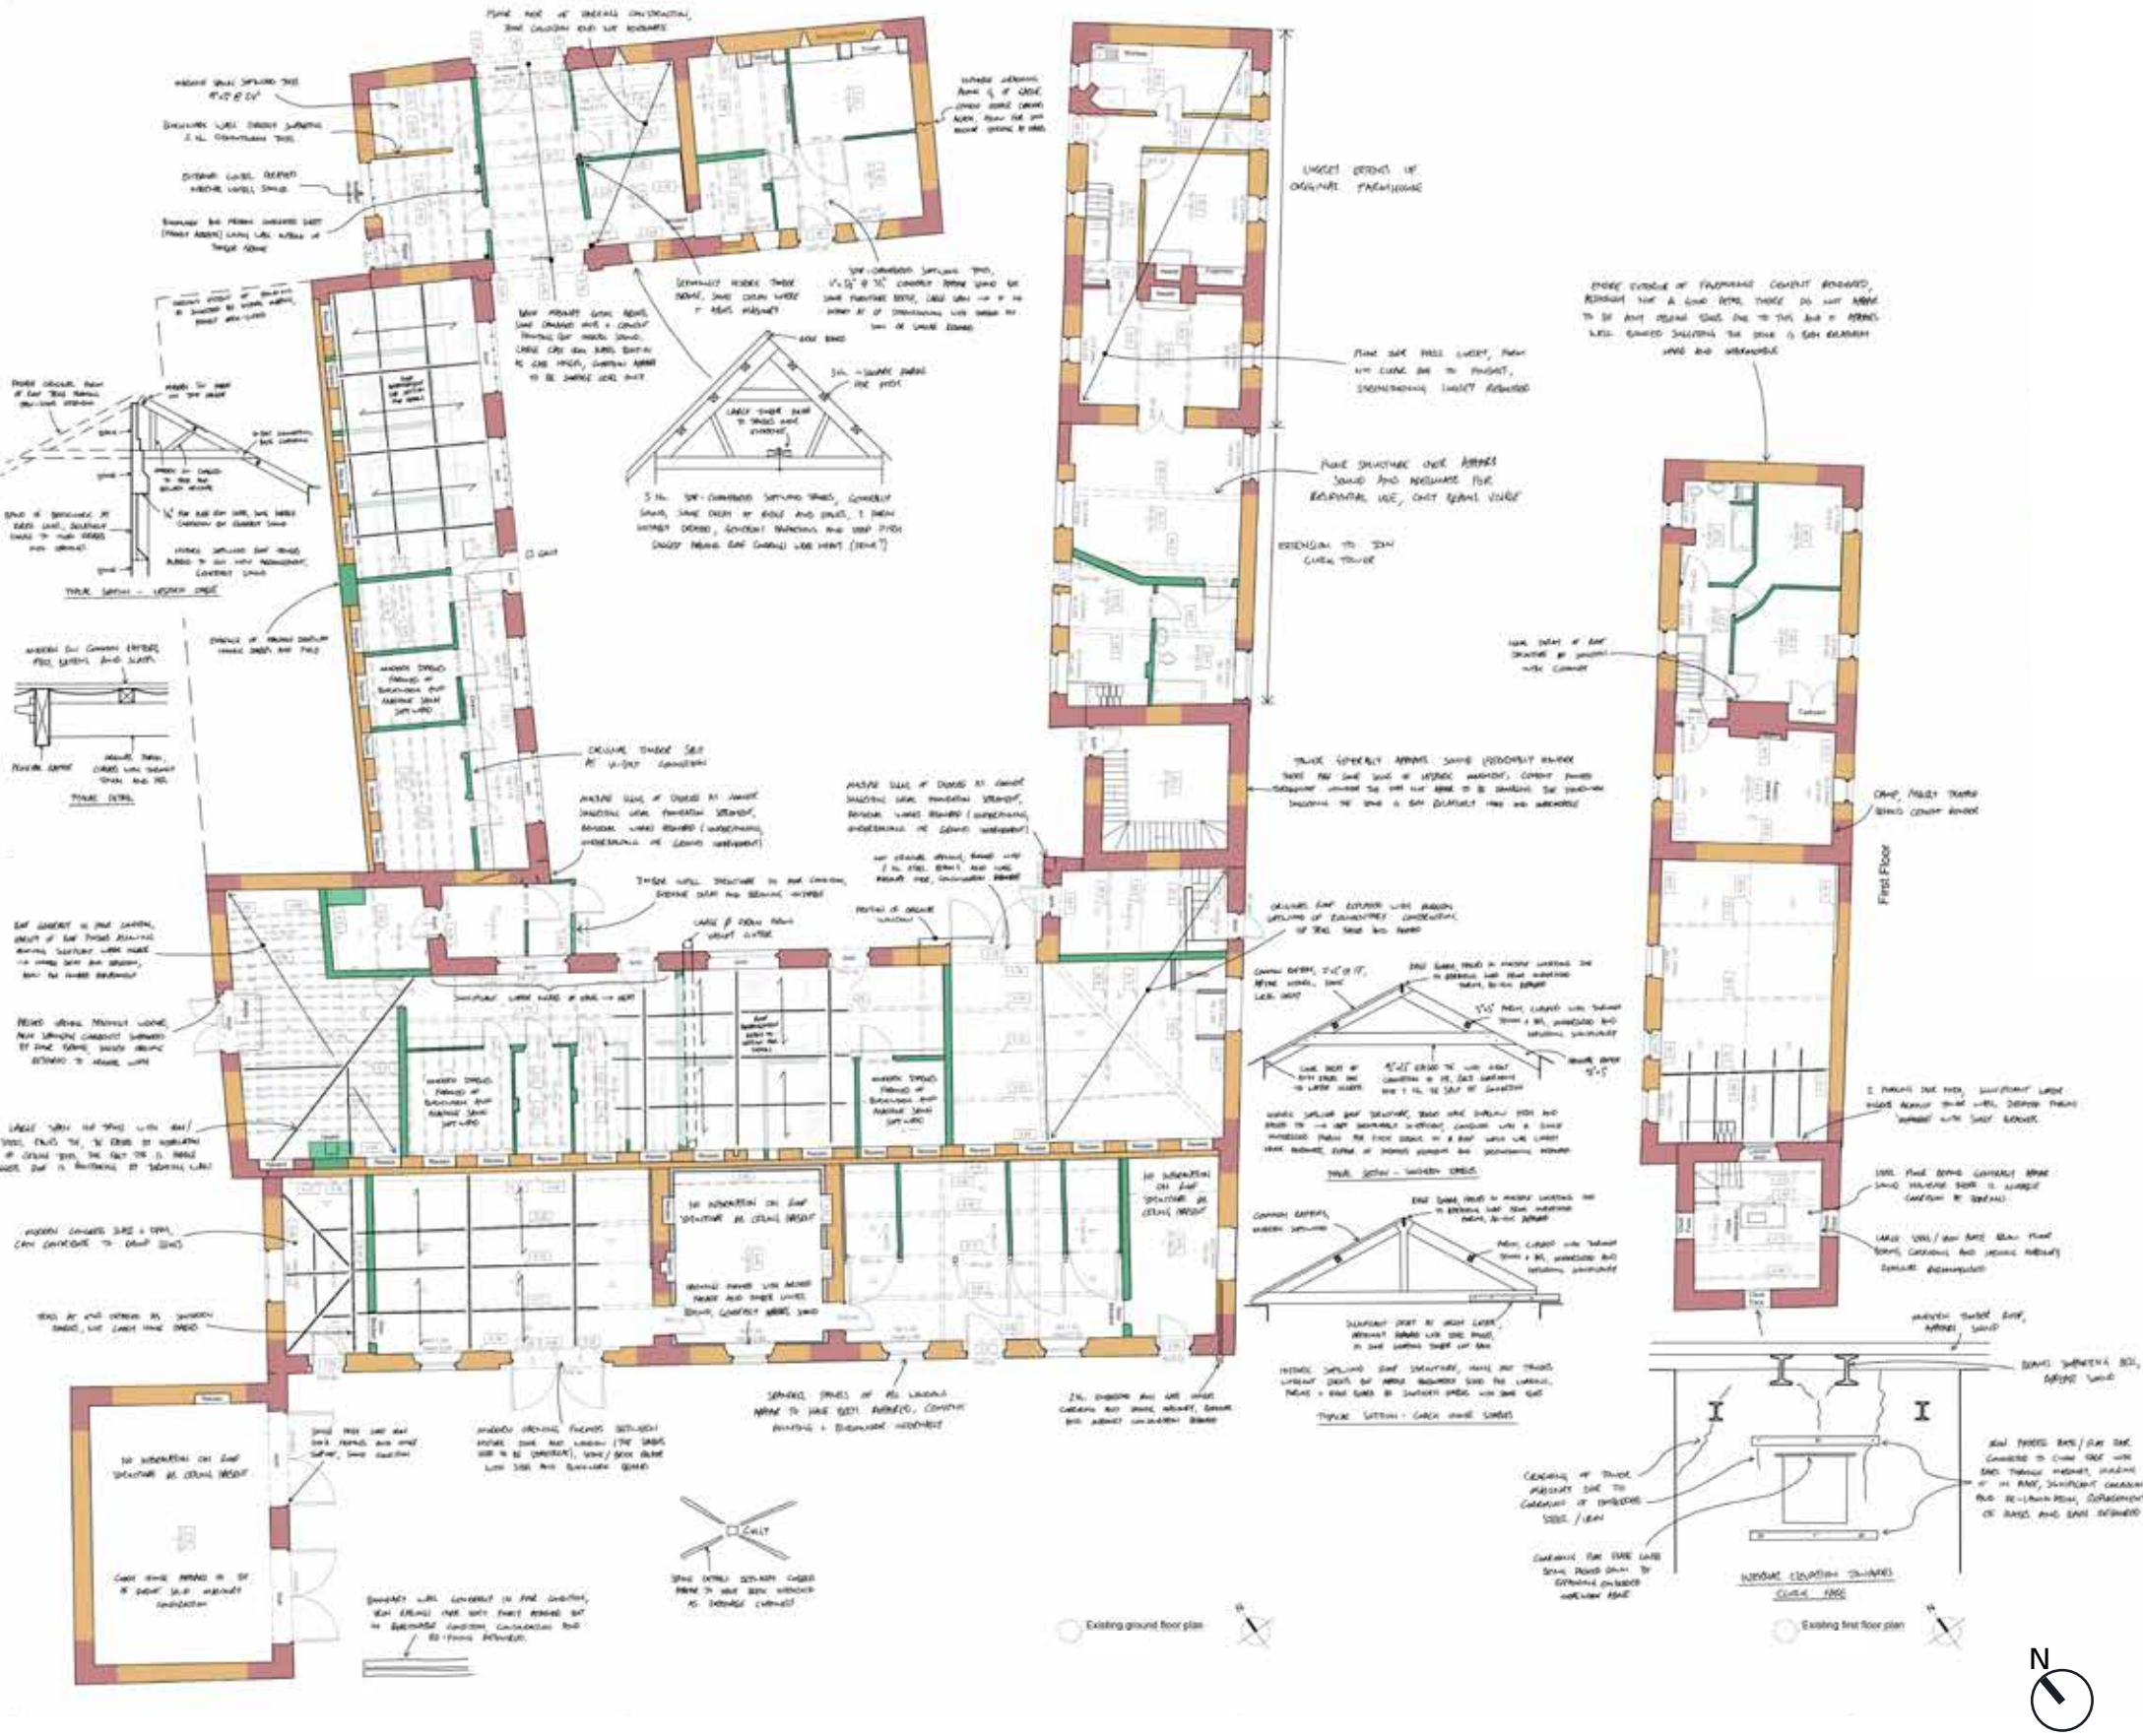
The structural appraisal has been fundamental to understanding the existing structure, its significance, and the way the buildings perform as a whole. Through careful assessment, it has identified the primary load-bearing elements and areas of structural sensitivity, allowing informed decisions to be made about where change can be accommodated. This process has ensured that proposed alterations are focused in locations that do not compromise the structural stability of the buildings, while respecting and retaining the integrity of the original structure.

An early stage structural feasibility was undertaken by Mann Williams in October 2021. The diagram showcases the notes provided from the initial inspection, which highlighted the key structural conditions on site. The previous works to the stables roof undertaken as part of LBC P/22/0317 has addressed many of the areas highlighted, including the majority of the structural items associated within the roof.

Key

Provide important structural function, can be altered but will require considered intervention.

Providing some structural function, can be altered with standard/typical intervention.

Providing little to no structural function, can be altered or removed entirely with minimal intervention.

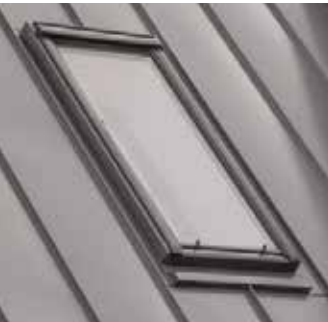
Proposed rooflights aligned to the standing seam roof finish.

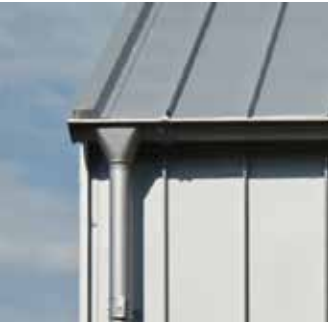
A grey standing seam cladding finish to roof and wall systems, with aluminium rainwater goods to express an agricultural language.

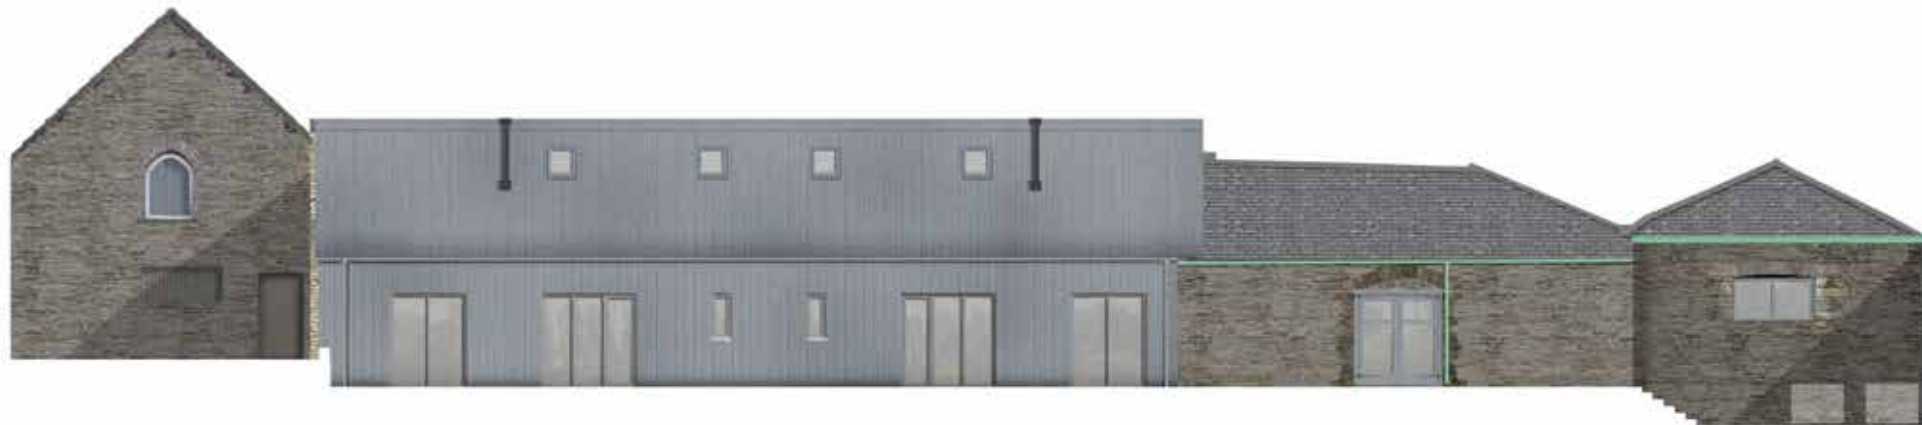
Rendered elevation showing proposed materiality.

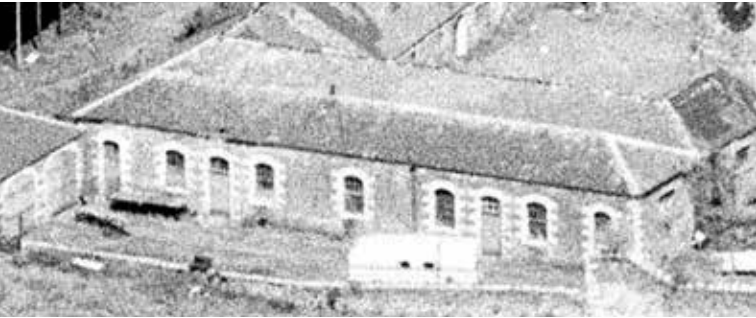
Aerial view of Cyfarthfa Castle, Merthyr Tydfil c. 1957 © Amgueddfa Cymru 2026

The 1957 image demonstrates the elevation prior to the contemporary works that enlarged the existing openings. It also shows that the fixed fanlights above the doors were originally either glazed or barred, and that the overall fenestration had a more domestic character.

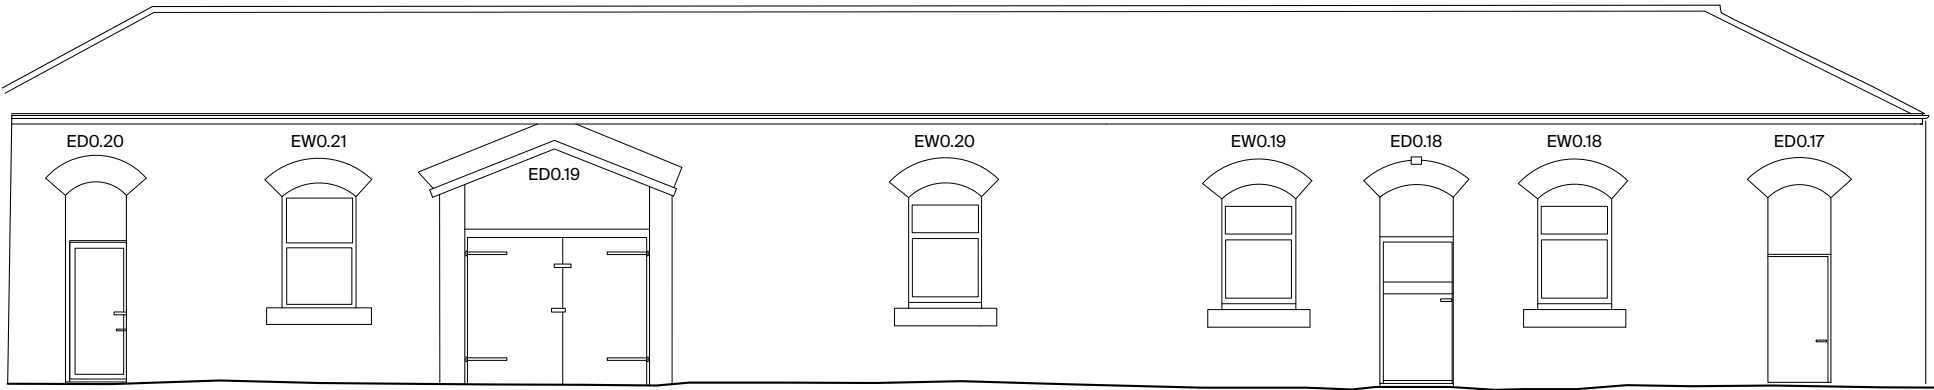
Existing Elevation

The south elevation of the south stable has historically undergone various alterations, most notably the large, contemporary, and crudely executed double-door insertion, which has significantly disrupted the building’s architectural quality and symmetry.

Historic evidence, including masonry rebuilding works internally, suggests that the window sill detail previously caused significant failure in the surrounding masonry, necessitating repair and reconstruction. As a result, much of the fabric below sill level is already contemporary infill or a poor-quality restoration of the original masonry.
