Treharris Library  
proposed plans + elevations

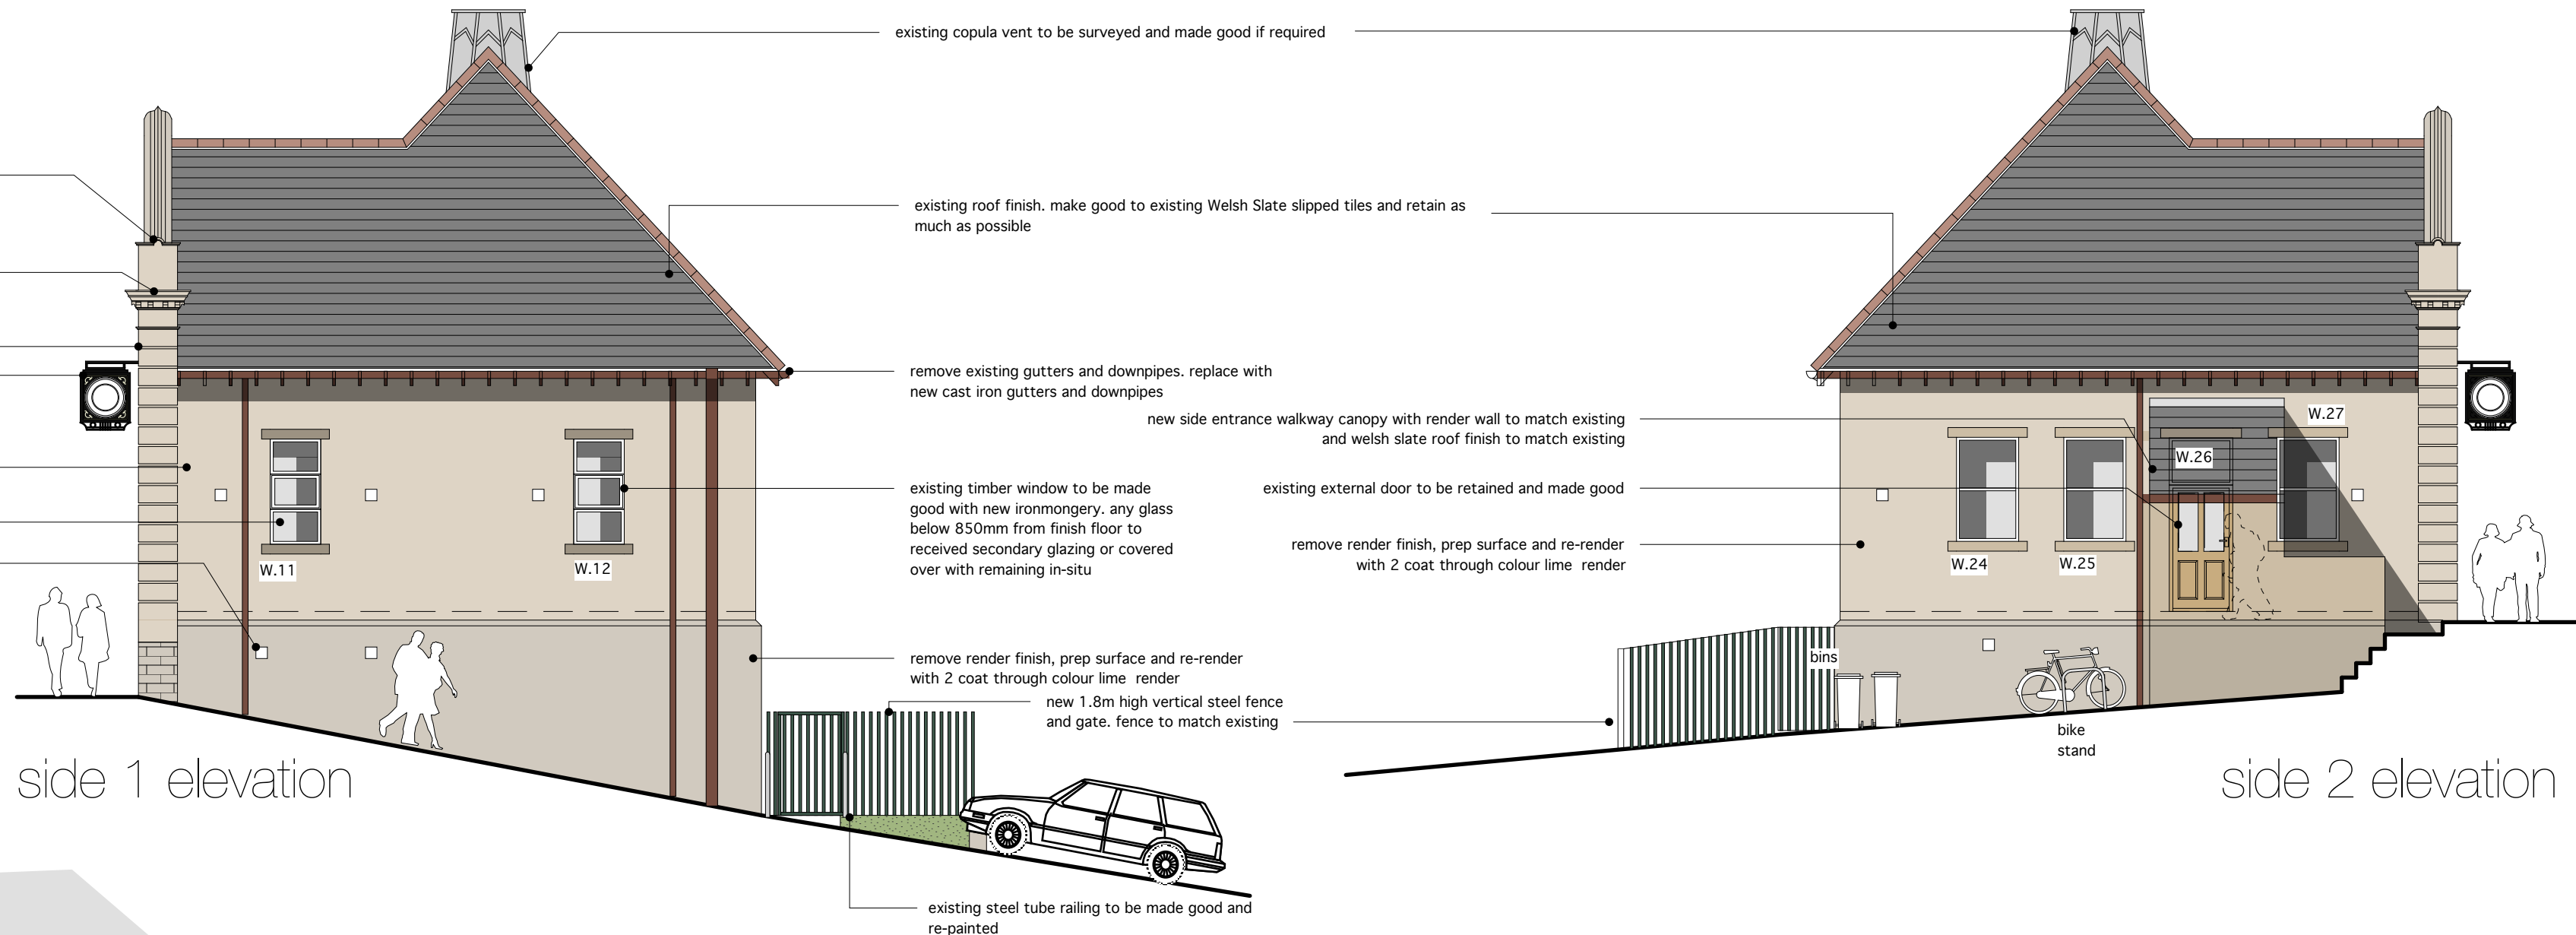
side 1 elevation

- clean all stone work. repair bath stone where previous fixtures and fittings have been removed or replace damaged stone details. method statement for cleaning bath stone features to be prepared in due course
- new code 6 lead weathering to cornices
- rake out and re-point lime mortar
- memorial clock to be carefully removed and stored for reuse. cleaning and repair included
- remove render finish, prep surface and re-render with 2 coat through colour lime render
- existing upvc window to be replaced by timber window to match existing
- all broken ceramic vent grilles to be replaced and matched existing

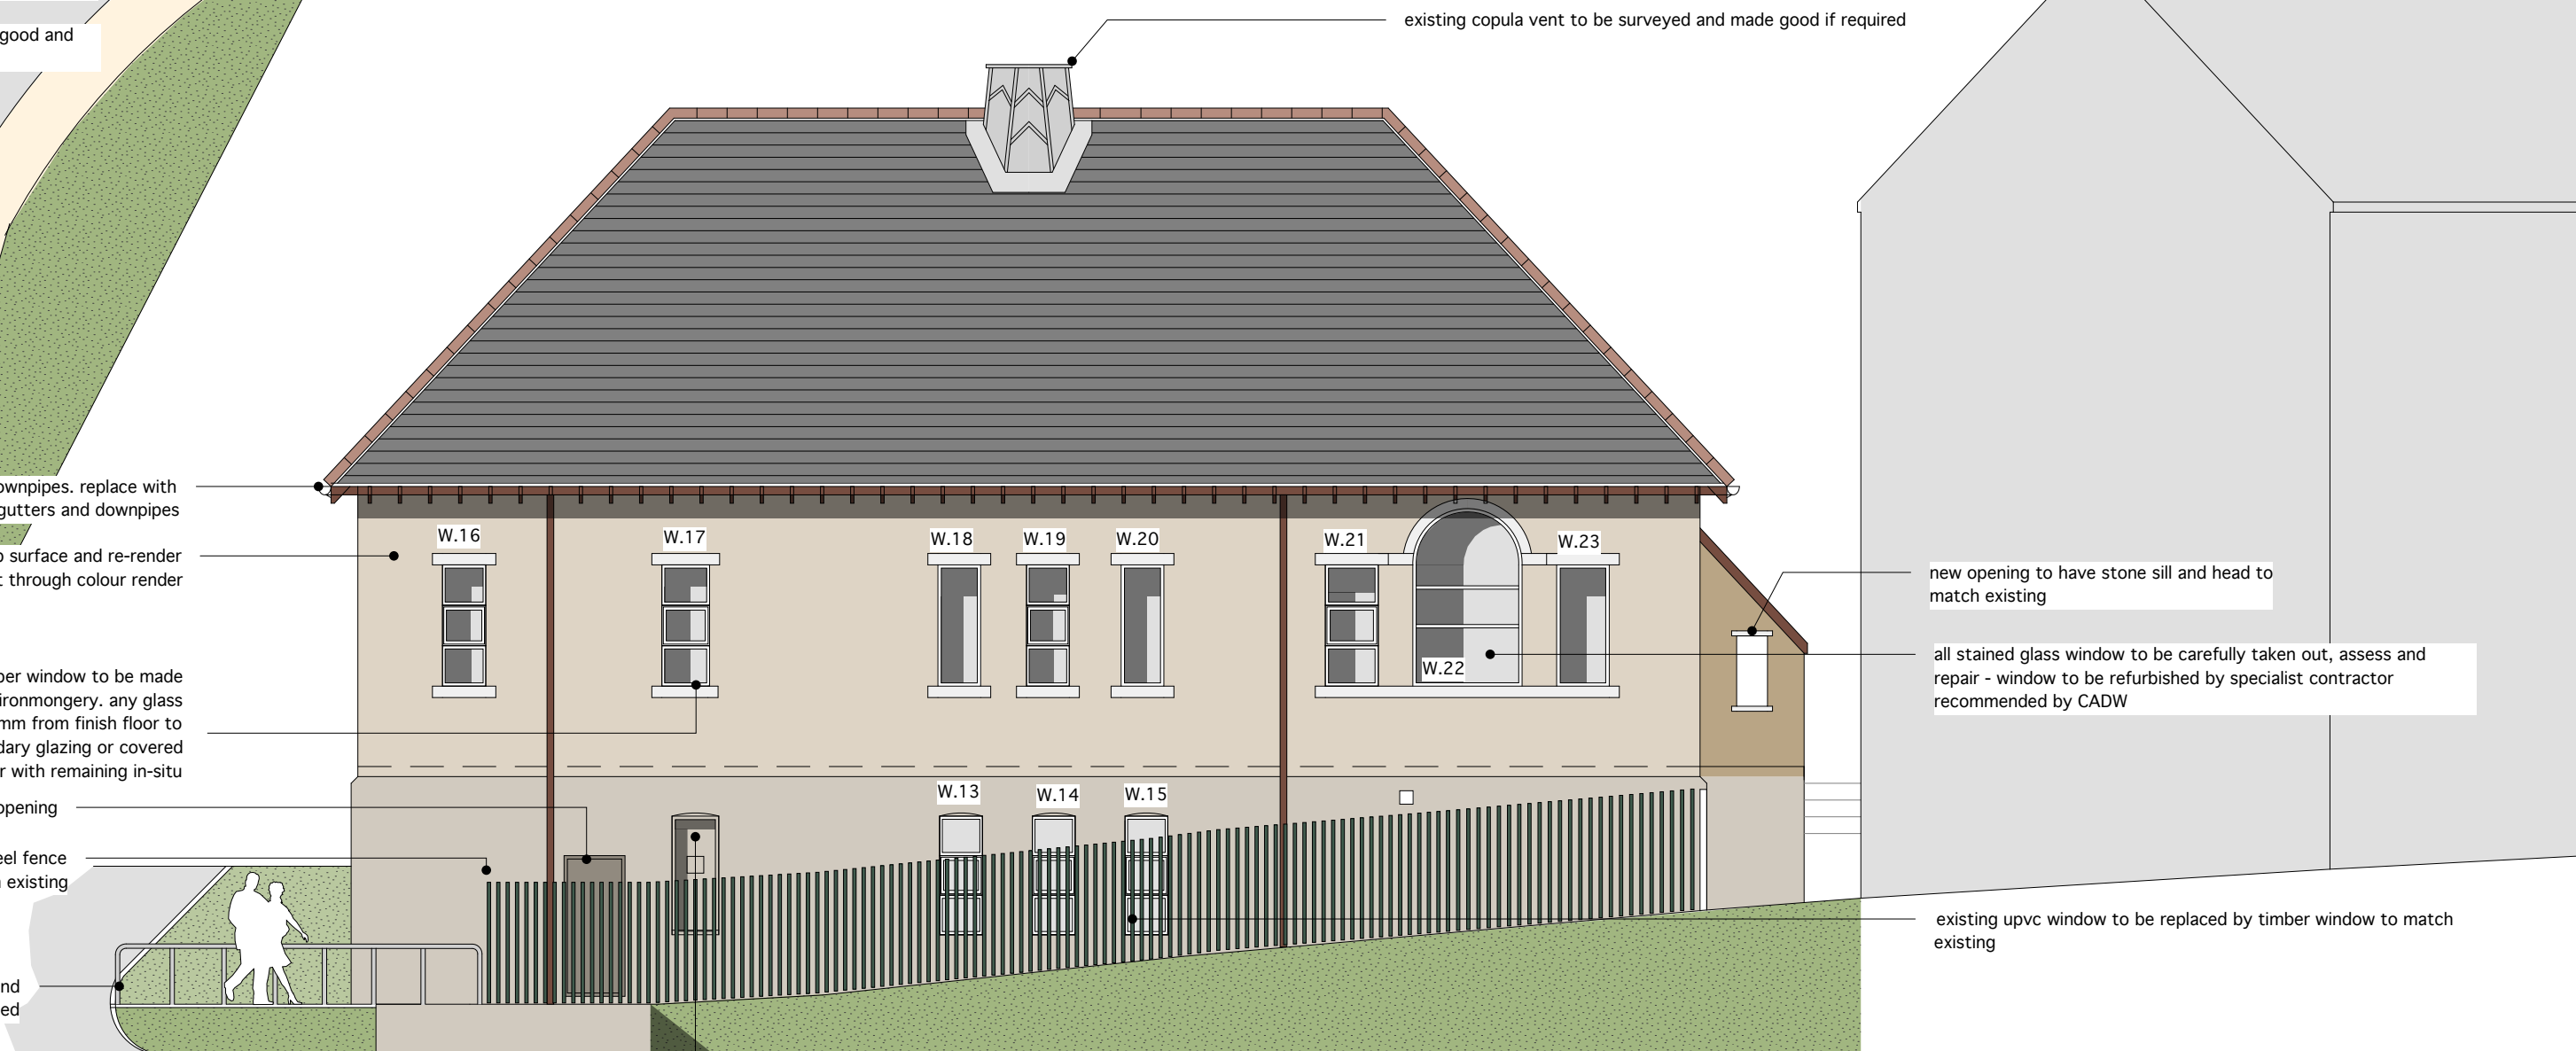
rear elevation

- new concrete patio
- existing concrete footpath. existing railing to be removed and replace with vertical steel tube railing
- existing steel tube railing to be made good and re-painted
