Welsh Jewish Heritage Centre, Merthyr Tydfil

THE EXTERNAL AREAS

at the Former Synagogue & Primrose Hill

THE PROPOSALS

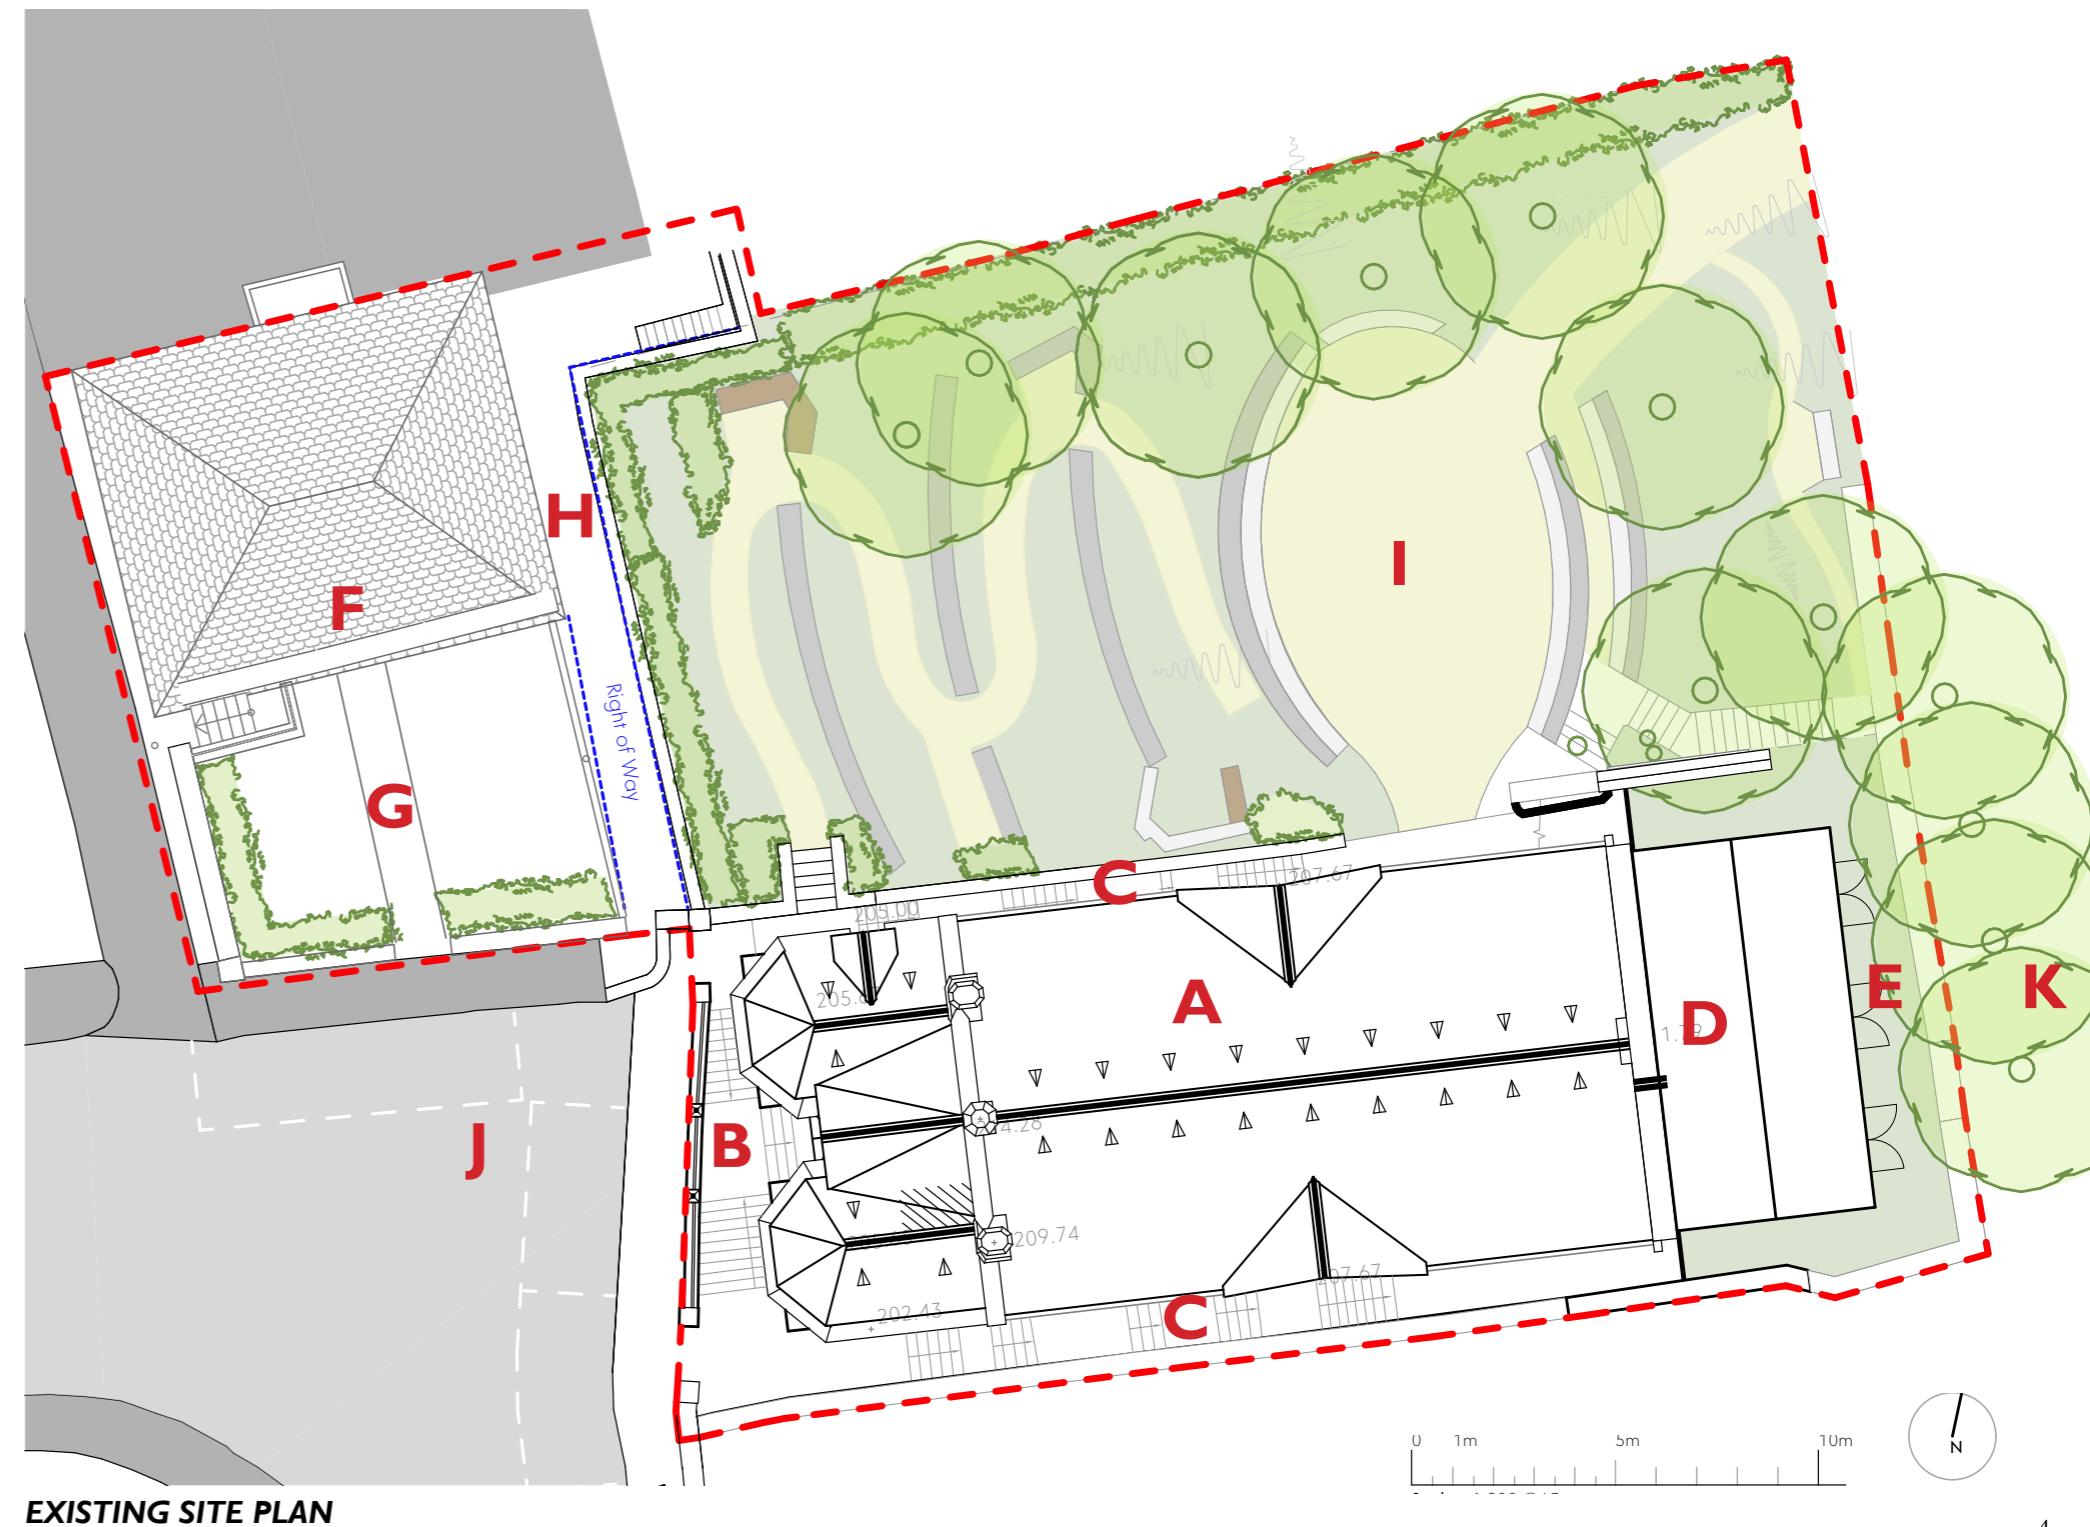
EXISTING SITE PLAN

The Welsh Jewish Heritage Centre comprises the following aspects, for which the letters below relate to the existing site plan to the right:

- A The Former Synagogue
- B Entrance Steps at the Front of the Former Synagogue
- C Two runs of Steps & Retaining Walls to the Sides of the Synagogue
- D Steps and a Retaining Wall at the Rear of the Former Synagogue
- E A narrow strip of derelict land beyond the rear steps
- F Primrose Hill House
- G The Front Garden to Primrose Hill House
- H A 'Right of Way' Path to the east of Primrose Hill House
- I A large area of Derelict Woodland to the North of the Synagogue

8.0 SECTION FOUR - EXPLANATION OF THE PROPOSALS - EXTERNAL AREAS

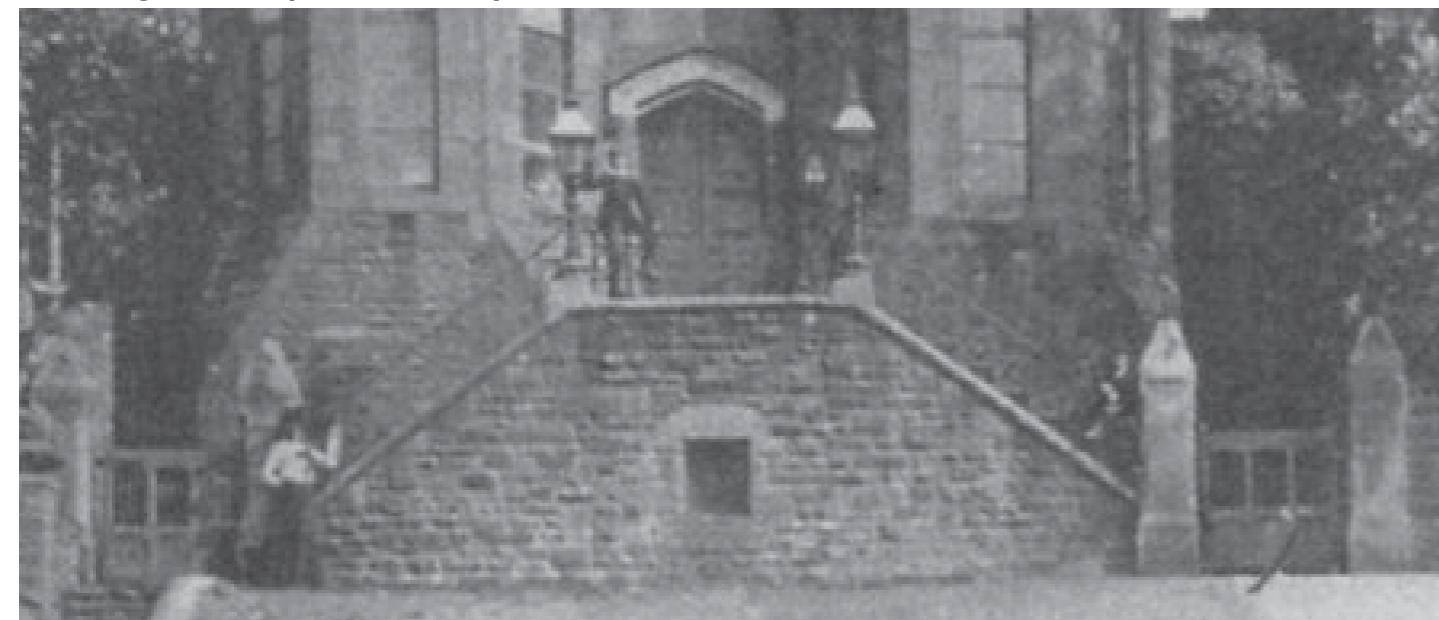
Retaining wall and pillars currently

The stone steps, retaining wall and pillars to the front are in an extremely poor condition; having been pulled apart by buddleia roots and other damage. Steps are partially missing or fractured, the landing has lost much of its surface and the wall and pillars are misaligned. The proposals involve the wall being taken down to level steps; and re-built once all the roots are removed. The stone pillars are to be taken down and re-built straight, once all the roots are removed.

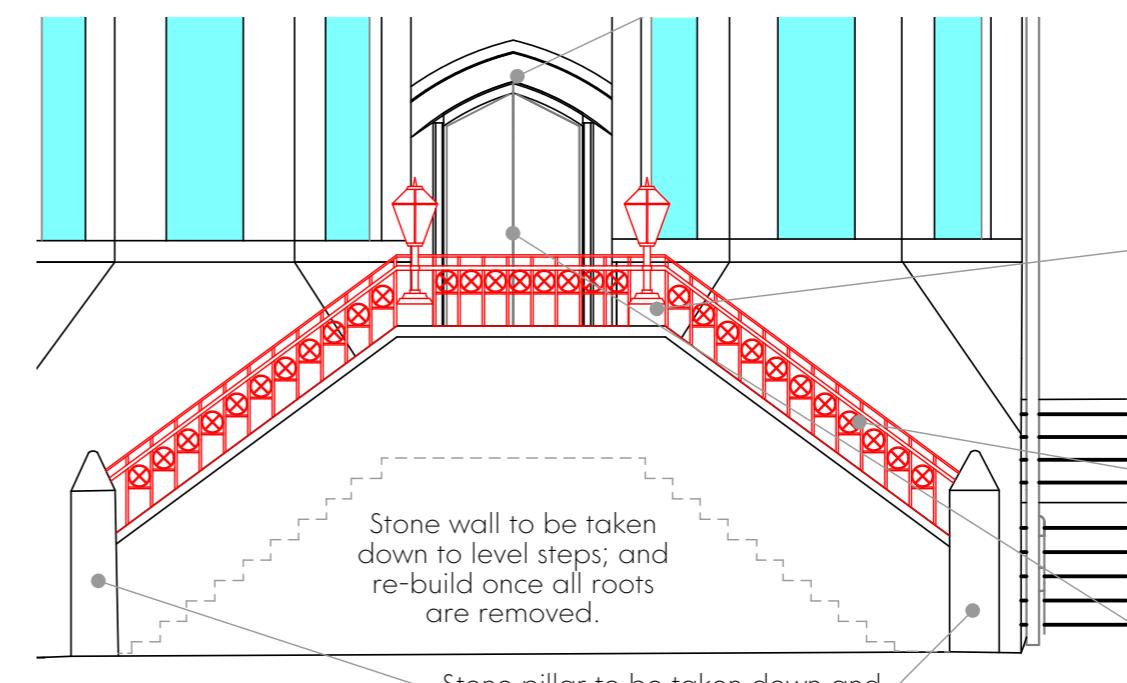
As the bottom image shows, there used to be decorative iron railings on top of the wall and iron lamp posts with copper heads on the two inner pillars. The proposals reinstate / replicate both the decorative iron railings and the two iron lamp posts with copper heads, which would be pinned down with stainless steel bars, with an electrical supply provided underneath the steps; all as shown in the bottom right hand elevation.

Historical view of Synagogue frontage showing railings and lamps (source: 'alangeorge.co.uk' website)

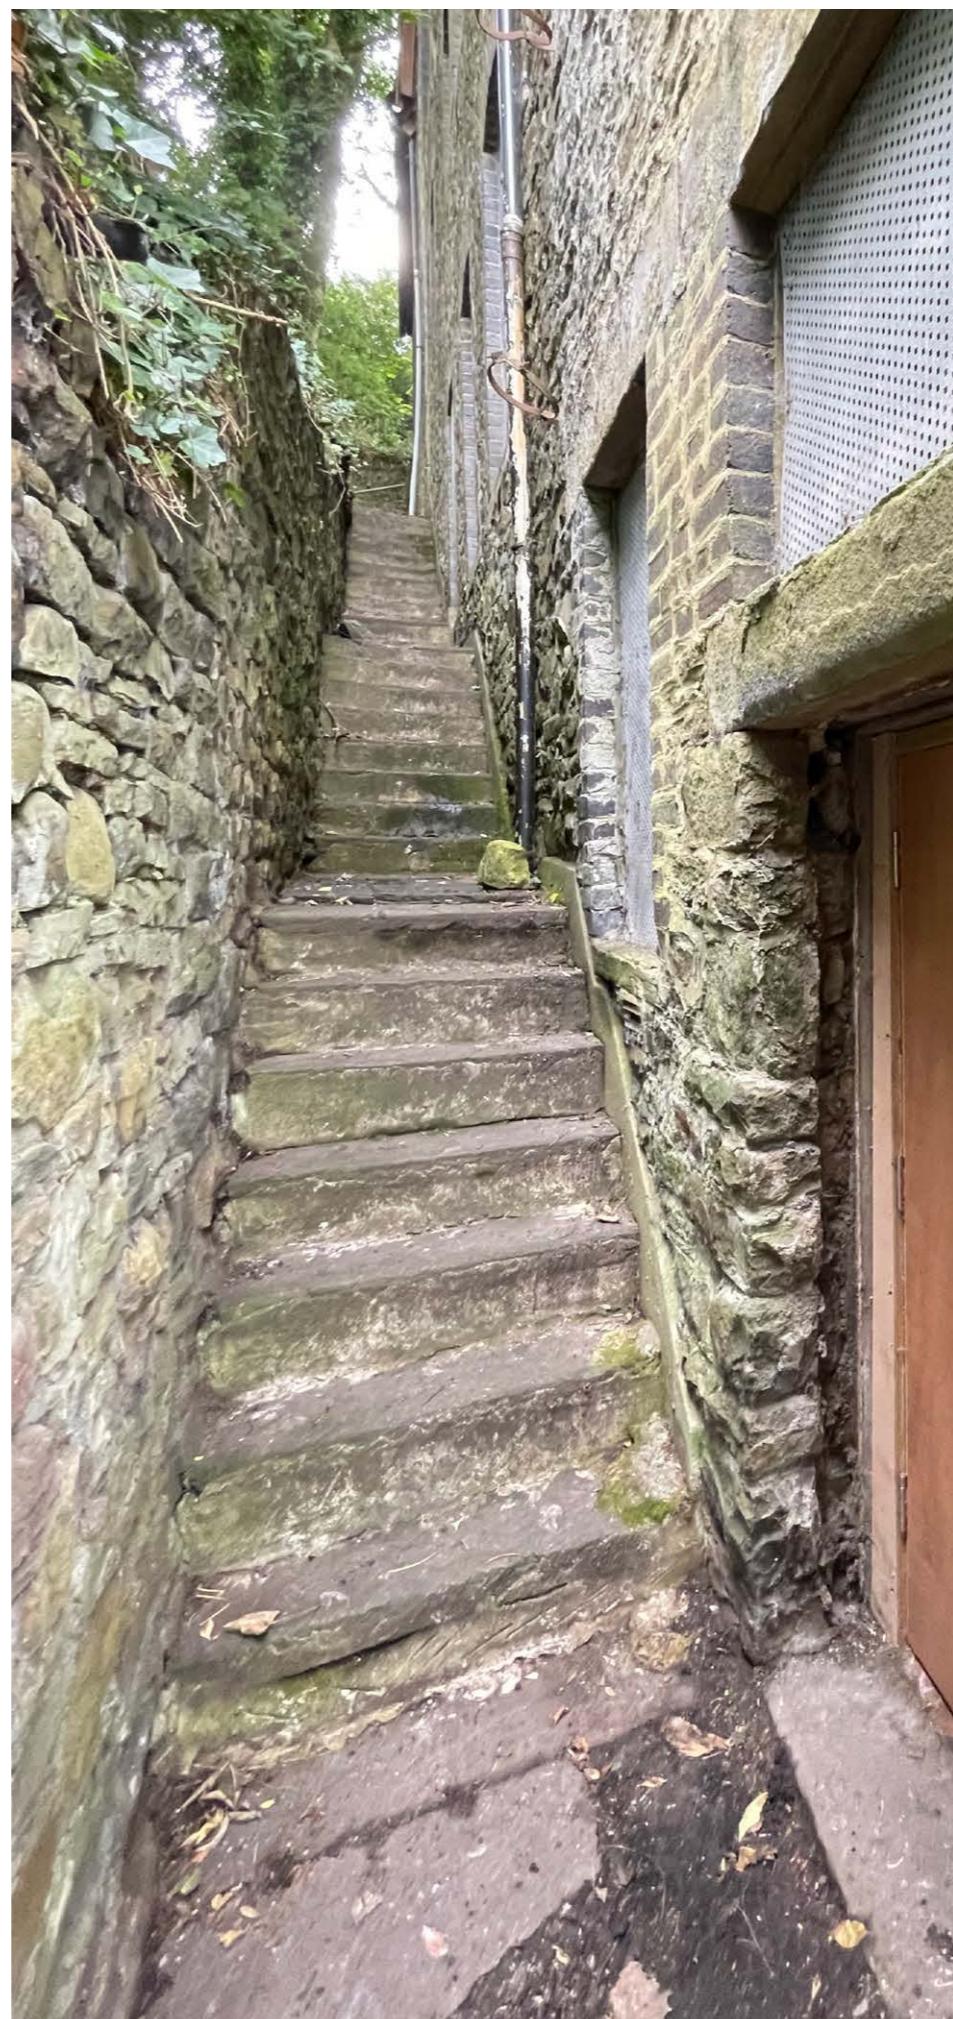
Proposed Lower Ground Floor with Red Lines where gates are proposed

To both sides of the Synagogue, there is a long, steep set of stone steps leading to the rear, with some brick inner body. Both are flanked by a stone boundary wall. Apart from one location on the north wall, the Structural Engineer believe that these walls are either built up from the step level or have a single course below the steps. Also, the steps appear to be embedded into the external wall of the building. Therefore, it is not possible to remove and replace the steps without taking down the walls completely; which is not desired. As a result, it is proposed that these steps are repaired, like-for-like, as best they can in situ. This would likely comprise a step by step repair undertaken from the bottom of the flight to the top. The southern steps are generally in a reasonable condition however there are localised areas in poor condition with degraded treads and landing slabs, and some minor vegetation growth. The northern steps are in poorer condition, with most of the treads failing or locally missing leaving ground material under exposed and vulnerable. The proposals also involve localised repairs to the south wall. A new opening is proposed within the north wall to provide access into the garden, opposite the door into the building.

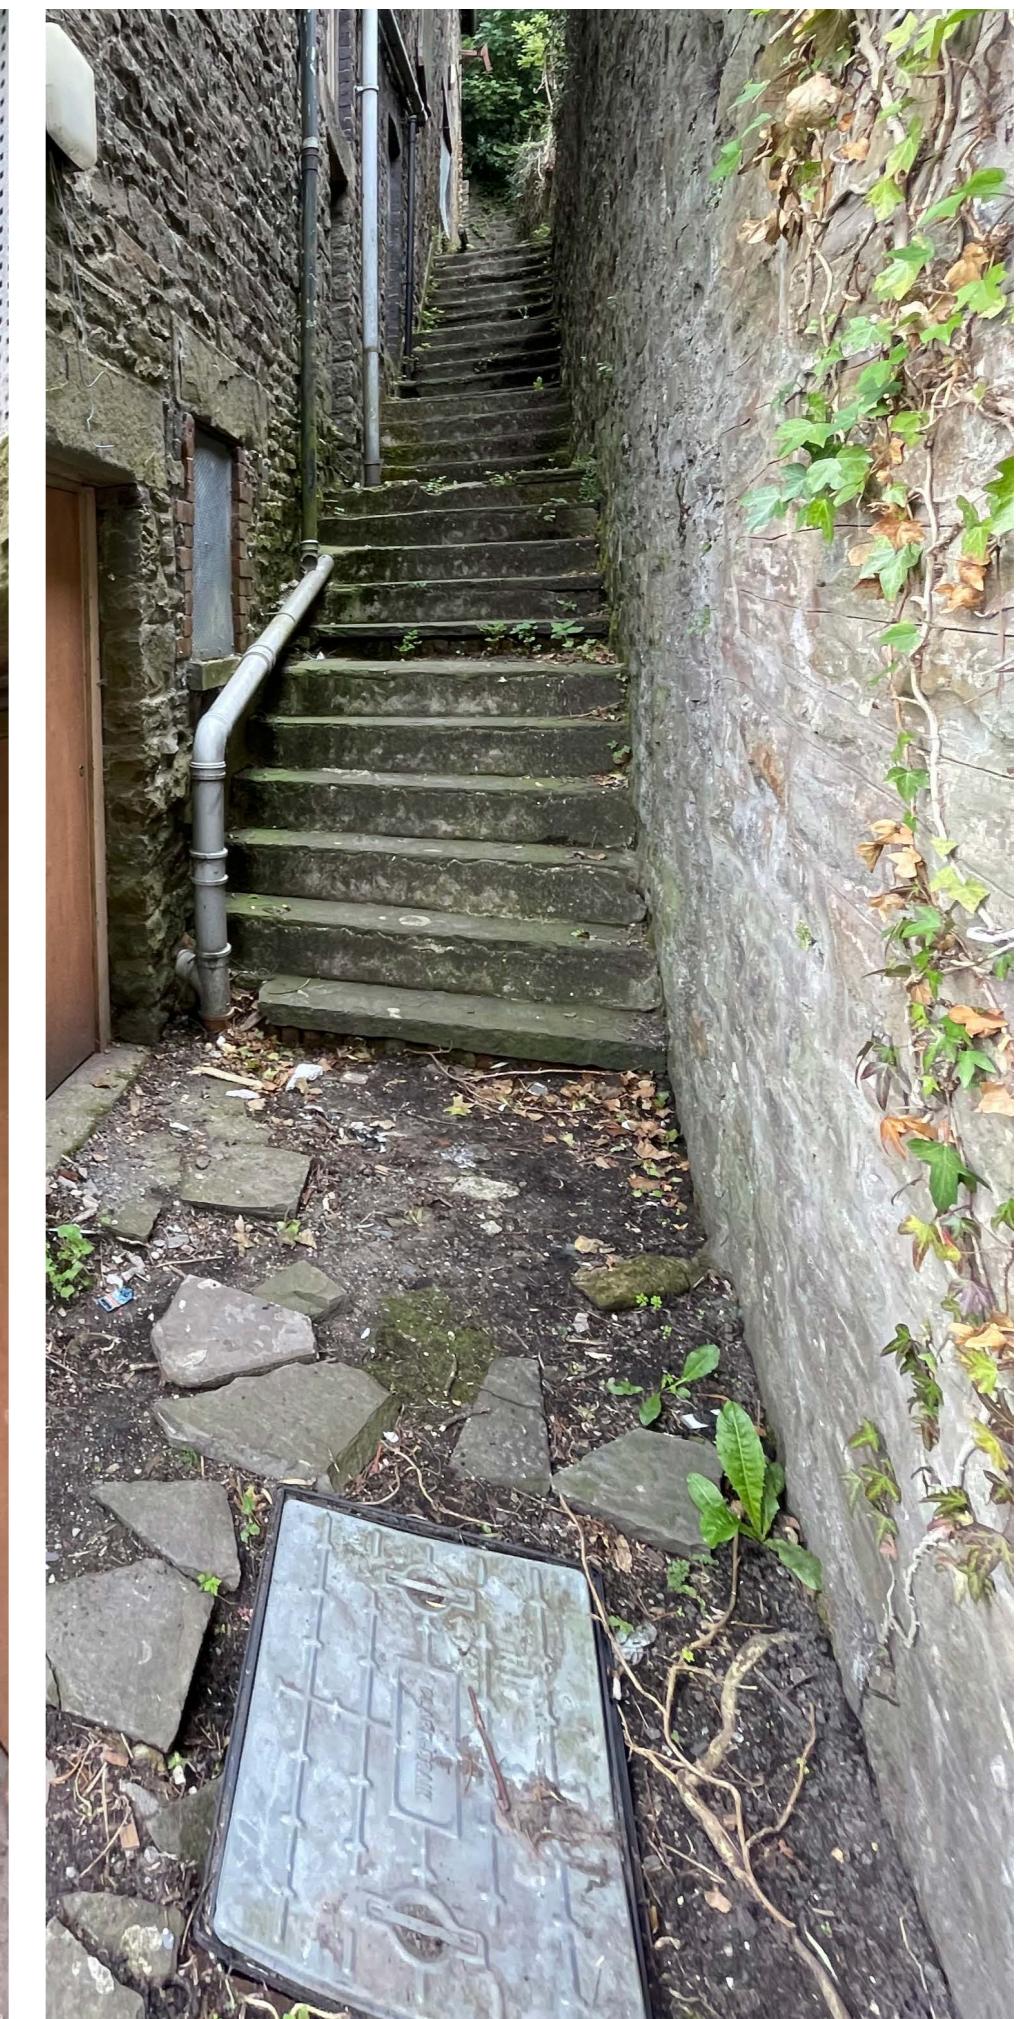
North side steps up the side of the Synagogue

The rainwater drainage pipework appears to run within these steps, for their full length. These 225mm diameter pipes are encased in concrete on 3no. sides and sit approximately 200mm off the face of the building. They terminate at the bottom of the site. The north pipe appears to be in reasonable condition and in relatively clear; whilst the south pipe is blocked along its lower half. The proposals involve the clearance and in situ repair of these pipes, as far as can be done; and the in situ repair of the steps around the pipes. If possible, a sleeve may be inserted along the length of the pipes to improve their operation and to address any areas of damage which cannot be suitably repaired.

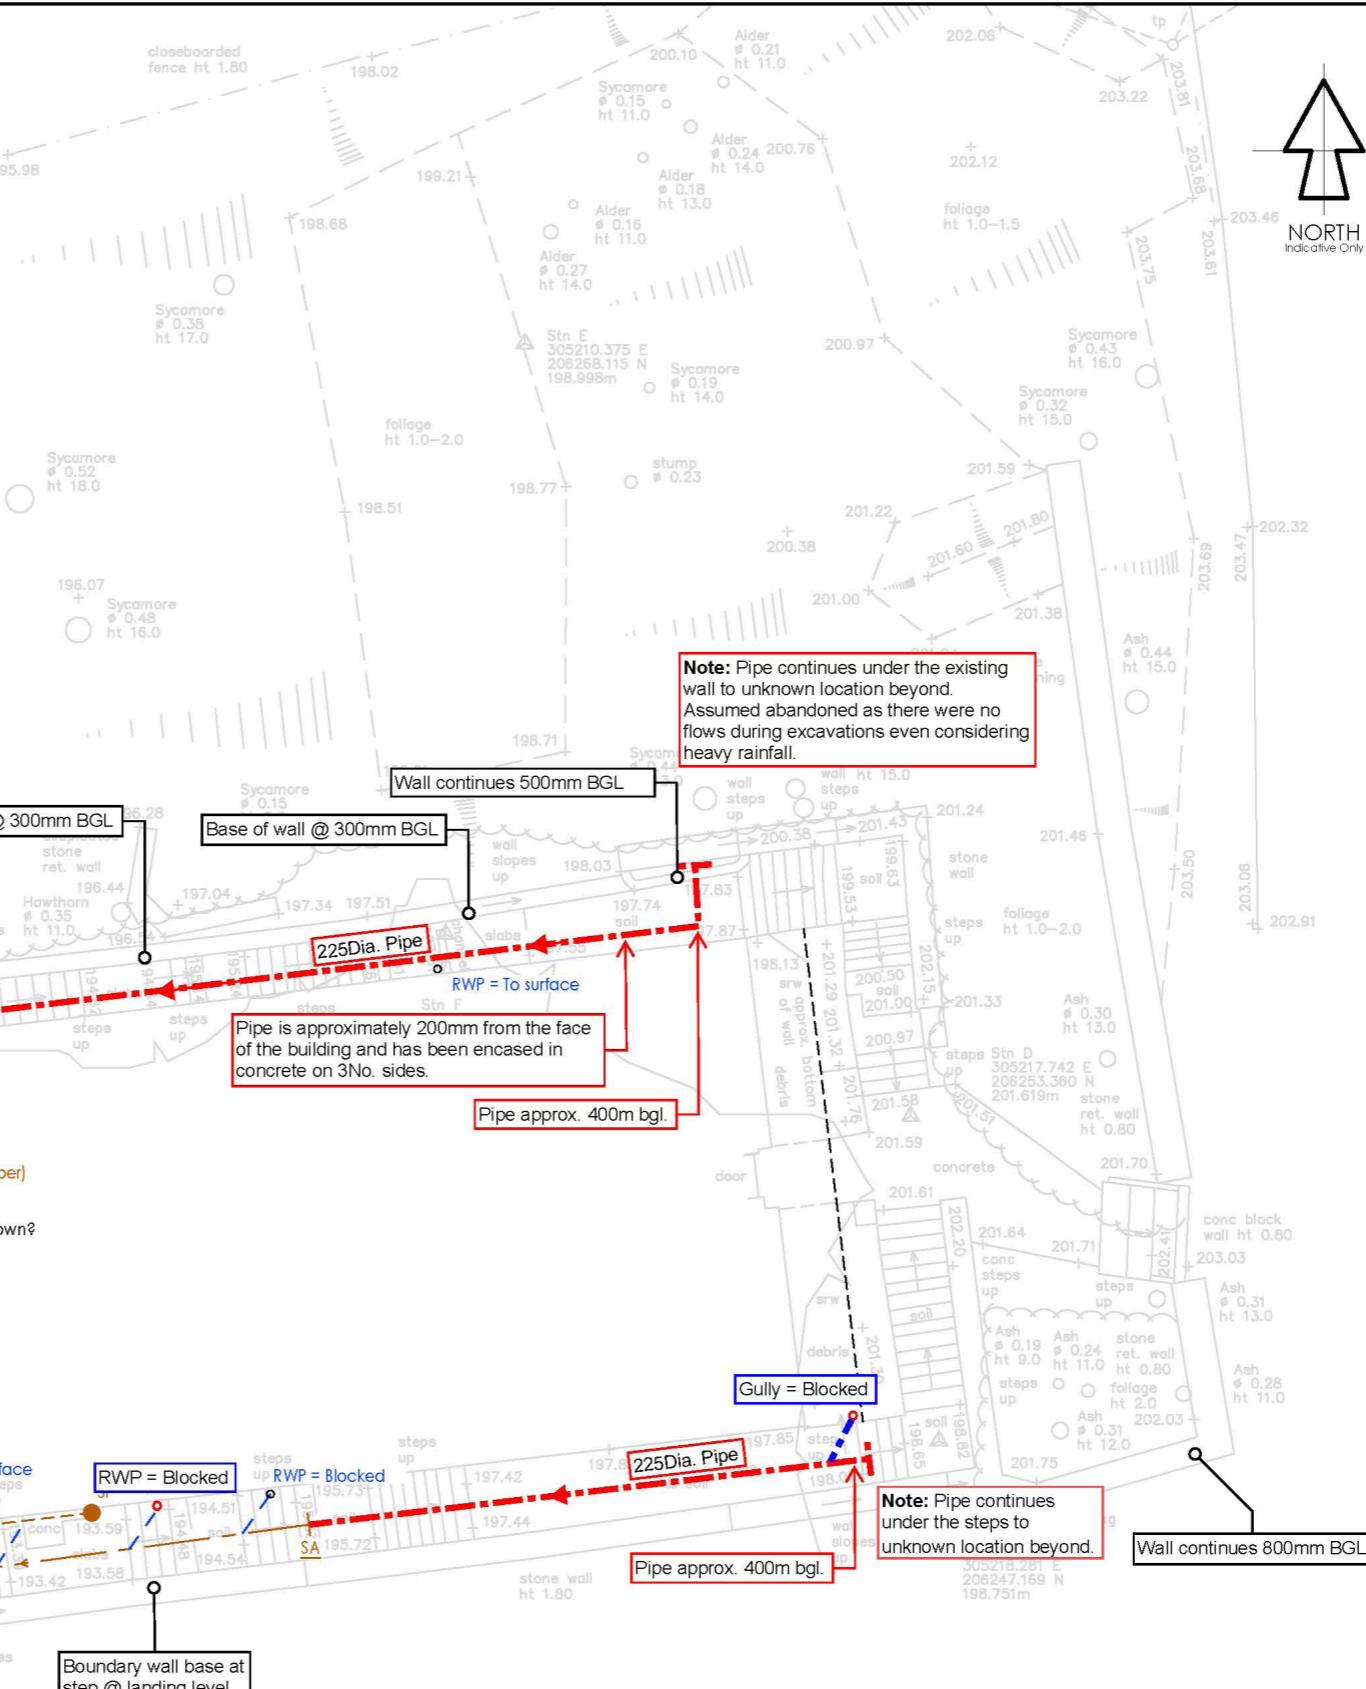
South side steps up the side of the Synagogue

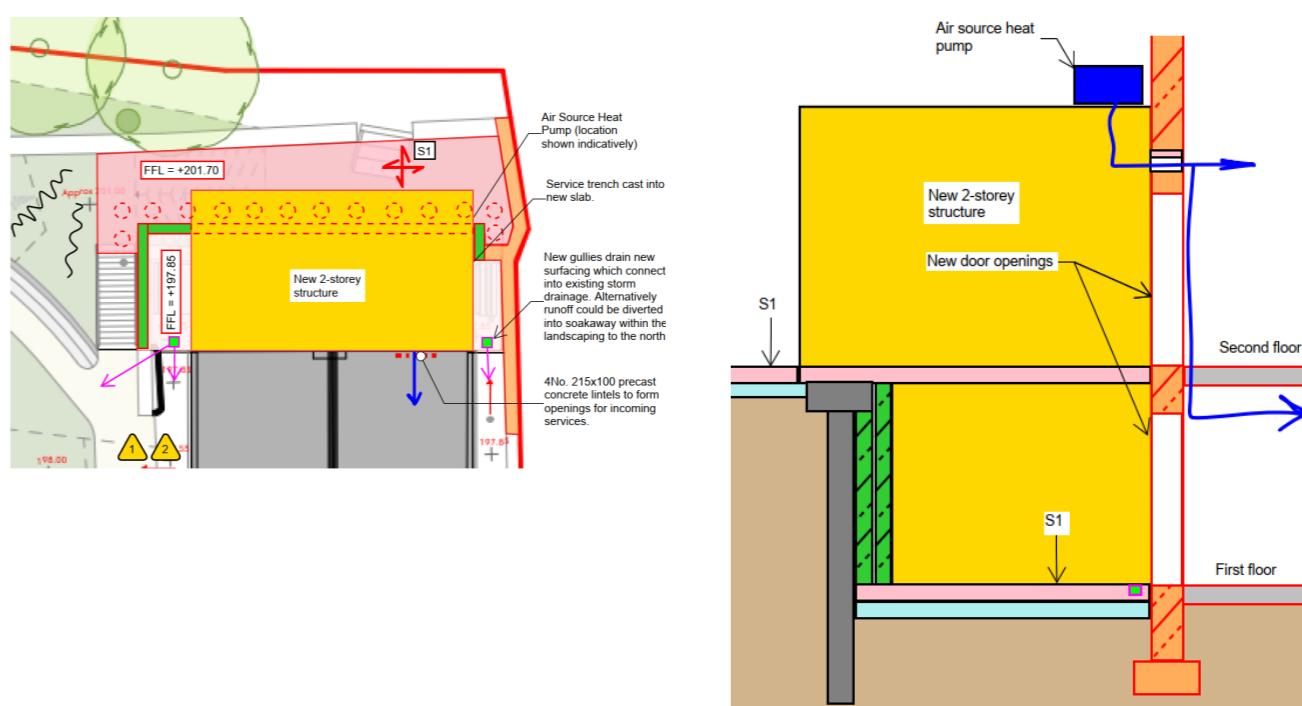
3.5 Option 4

Plan View

Section

- ✓ Potentially safer to construct than the other options as this option limits time operatives have to spend in proximity to the failed retaining wall and on the existing steps in poor condition.

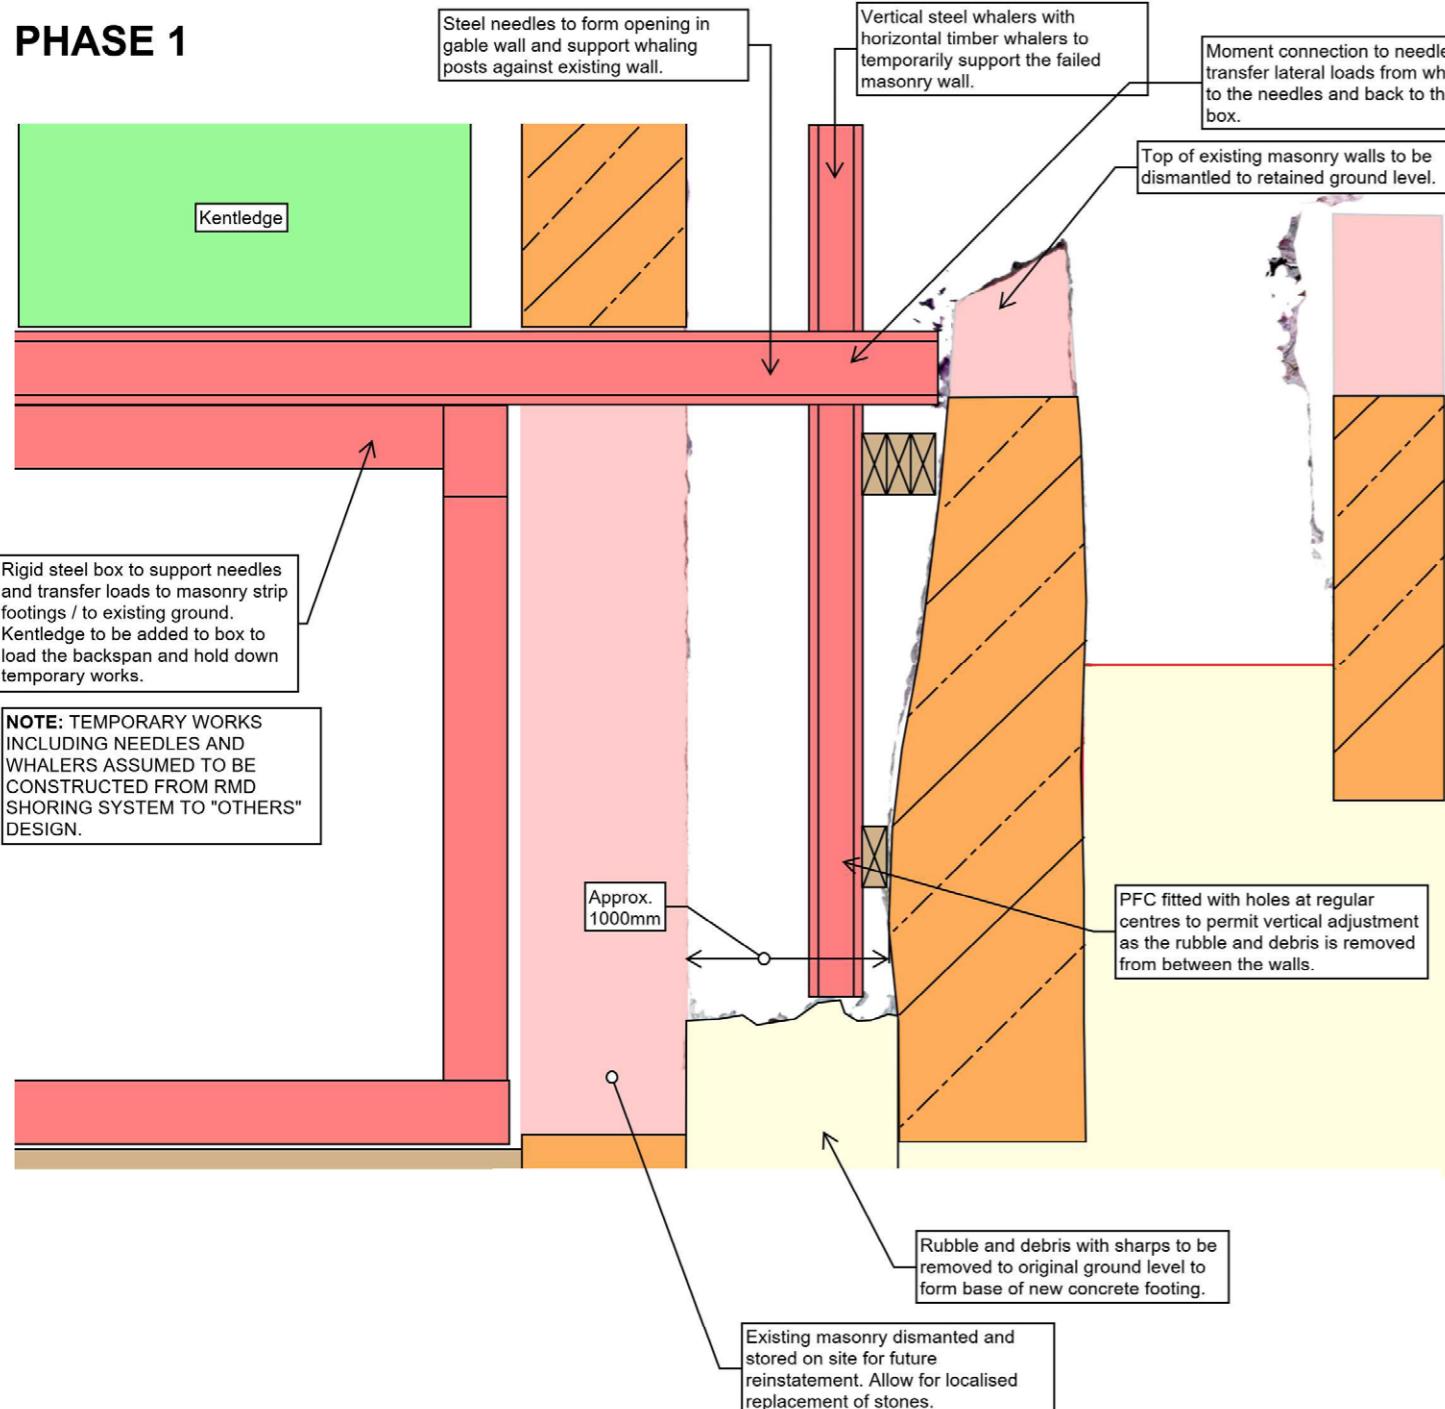
PHASE 1

Phase 1 would involve the careful dismantling of two sections of the external stone gable wall of the Synagogue at first floor level, to form openings in order to access and work on the rear wall and steps. Each section would be approximately 1.2m wide x 2.2m high. The stones are to be numbered before dismantling and set aside for later reinstatement. The masonry above is to be steel needled for temporary support. A series of vertical steel whalers are to be installed in front of the existing failed retaining wall, with timber whalers set between the steels and the wall. The tops of the masonry retaining wall and the partly retaining wall behind would be taken down to the level which will be the underside of the new slab over. The rubble and debris within the 1 metre gap between the building and retaining walls will be removed to the original level of this gap.

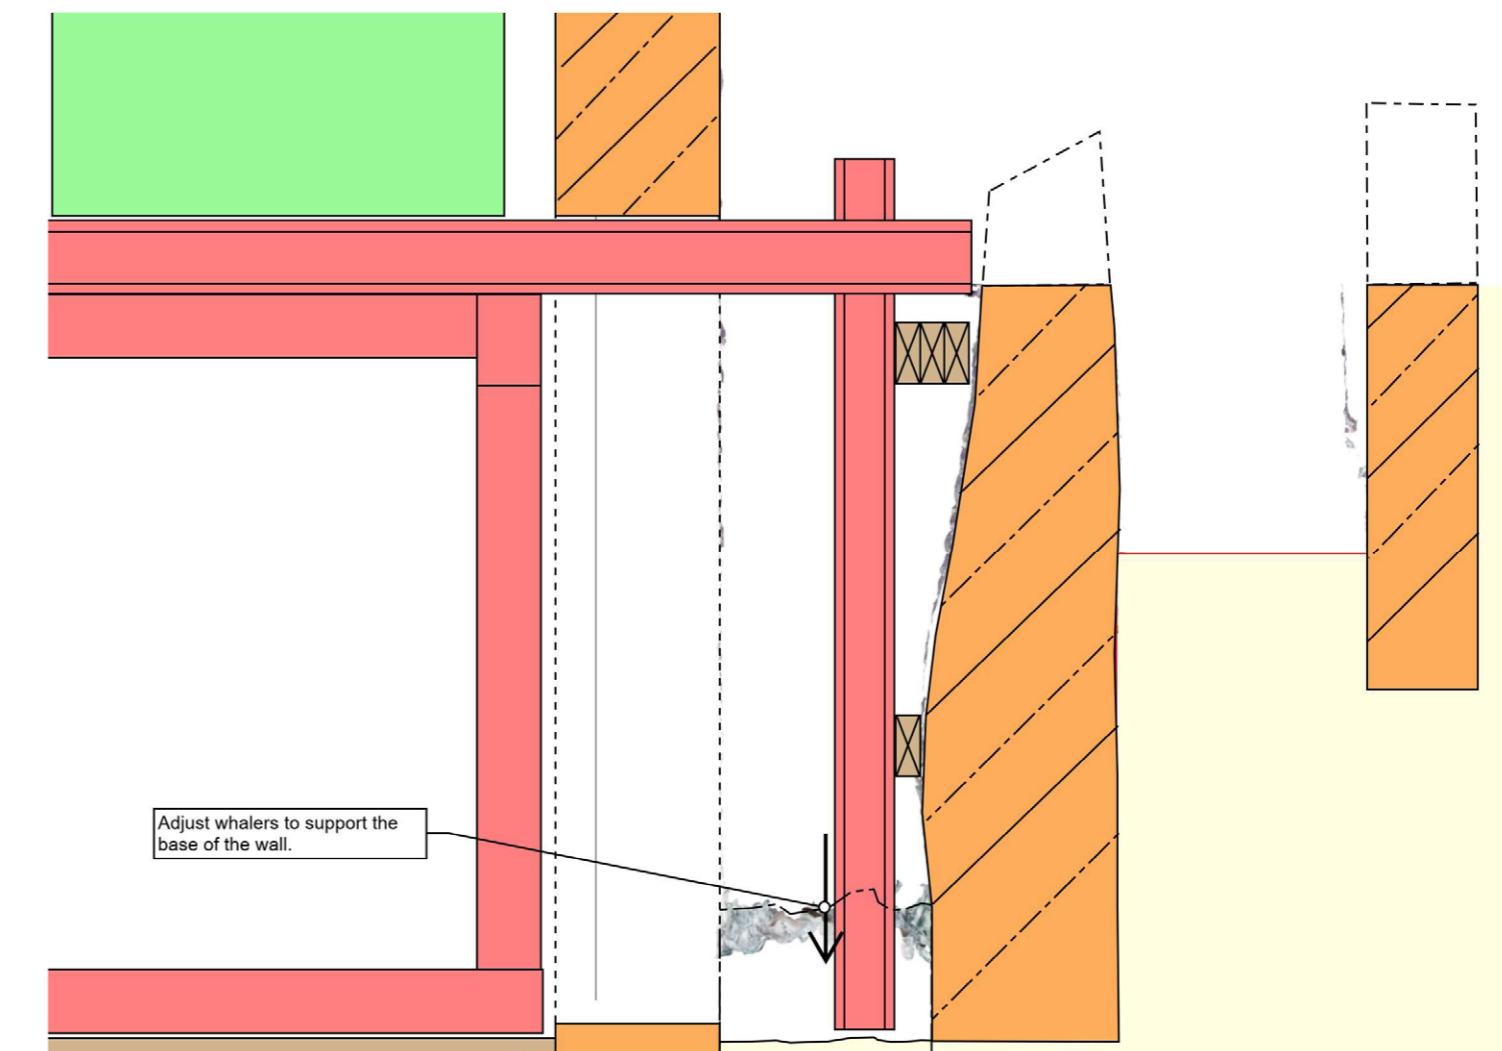
PHASE 2

Phase 2 would involve the vertical steel whalers being dropped and adjusted to support the base of the retaining wall.

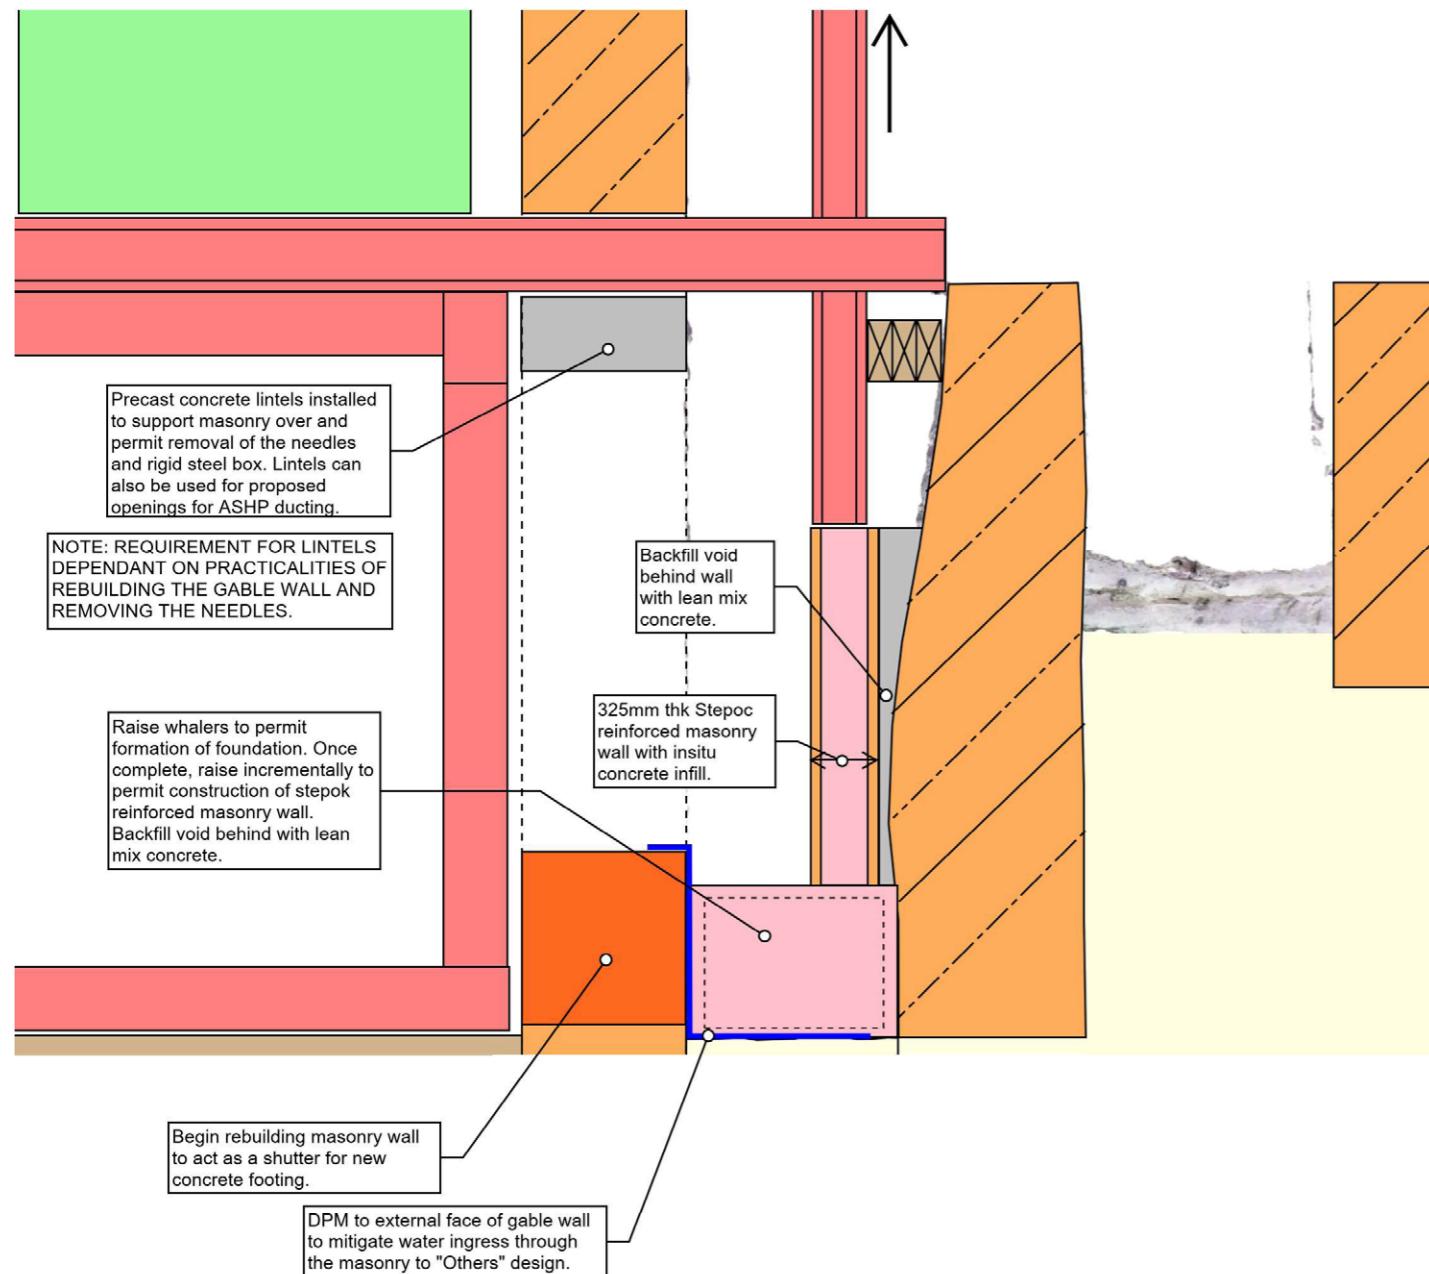
PHASE 3

Phase 3 would involve the vertical steel whalers being raised as a concrete foundation strip is formed at the base of the retaining wall. The bottom of the two temporary openings in the gable wall would be laid with the retained stones to act as shuttering for this foundation strip. A damp proof membrane would be laid between the two parts to control water ingress to the building fabric, and partly to avoid the concrete 'sticking' to the stone, thereby making the installation potentially reversible. Off this strip, a 325mm thick reinforced masonry wall would be constructed with insitu concrete infill. As this happens, the space behind would be backfilled with a lean mix concrete.

As stated, the zone between the existing steps and the underside of the new slab is to be offered as a compensatory bat hibernation roost. This would mean that, whilst not shown on the drawing below, the reinforced concrete capping beam would extend over the steps and sit on the outer original masonry wall, thereby forming a void.

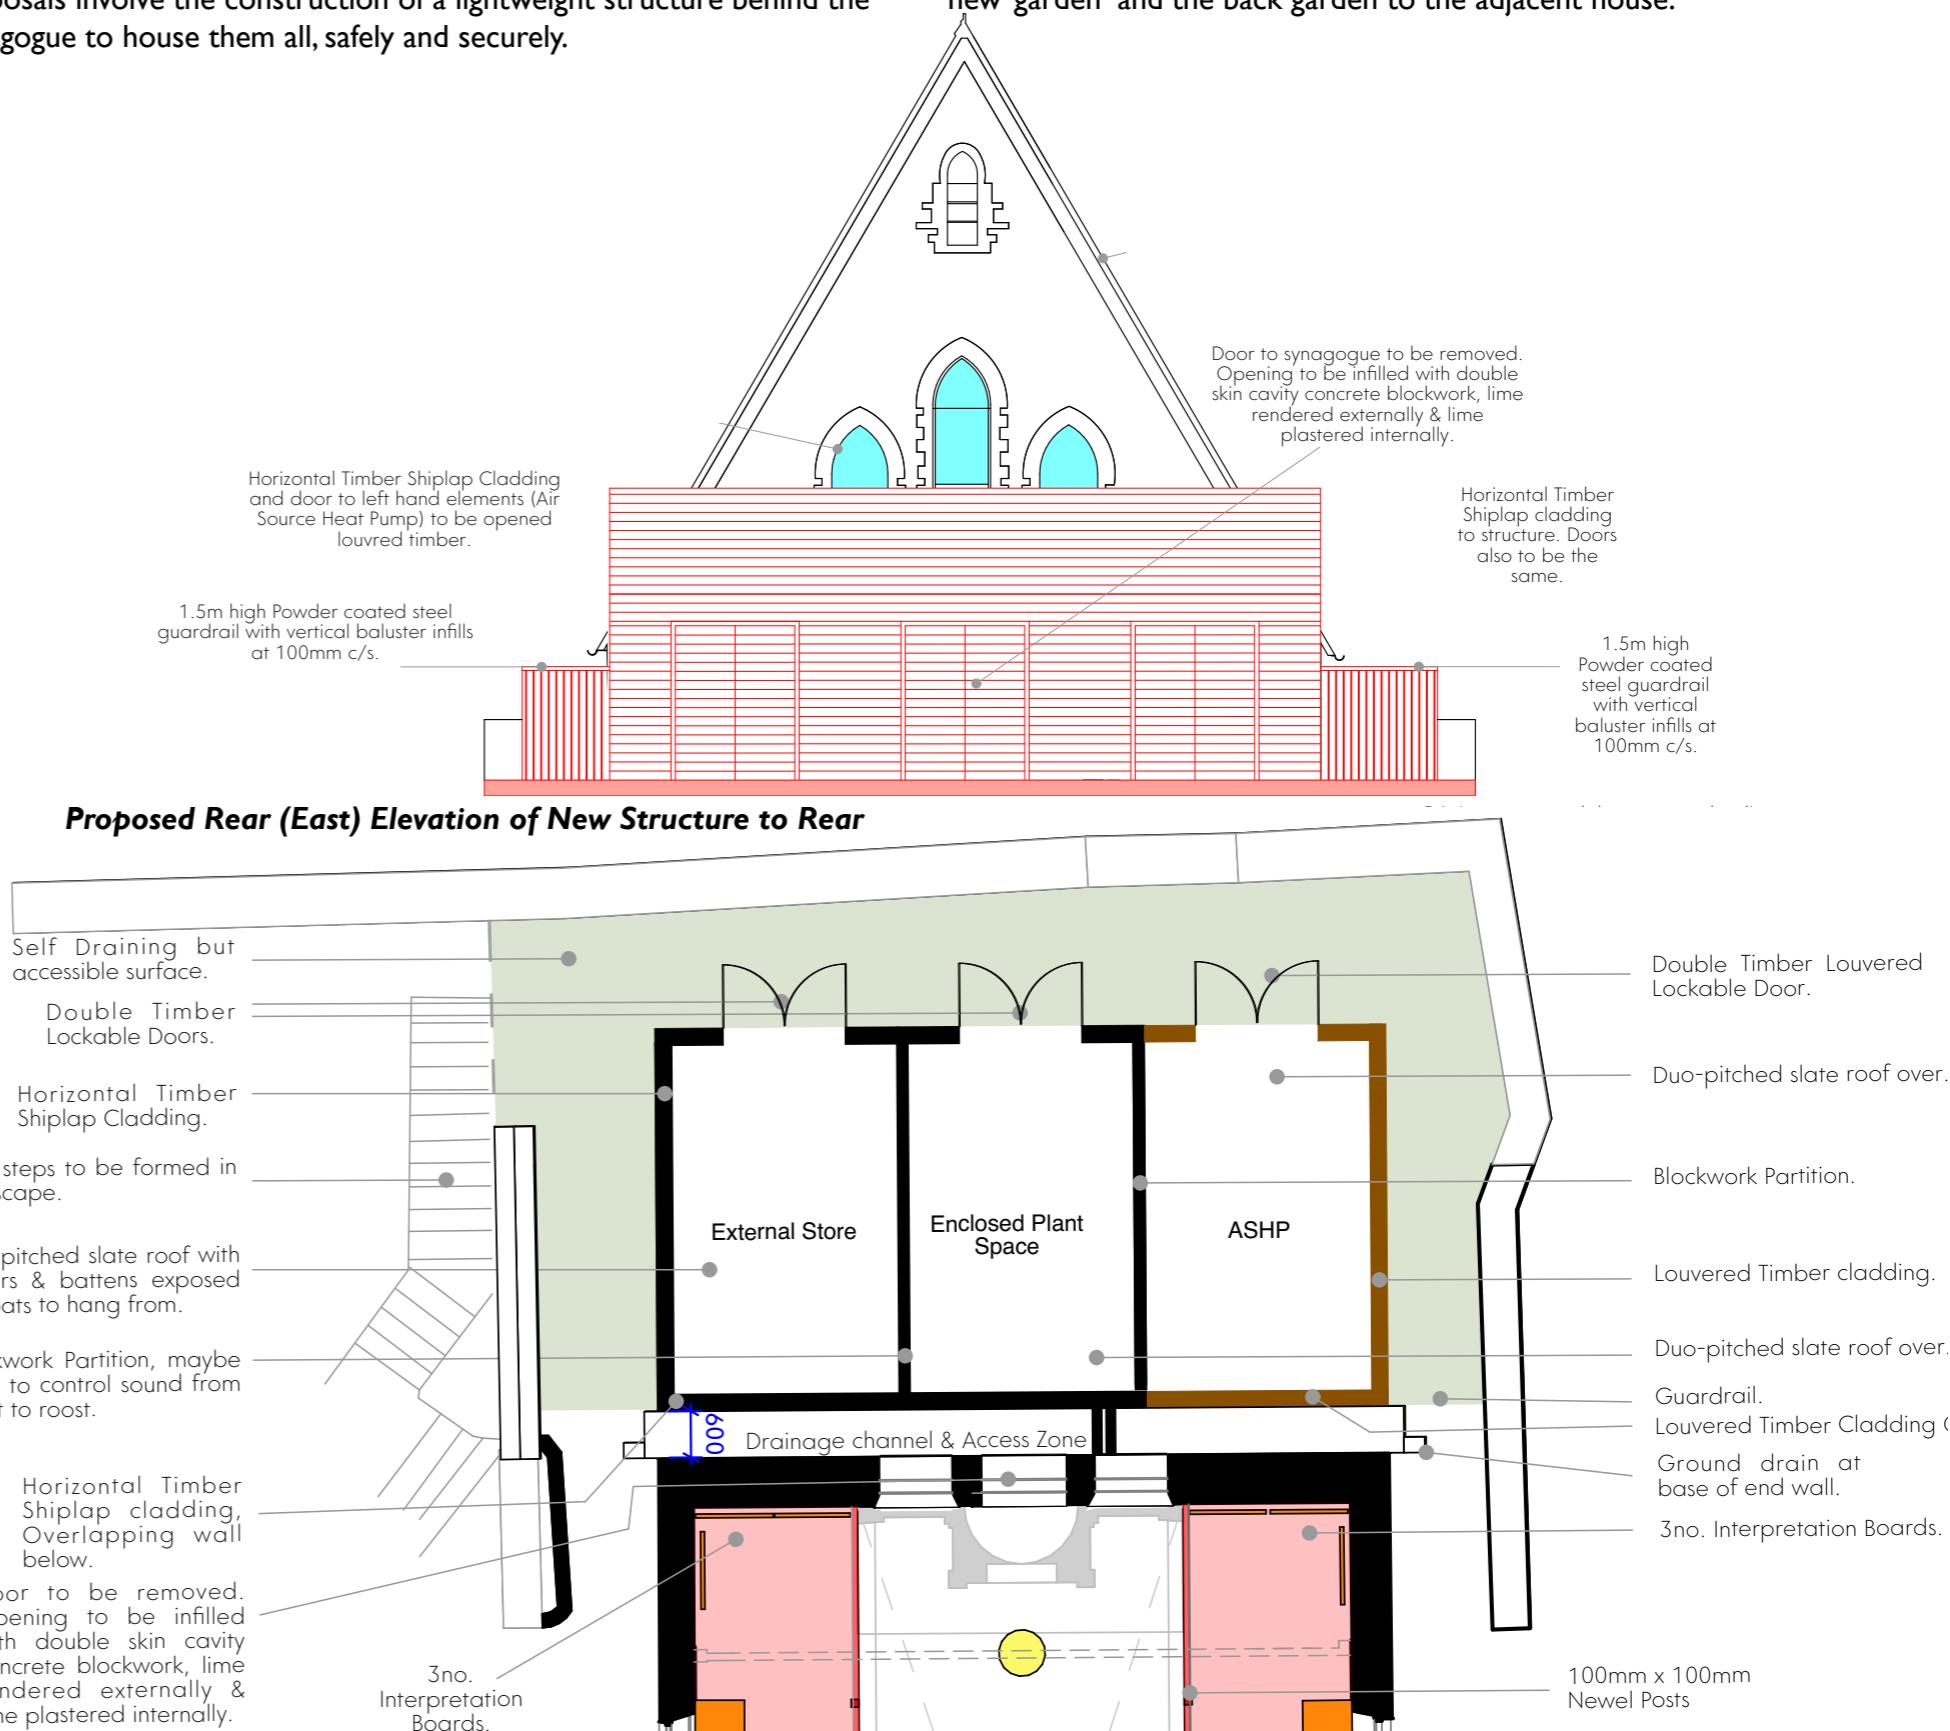
With the rear of the site being the only suitable location for the external Air Source Heat Pump, this provides the obvious location for it, and its enclosure. Given the lack of space inside the building, and the desire to restore the original 'Prayer Hall' back to its original volume, there is nowhere to locate the necessary Plant provision, apart from out the back. This also needs to be enclosed. On top of this, the large 'garden' area will require equipment to be safely stored. With these three requirements, the proposals involve the construction of a lightweight structure behind the Synagogue to house them all, safely and securely.

On this page are the proposed plan and elevations for this structure, which would be a lightweight structure clad in horizontal timber shiplap cladding, which will sit well within the wooded environment here. The form would be simple, with a duo-pitched roof with a natural slate covering, as the Synagogue. The roof pitch would be shallower, to minimise visual impact. Given its location, this structure would not be visible from the public road; only visible from the private road behind, the new 'garden' and the back garden to the adjacent house.

Proposed Plan showing New Structure to Rear
