Welsh Jewish Heritage Centre, Merthyr Tydfil

THE EXTERNAL AREAS

at the Former Synagogue & Primrose Hill

THE PROPOSALS

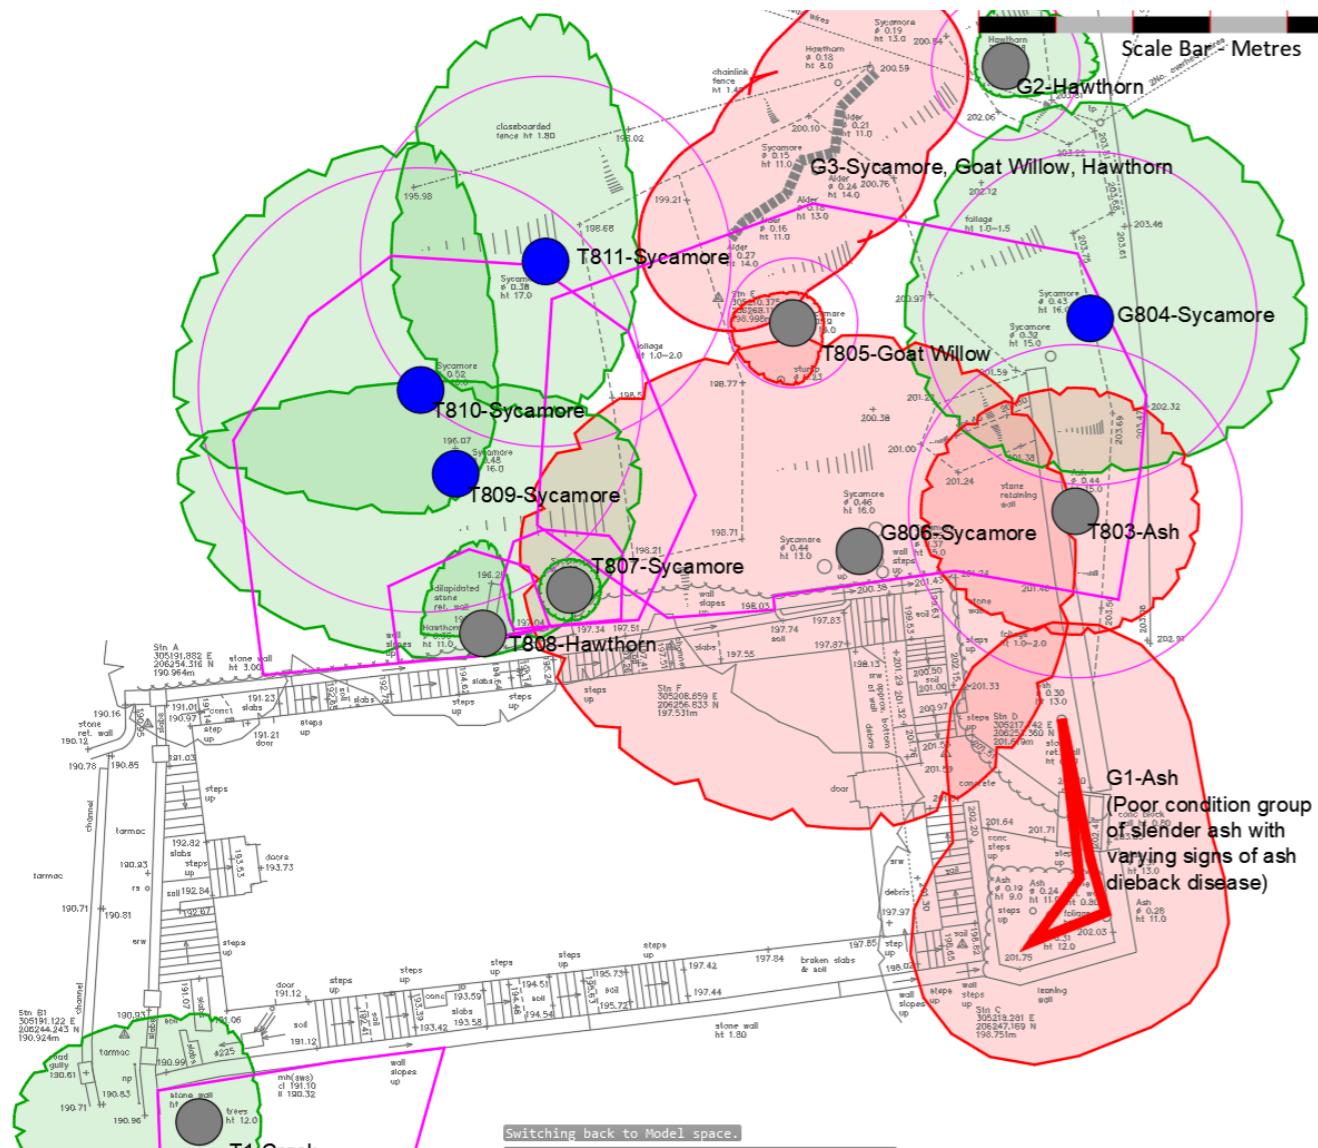
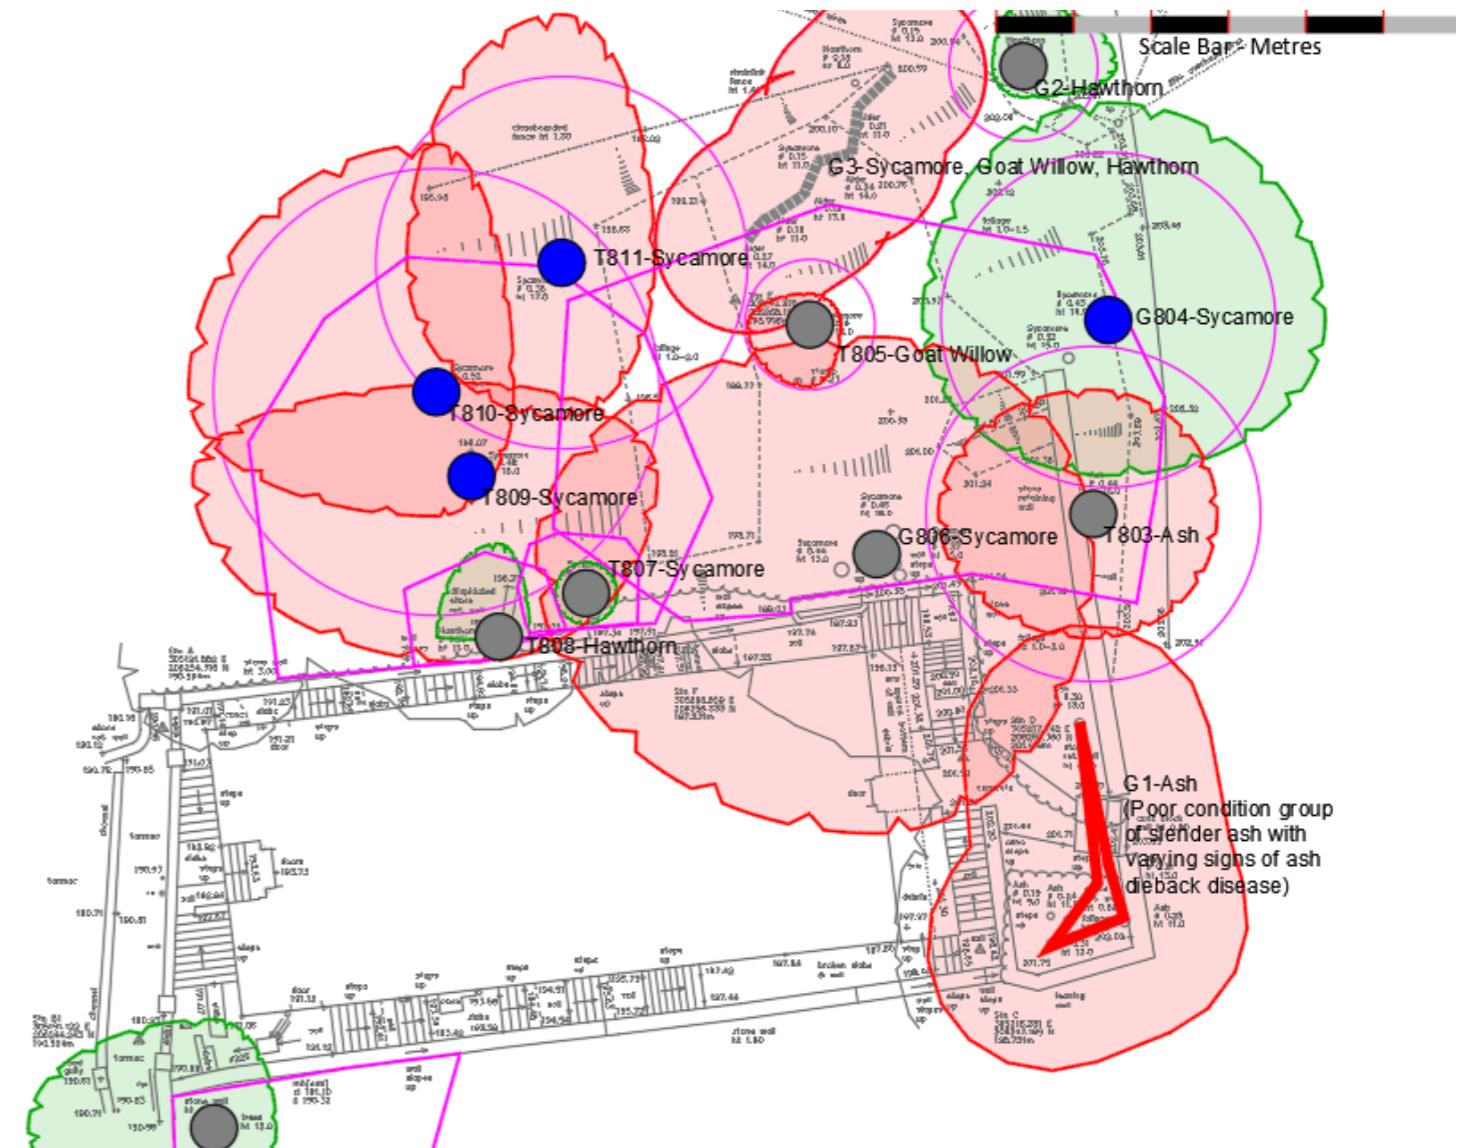
TREE CONSTRAINTS PLANS below

- Trees with Blue trunks in 'Moderate' Condition
- Trees with Grey trunks in 'Low' Condition
- Trees within Red shape in 'Poor' Condition

An Arboricultural Report was produced by Arboricultural Technician Services Ltd (Tree Consultancy) to assess the nature and condition of the trees within the derelict land to the rear (east) and side (north) of the Synagogue. The results of this assessment would guide any thoughts on how the existing wooden area could be best approached, i.e.:

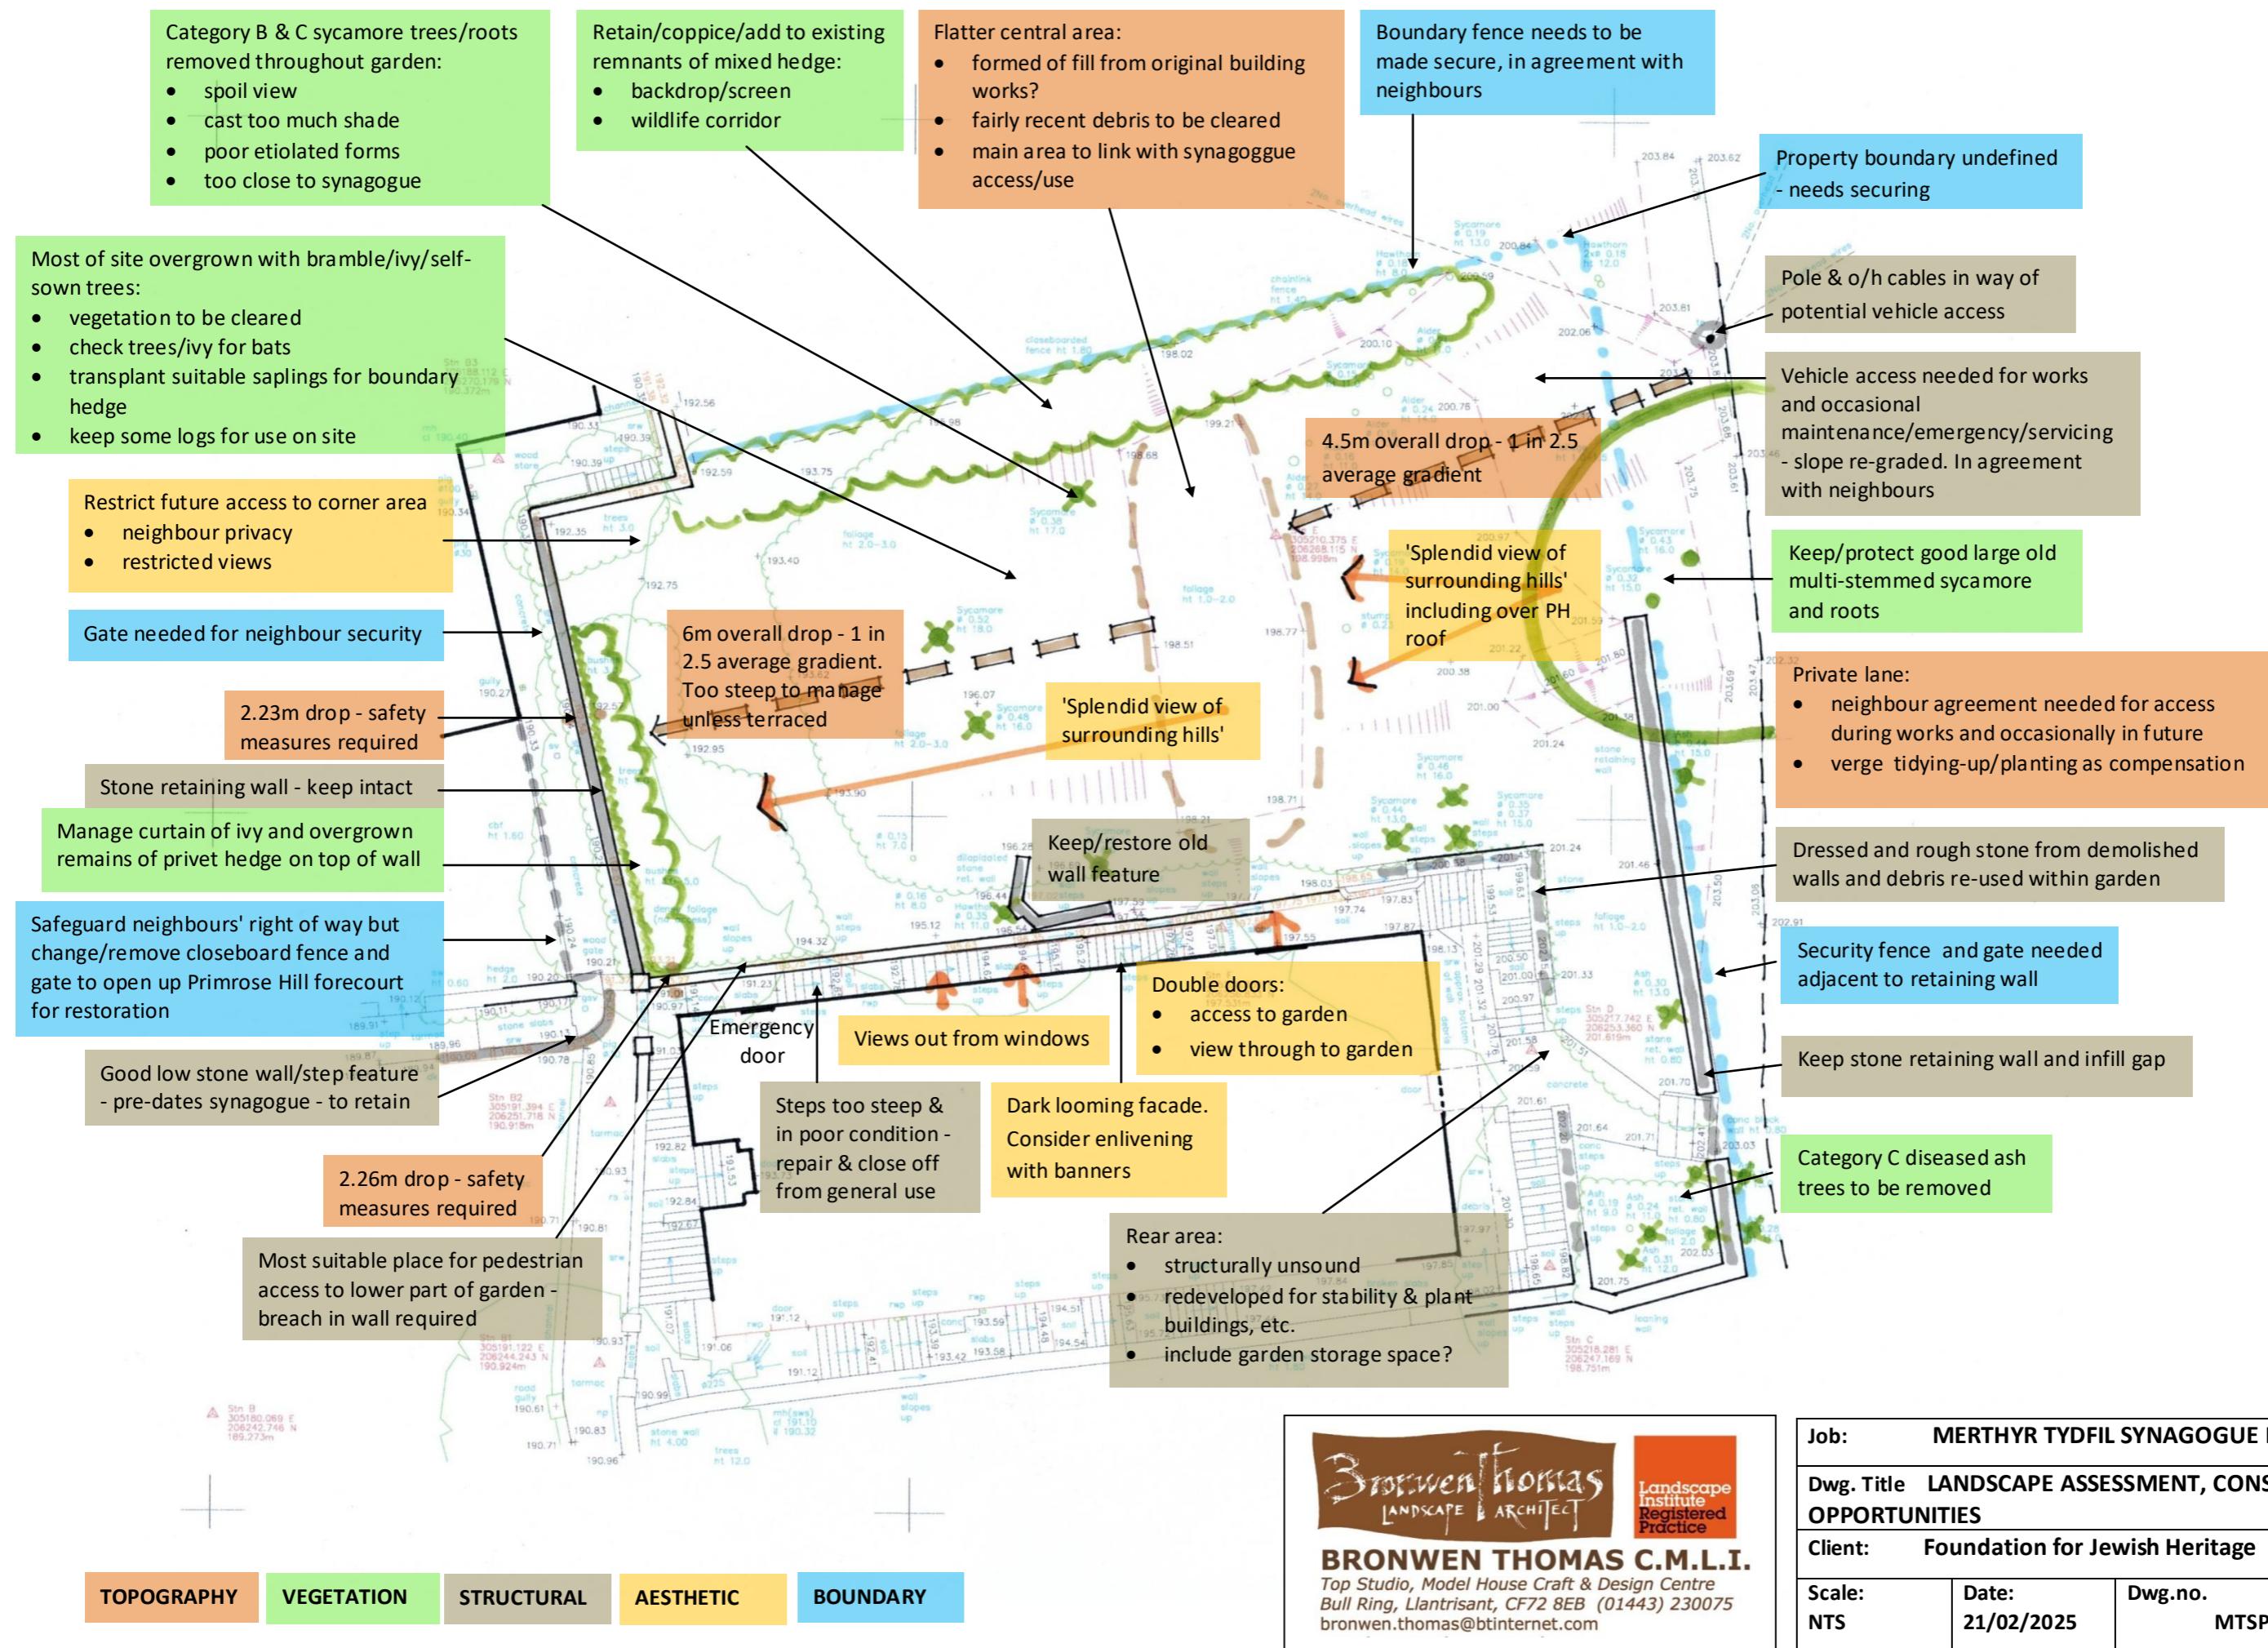
8.5.1 Proposed Landscaping Strategy for Derelict Land to North of Synagogue, produced by Bronwen Thomas, Landscape Architect

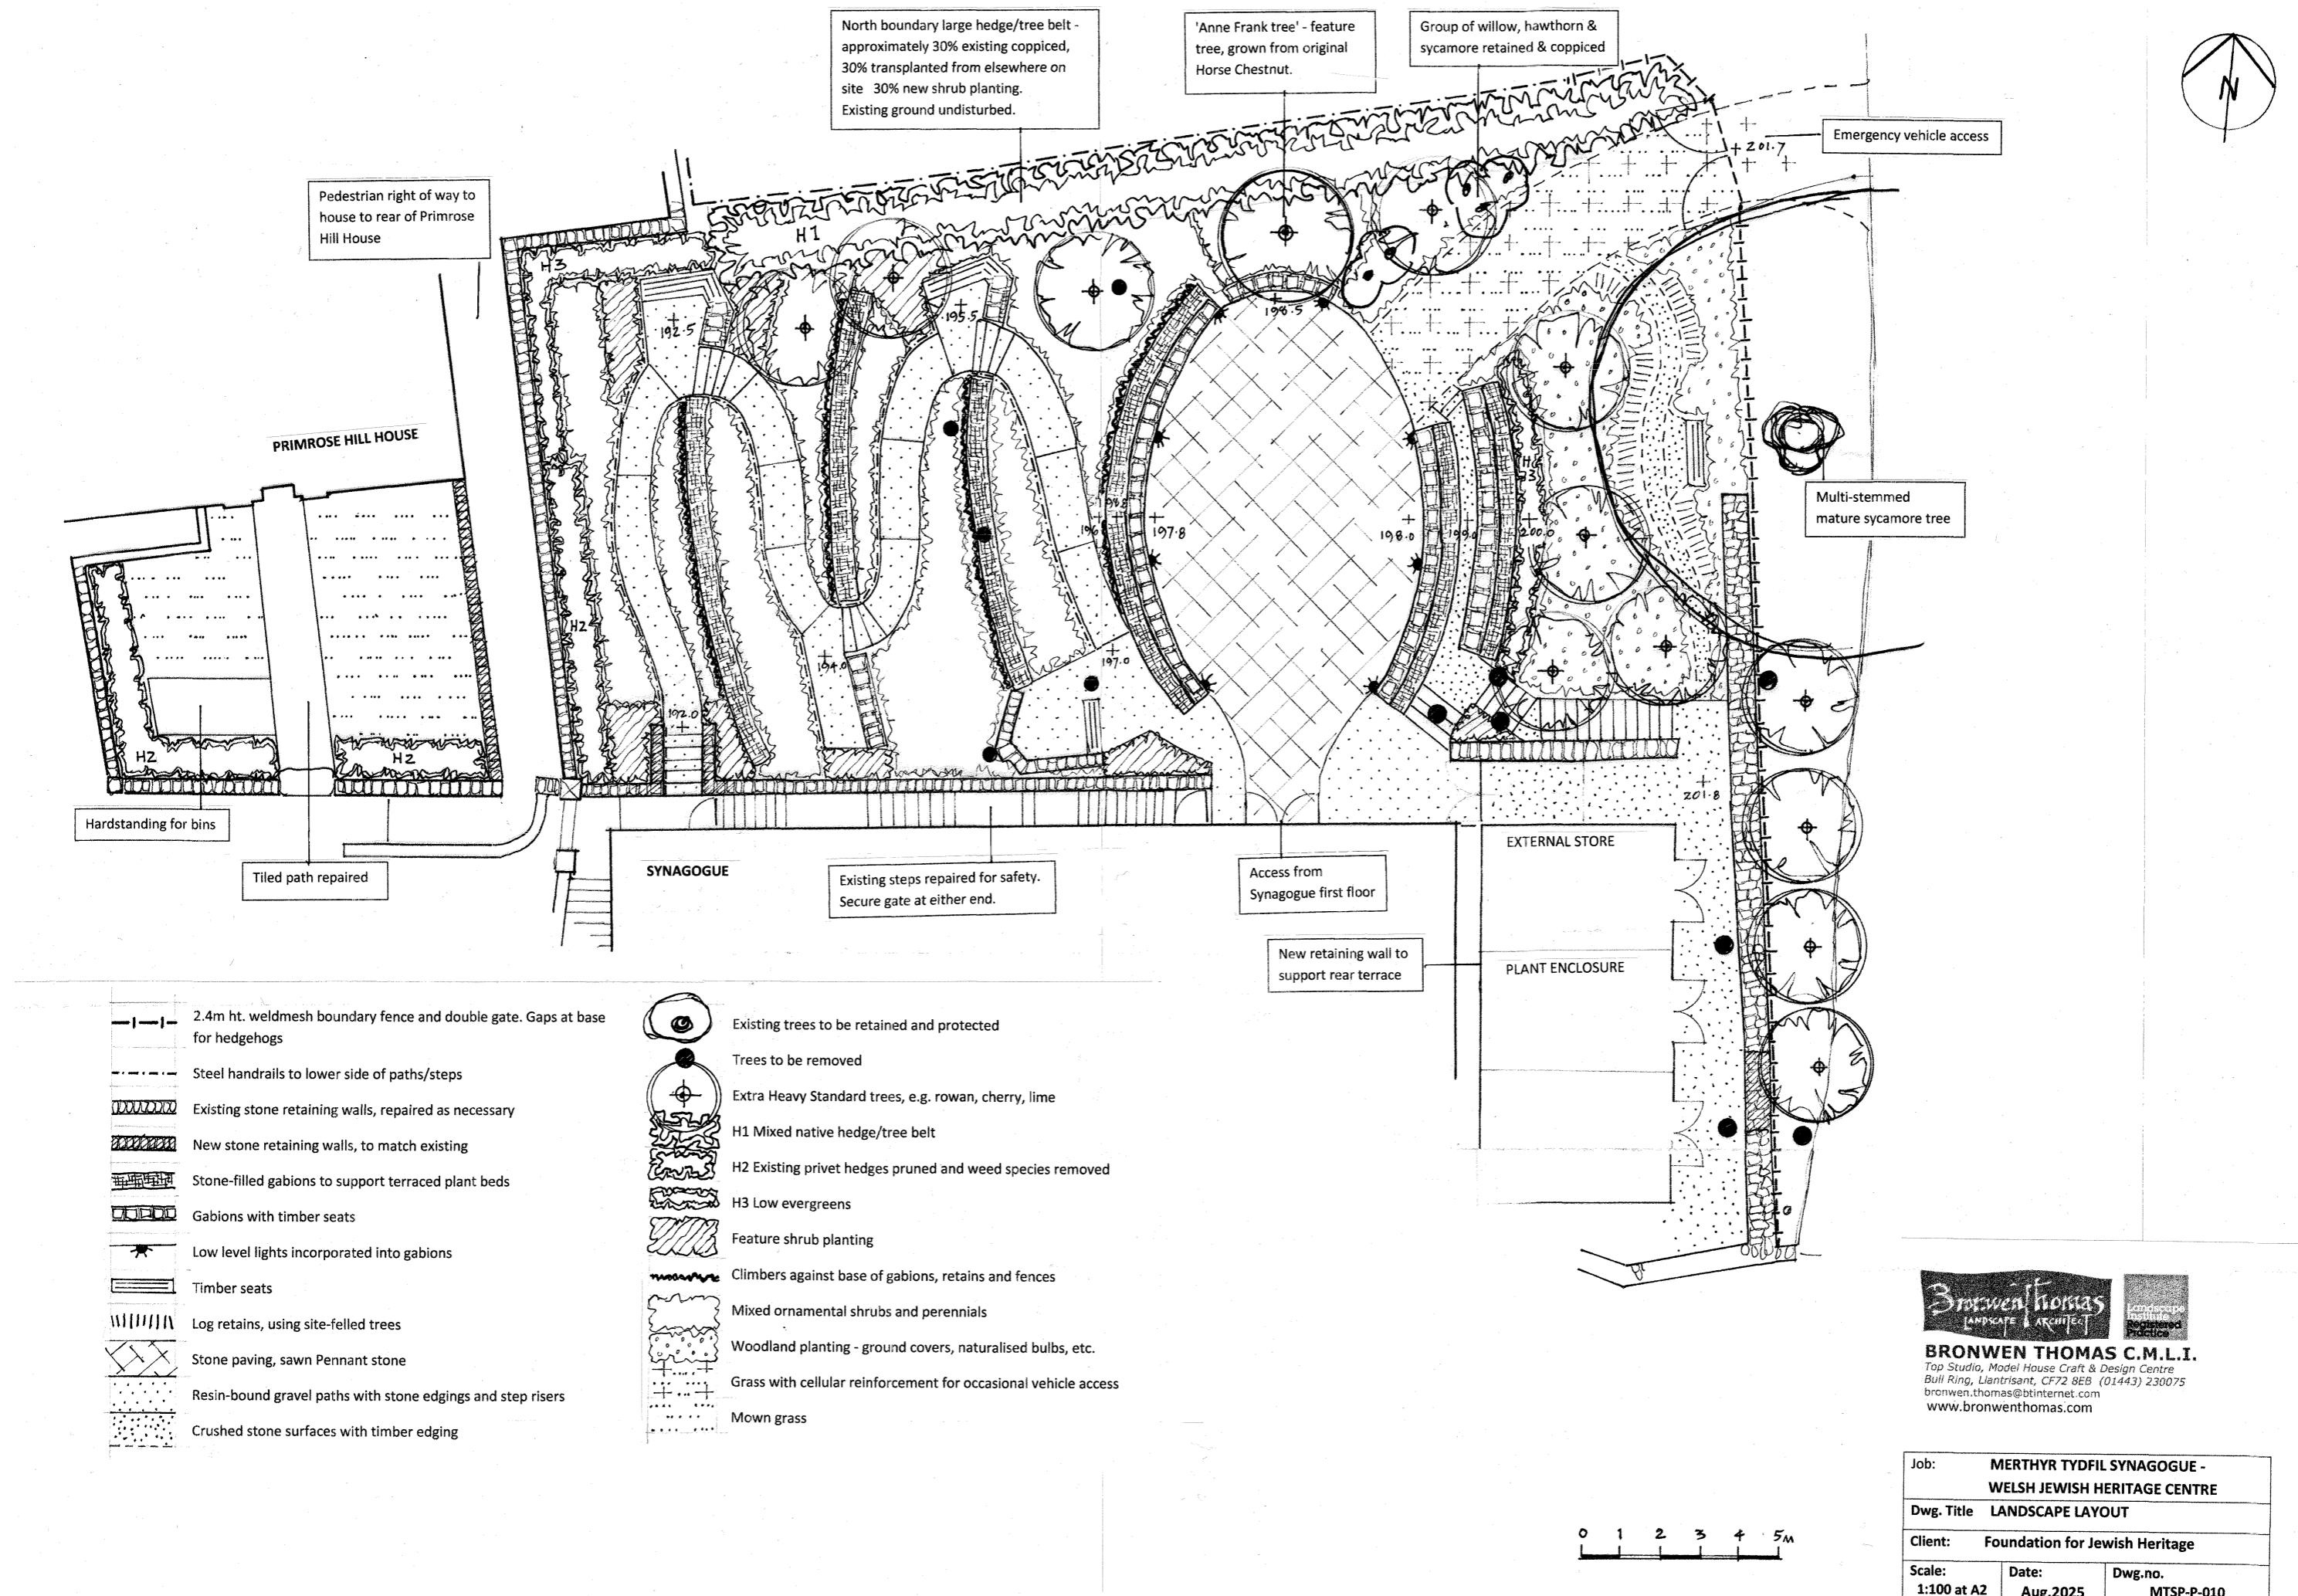
8.5.2 Proposed Landscaping Plan for Derelict Land to North of Synagogue, produced by Bronwen Thomas, Landscape Architect

North boundary large hedge/tree belt - approximately 30% existing coppiced, 30% transplanted from elsewhere on site 30% new shrub planting. Existing ground undisturbed.

'Anne Frank tree' - feature tree, grown from original Horse Chestnut.

Group of willow, hawthorn & sycamore retained & coppiced

Based on the Arboricultural Report, a concept was developed involving the removal of those trees deemed to be in both poor and low condition, and some of those in moderate condition; retaining others also in moderate condition.

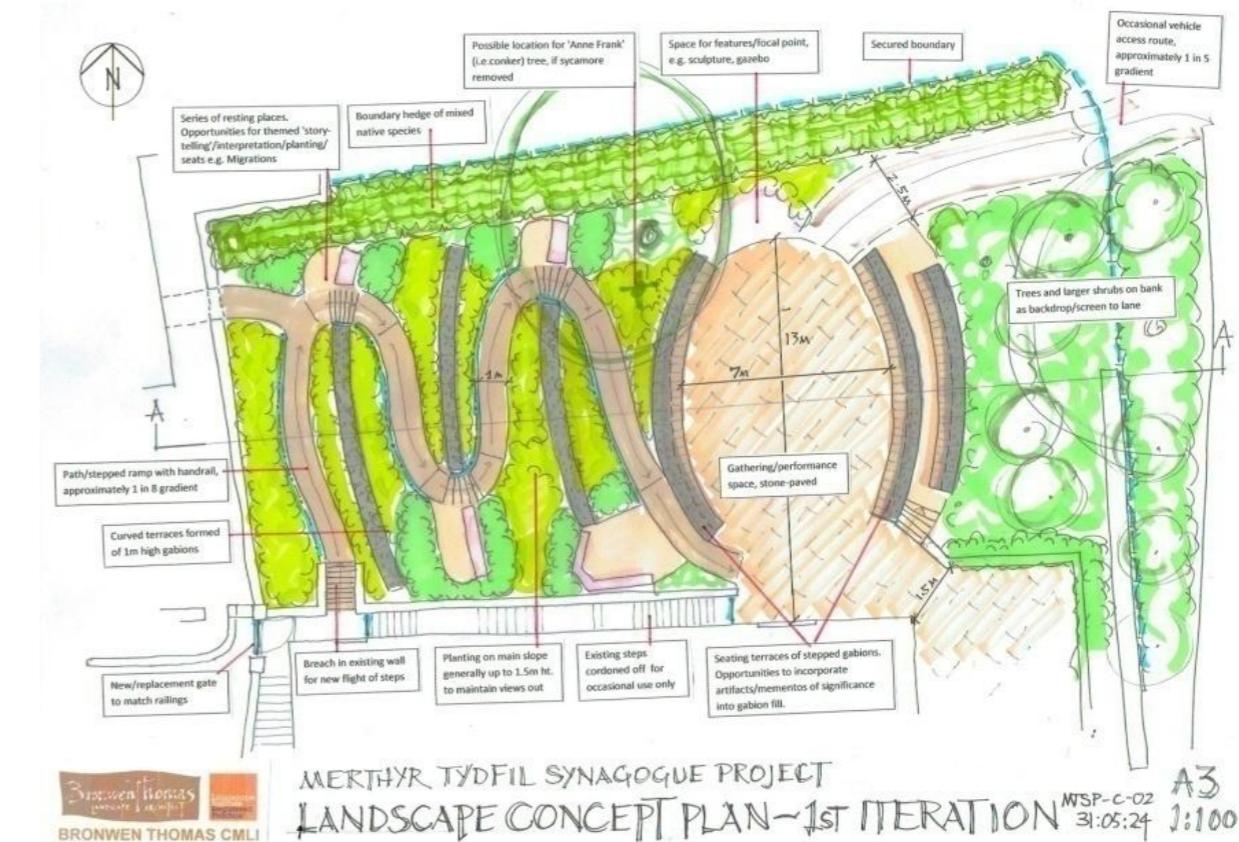
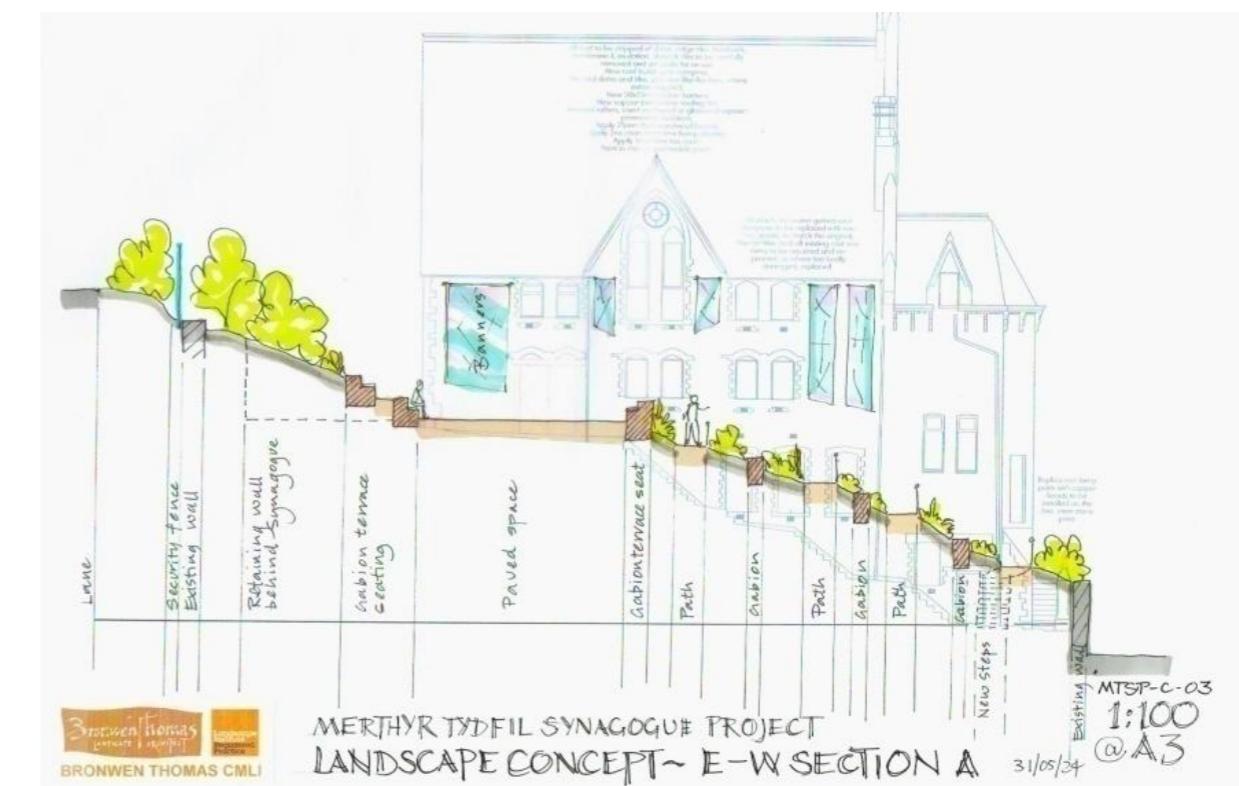
Early sketch proposals - Landscape Concept

The Synagogue garden will make the most of the dramatic steep slope with extensive views across the valley. It will be terraced with a snaking path down to a new entrance near the Synagogue's main entrance. There will be a central paved small arena, with a new door directly from the first floor of the Synagogue, ensuring that it is accessible within the constraints of the steep site and limited access opportunities. Primrose Hill forecourt will function primarily as a visitor gathering area on arrival and departure. Together they will provide appropriate and attractive setting for the cultural centre, with physical and visual links between the Synagogue and Primrose Hill and a safe secure environment for visitors.

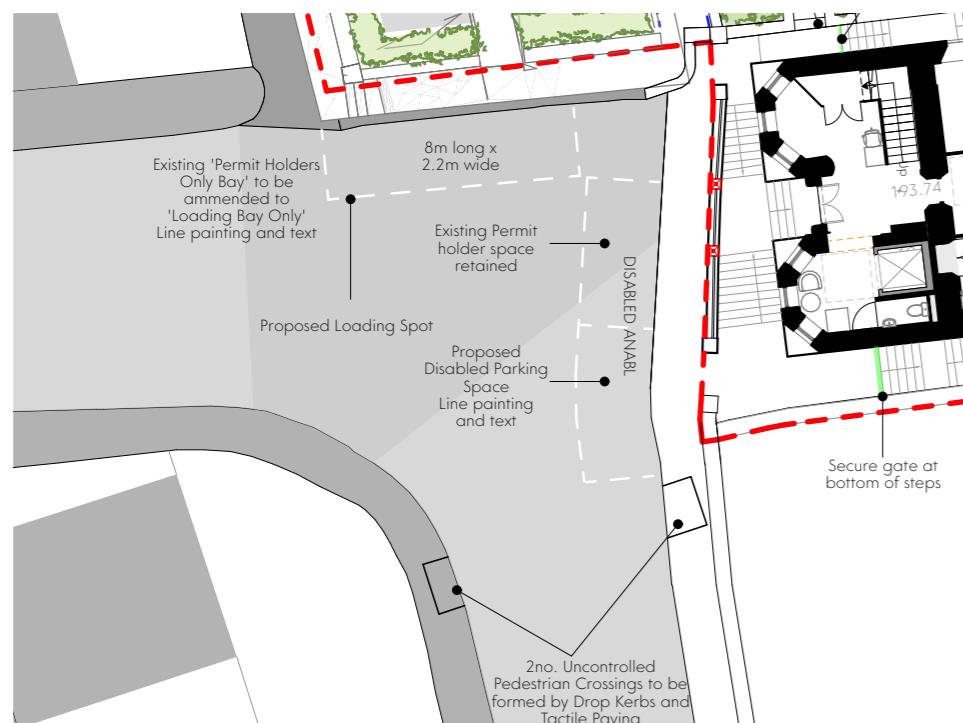
To the right is the plan included within the Transport Statement; whilst below is the same extract from the Proposed Site Plan. Above and to the right are two photos of the road area in question.

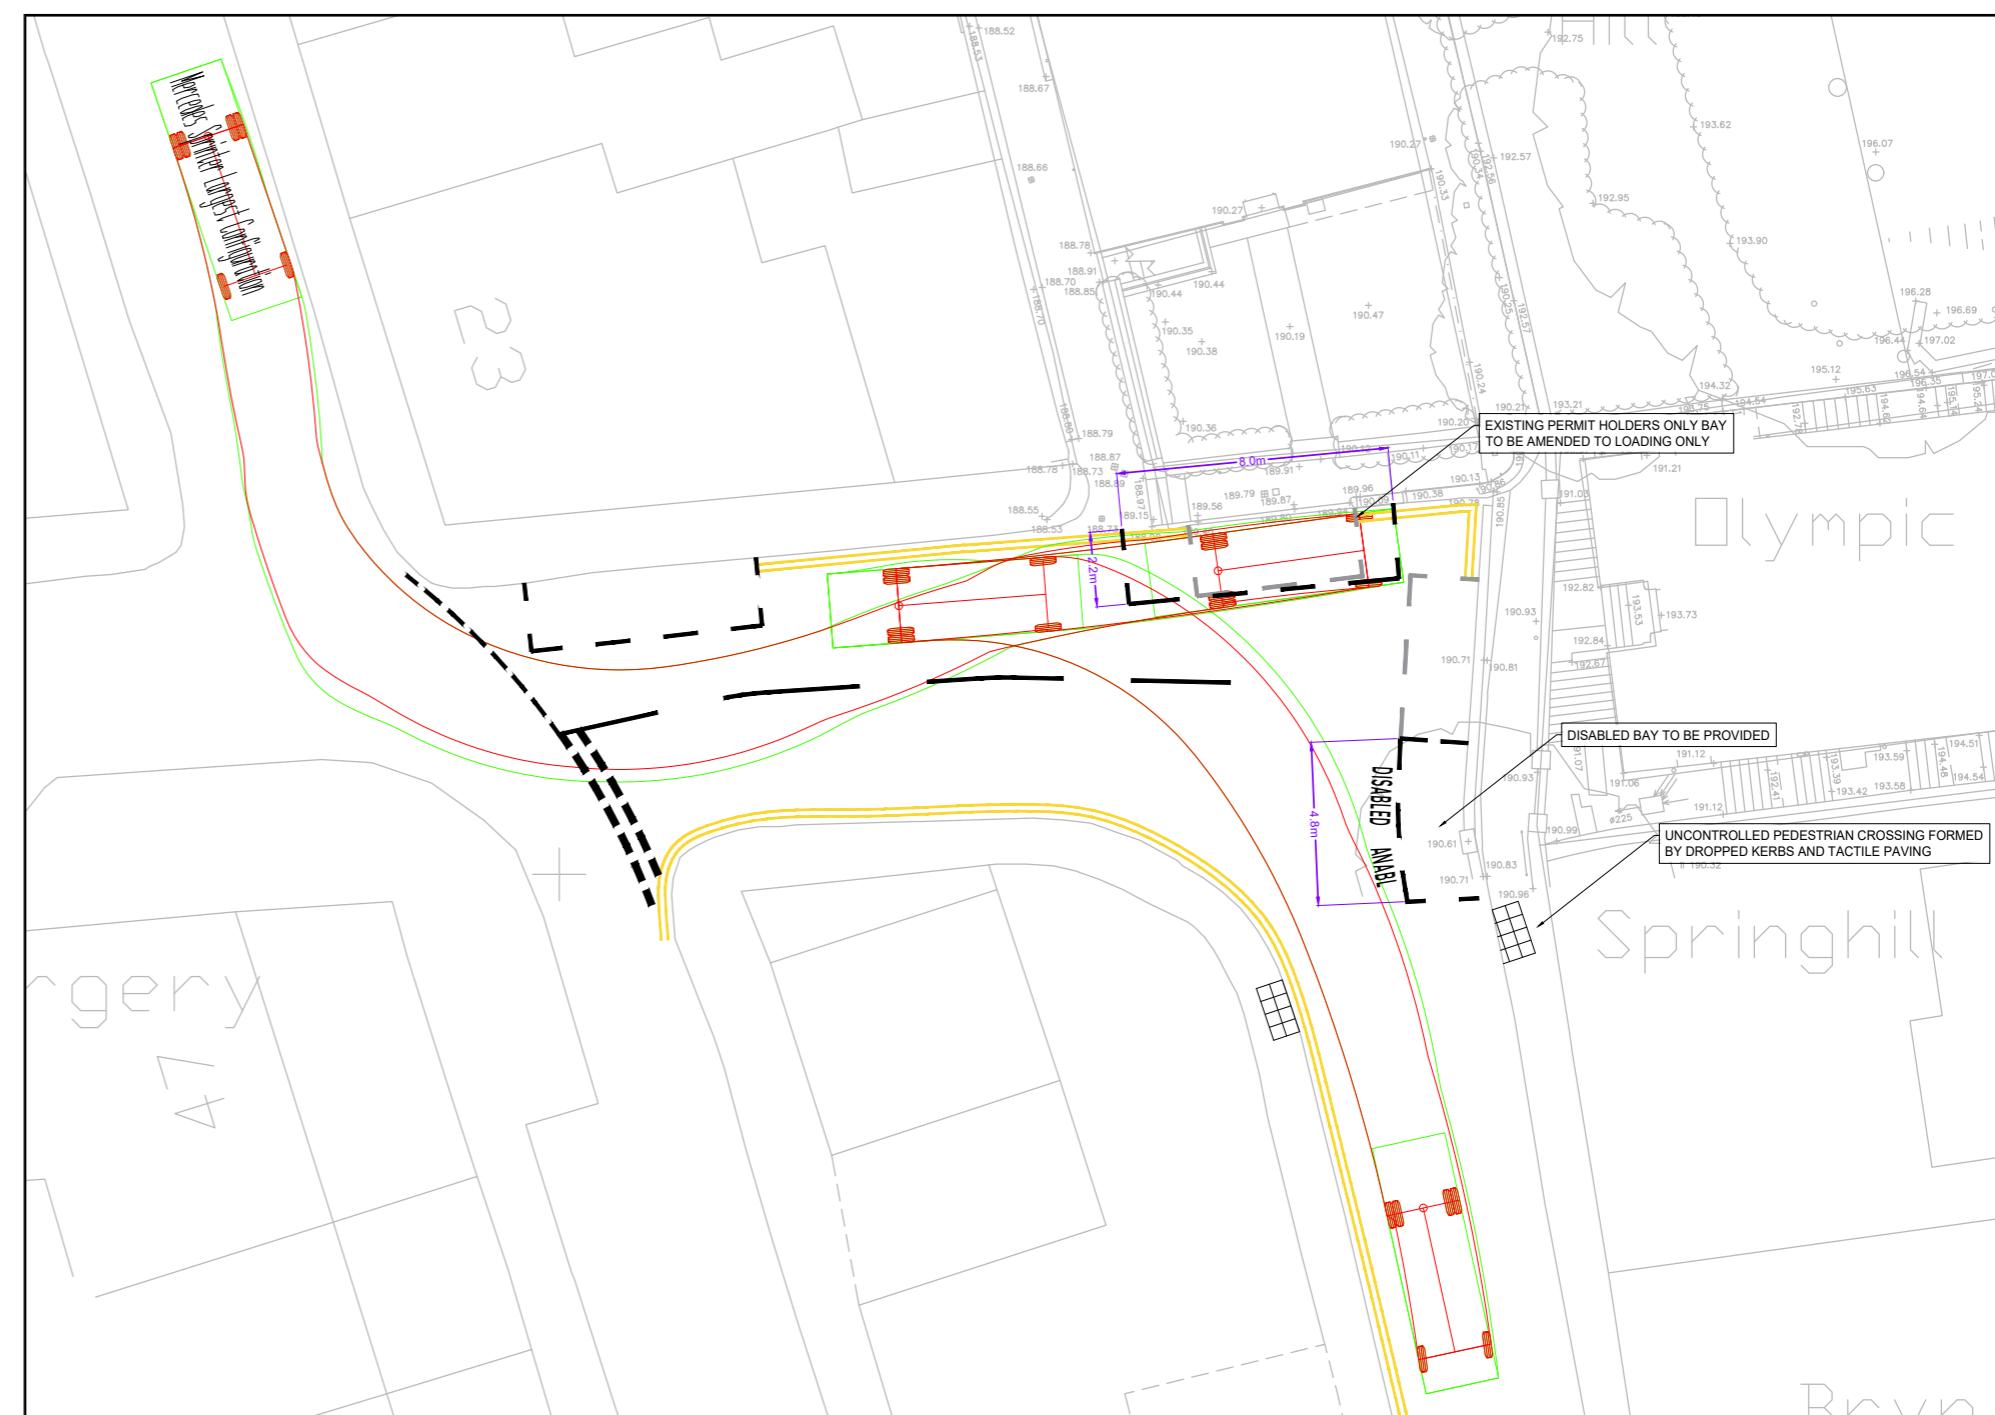
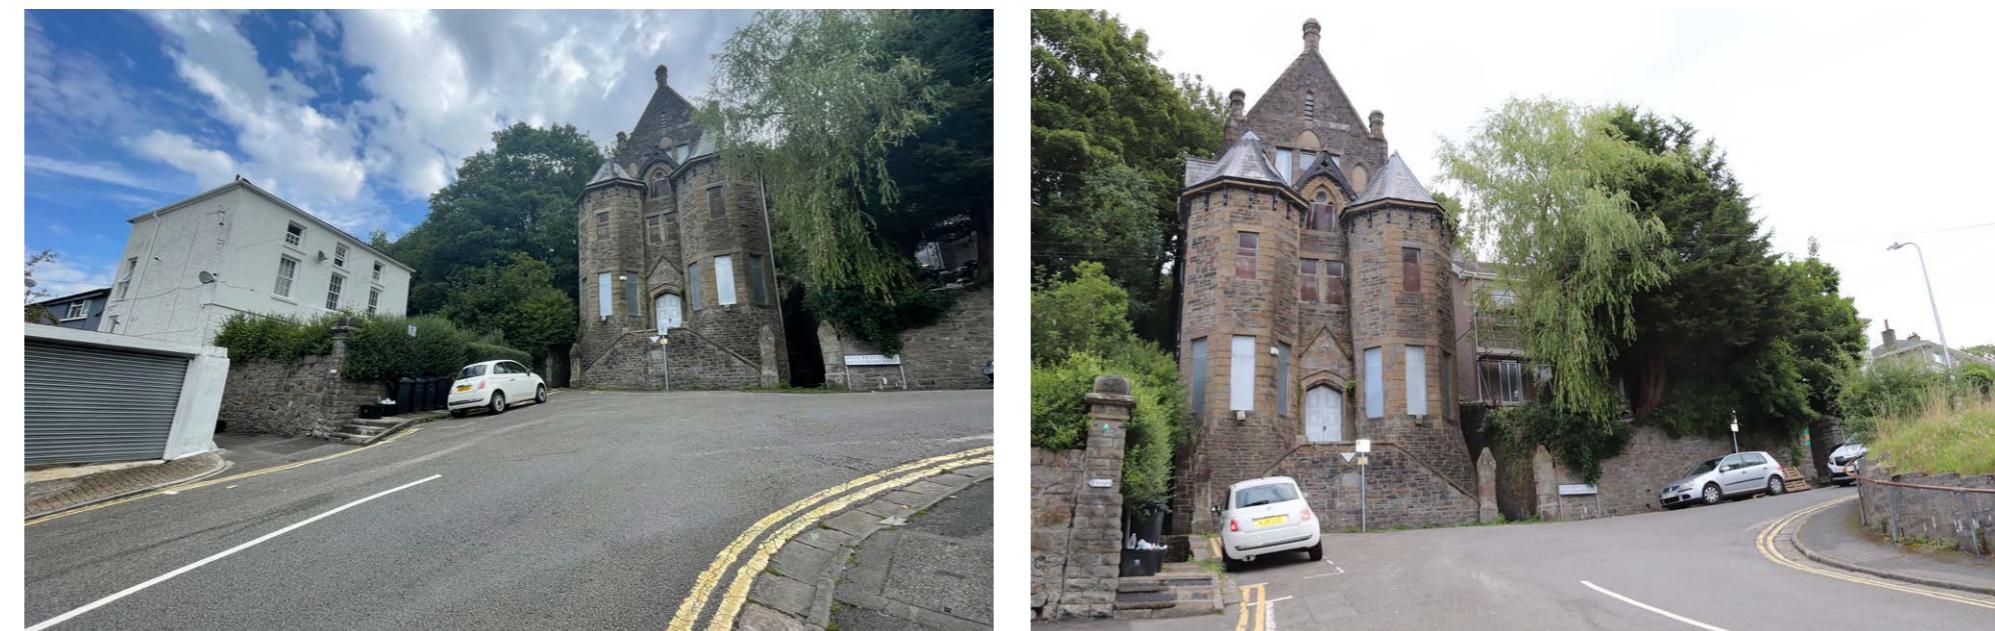
In order to facilitate servicing of the Centre and its commercial uses, it is proposed that the existing permit parking bay outside Primrose Hill is amended to become a loading bay. This will allow for the delivery and collection of goods from the centre, as well as allow loading and unloading of minibuses. This proposal would result in the loss of one permit parking bay. A survey has determined that the proposed loss of one bay would not have a detrimental impact on the availability of parking in the area.
