THE FORMER SYNAGOGUE

THE PROPOSALS

.....
(449)2503-GWP-A-HIS-P02

6.0 SECTION FOUR - EXPLANATION OF THE PROPOSALS

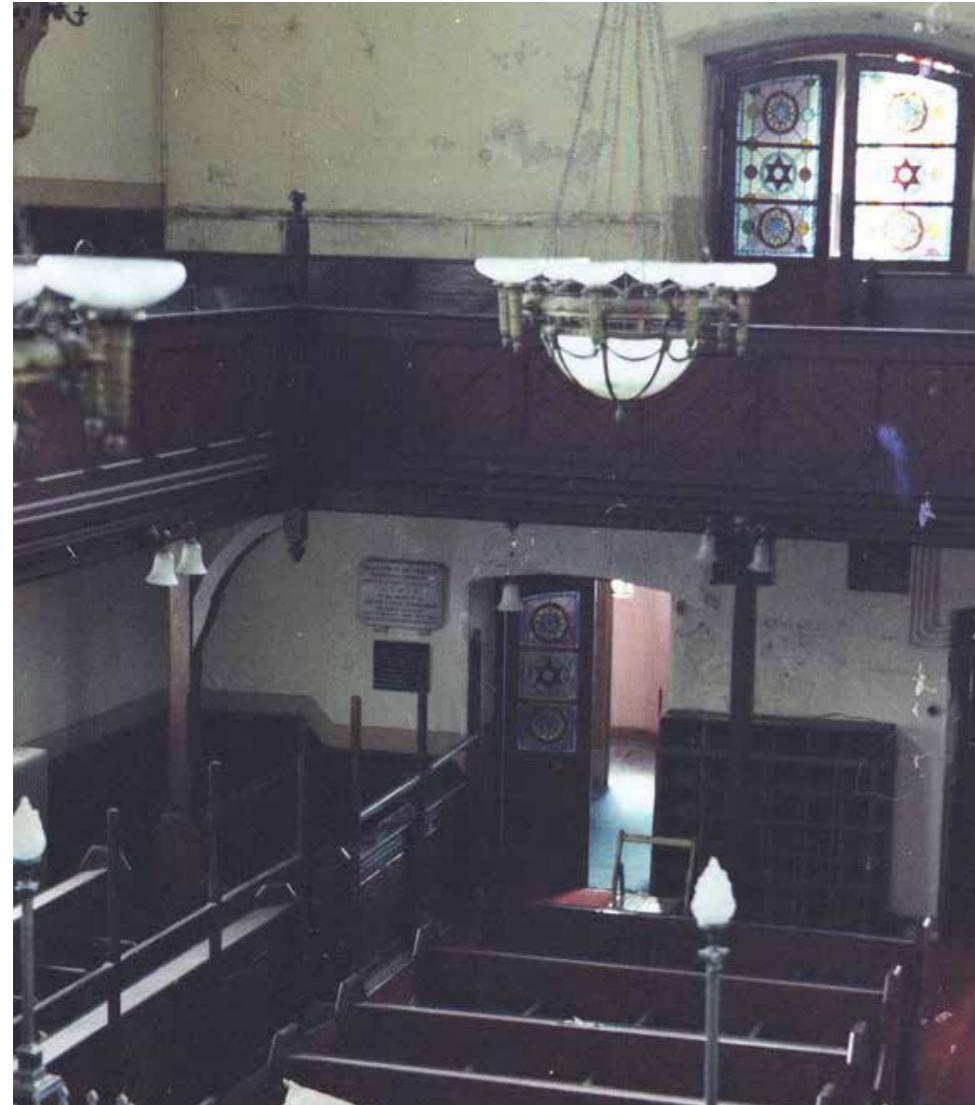
Original space looking west c.1978 (source: 'alangeorge.co.uk' website)

As a result, the brief for the Synagogue building changed during Stage 2 to focus more on providing entry, circulation (including stairs and lift) and toilets within the front range; and reinstating the rear range, at 1st and 2nd floor levels, as a two-storey interior with a 3-sided balcony around a central void - as per historic photographs and plans, dating from the late 1970s / early 1980s.

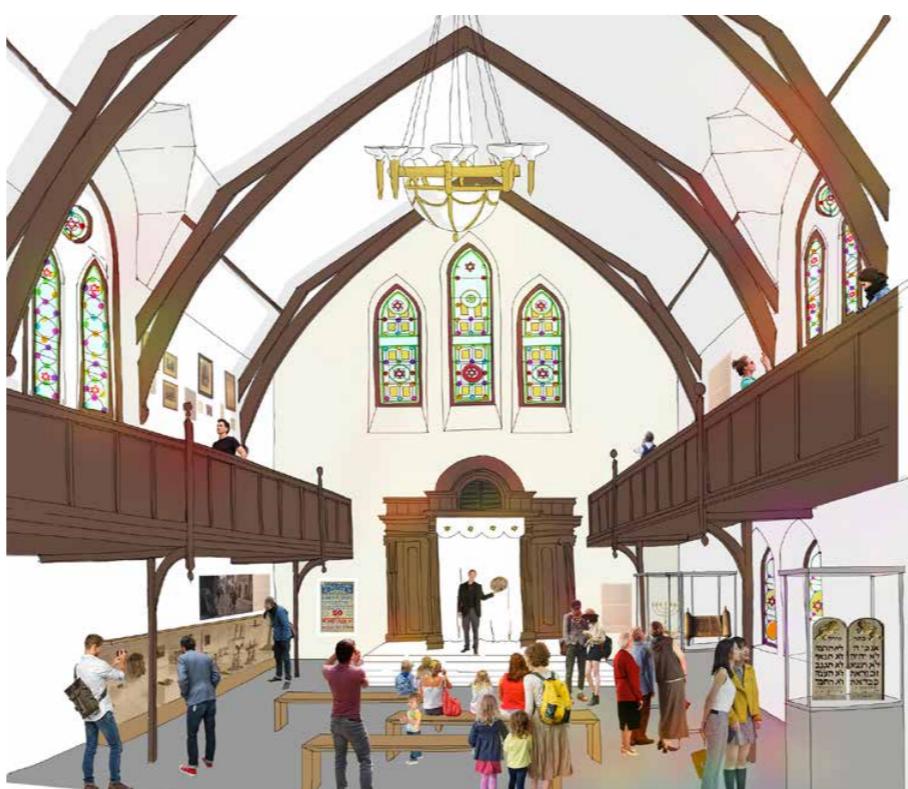
Early Sketch of how the restored 'Prayer Hall' space could look - looking eastwards towards the rear, and the Ark

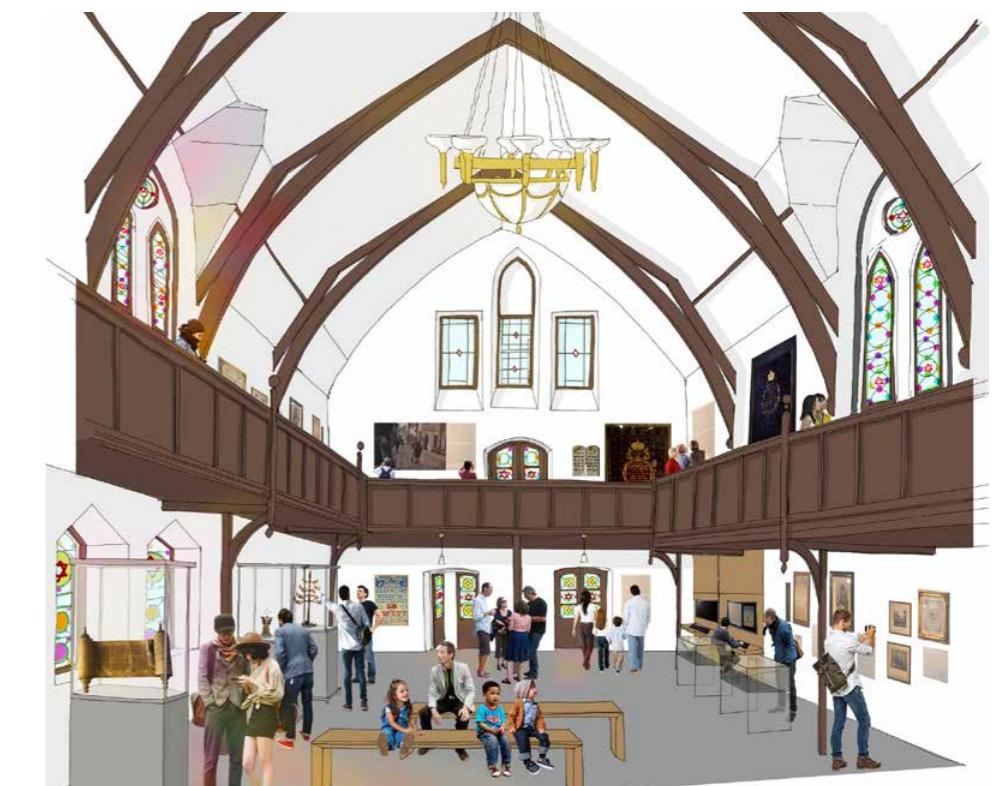
Early Sketch of how the restored 'Prayer Hall' space could look - looking westwards towards the entrances to the space

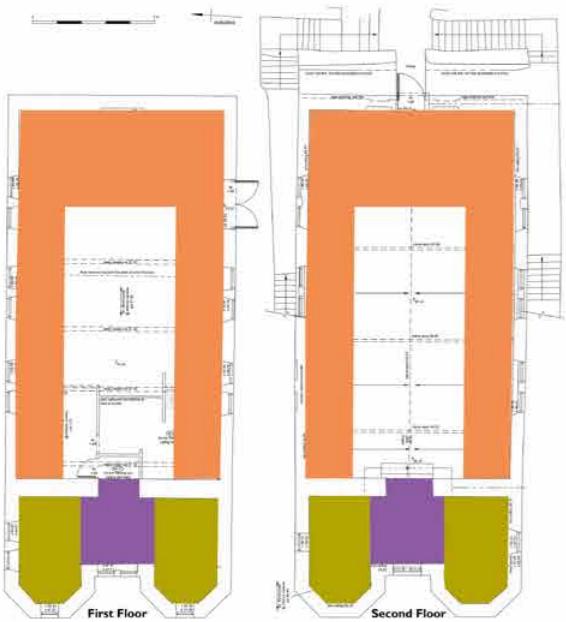
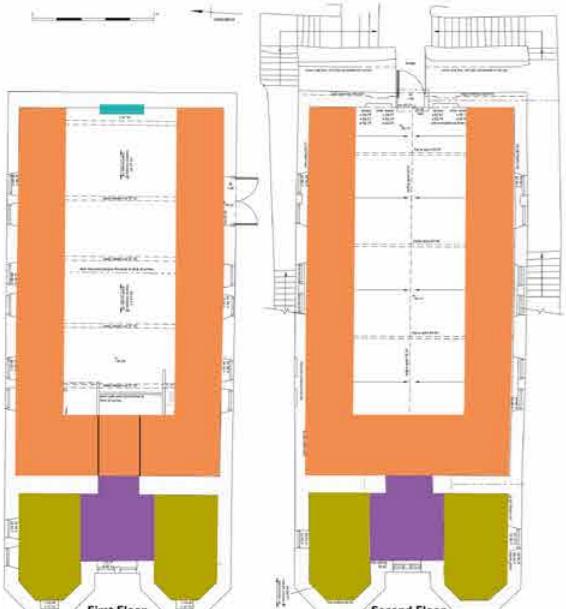
Reversed Configuration with Balcony

Least amount of floor area
Not honest replication;
Cannot locate Ark at rear

The layouts show that the original configuration of the balcony, be that as existing or extended, means that the two-storey void may not be immediately apparent, and there may be a need for a corridor, or open circulation space, leading to the double-height space. However, where the balcony is orientated the other way round (not as original), this corridor is not required, and the double-height space is immediately apparent; whilst the original location of the ark is not viable.

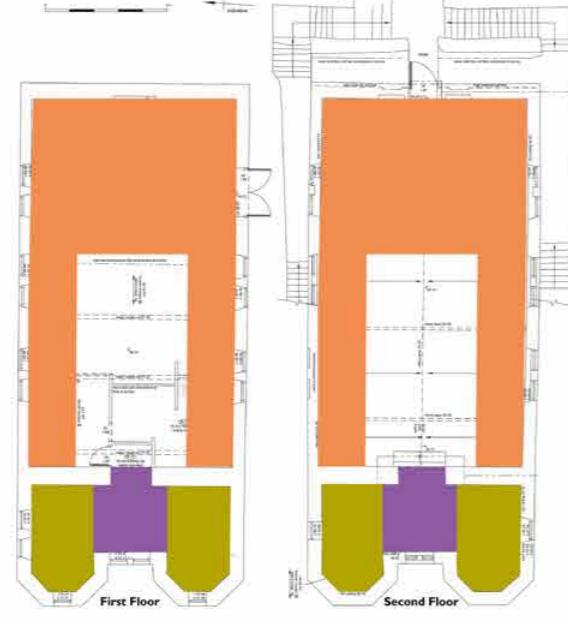
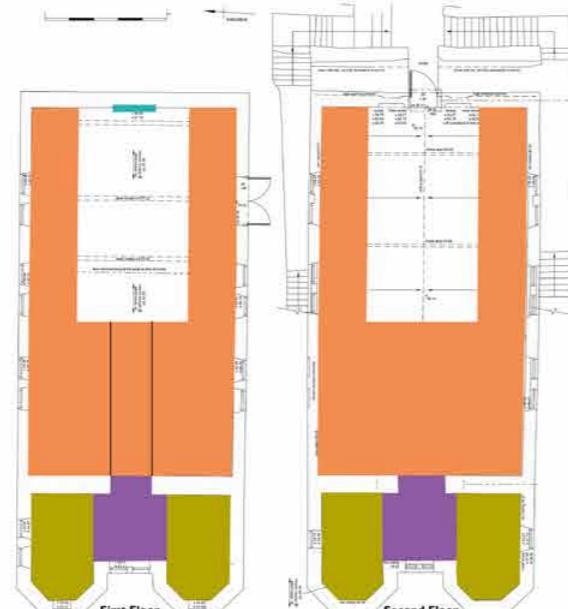
Original Configuration with Balcony

Not honest replication;
Cannot locate Ark at rear

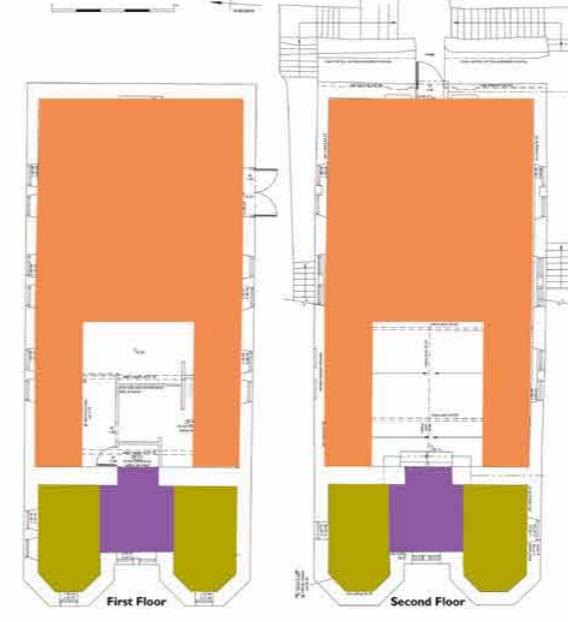
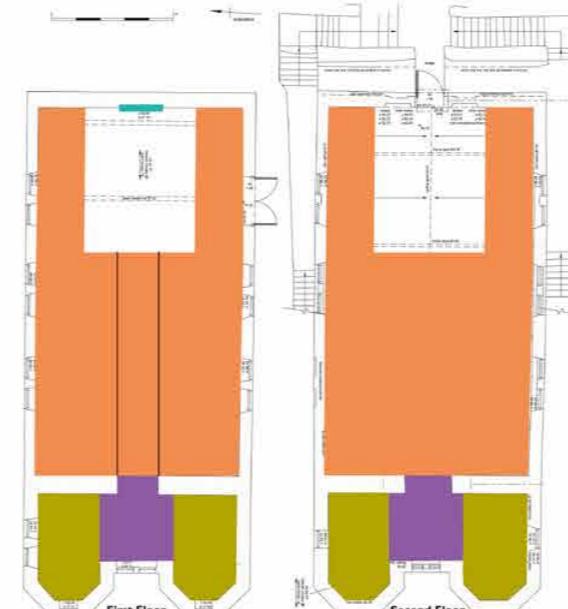
Original with 1no. additional Bay

Not honest replication;
Cannot locate Ark at rear

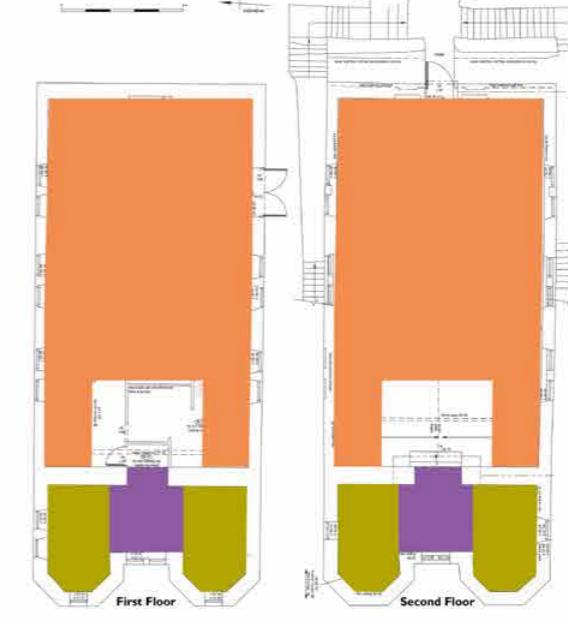
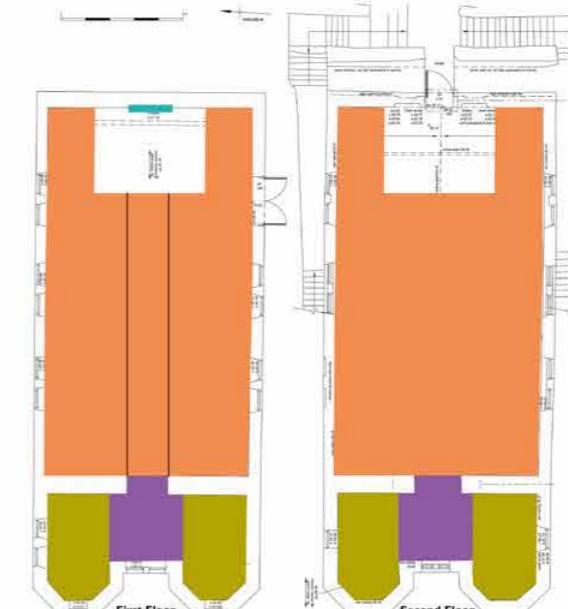
Original with 2no. additional Bays

Not honest replication;
Cannot locate Ark at rear

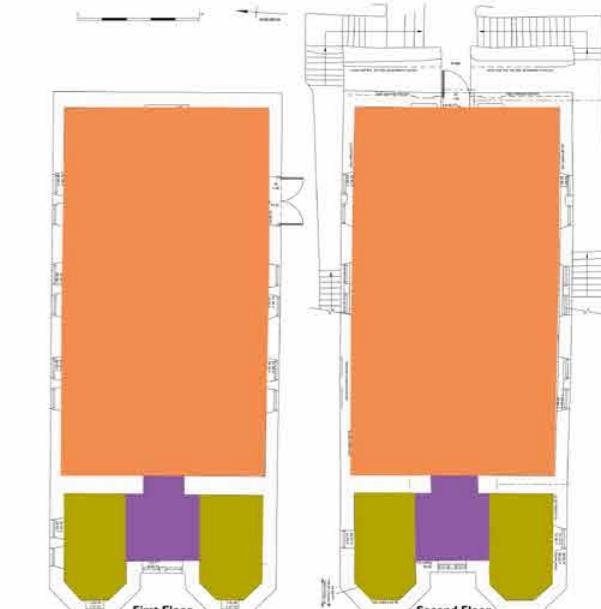
Original with 3no. additional Bays

Not honest replication;
No double height space / no view of roof
& windows from 1st floor

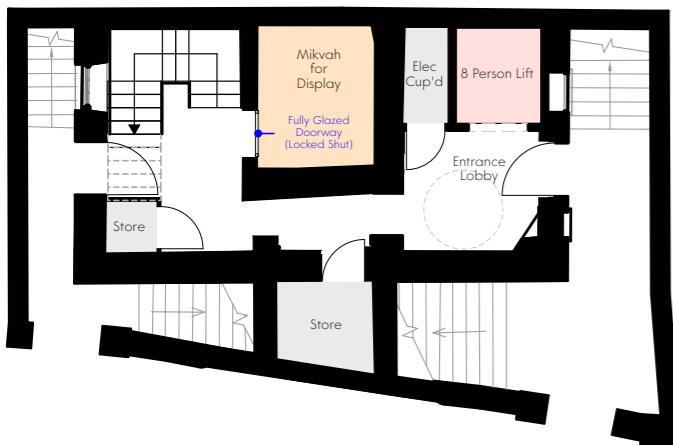
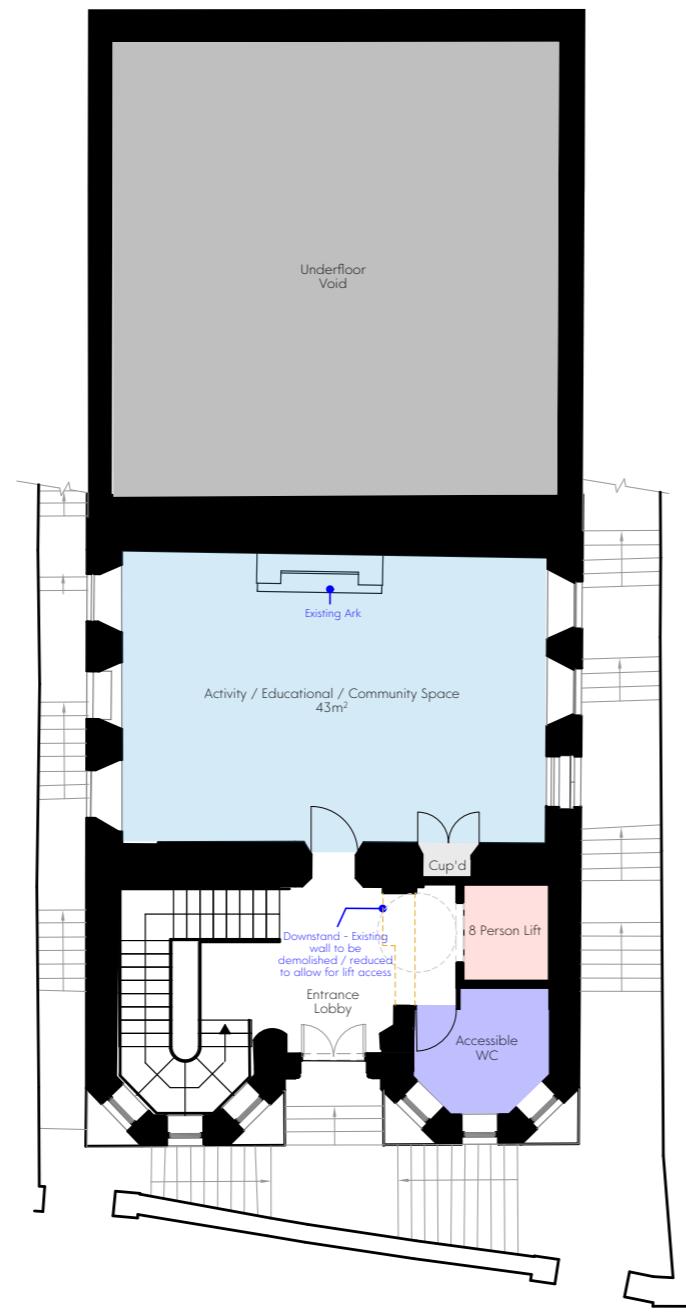
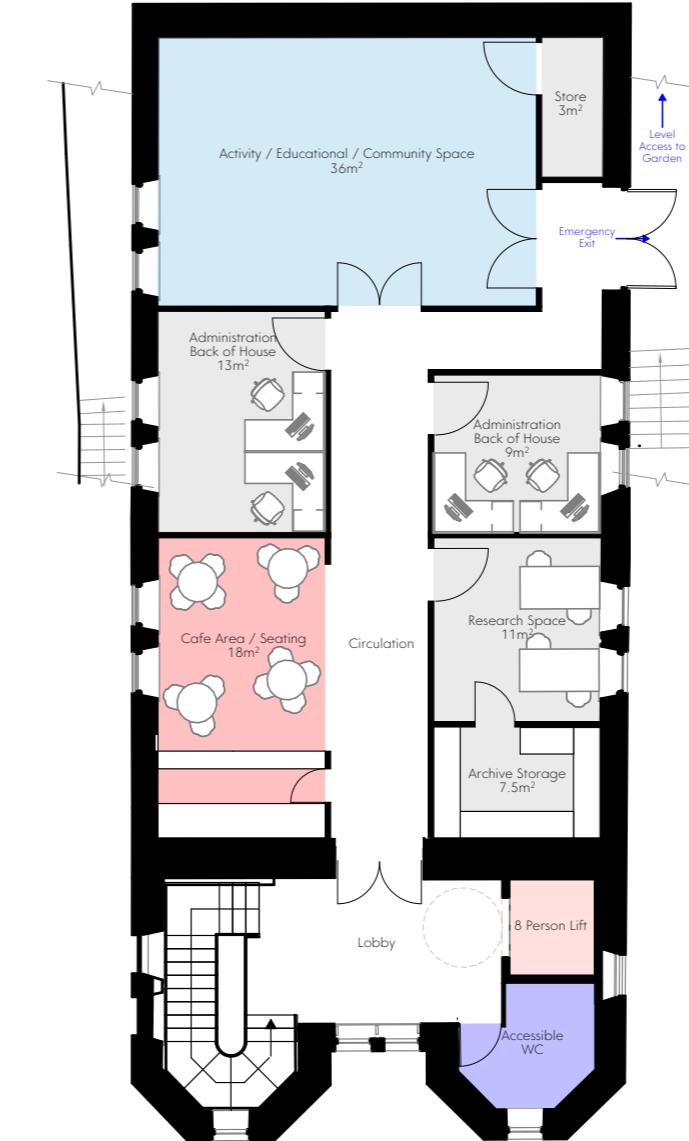
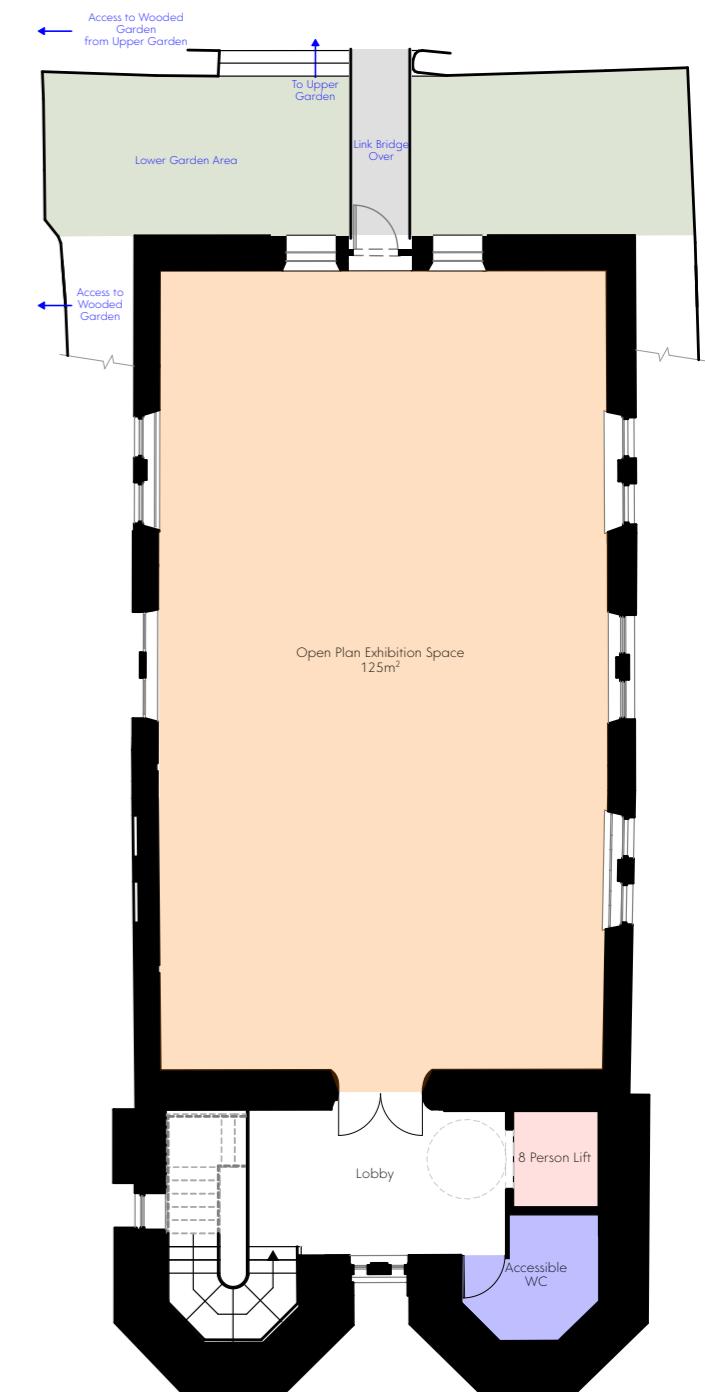
6.2.5 Next Stage Layout Options - Option C

Option C involved a full floor plate to the 2nd floor, set up as the main Exhibition space; and, to the single-storey 1st floor, a series of cellular space, providing a series of smaller spaces (for a Cafe, Administration, Archive and Research) with a larger Activity space at the rear.

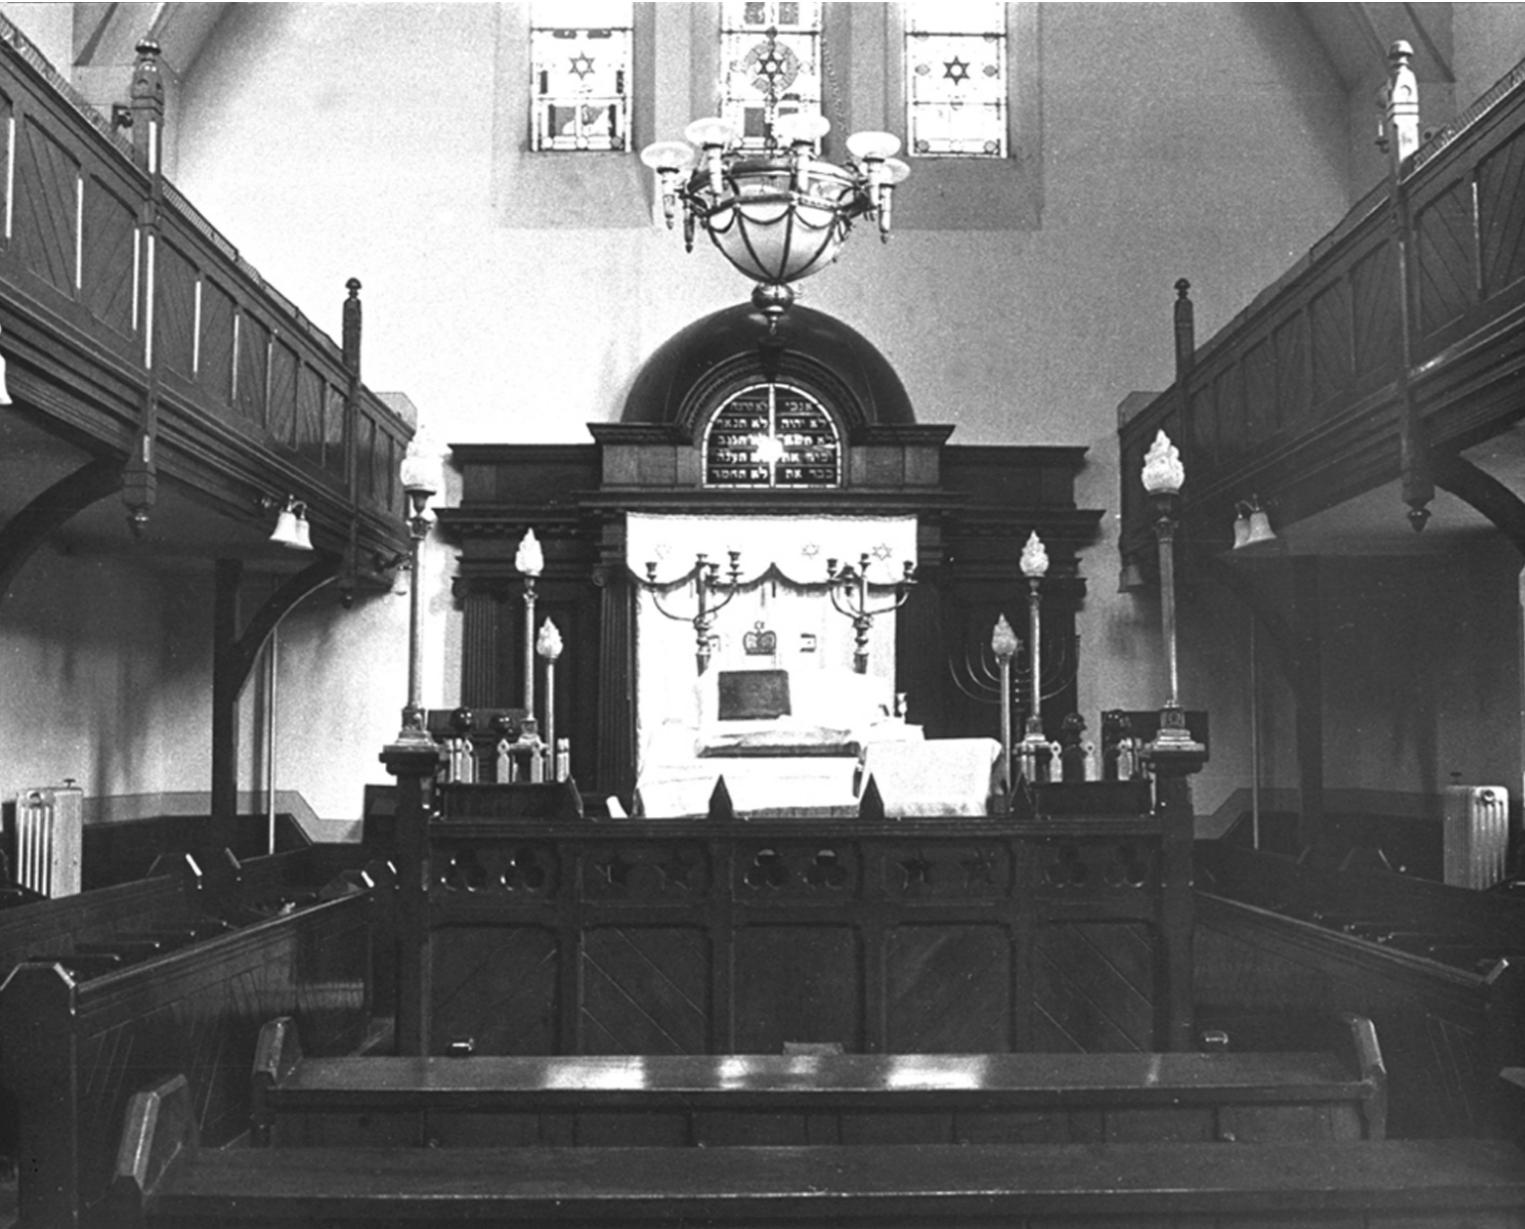
View of original Synagogue Prayer Hall looking towards Ark (source: Doreen Jacob)

The photo below left shows the east end of the Synagogue when it was still in use as such. The three-sided balcony is evident, as is the Ark, the Bema, the pews, one of the feature chandeliers and the coloured leaded windows.

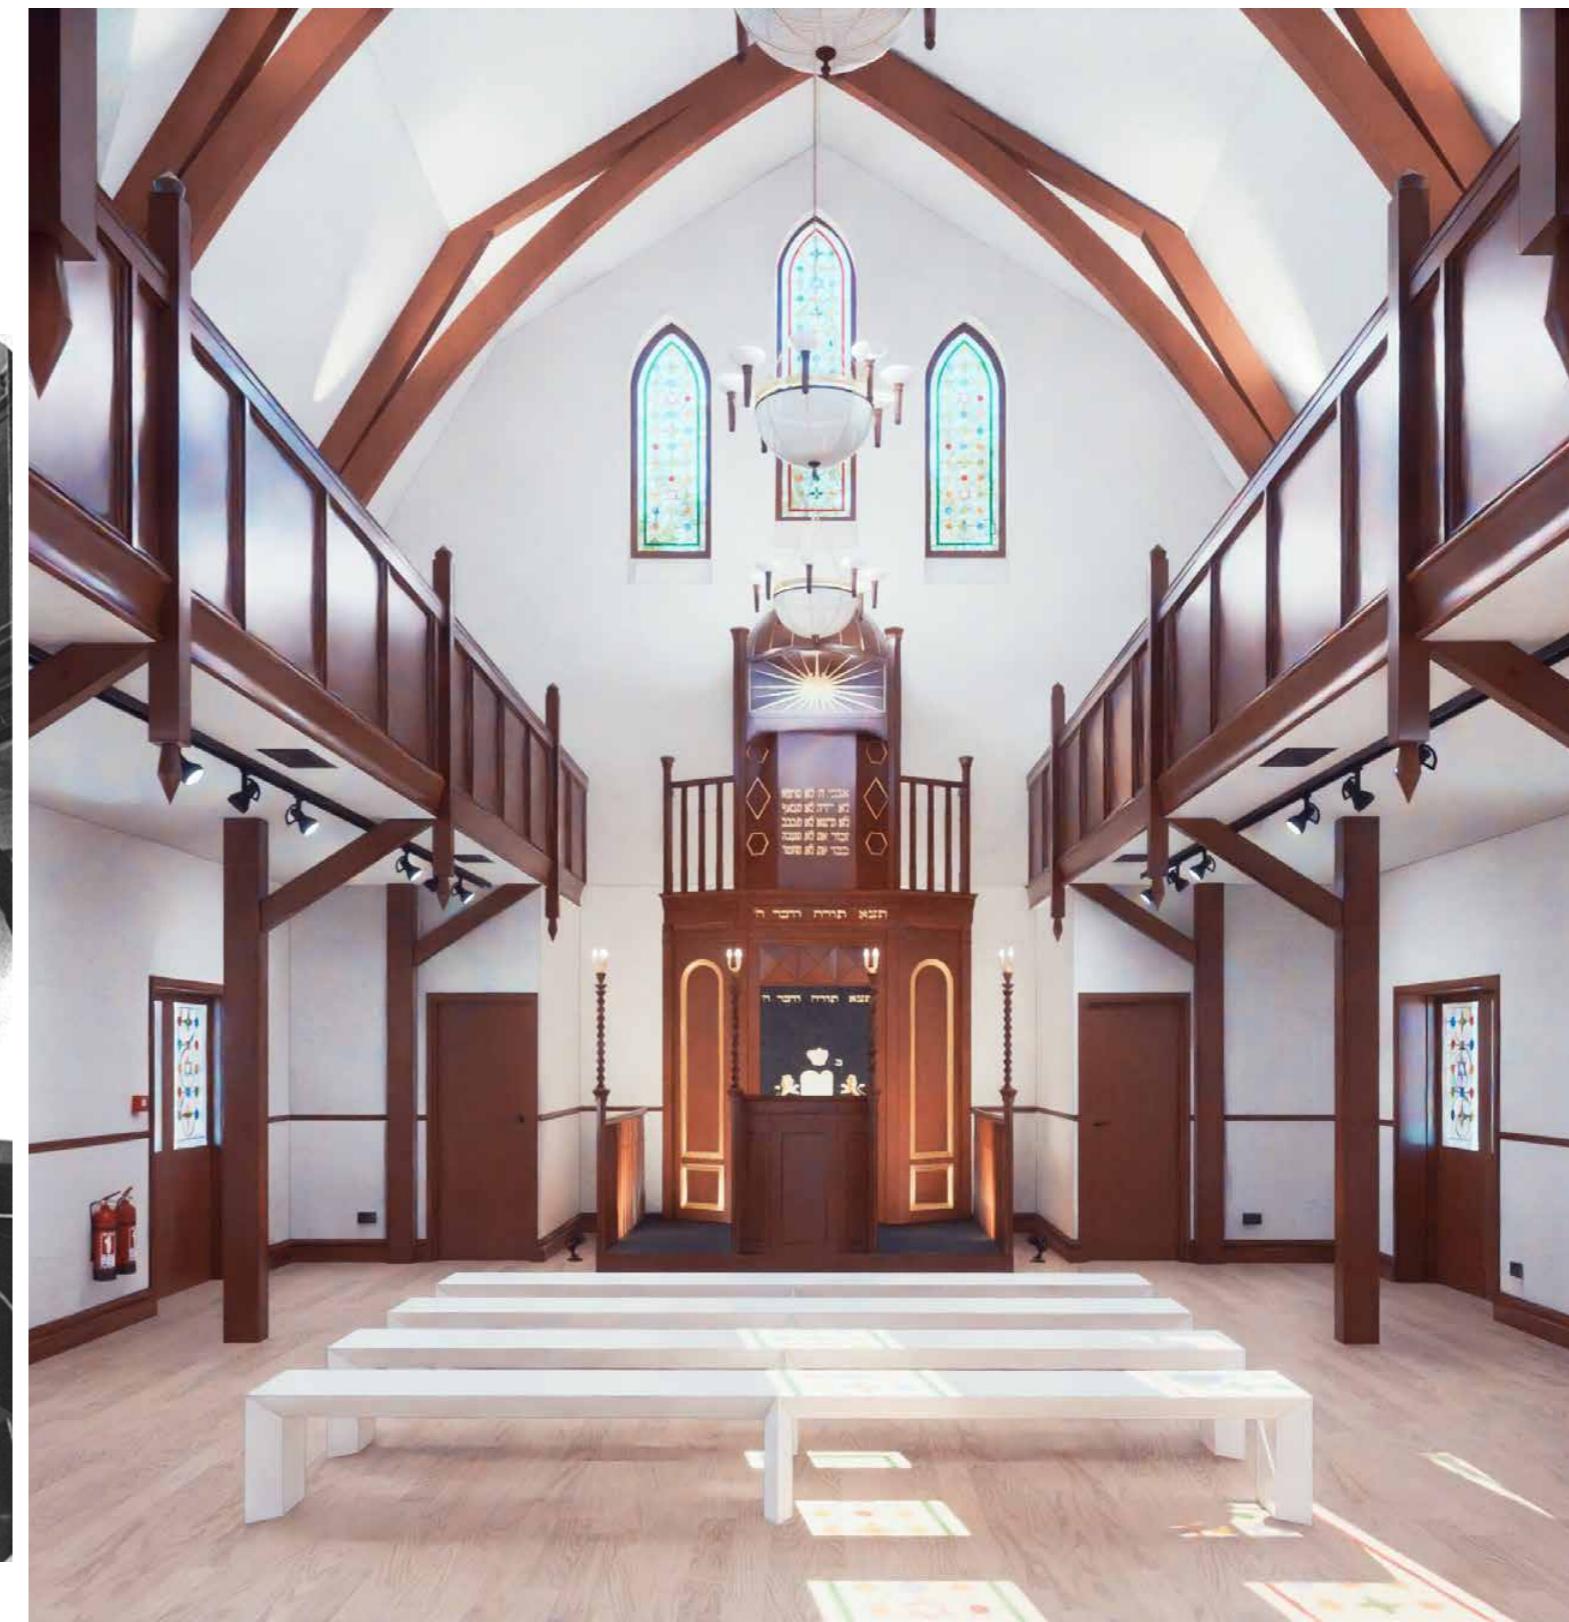
A CGI of the proposals, bottom right, presenting the same view, shows a reconstructed three-sided balcony (in lieu of the current floor), a replacement Ark (extracted from the Langside in Glasgow, as the original Ark is not available), replica chandeliers and new coloured leaded windows. The Bema is omitted, as it would take up too much space.

CGI of Proposals looking in the same direction

As stated, the original Ark has been removed and is not available for reinstatement; and so the Ark from the now-closed Langside Synagogue in Glasgow would replace it, and would be located in exactly the same location. That Ark is currently in storage and images of that are shown on the next page. If installed with the full set of steps in front of it, the height of the Ark would extend above the window cills. As a result, the Ark would be reinstated with the platform in front of it much lower and only one set of steps included.

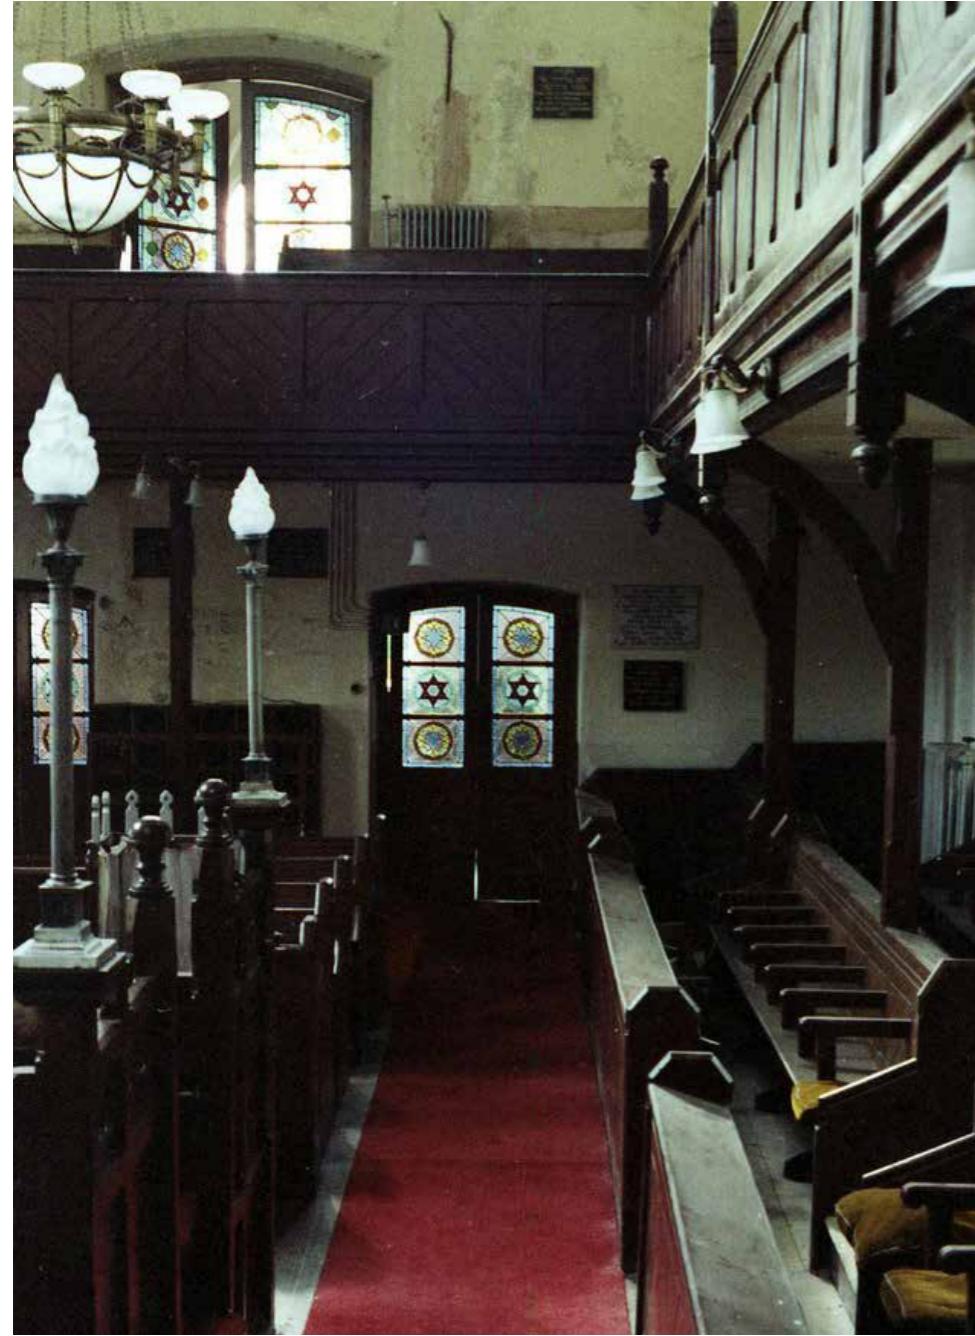
Internal Photo (c.1978) looking towards entrance doors
(source: 'alangeorge.co.uk' website)

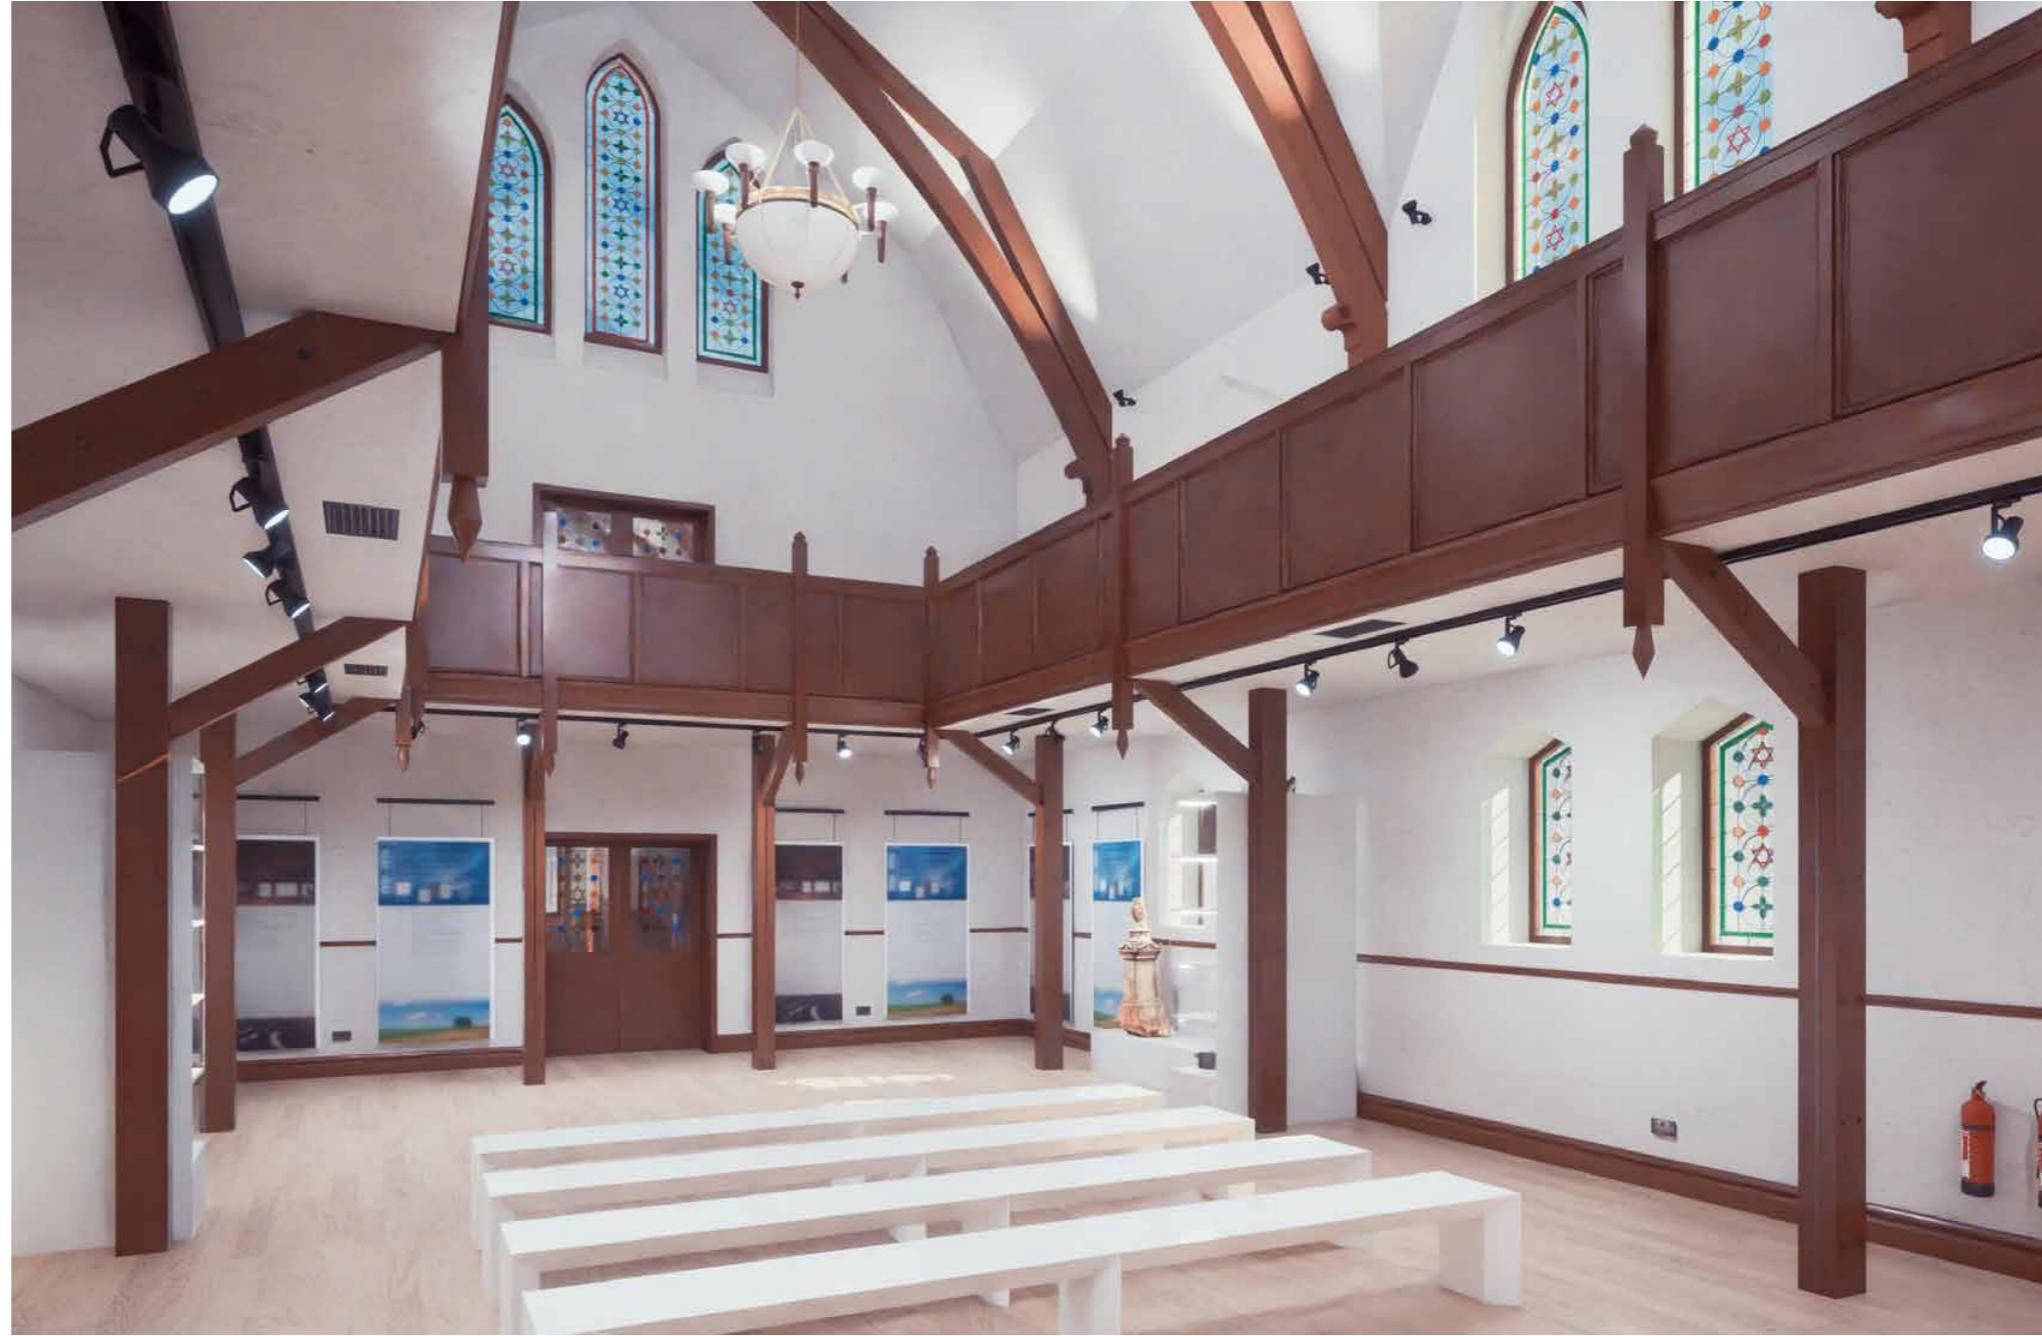
CGI of Proposals looking in the same direction

Currently, almost all of the windows are badly damaged, with virtually all of the coloured leaded glass lost. Only 3no. of the 'Star of David' lights remain at the top of 3no windows. The proposals repair (or replace like-for-like) all of the window frames to be repaired. Apart from the 'Star of David' lights all of the glazing would be new. To this main space, and other spaces, new colourful design are to be produced by a specialist glass artist, to celebrate and commemorate the building, its heritage and that of the Jewish faith. It is possible that the colours would be fairly dark, so to minimise bright light within the space, thereby avoiding the need for black-out blinds. The glazing is either to be encapsulated into a Slimline double-glazed unit or is to incorporate secondary glazing behind in order to reduce heat loss which, through windows of this size, would be considerable.

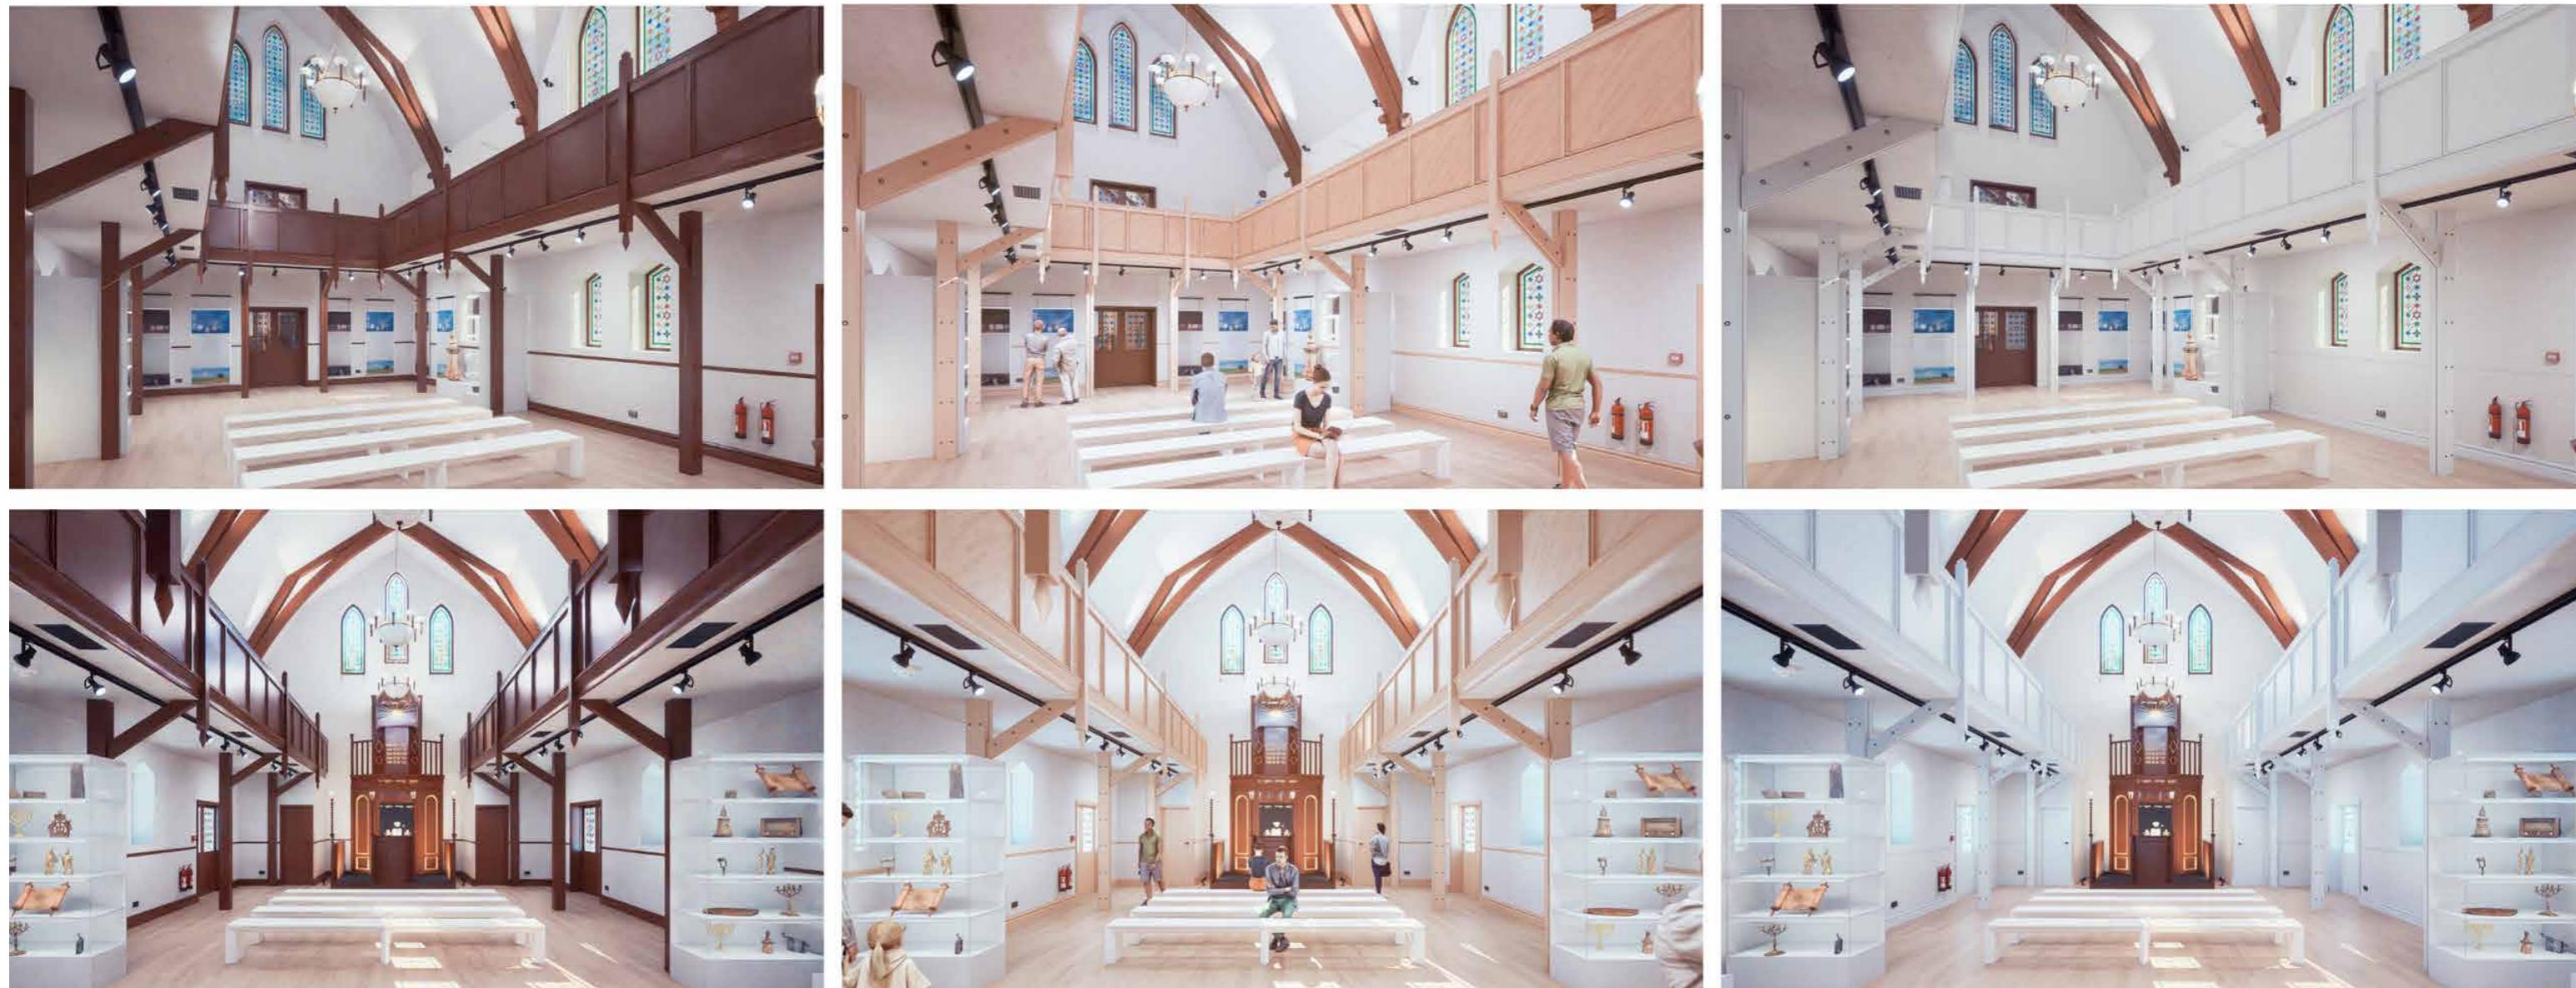
6.3.1 CGIs showing how the space might look (prepared by 'Creative Core') with Main Space at First Floor to the Left and Upper Level Balcony to the Right (with photo of existing from similar view below)

Same visuals testing the different wood colours were produced - see below.

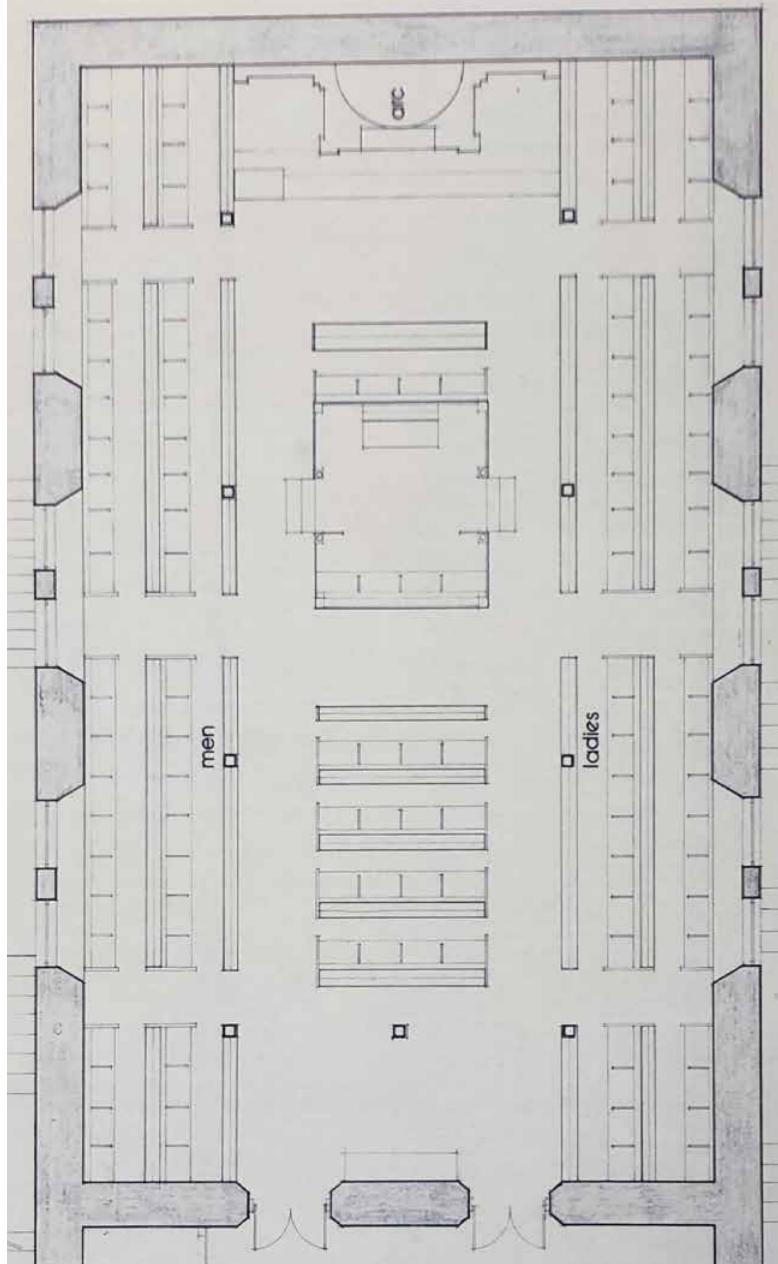
First Floor Plan in 1978 showing Prayer Hall

Below are the floor plans of the main Prayer Hall space in 1978 when still in use as a Synagogue, produced by (then) students of the Welsh School of Architecture (Chris Loyn, Duncan Lawrence and Paul Hutchison), kindly supplied to Mann Williams by Chris Loyn and reproduced herein with thanks to Messers Loyn, Lawrence and Hutchison. To the right are the proposed floor plans of the main Exhibition space.

To the main first floor, the columns from the balcony likewise match their location originally. It must be said that the columns are shown in the wrong place on the 1978 plan, as they were in board of the balcony edge, as the proposals locate them.

Along the short (west) side, however, there were originally 3no. columns, whereas the proposals show 4no. This is because, since 1978, the two doorways to the room have been filled in and a single, central doorway formed. To locate a column immediately opposite the single doorway would be wrong, and so 2no. columns are now proposed either side of the centre line.
