THE FORMER SYNAGOGUE

THE PROPOSALS

.....
(449)2503-GWP-A-HIS-P02

6.0 SECTION FOUR - EXPLANATION OF THE PROPOSALS

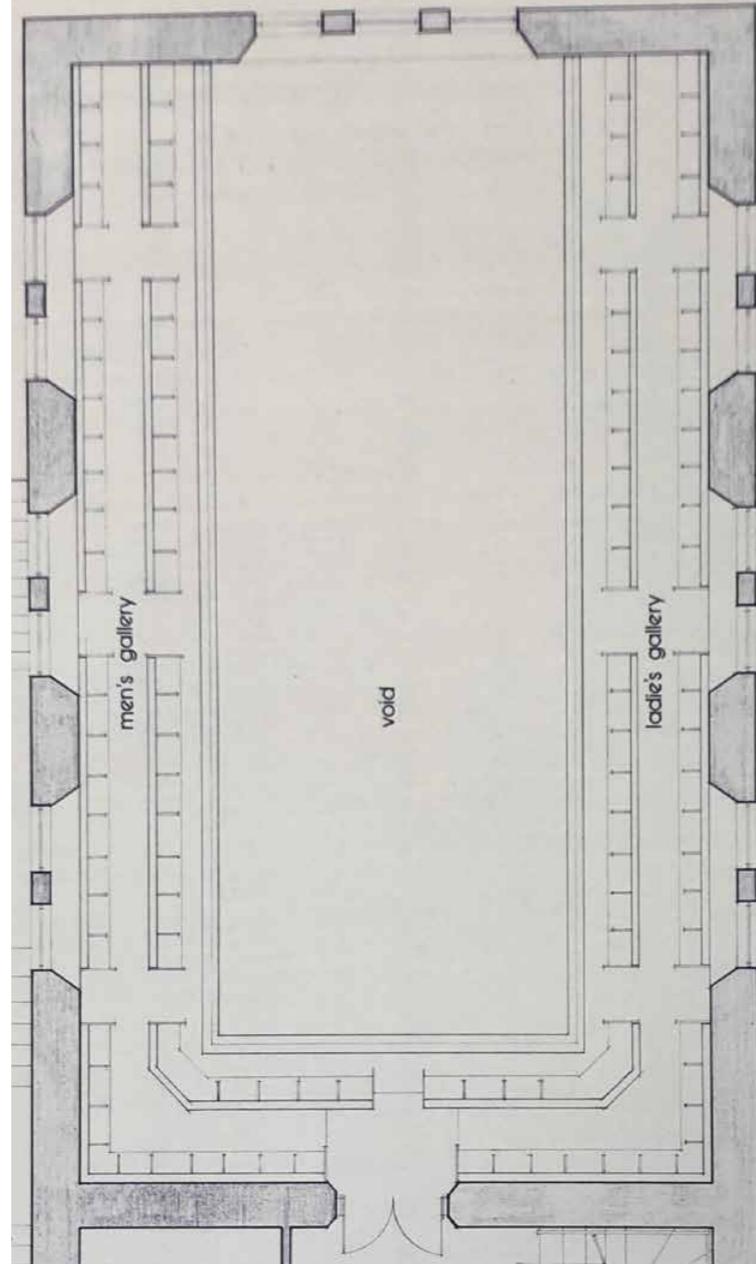
Second Floor Plan in 1978 showing Prayer Hall

The new 3-sided balcony to the second floor matches that of the original, albeit without the pews. The balcony would be at least 1100mm high, in order to meet Building Regulations. It is not known whether the original balcony was that high or not (probably not), but it makes sense to ensure that the new one is safe and adheres to legislation.

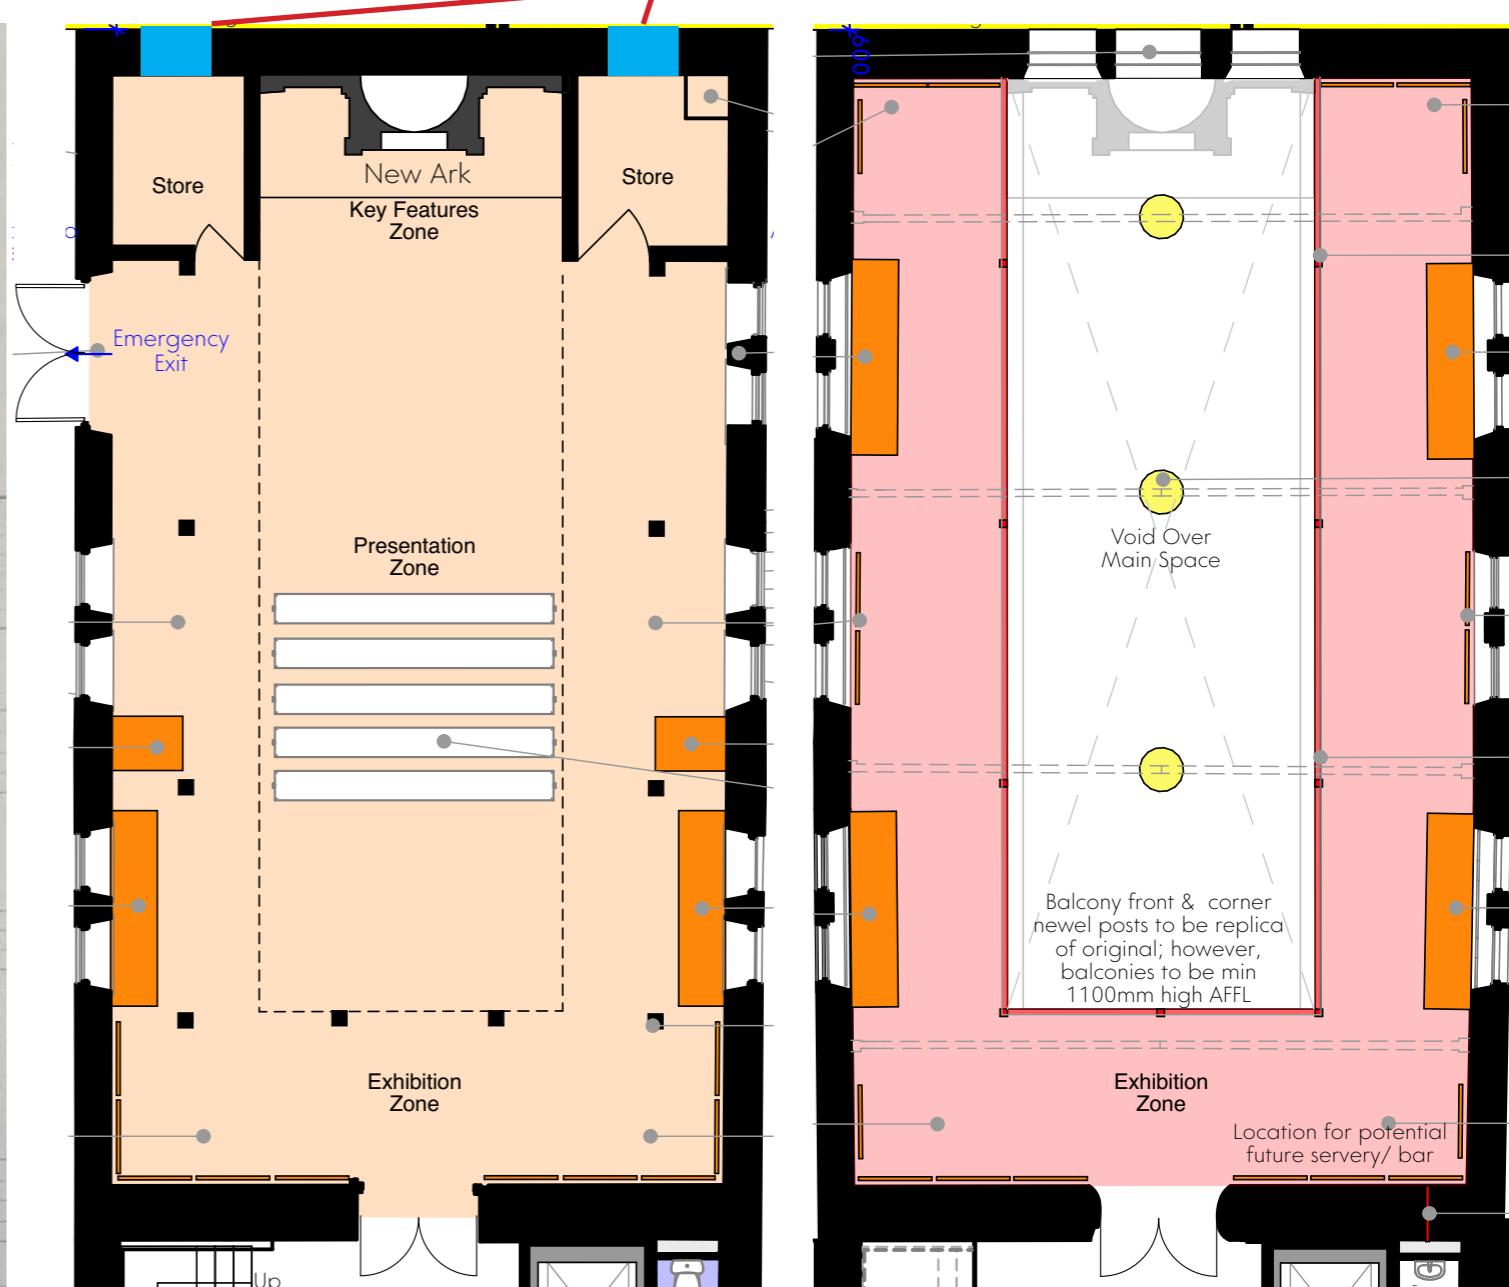
Proposed First Floor Plan showing Main Hall

A matter is explained within the 'External Proposals' document relating to the means of forming two openings in the back wall of the Synagogue to gain access to the rear retaining wall and steps in order to undertake their safe stabilisation and retention. This involves the careful dismantling of two sections of masonry, each at approximately 1.2m wide x 2.2m high. Both openings would be infilled on completion, with the stones taken out numbered and reinstated; albeit with one smaller opening left for the ducts from the Air Source Heat Pump to pass. These two openings are identified on the plan below in blue.

To the main first floor, the columns from the balcony likewise match their location originally. It must be said that the columns are shown in the wrong place on the 1978 plan, as they were in board of the balcony edge, as the proposals locate them.

Along the short (west) side, however, there were originally 3no. columns, whereas the proposals show 4no. This is because, since 1978, the two doorways to the room have been filled in and a single, central doorway formed. To locate a column immediately opposite the single doorway would be wrong, and so 2no. columns are now proposed either side of the centre line.

As stated, the original Ark has been removed and is not available for reinstatement; and so the Ark from the now-closed Langside Synagogue in Glasgow would replace it, and would be located in exactly the same location. That Ark is currently in storage and images of that are shown on the next page. If installed with the full set of steps in front of it, the height of the Ark would extend above the window cills. As a result, the Ark would be reinstated with the platform in front of it much lower and only one set of steps included.

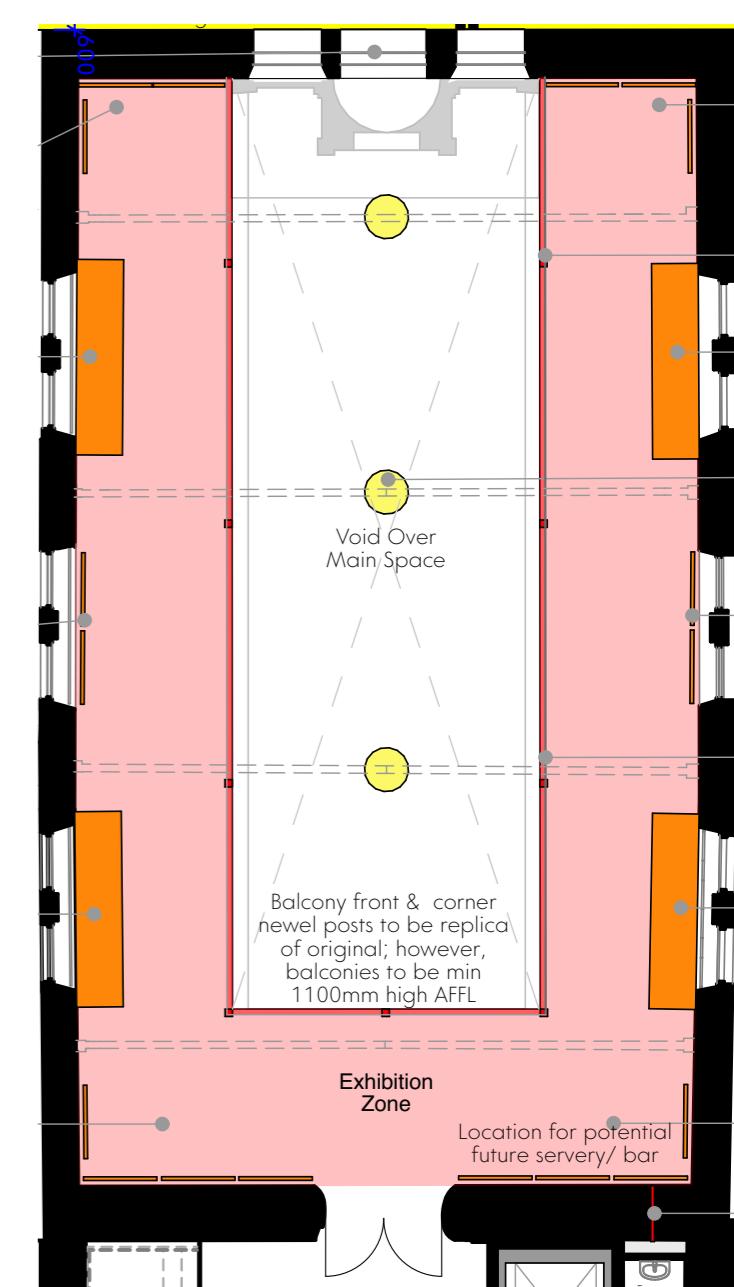
Proposed Second Floor Plan showing Main Hall

Also shown on the proposed second floor plan (as yellow circles) are the chandeliers proposed to replicate the originals as closely as possible.

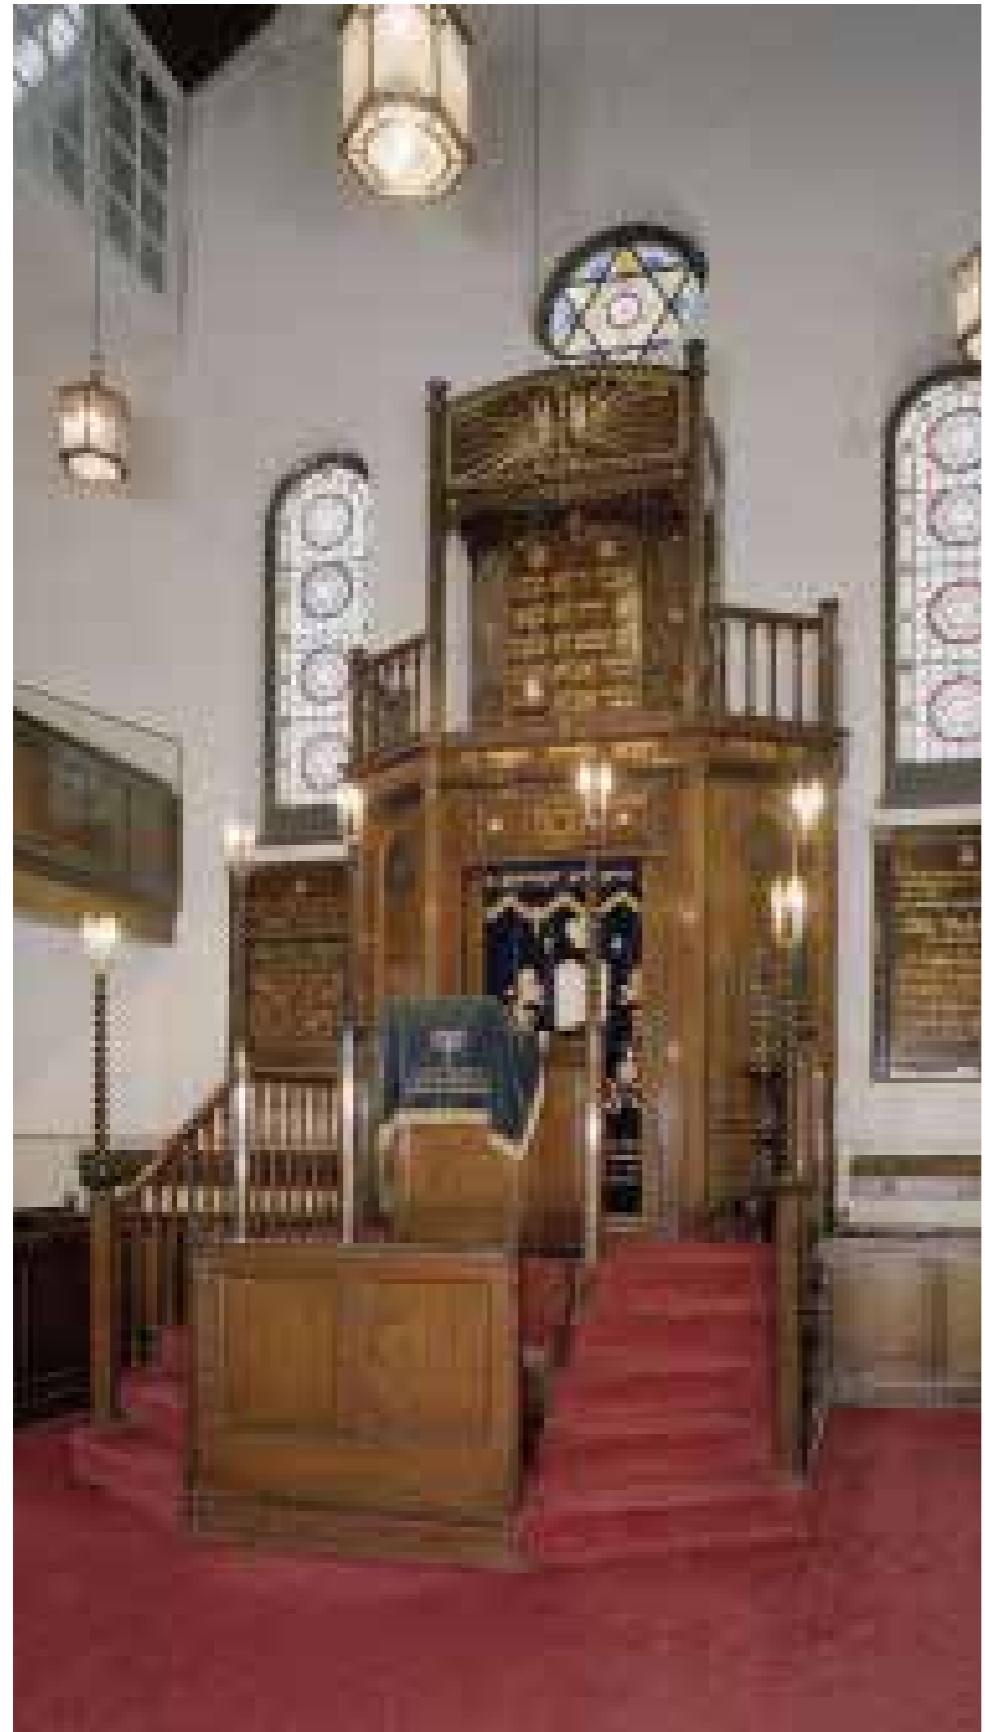
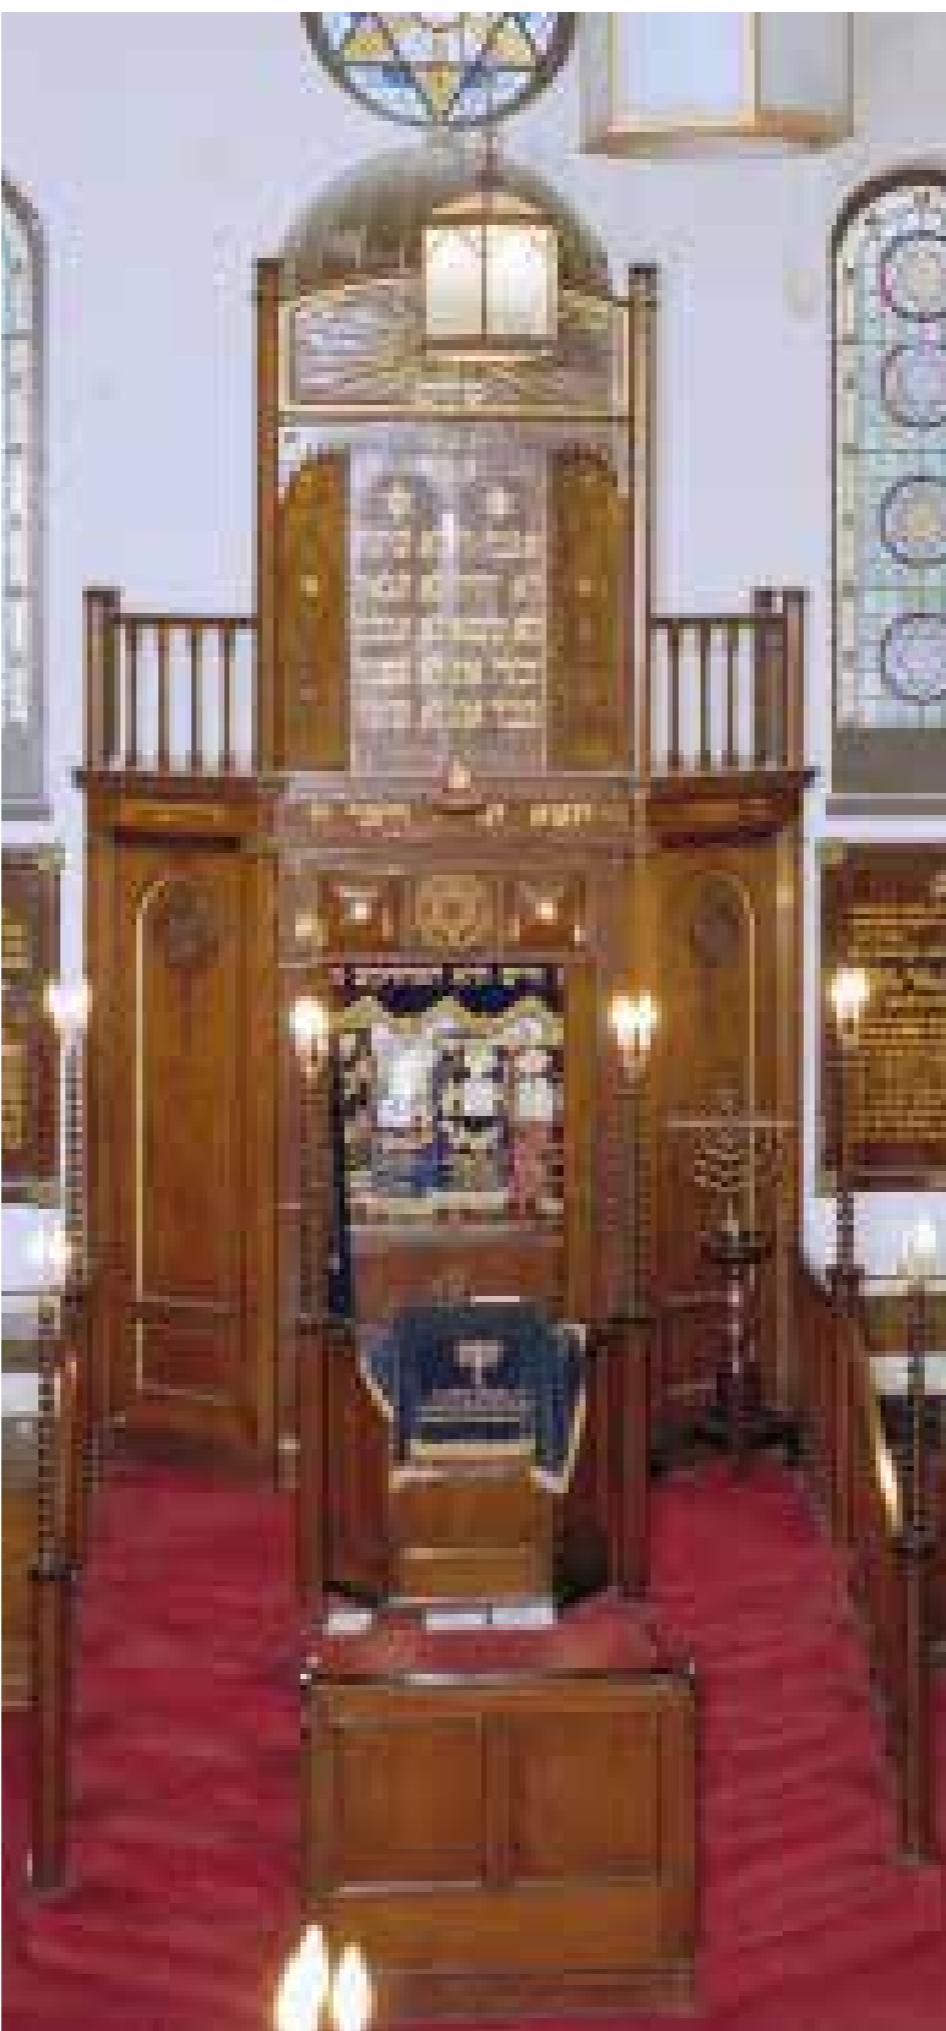
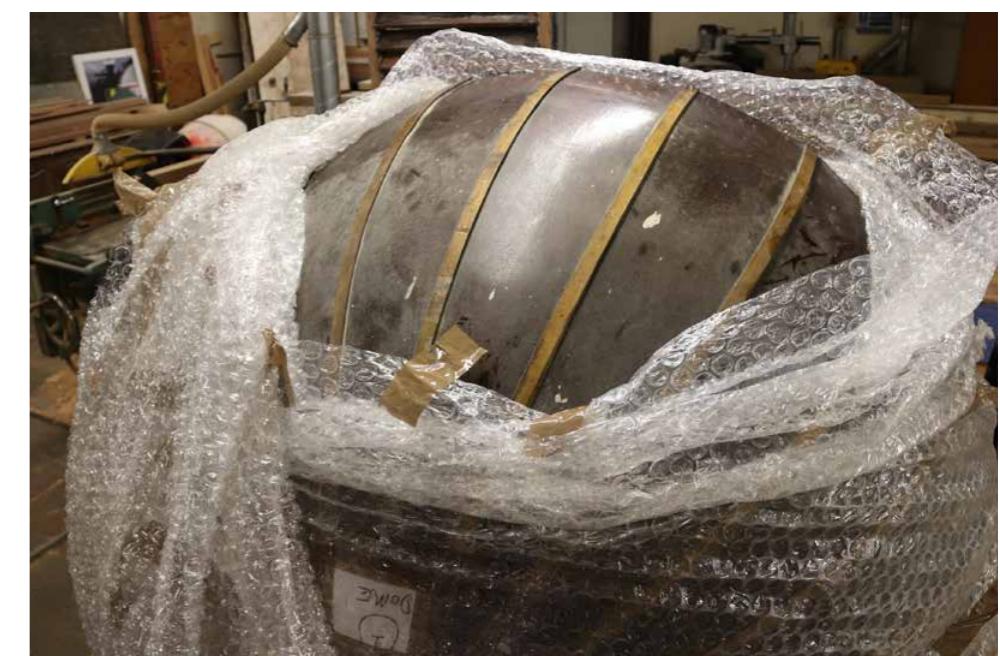
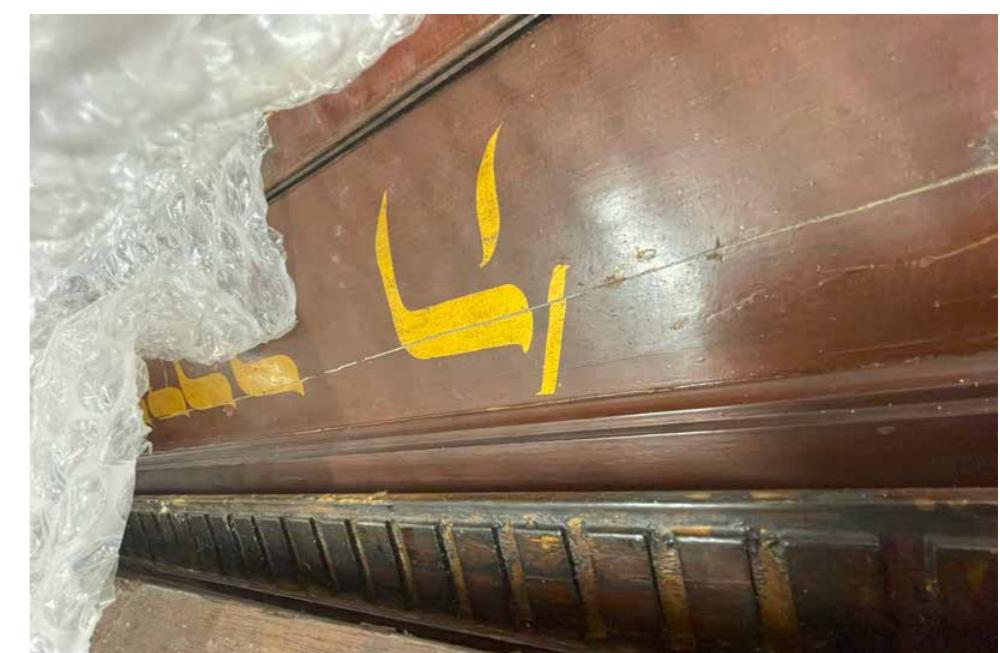
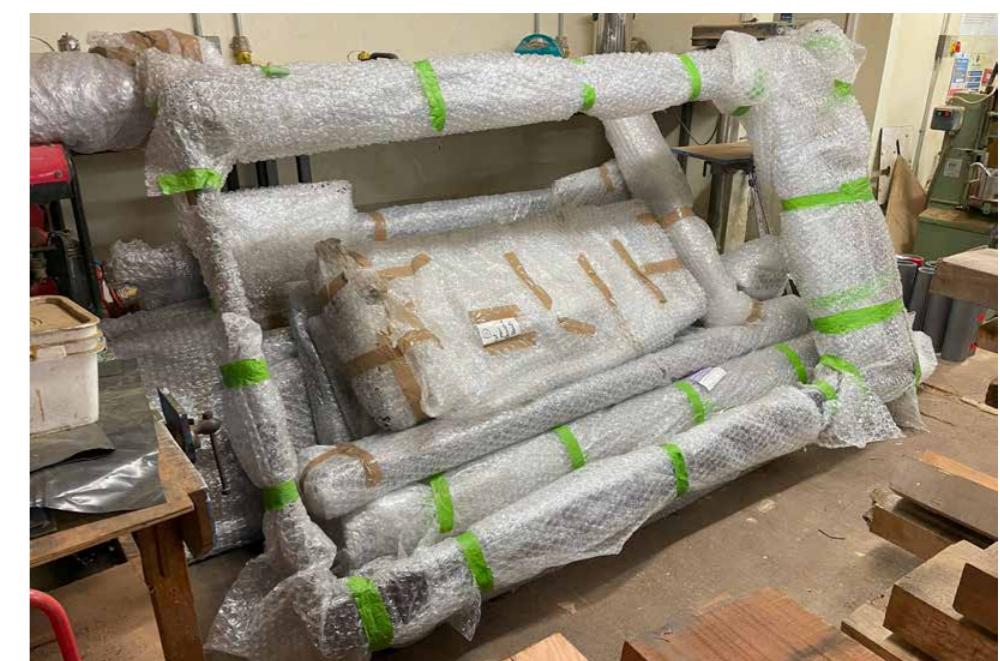
6.3.1 Photos of the Langside Ark proposed for installation

The images to the left and centre are of the now-closed Langside Ark still insitu in Glasgow, and reproduced courtesy of the 'Jewish Small Communities Network'; whilst the images to the right show the pieces of the Ark safely in storage, ready for installation.

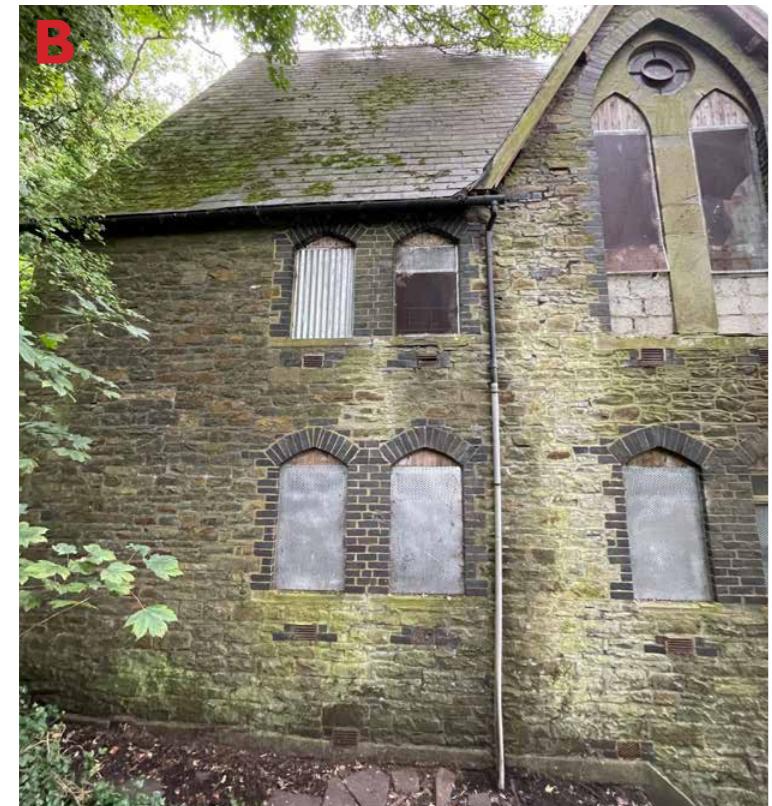
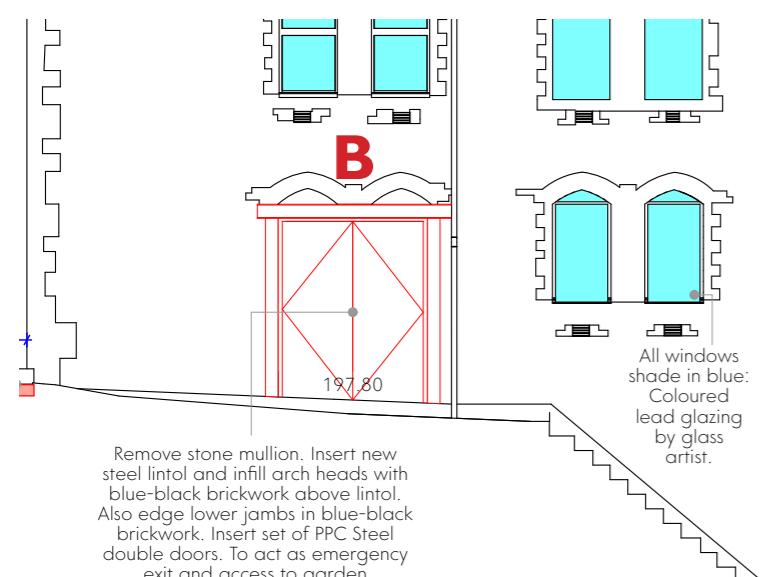
Extract of Proposed North Elevation

Since the building ceased to be used as a Synagogue, the two first floor windows at the east end of the south elevation (see 'A's on Plan, Elevation and Photos to the right) were removed and a larger opening formed which included a set of emergency escape double doors. To the north elevation, these windows still exist (see 'B's on Plan, Elevation and Photos to the left). However, with the garden to the north of the building, the opportunity to connect, at the same level, the main space in the building with the main space within the garden is a very significant opportunity which cannot be missed. Not to do so would result in a disconnect between the building and the garden, and no opportunity for people with restricted mobility to access the garden, as the steep steps would be the only option.

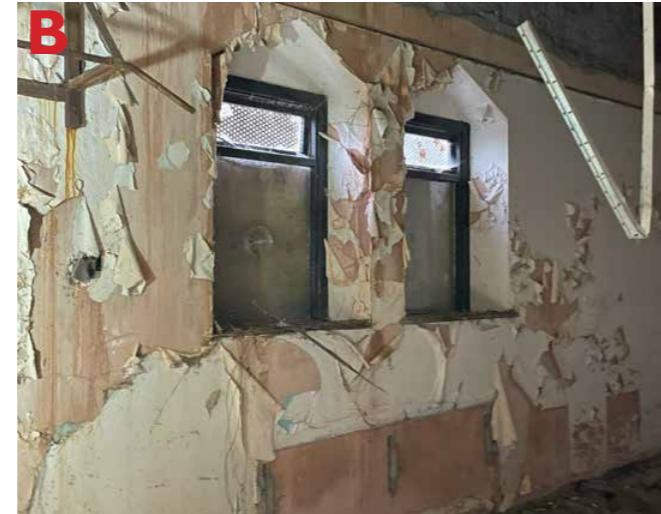
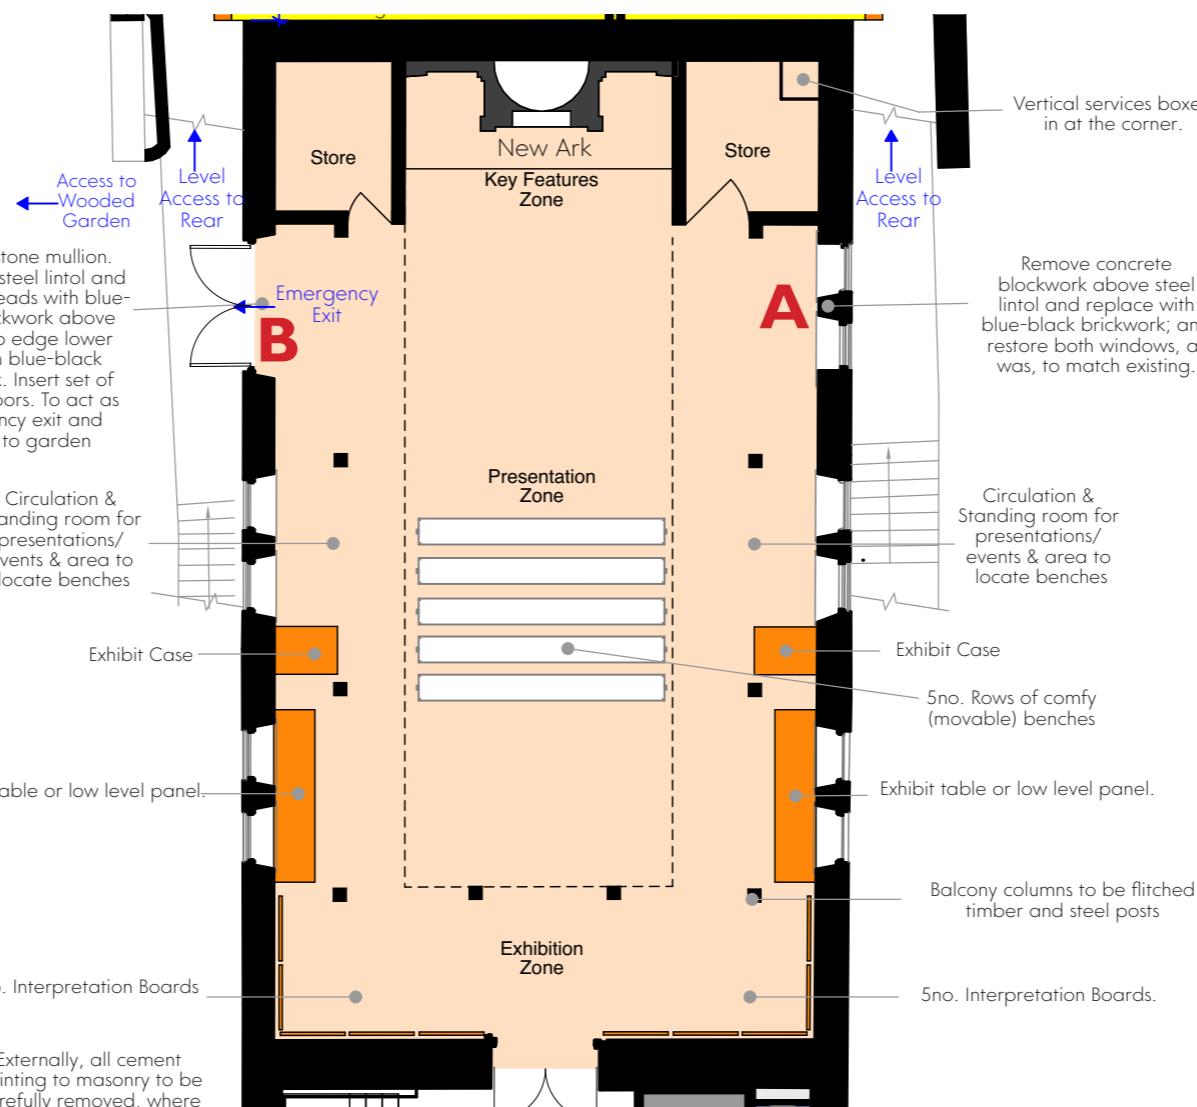
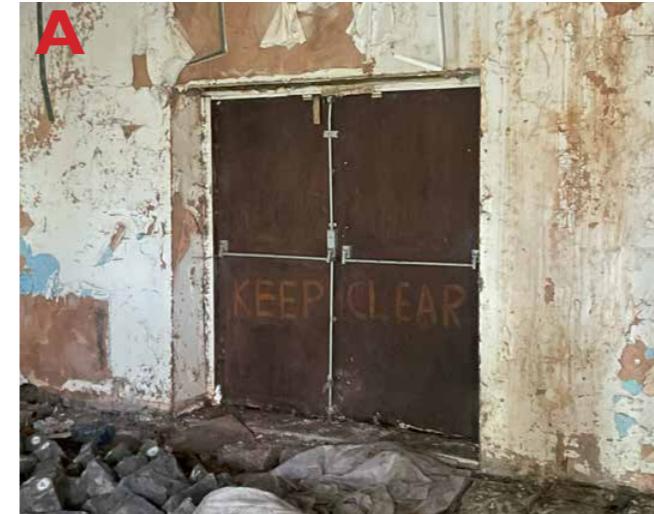
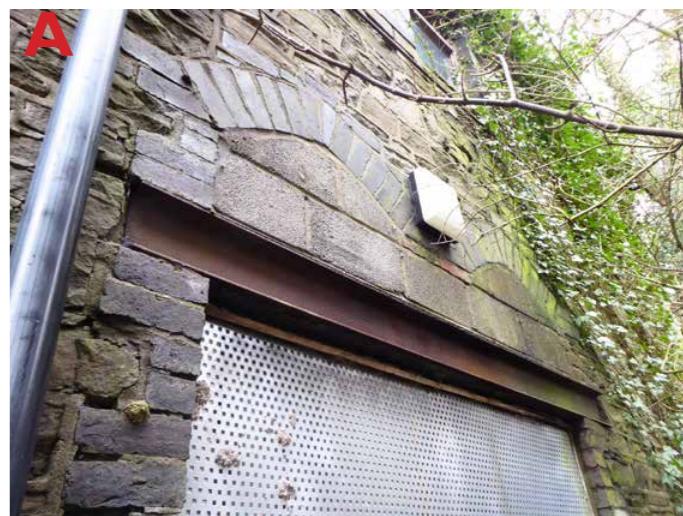
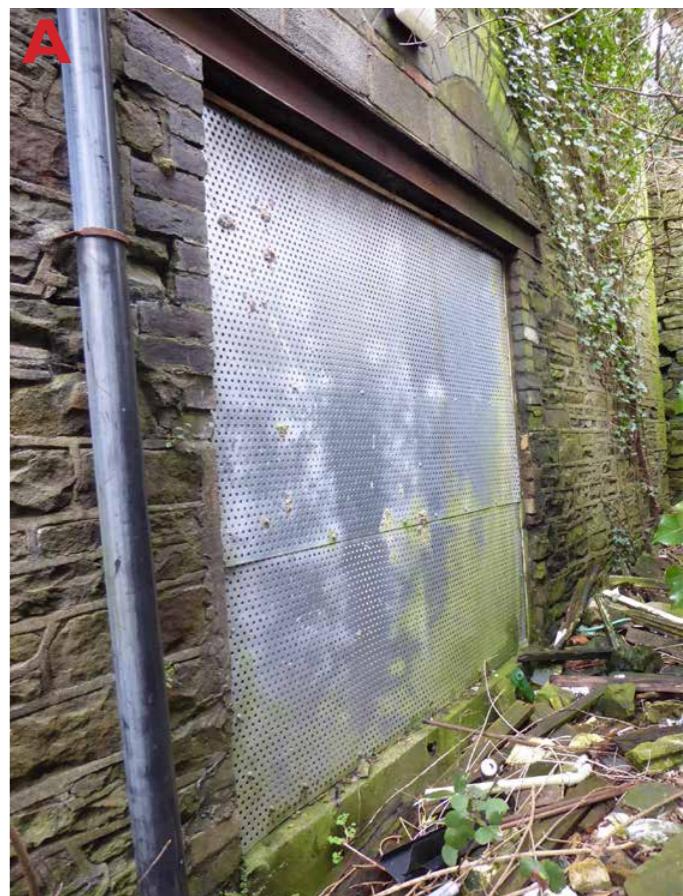
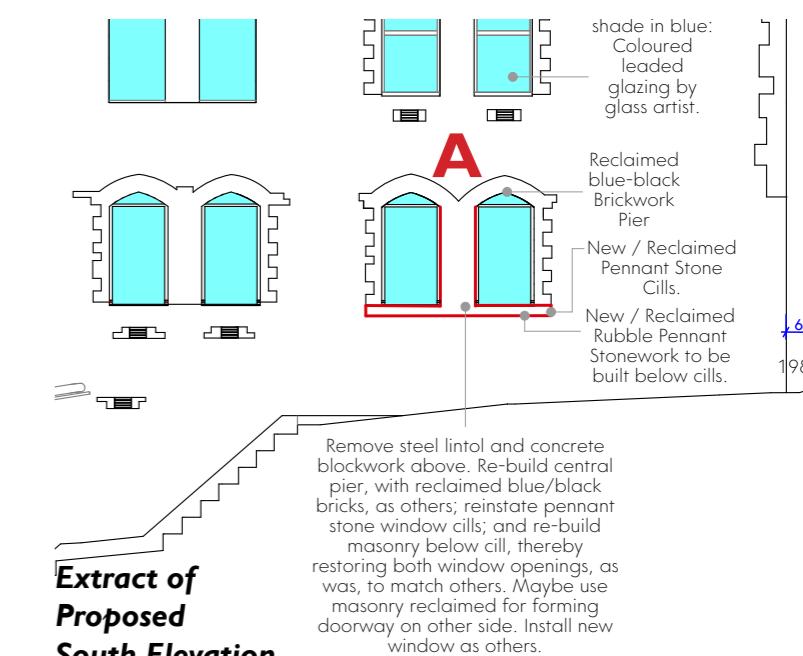
In addition, as was realised when the south elevation doors were incorporated, a secondary emergency exit is required; and this location would be ideal for that, providing escape to the garden, and access for all off the site. The current door to the south elevation would provide only access to the steep steps, with no level access. As a result the proposals seek to open up these two windows to form a larger opening for a set of double doors.

Because the existing south doors would be of no use (i.e. no access to the garden and no level or suitable escape); and because low level wall space inside the building is at a premium; the proposals bring back the two windows, as original. As a result, the impact is no change, just moving the doors to the other side.

The formation of the larger opening would be done more neatly than the previous version (see descriptions below); whilst the windows would be accurately reinstated.

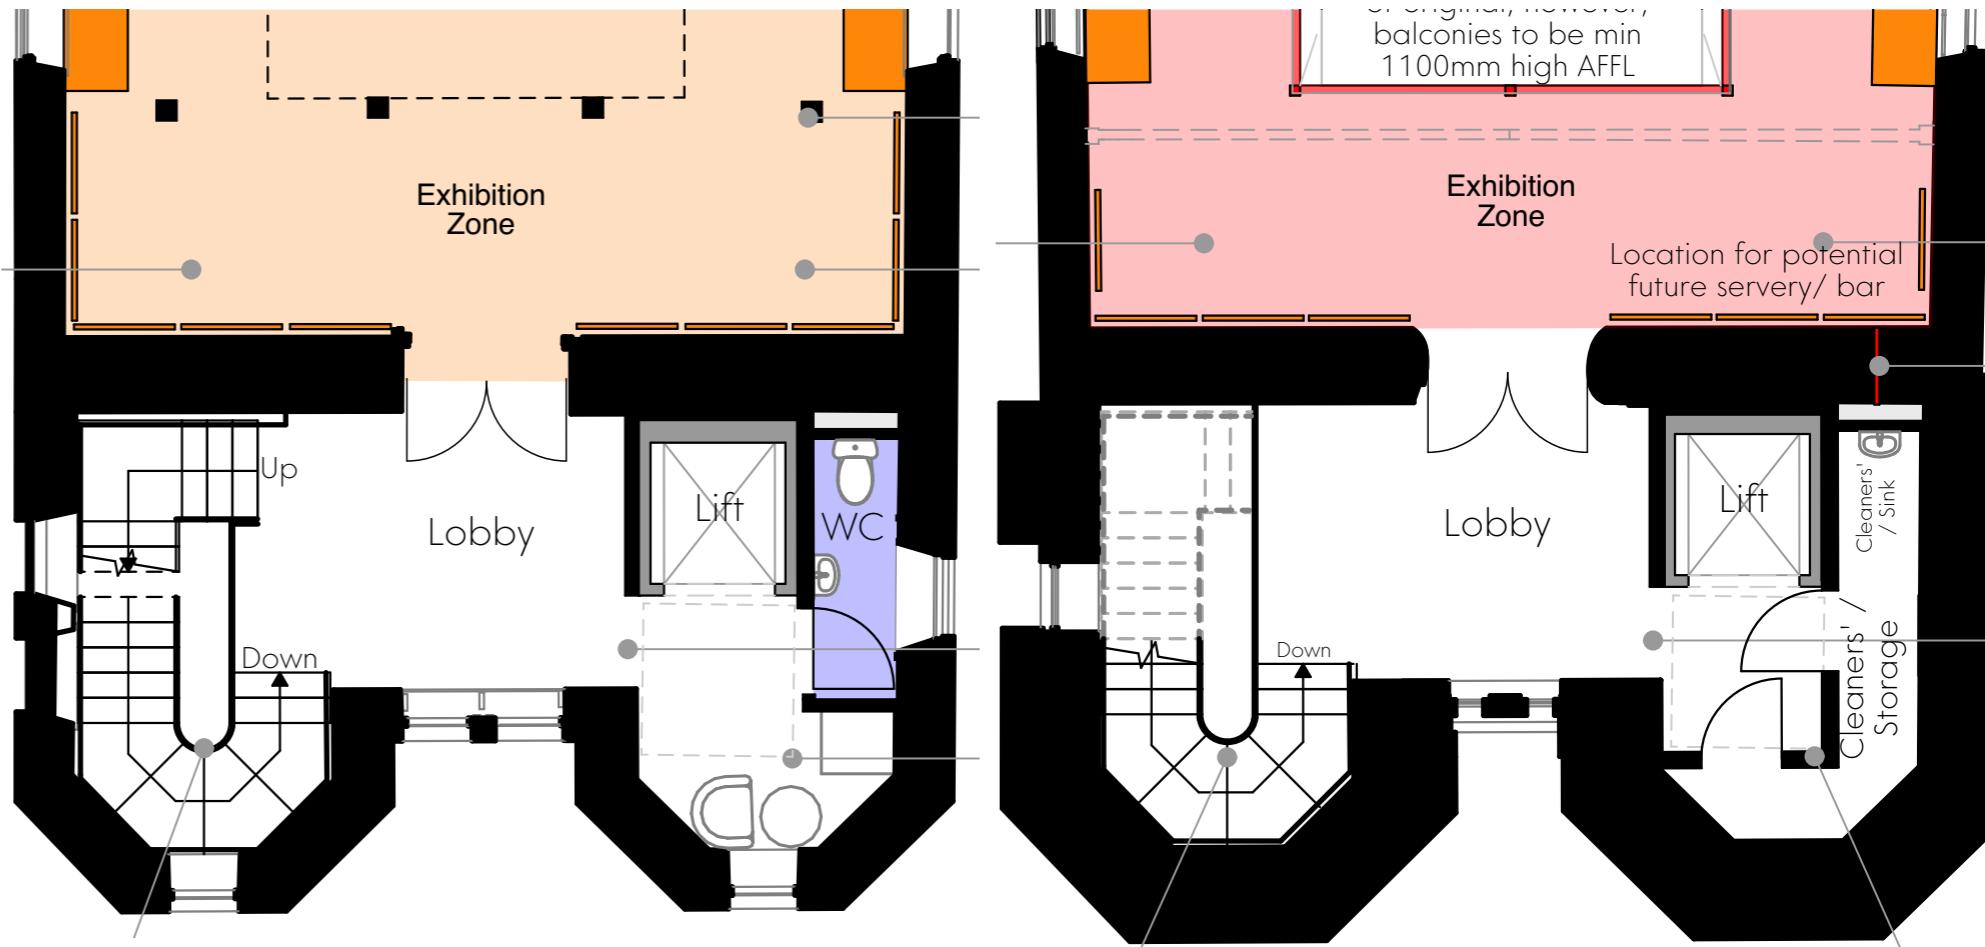
Proposed First Floor Plan of Front Range

The front range of the building is the only part of four storeys. It has always provided entrance, reception, circulation and toilets. The proposals seek to re-use it for the same purposes. However, one significant change is required; that of installing a passenger lift shaft and lift. The building has no such provision and, at 4-storeys, a lift is essential. Being the only part of the building spanning these 4-storeys, the lift must be in this range.

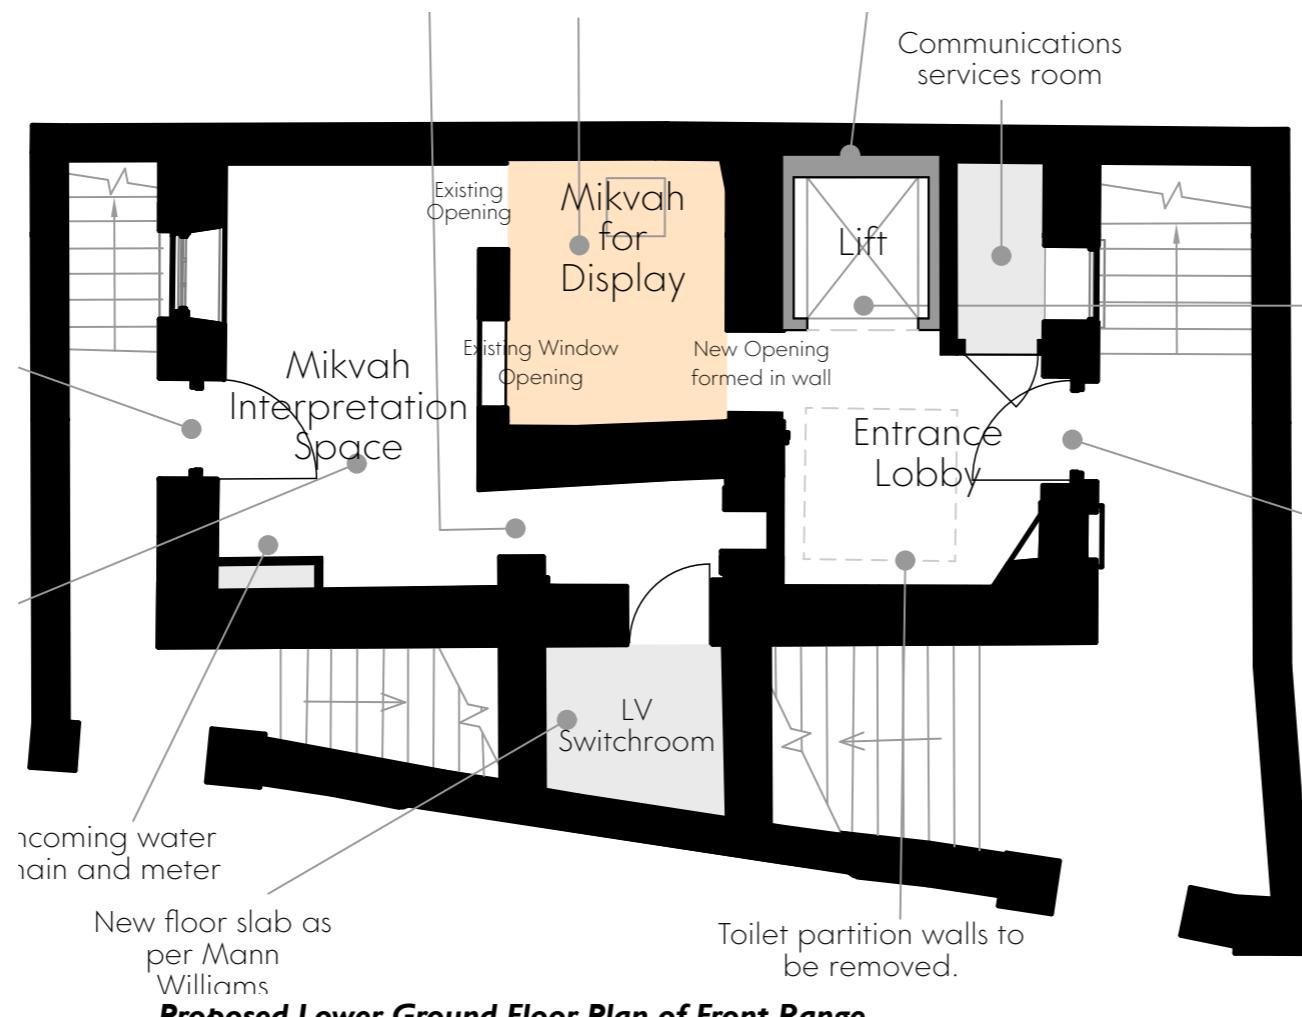
Proposed Lower Ground Floor Plan of Front Range

The lower ground floor would also accommodate the incoming services (as it does currently), an LV switchroom and the communications room.

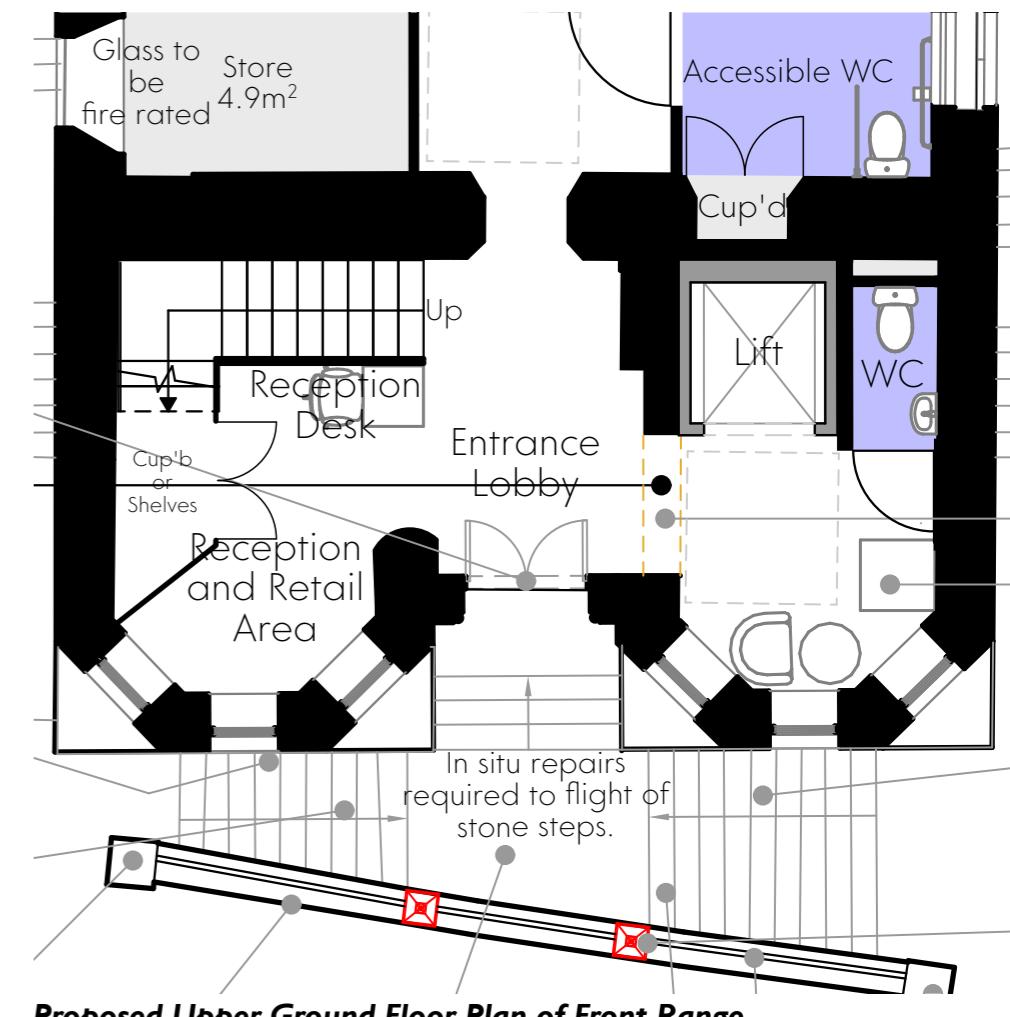
Proposed Upper Ground Floor Plan of Front Range

As a result, there is space on the ground floor, below the rising staircase, for a Reception and Retail Area with storage behind.
