THE FORMER SYNAGOGUE

THE PROPOSALS

.....
(449)2503-GWP-A-HIS-P02

6.0 SECTION FOUR - EXPLANATION OF THE PROPOSALS

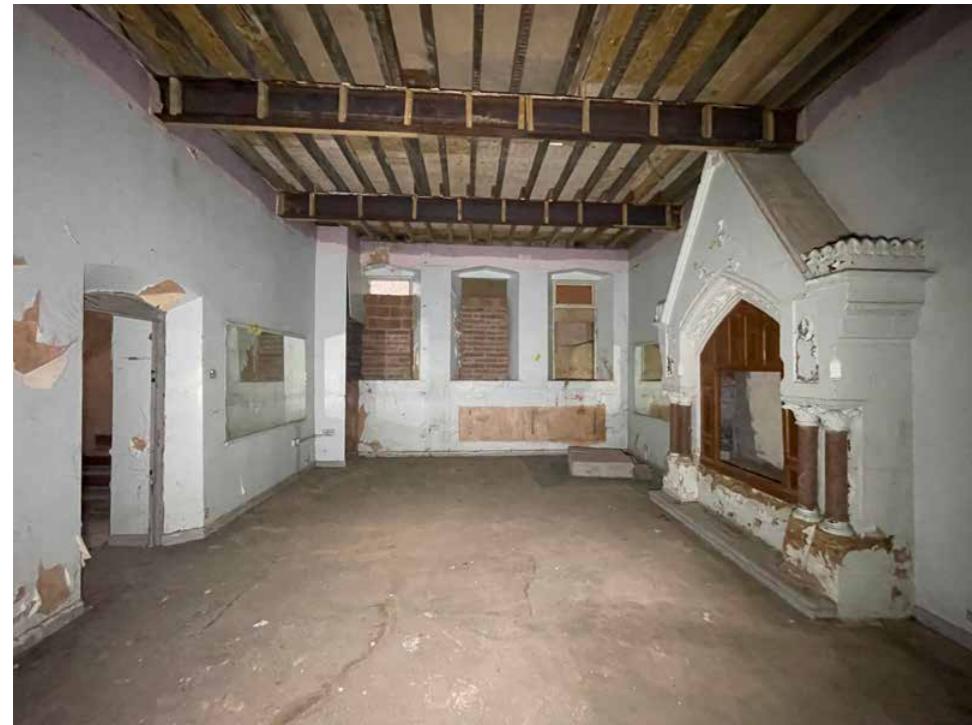
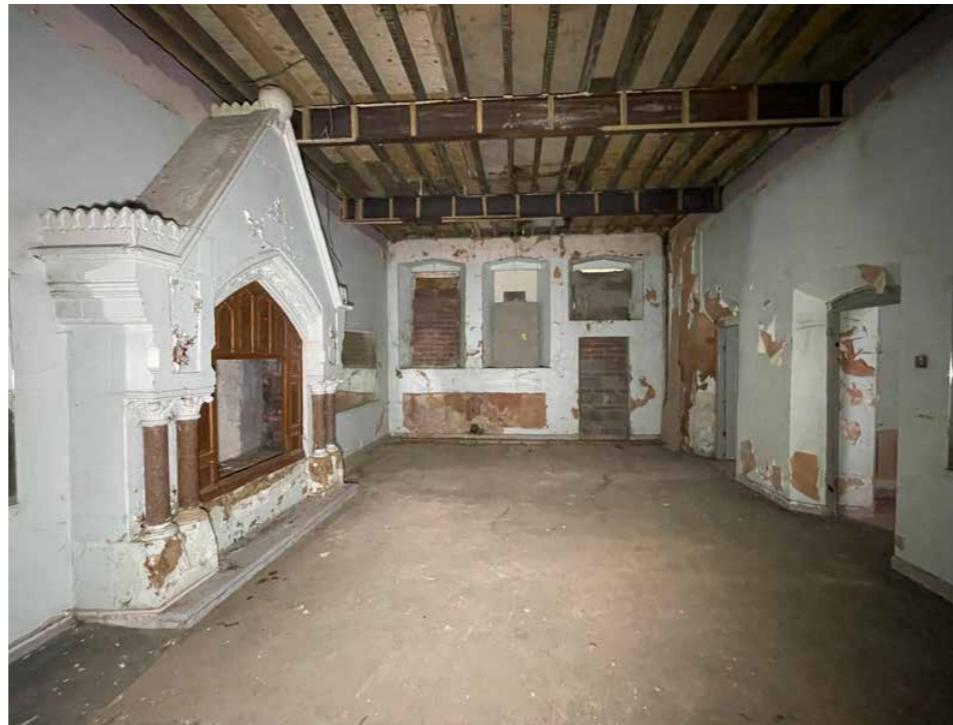
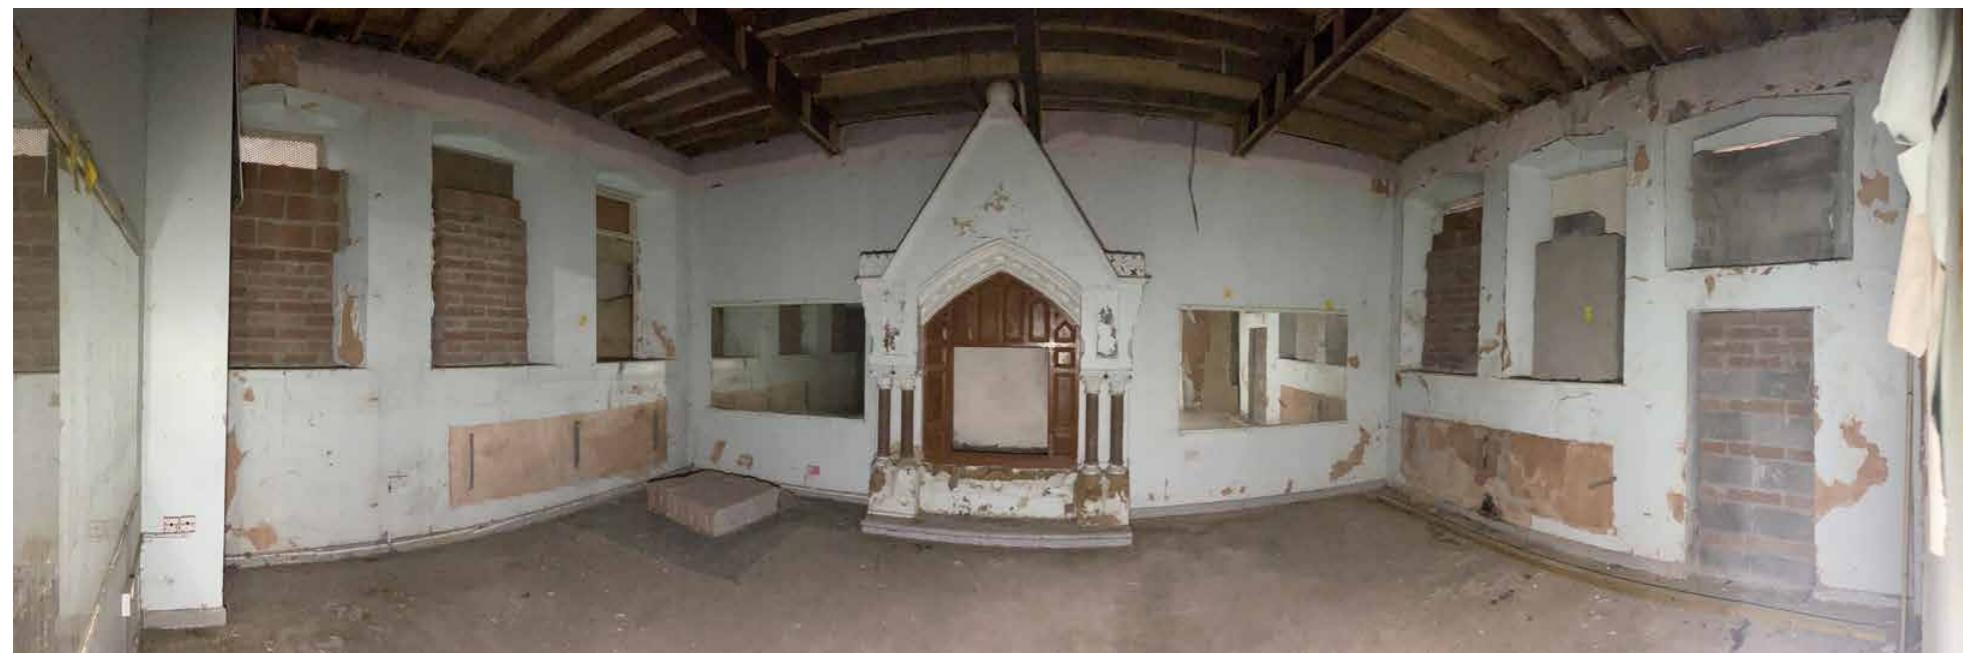
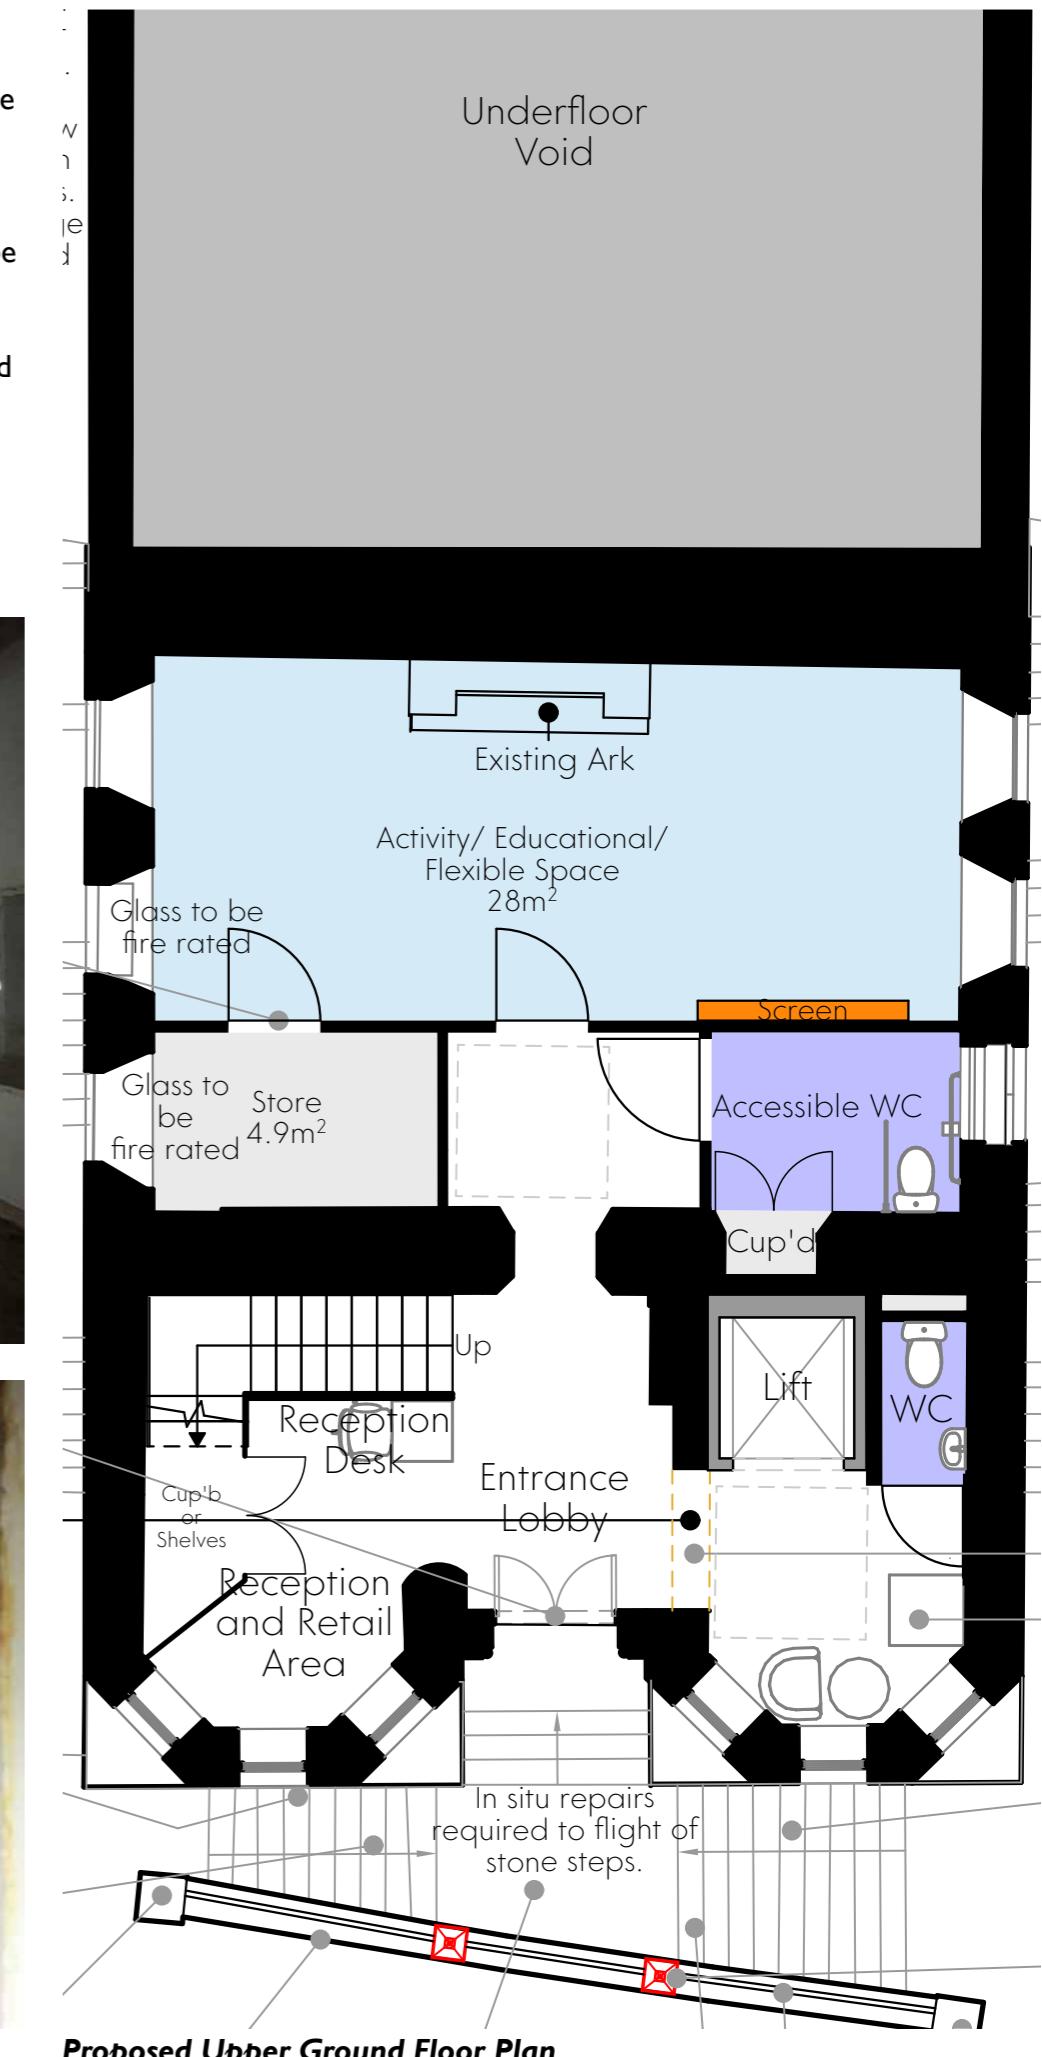
To the front range, with the staircase and lift both essentials, as well as the circulation space in front of the lift, it is not possible to fit an accessible WC. However, it is essential that there be at least one accessible WC within the building. As a result, the accessible WC has been located within the first of the three bays of the original School Room. It would be serviced from the water and drainage runs in the front range.

The result of this is to reduce the main room from three to two bays, and insert a store room on the opposite side of the WC.

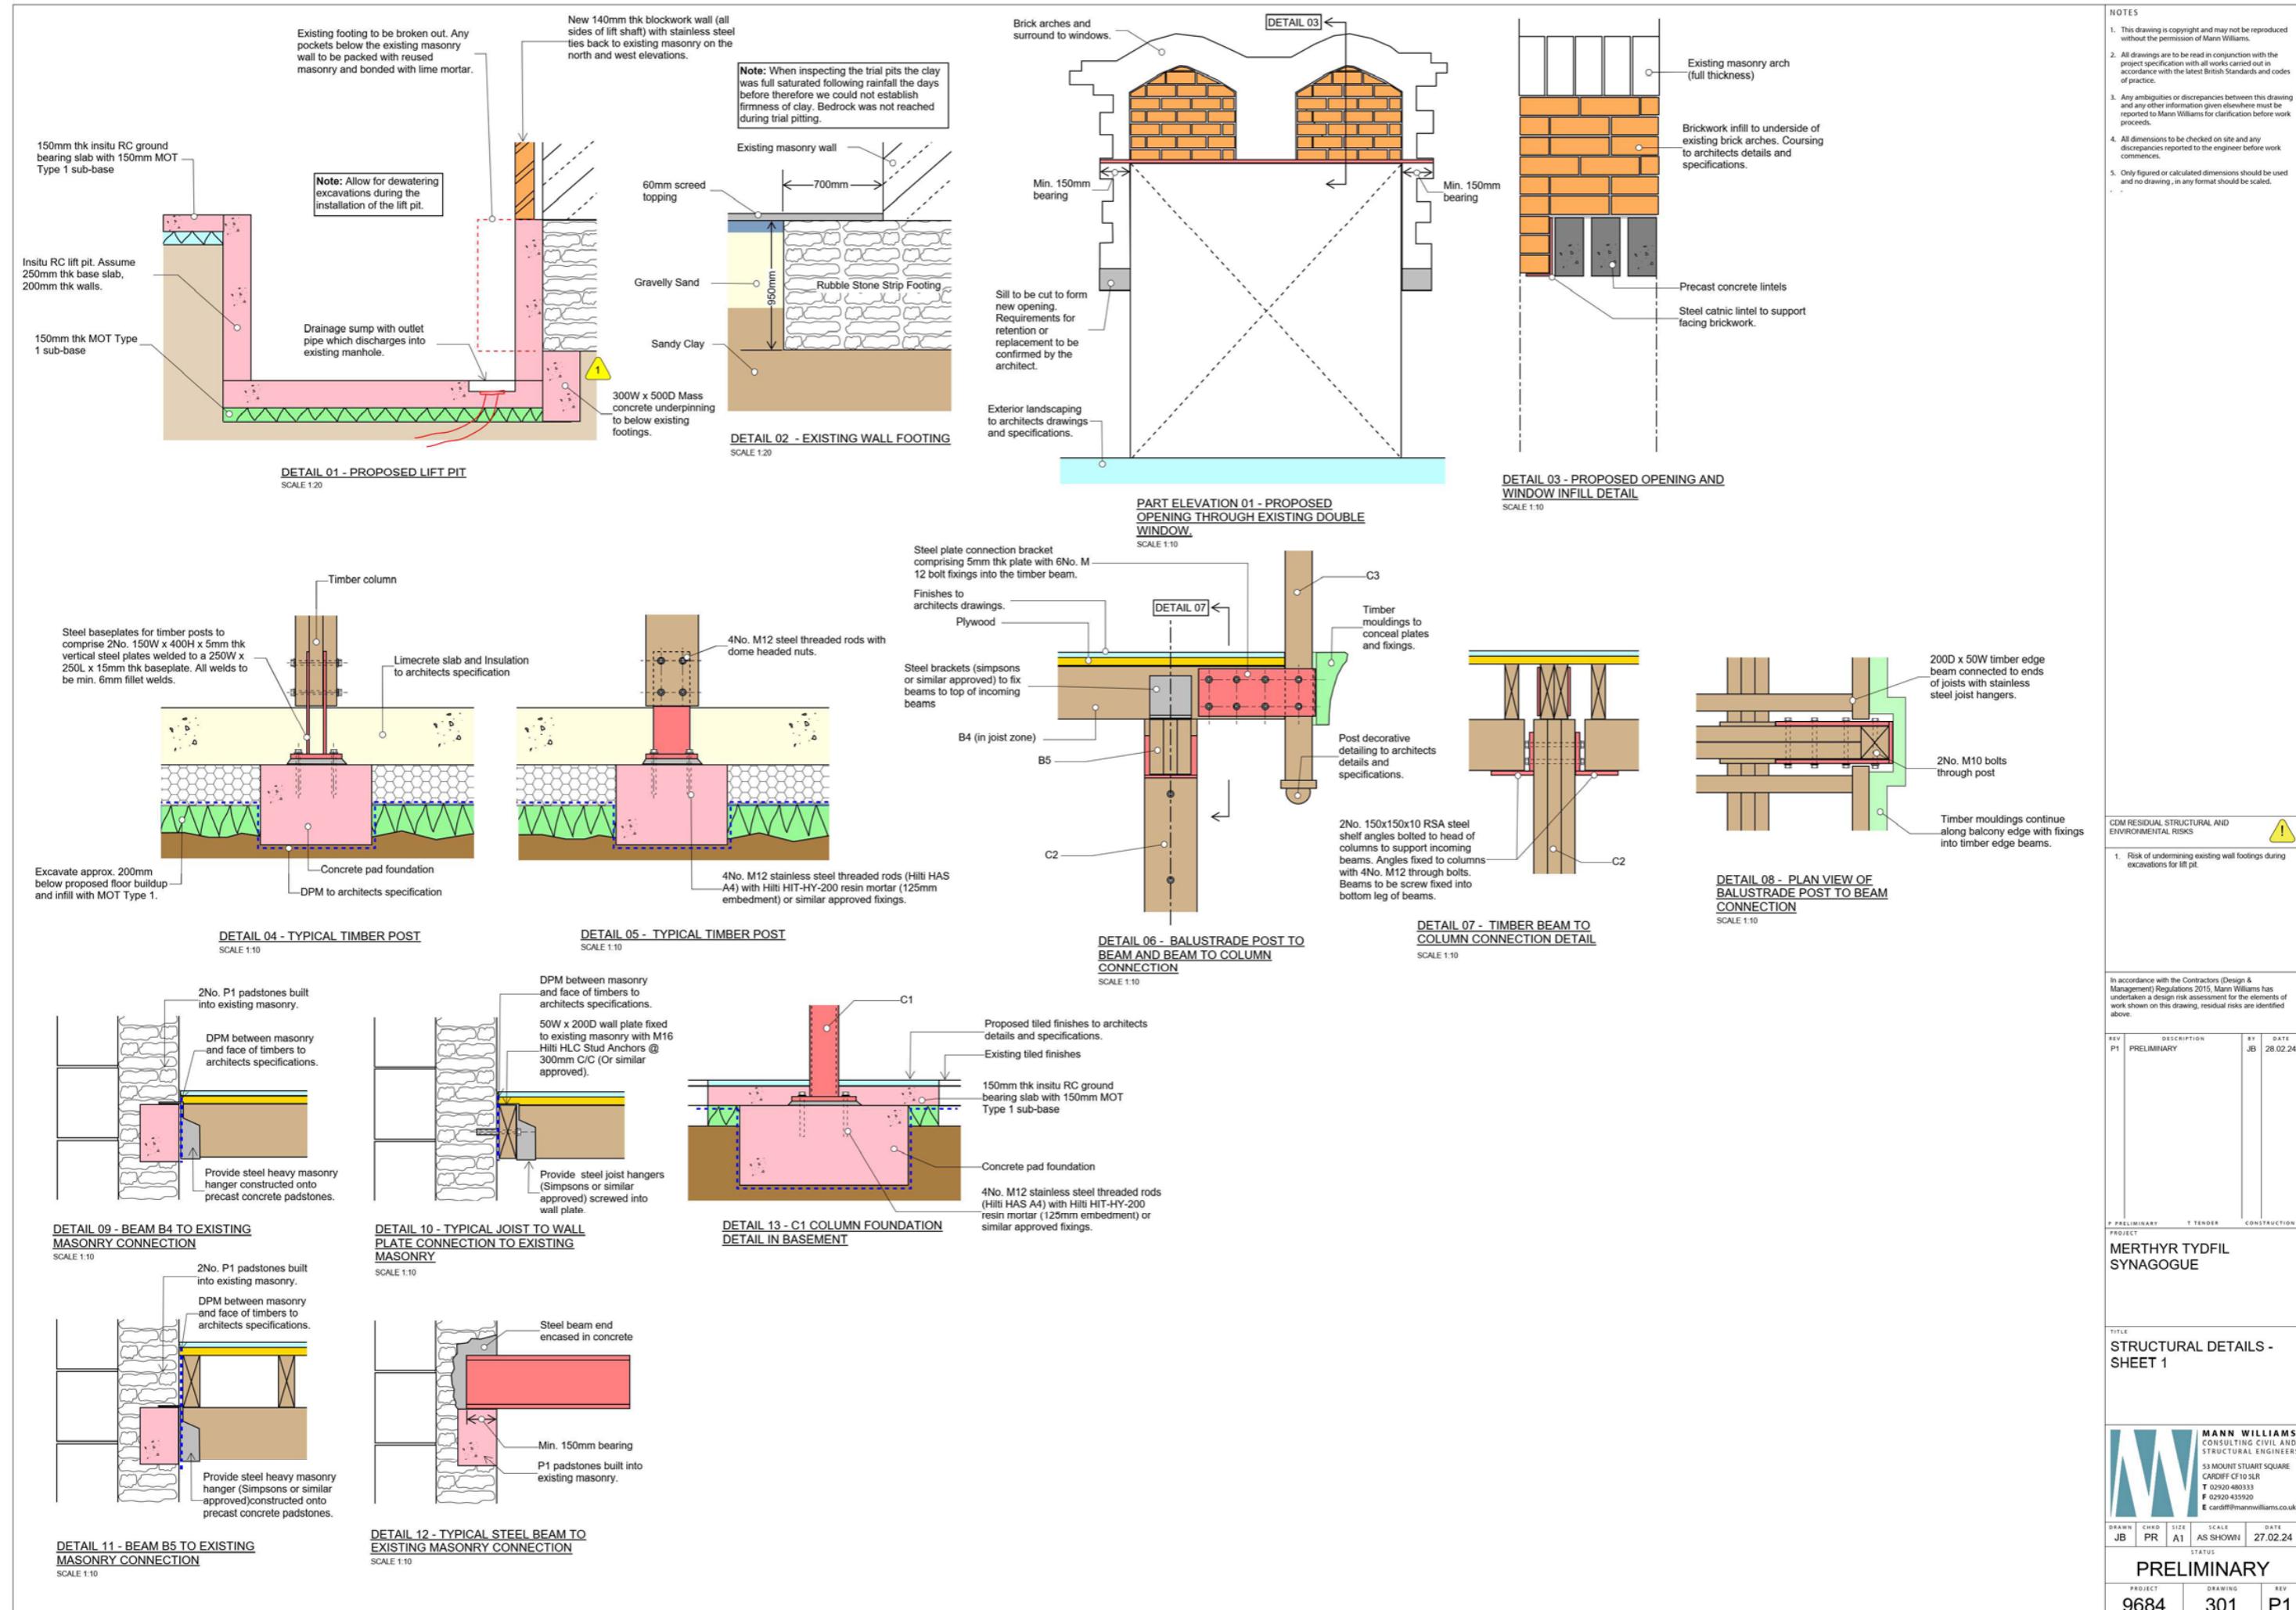
6.3.3 Structural Engineering Details - On this page are the Structural Engineers Proposed Details relating to the Lift Pit, the formation of the First Floor External Door, the Balcony Structure and Intermediate Floor Supports

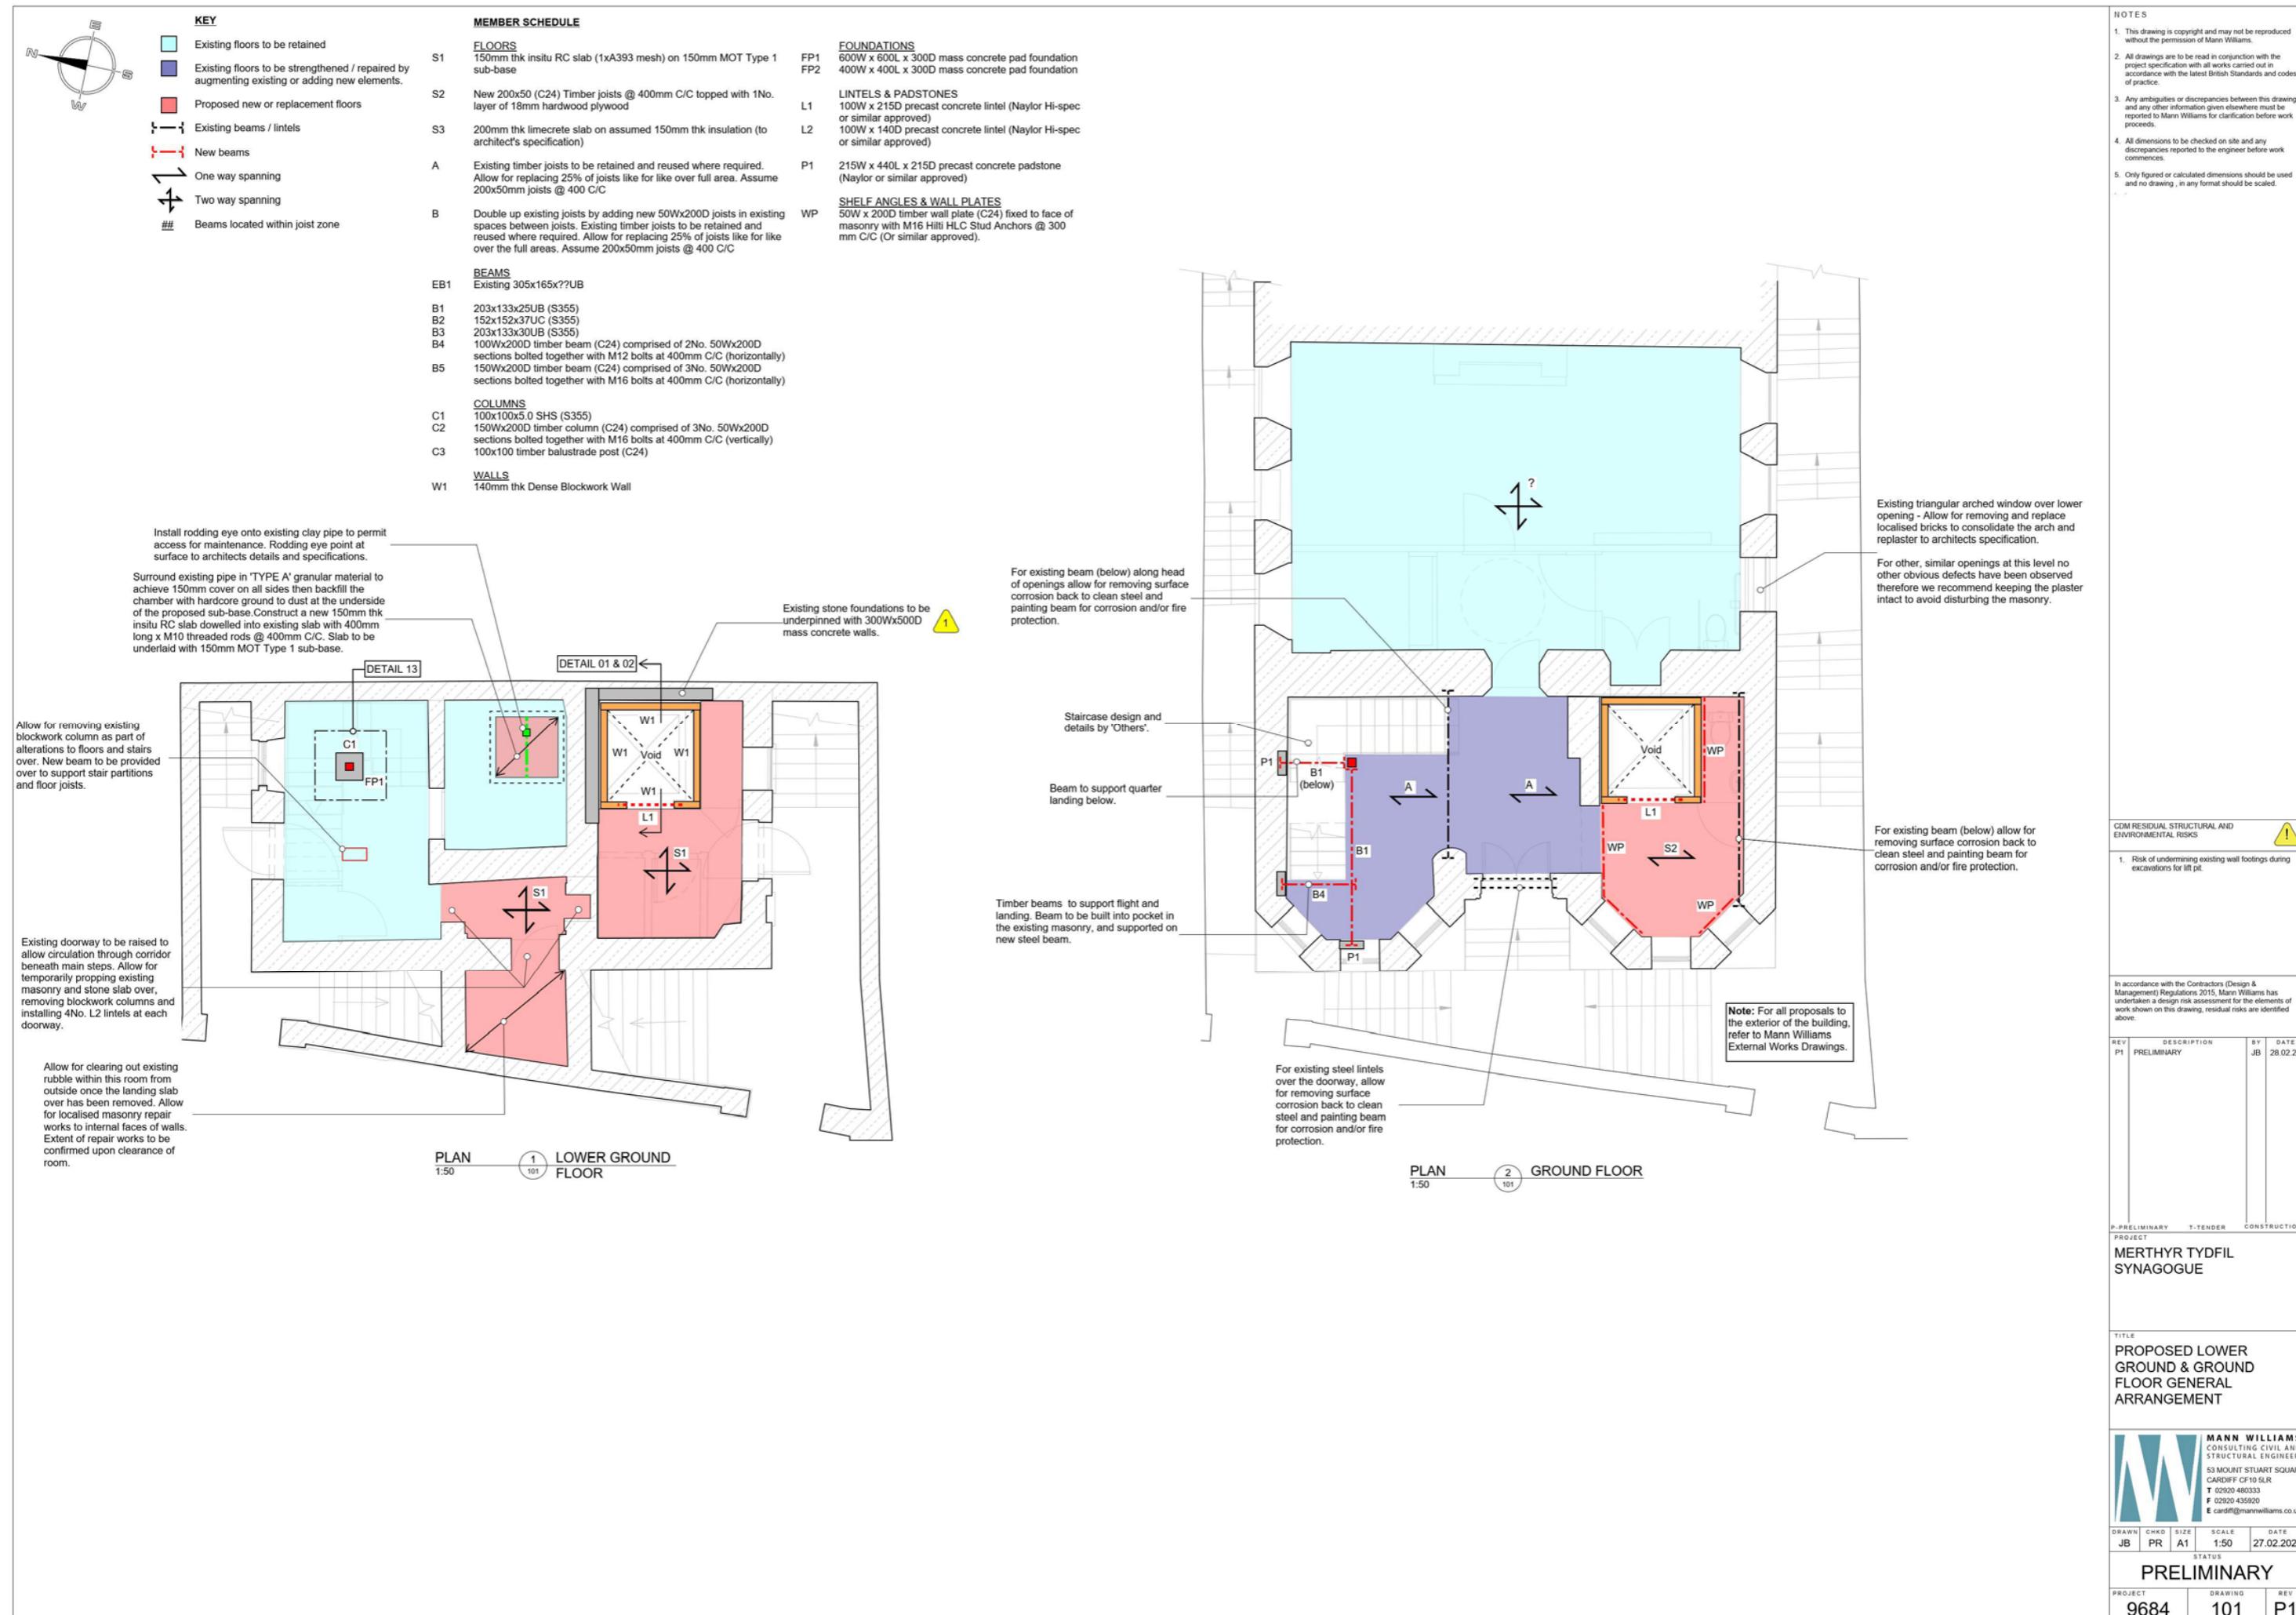
6.3.3 Structural Engineering Details - On this page are the Structural Engineers Proposed Details relating to the Floors, Staircase Supports, Lift Shaft and Other Supports to the Lower and Upper Ground Floors

The proposals remove the second floor plywood and OSB board intermediate floor altogether, along with the steel beams, and replace it with the new balcony structure. However, given the poor condition of much of the first and upper ground floor intermediate floors, significant repair and replacement is proposed for these. For this, please refer to Mann Williams' drawings later in this report.

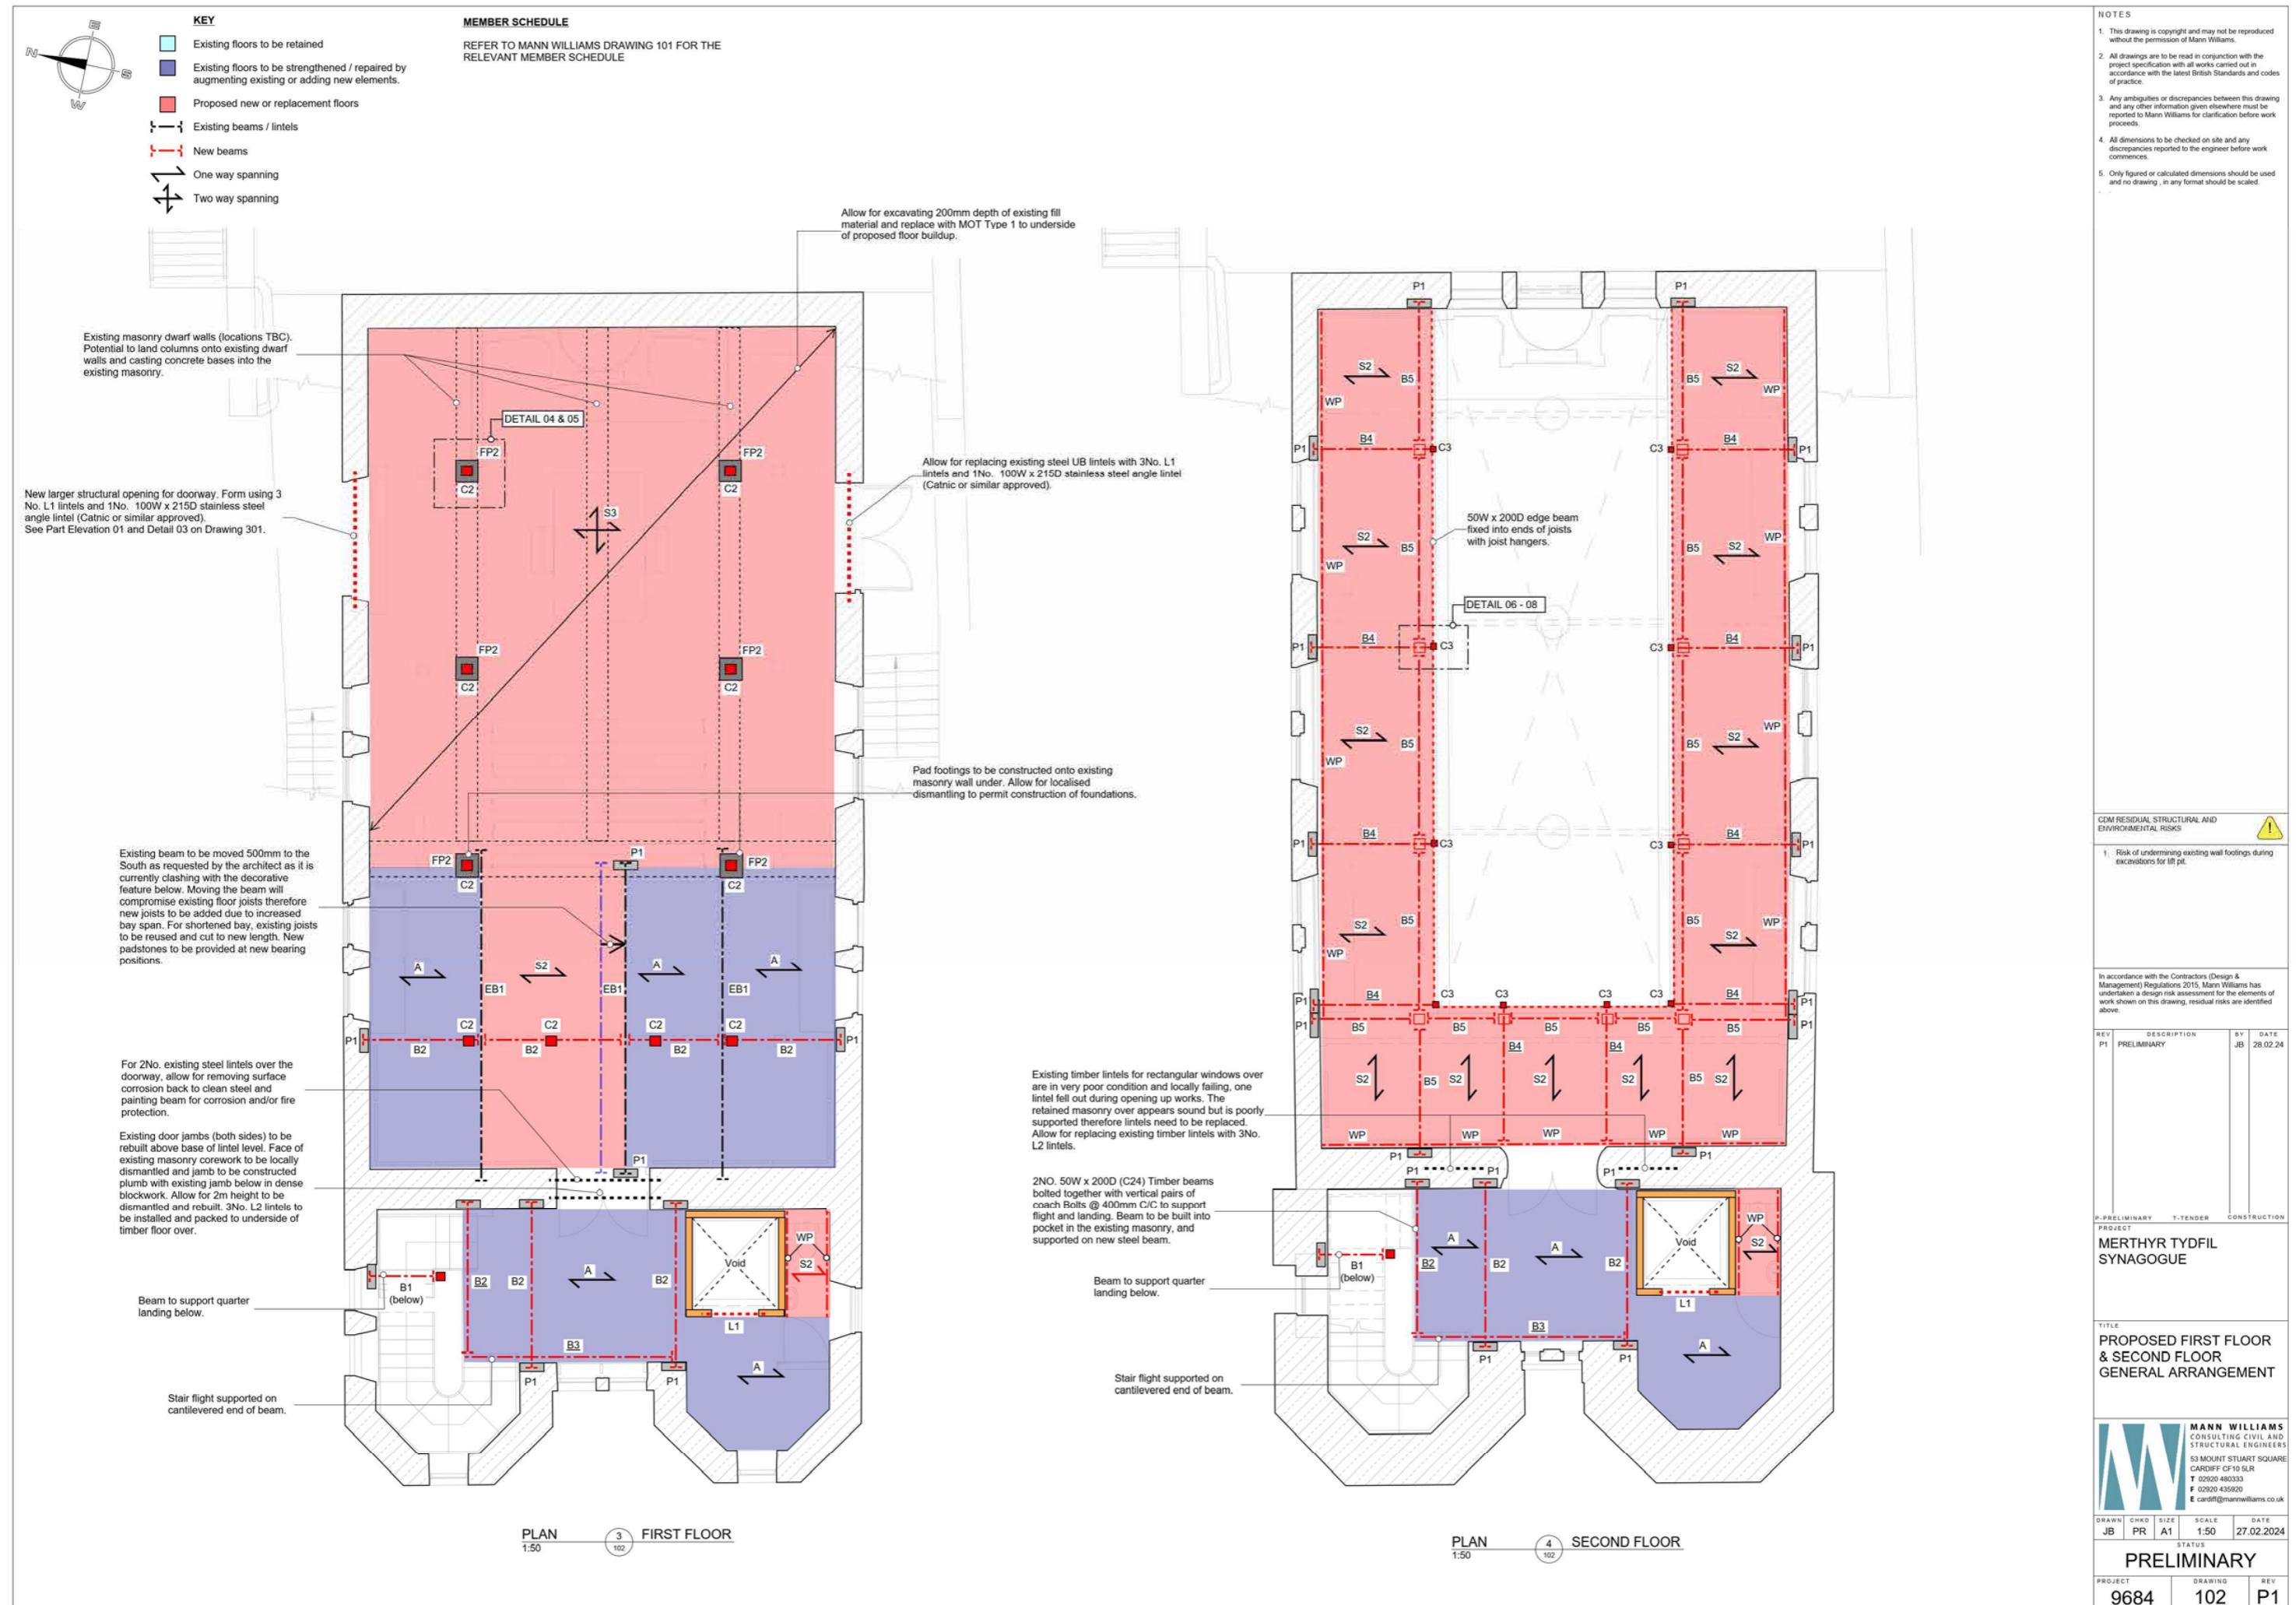
6.3.3 Structural Engineering Details - On this page are the Structural Engineers Proposed Details relating to the Floors, Staircase Supports, Lift Shaft, Balcony Construction and Other Supports to the First and Second Floors

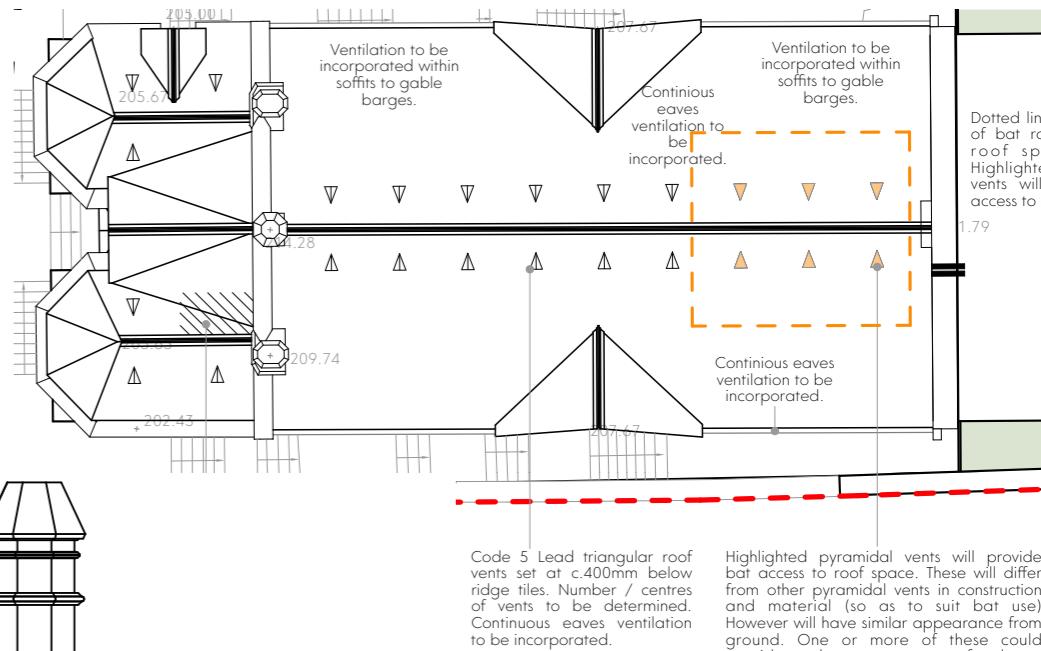
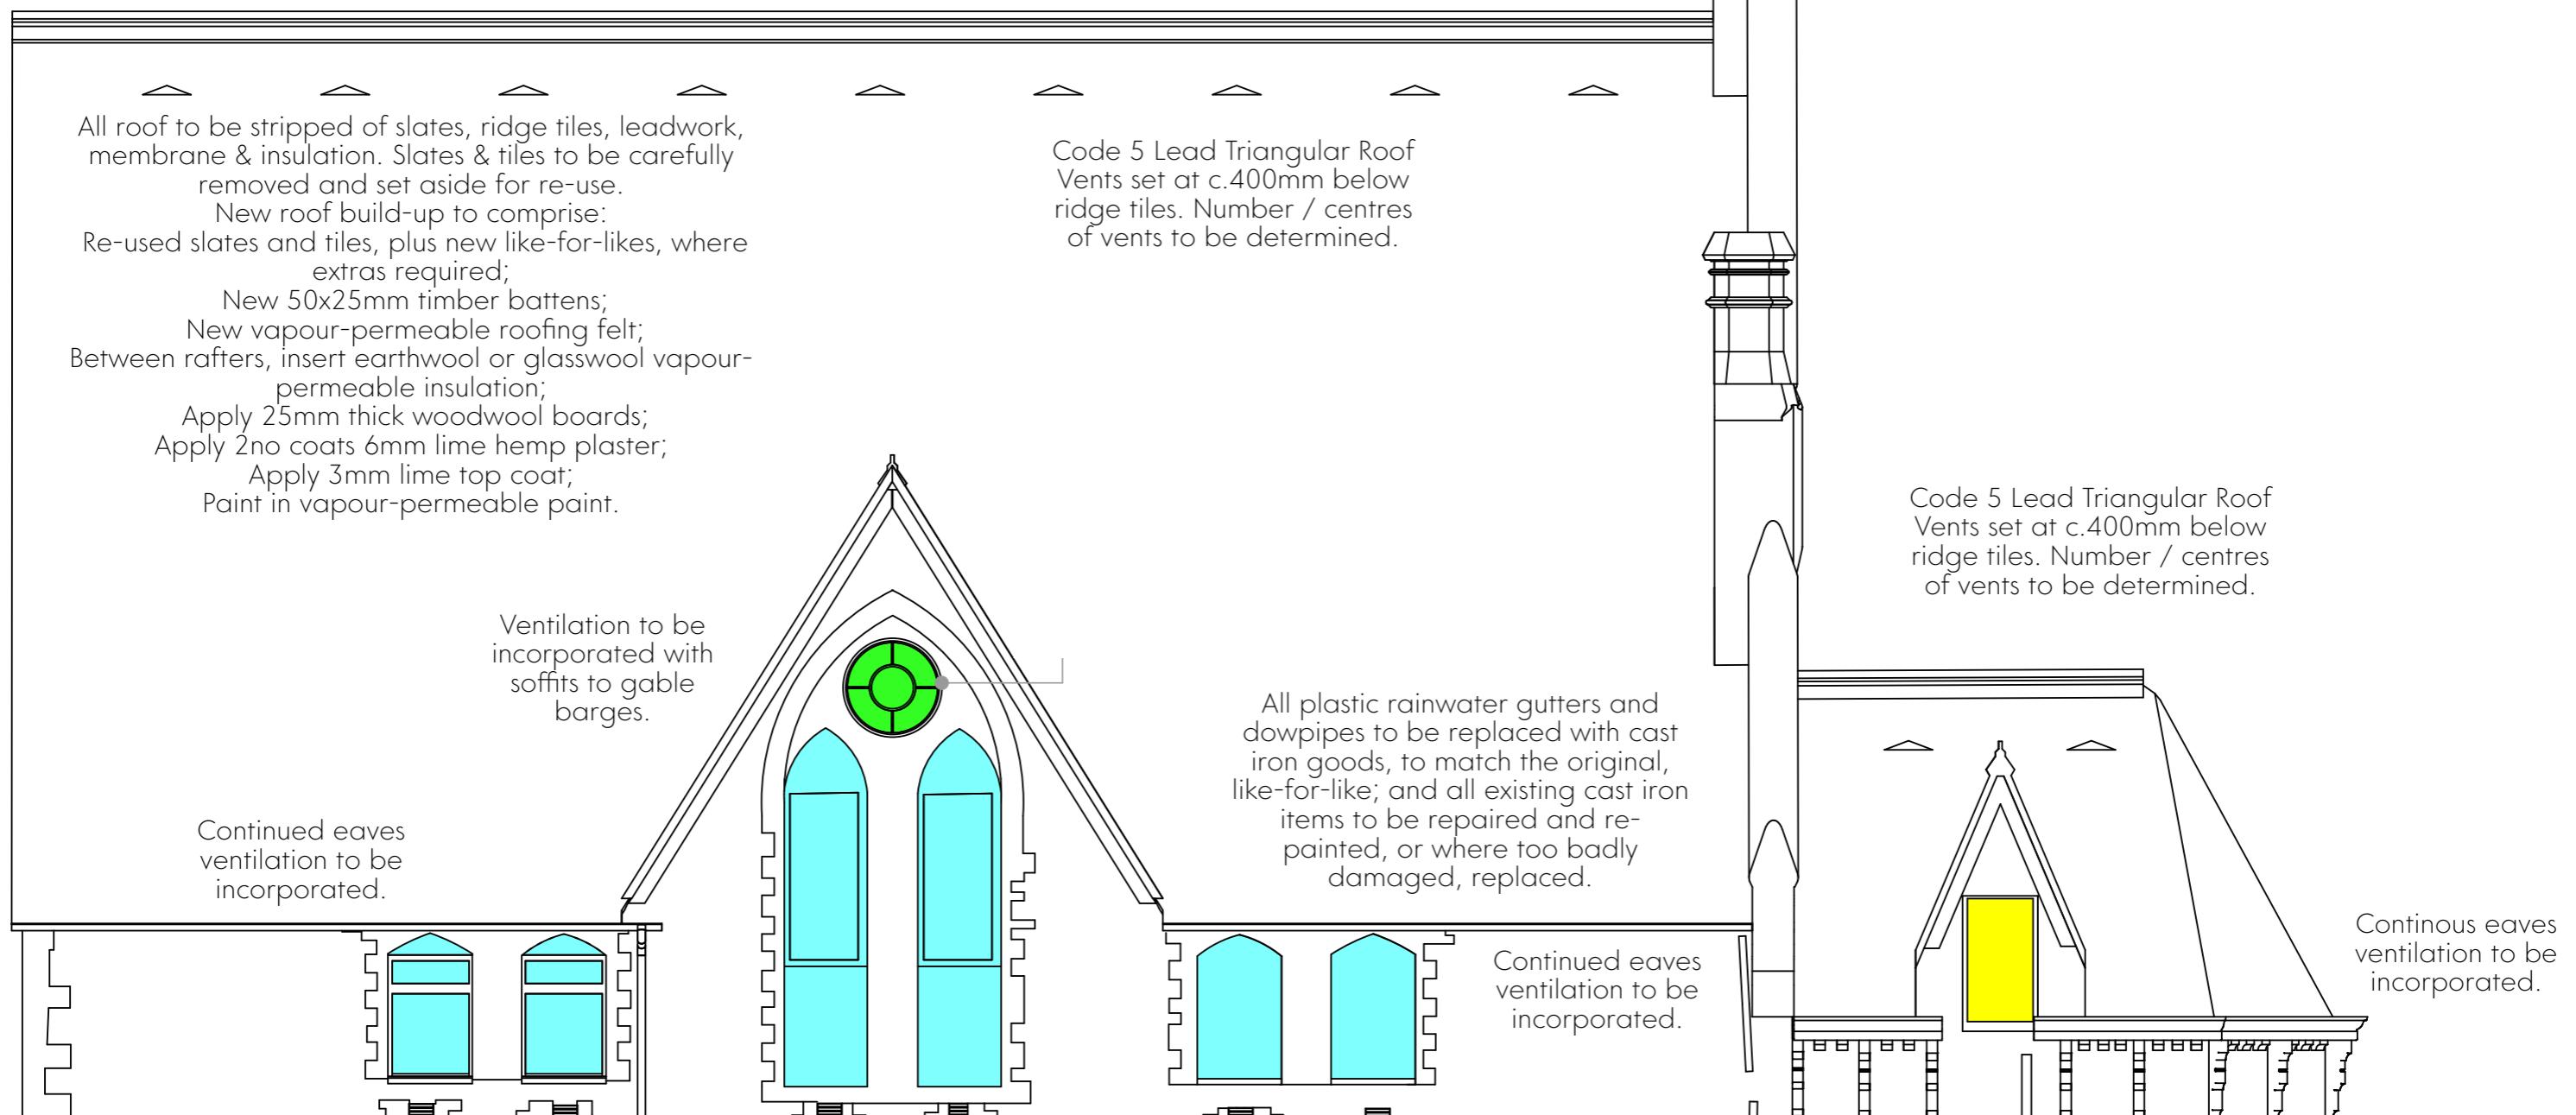
The natural slate, black clay roll top ridge tiles and leadwork coverings to the main and front range roofs are in poor condition. Patch repairs were undertaken in 2020; but this only addressed the worst issues of water ingress. There is also an impervious membrane within the roof make-up. As a result, the proposals seek to take up the whole of the roof and re-lay it. The slates and ridge tiles are to be carefully removed and set aside for re-use. New, matching natural Welsh slates are to replace those in poor condition, broken or lost. The same is to be the case with the ridge tiles.

As previously states, it is possible that the lift shaft within the front range will require additional headroom beyond the roof structure, possibly only for installation of the lift itself; and/or possibly for one-off future maintenance. To achieve this, a section of the roof rafters, insulation, membrane, battens and slates is to be independent of the rest, allowing for installation after the lift and possible removal in the future. In terms of appearance, the roofline will be unimpacted.

All of the plastic rainwater gutters and dowpipes would be replaced with cast iron goods, to match the original, like-for-like; and all existing cast iron items to be repaired and repainted, or where too badly damaged, replaced.

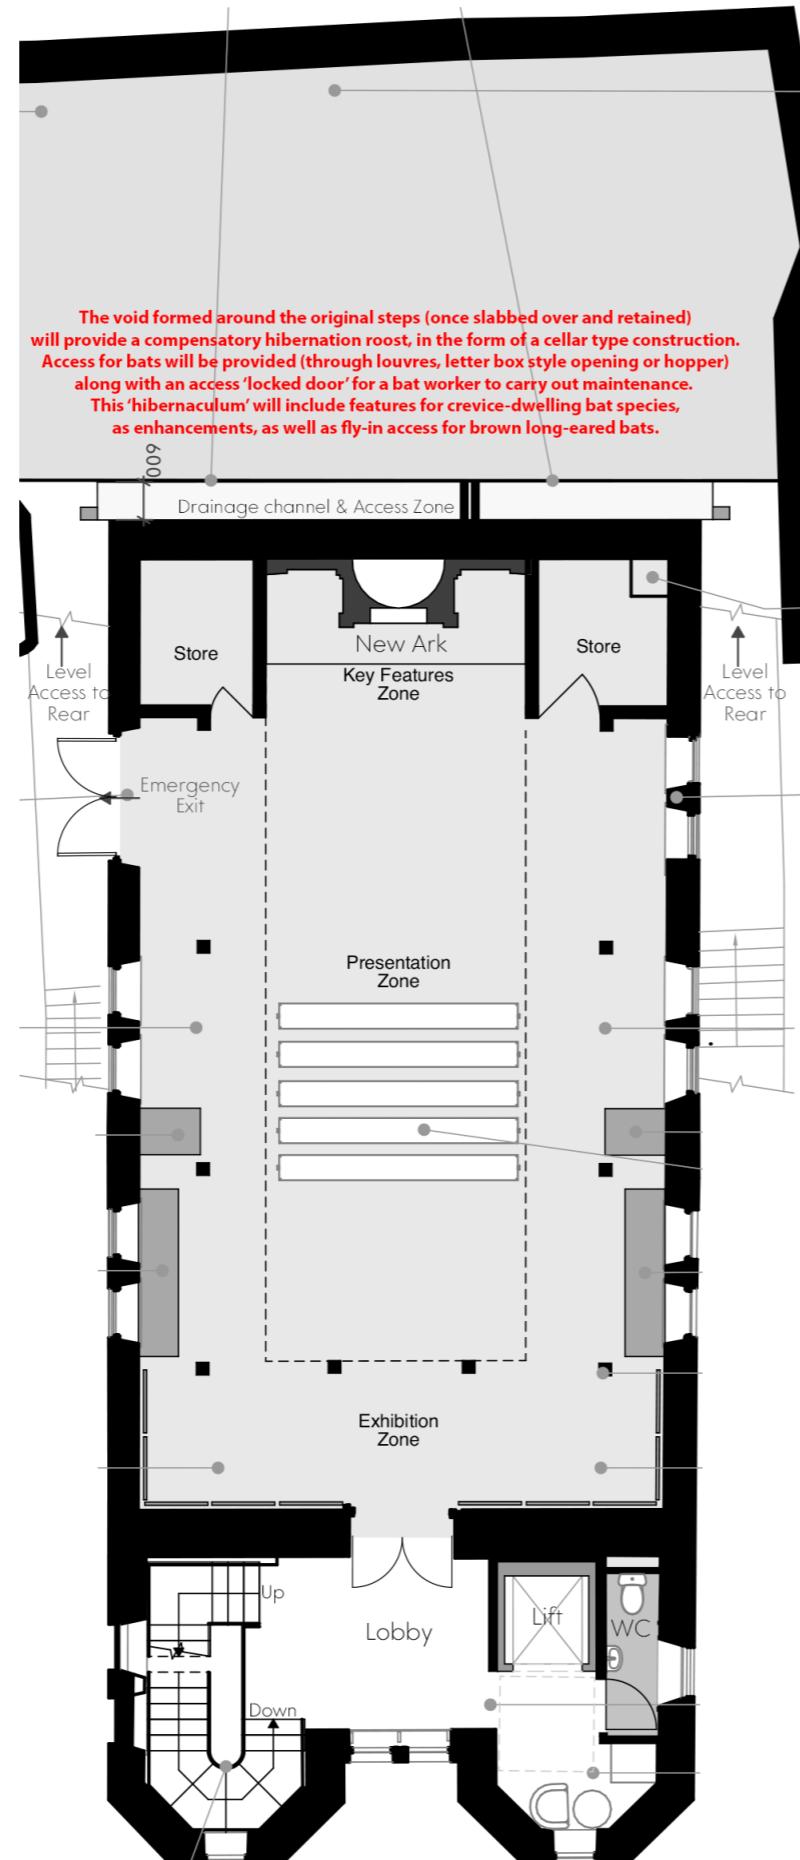
Proposed First Floor Plan

Below is Roof Plan, Roof Loft Plan and a First Floor Plan, all showing the features being proposed to accommodate the Ecologists' comments
