THE FORMER SYNAGOGUE

THE PROPOSALS

.....
(449)2503-GWP-A-HIS-P02

6.0 SECTION FOUR - EXPLANATION OF THE PROPOSALS

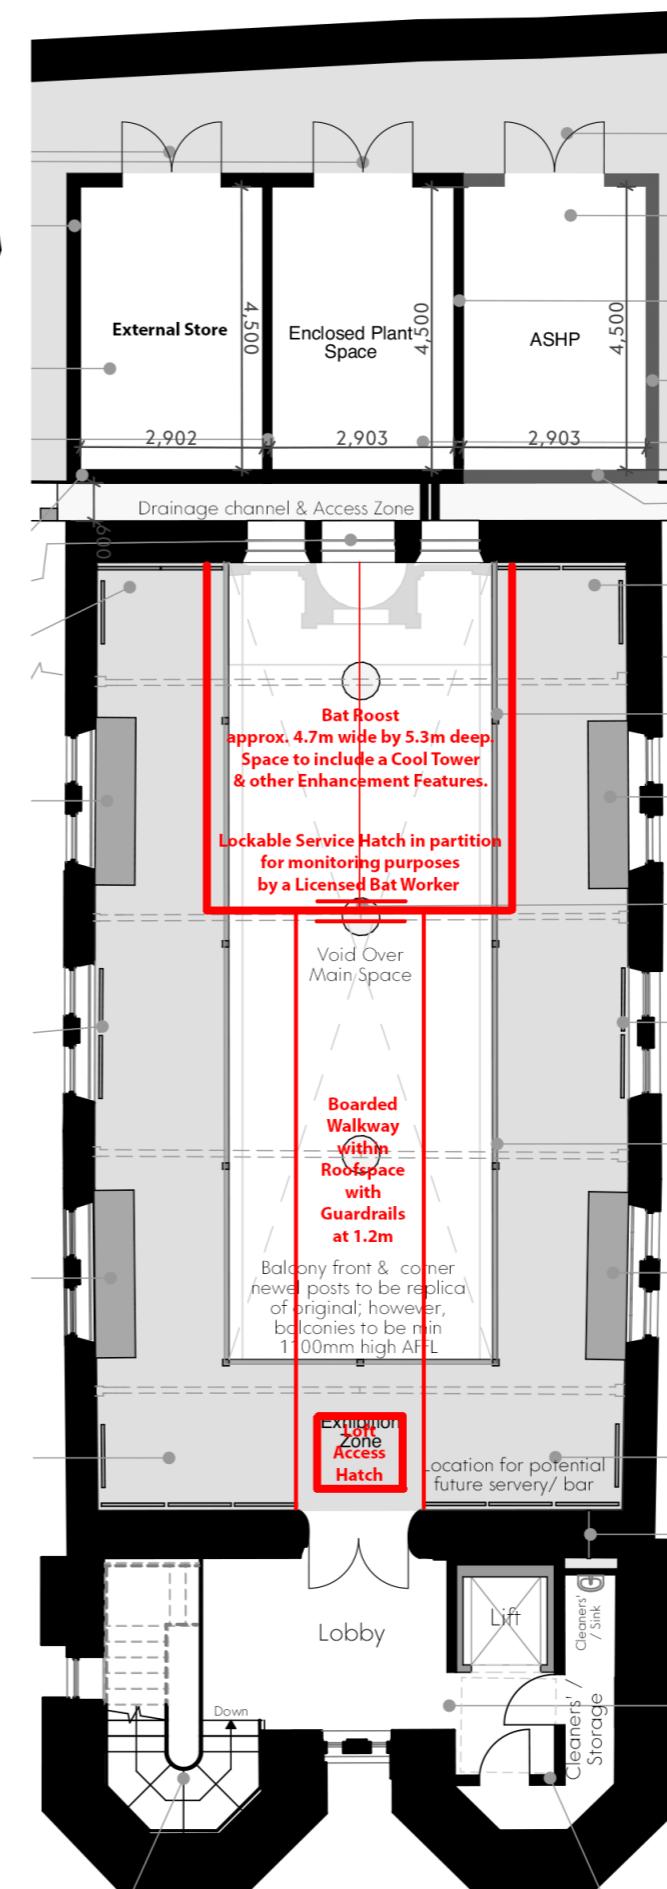
Proposed Roofspace Plan

Below is Roof Plan, Roof Loft Plan and a First Floor Plan, all showing the features being proposed to accommodate the Ecologists' comments

By virtue of an Ecological Impact Assessment, the Consultant Ecologists, Wildwood Ecology, have advised that a Bat Loft Roost and a Bat Hibernaculum are required; and that the roost must be within the roofspace of the Synagogue building, and not within a separate roost structure, not least as such a space would not be hot enough. They stipulated that the following would be required:

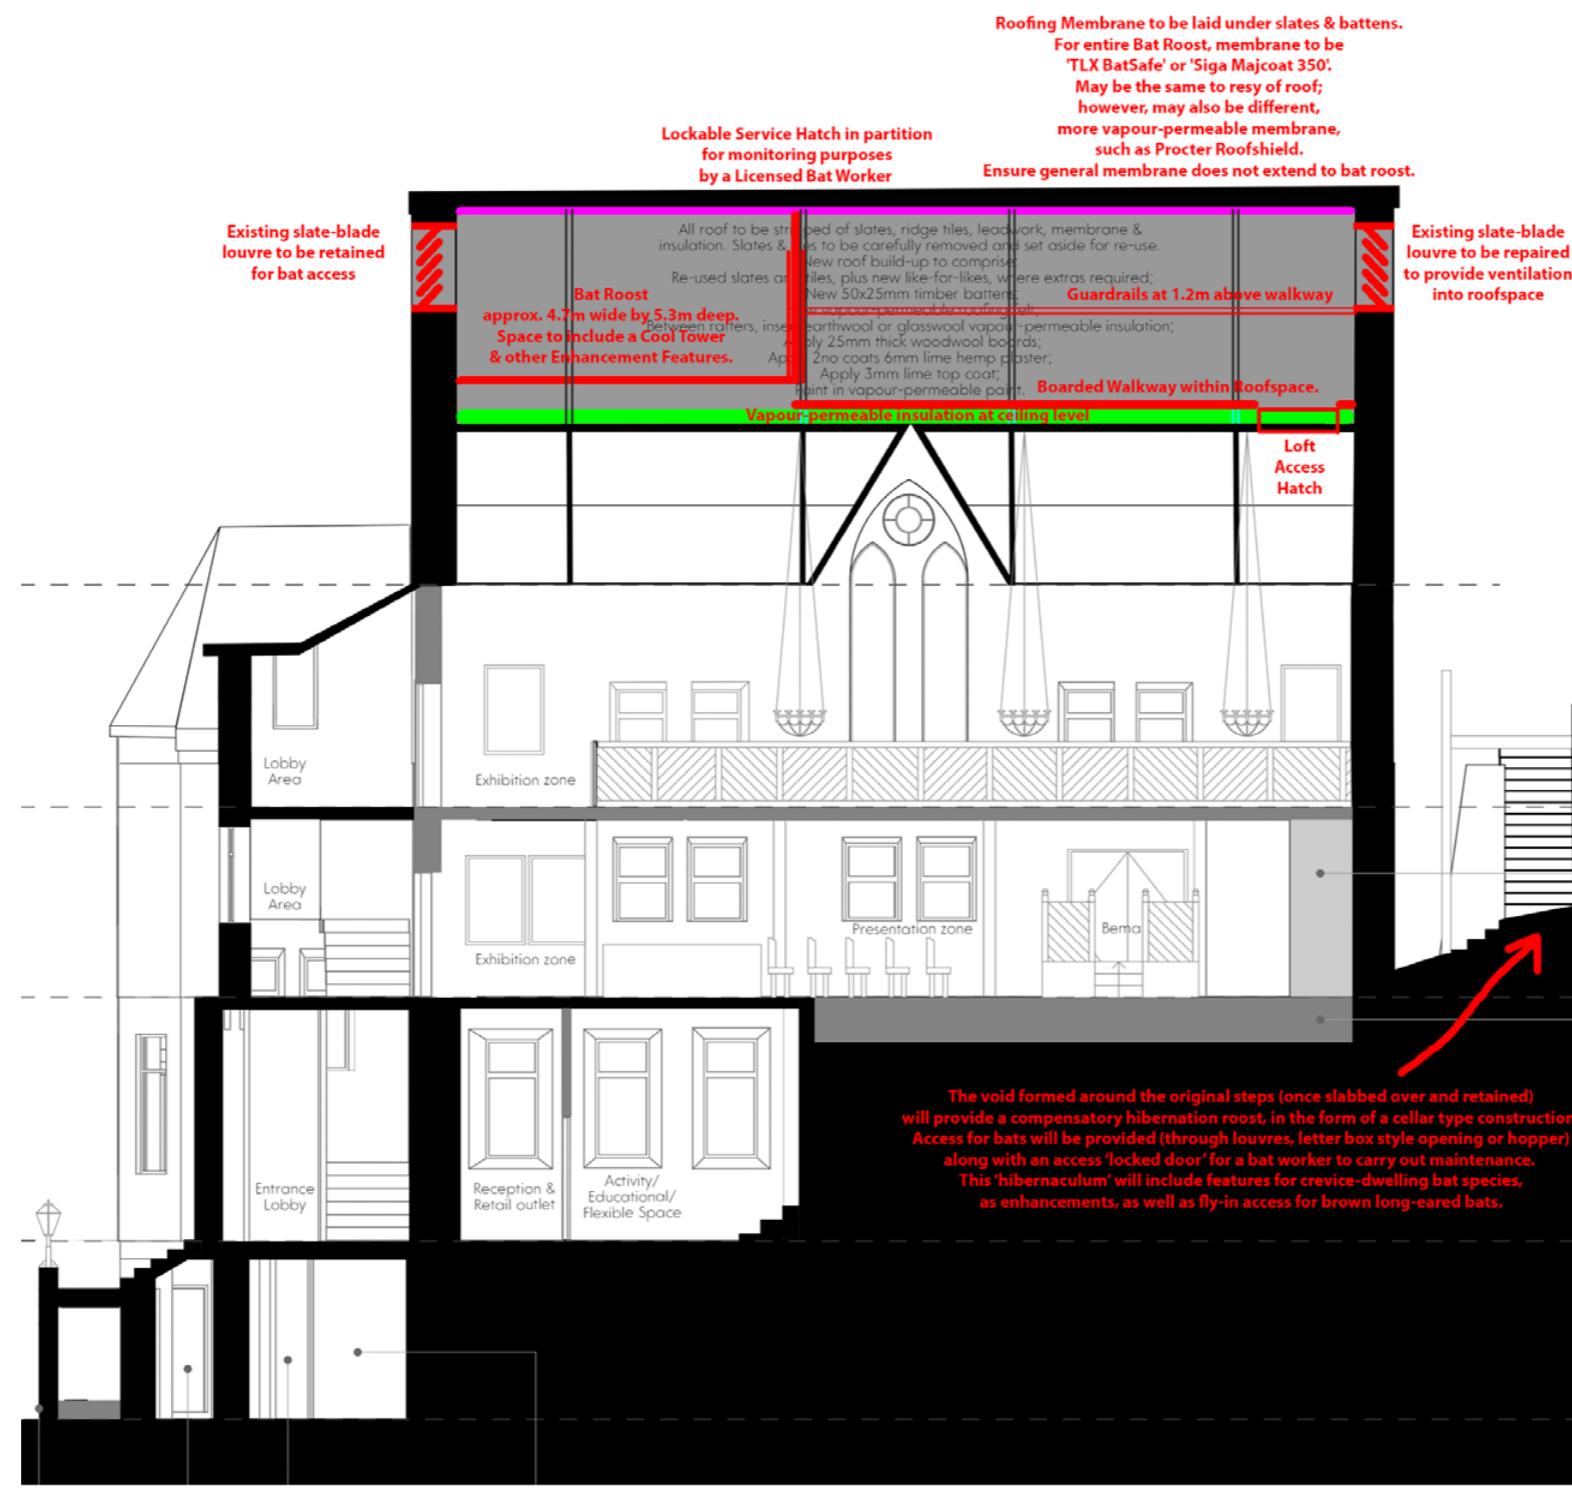
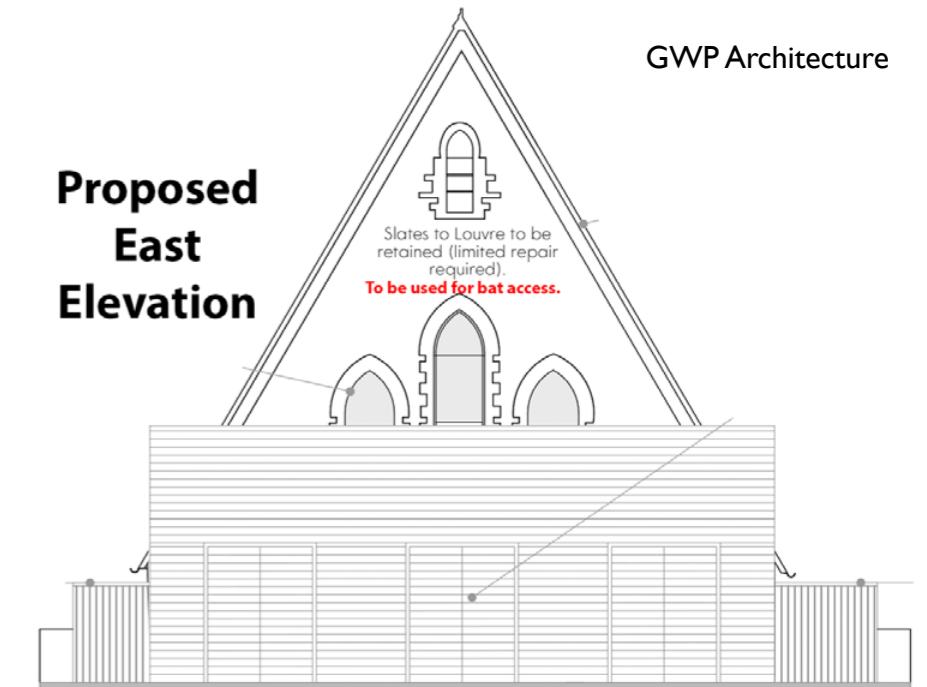
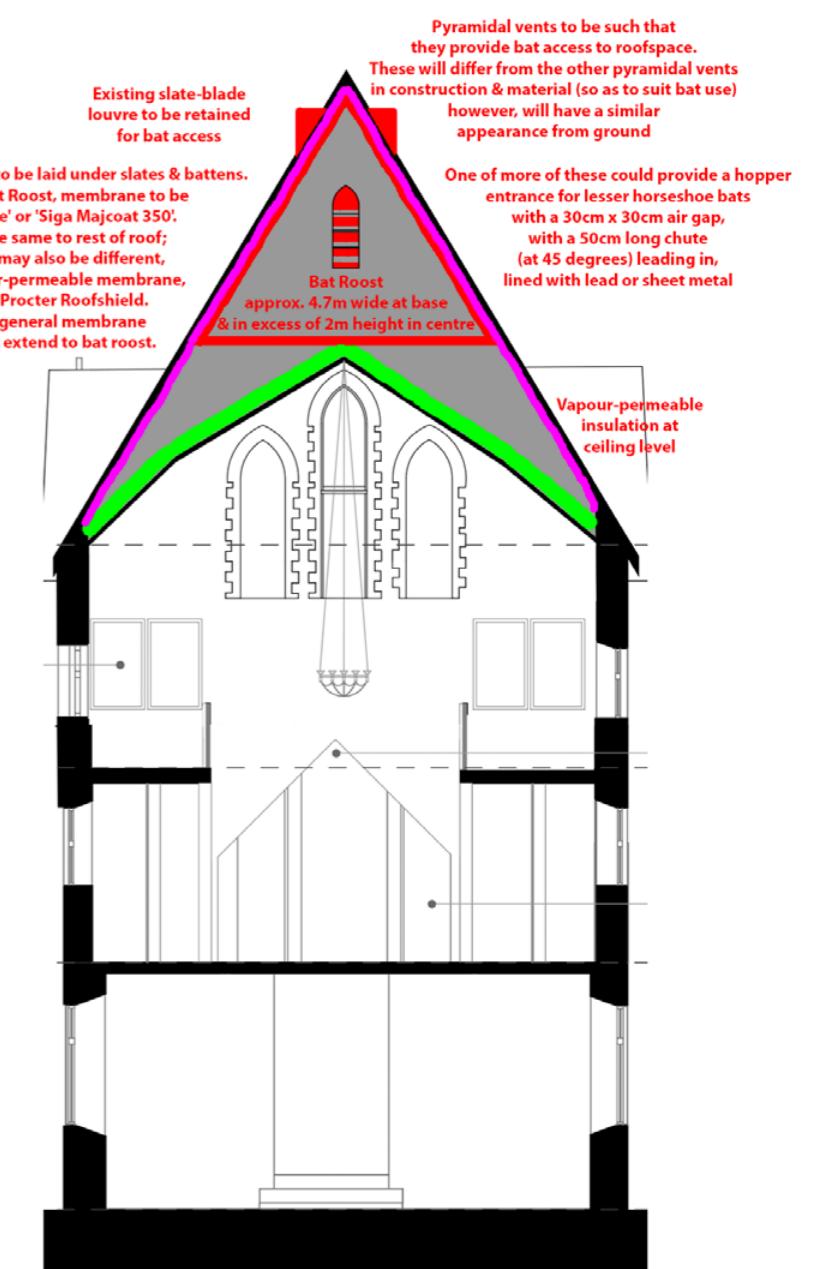
On this page are a Longitudinal Section, a Cross Section and a Partial Elevation showing the features being proposed to accommodate the requirement for the Bat Loft Roost and Bat Hibernaculum and the Ecologists' comments. These should be read along with the plans on the previous page.

- A compensatory hibernation roost is required, which will need to be separate from the bat loft, as this will be too warm and dry for hibernating bats. The utilisation of the space at the rear of the building for the compensatory hibernation roost, in the form of a cellar type construction, would work well. The construction will need to be dug into the ground and access provided to bats, as well as a bat worker to carry out maintenance, will be.

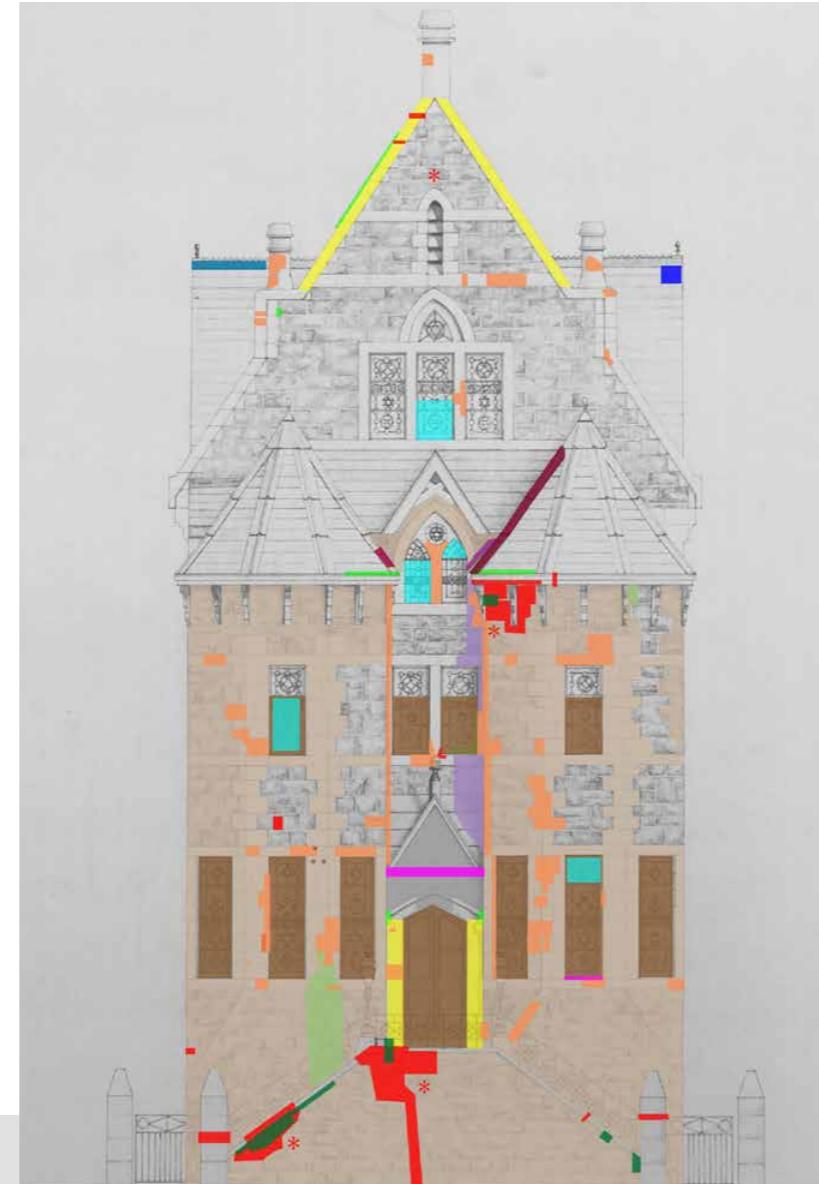
Condition Drawing for North Elevation

Over the next pages are the proposed Outline Repair Specifications; whilst on this page are the marked-up Condition Assessment drawings for the four elevations.

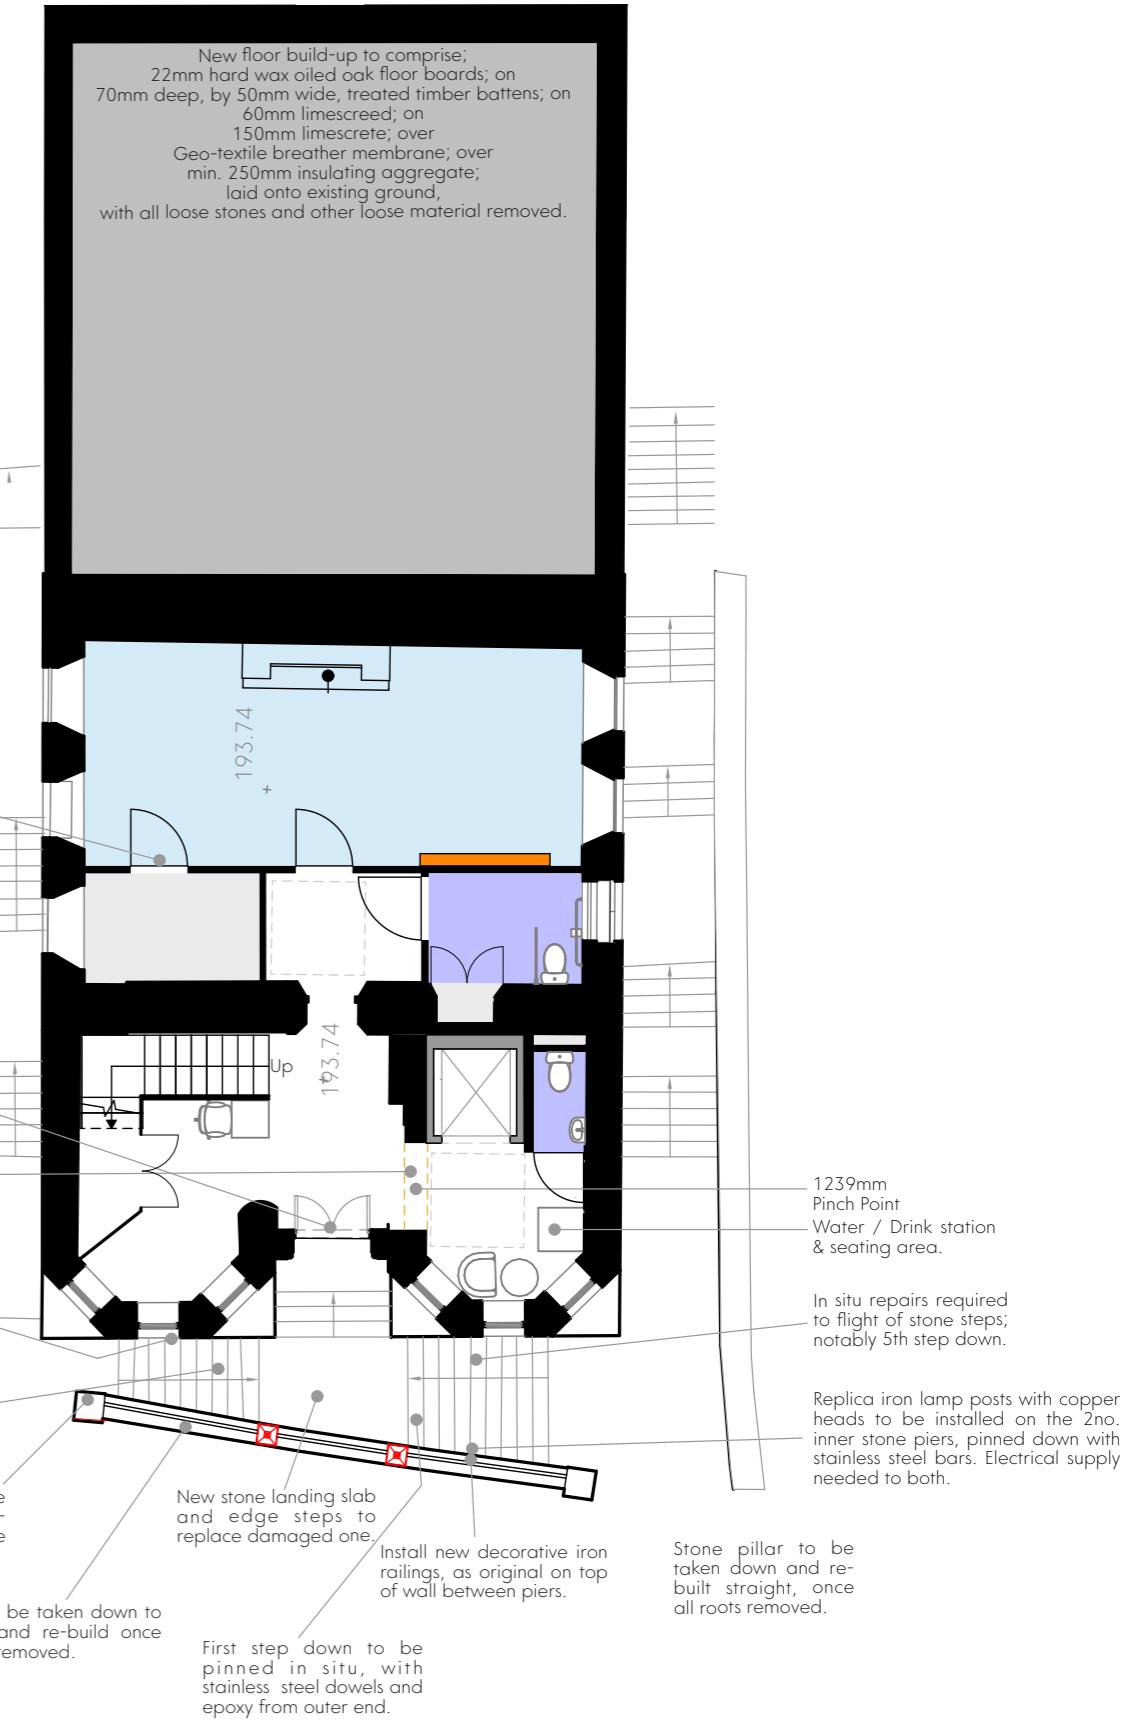
PROPOSED UPPER GROUND FLOOR PLAN

Two sections of stone outer wall (each approx. 1.2m wide x 2.2m high) to be carefully dismantled to form openings in order to access and work on rear wall and steps stabilisation and retention. Stones to be numbered before dismantling and set aside for later reinstatement. Masonry above to be needleled and supported as per Mann Williams details / specifications. Once works to rear completed, masonry to be reinstated, as original with matching / suitable lime bedding mortar and pointing.

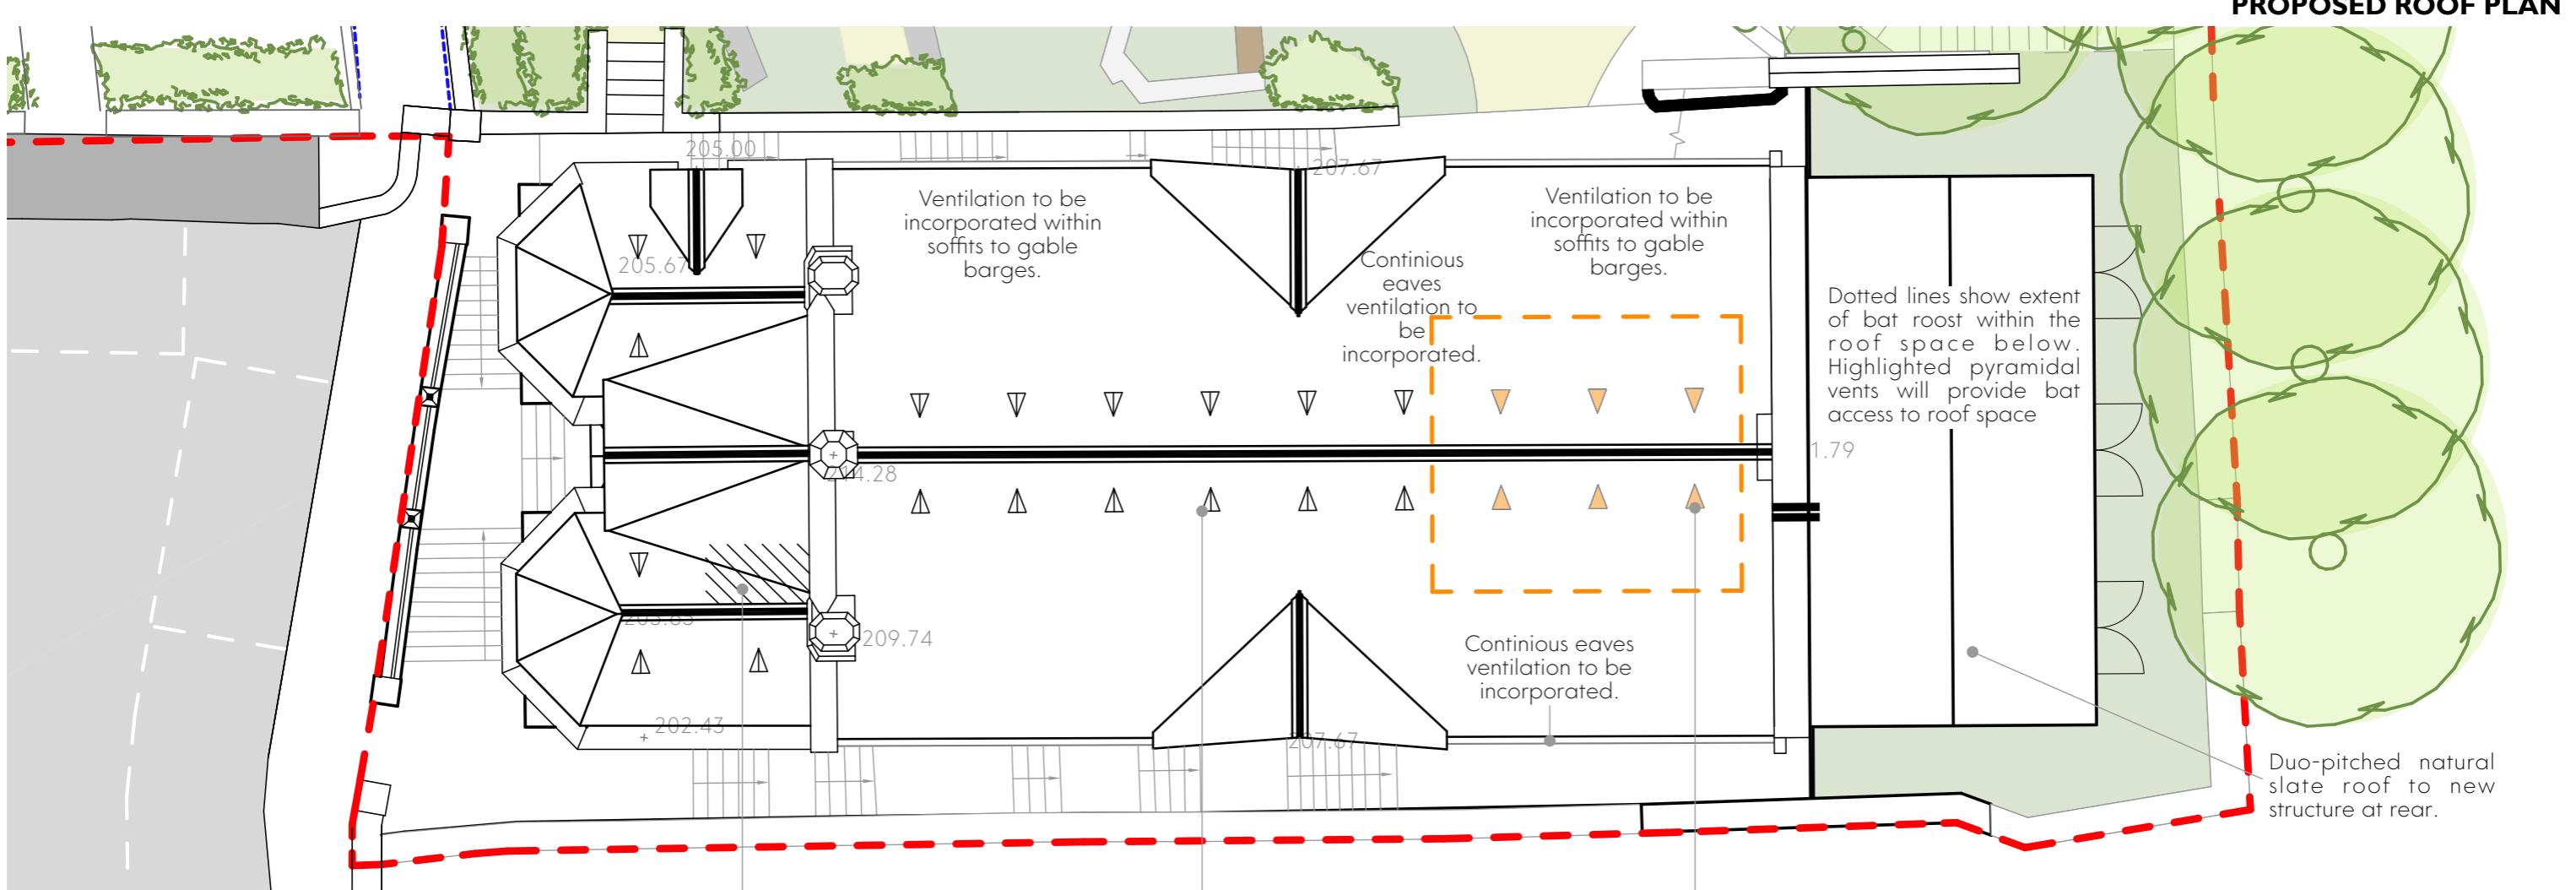
6.6.5 Existing & Proposed Roof Plans

Lift requirements are subject to detailed design. It is possible that the lift shaft will require additional headroom beyond the roof structure, possibly only for installation of the lift itself; and/or possibly for one-off future maintenance. To achieve this, a section of the roof rafters, insulation, membrane, battens and slates is to be independent of the rest (as hatched), allowing for installation after the lift and possible removal in the future. In terms of appearance, the roofline will be unimpacted.

Code 5 Lead triangular roof vents set at c.400mm below ridge tiles. Number / centres of vents to be determined. Continuous eaves ventilation to be incorporated.

Within roof plane over bat roost, there will be further access tiles and modified ridge tiles to provide dedicated access into the roof for crevice-dwelling species present onsite. Access will also be created under some of the standard roof slates, by cutting a notch from the new slate to create a gap under the slate, which will lead to the narrow space between membrane, timbers and slates. Notches will also be cut out of the battens in some areas to enable the bats to move more easily up and down the roof under the slates.

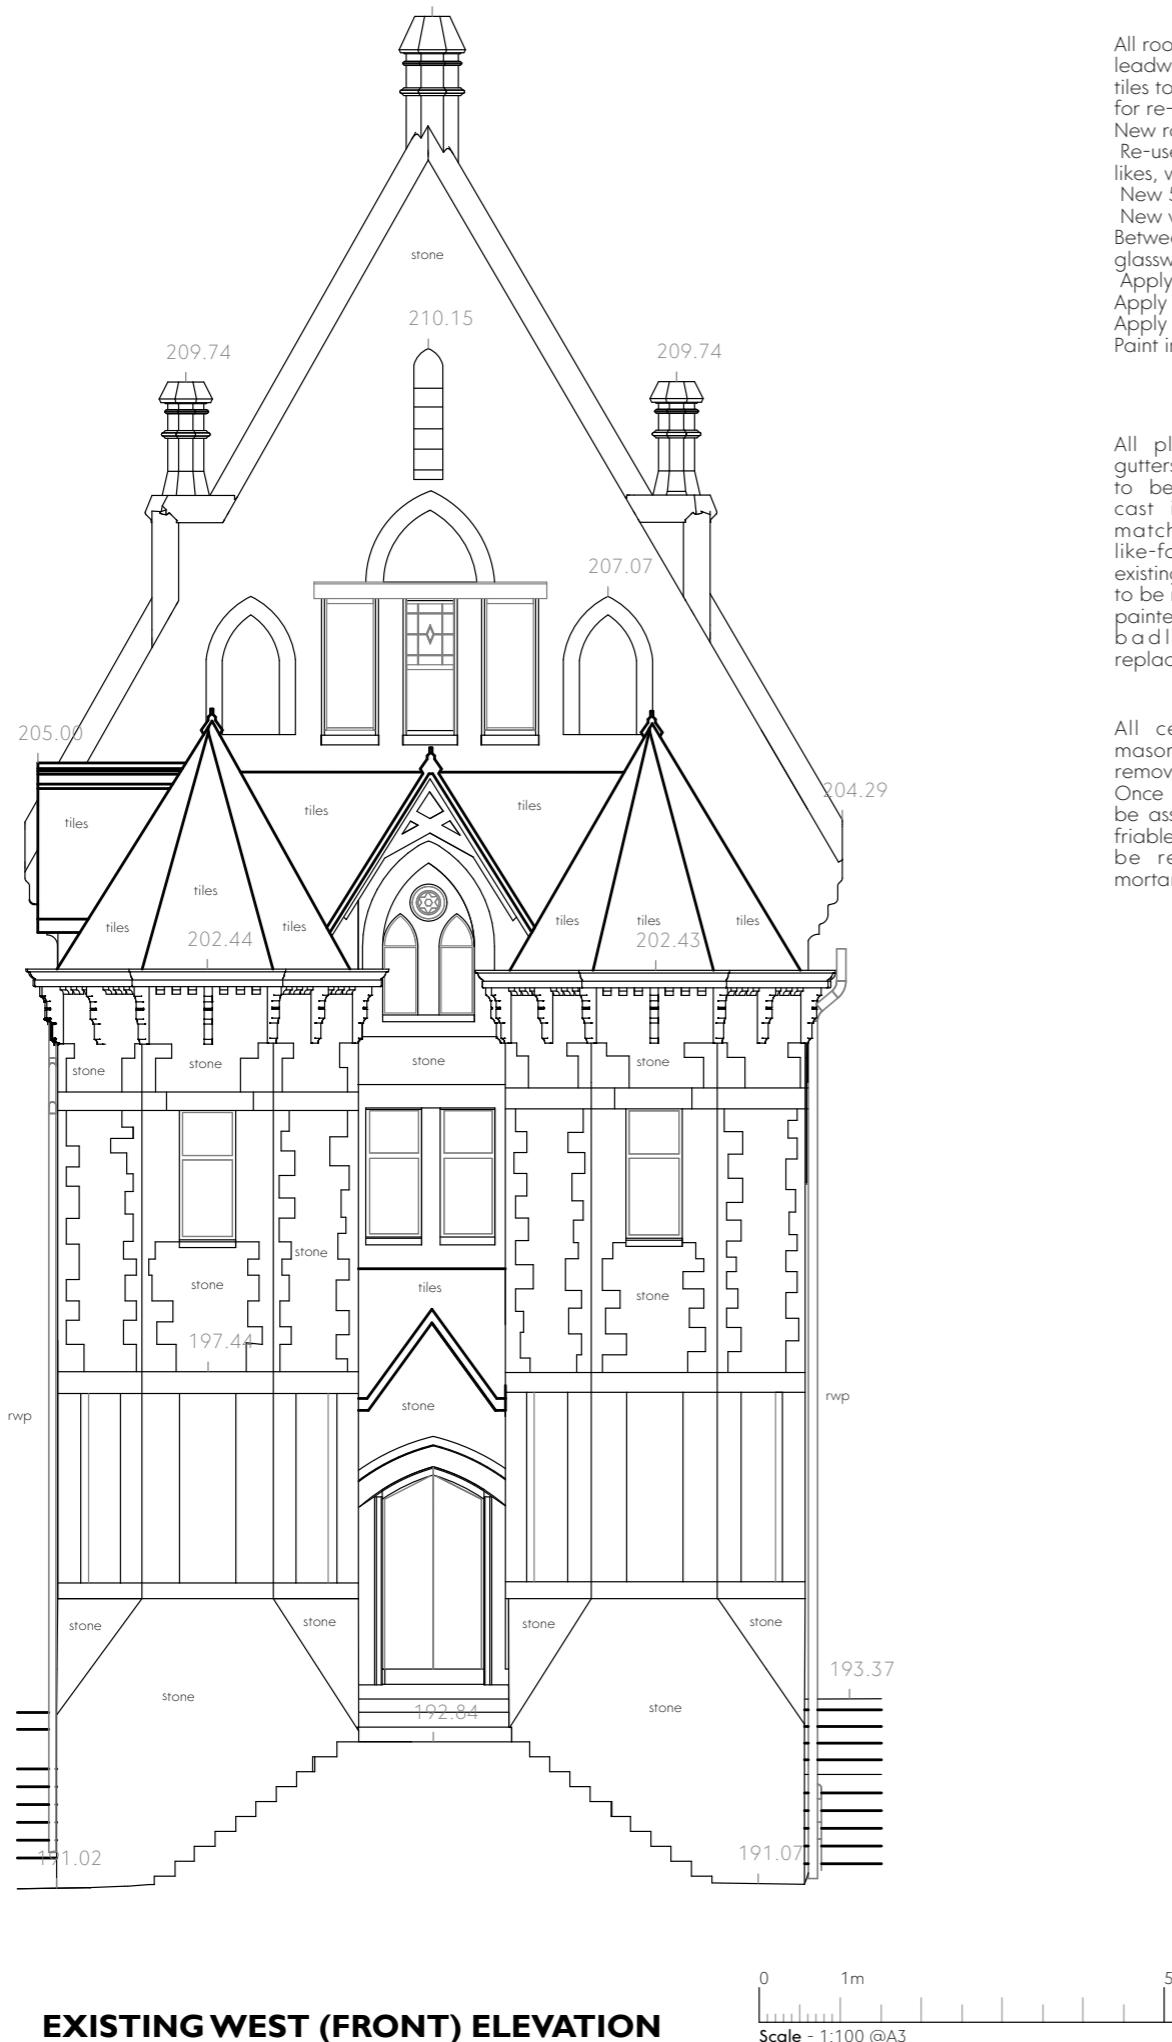
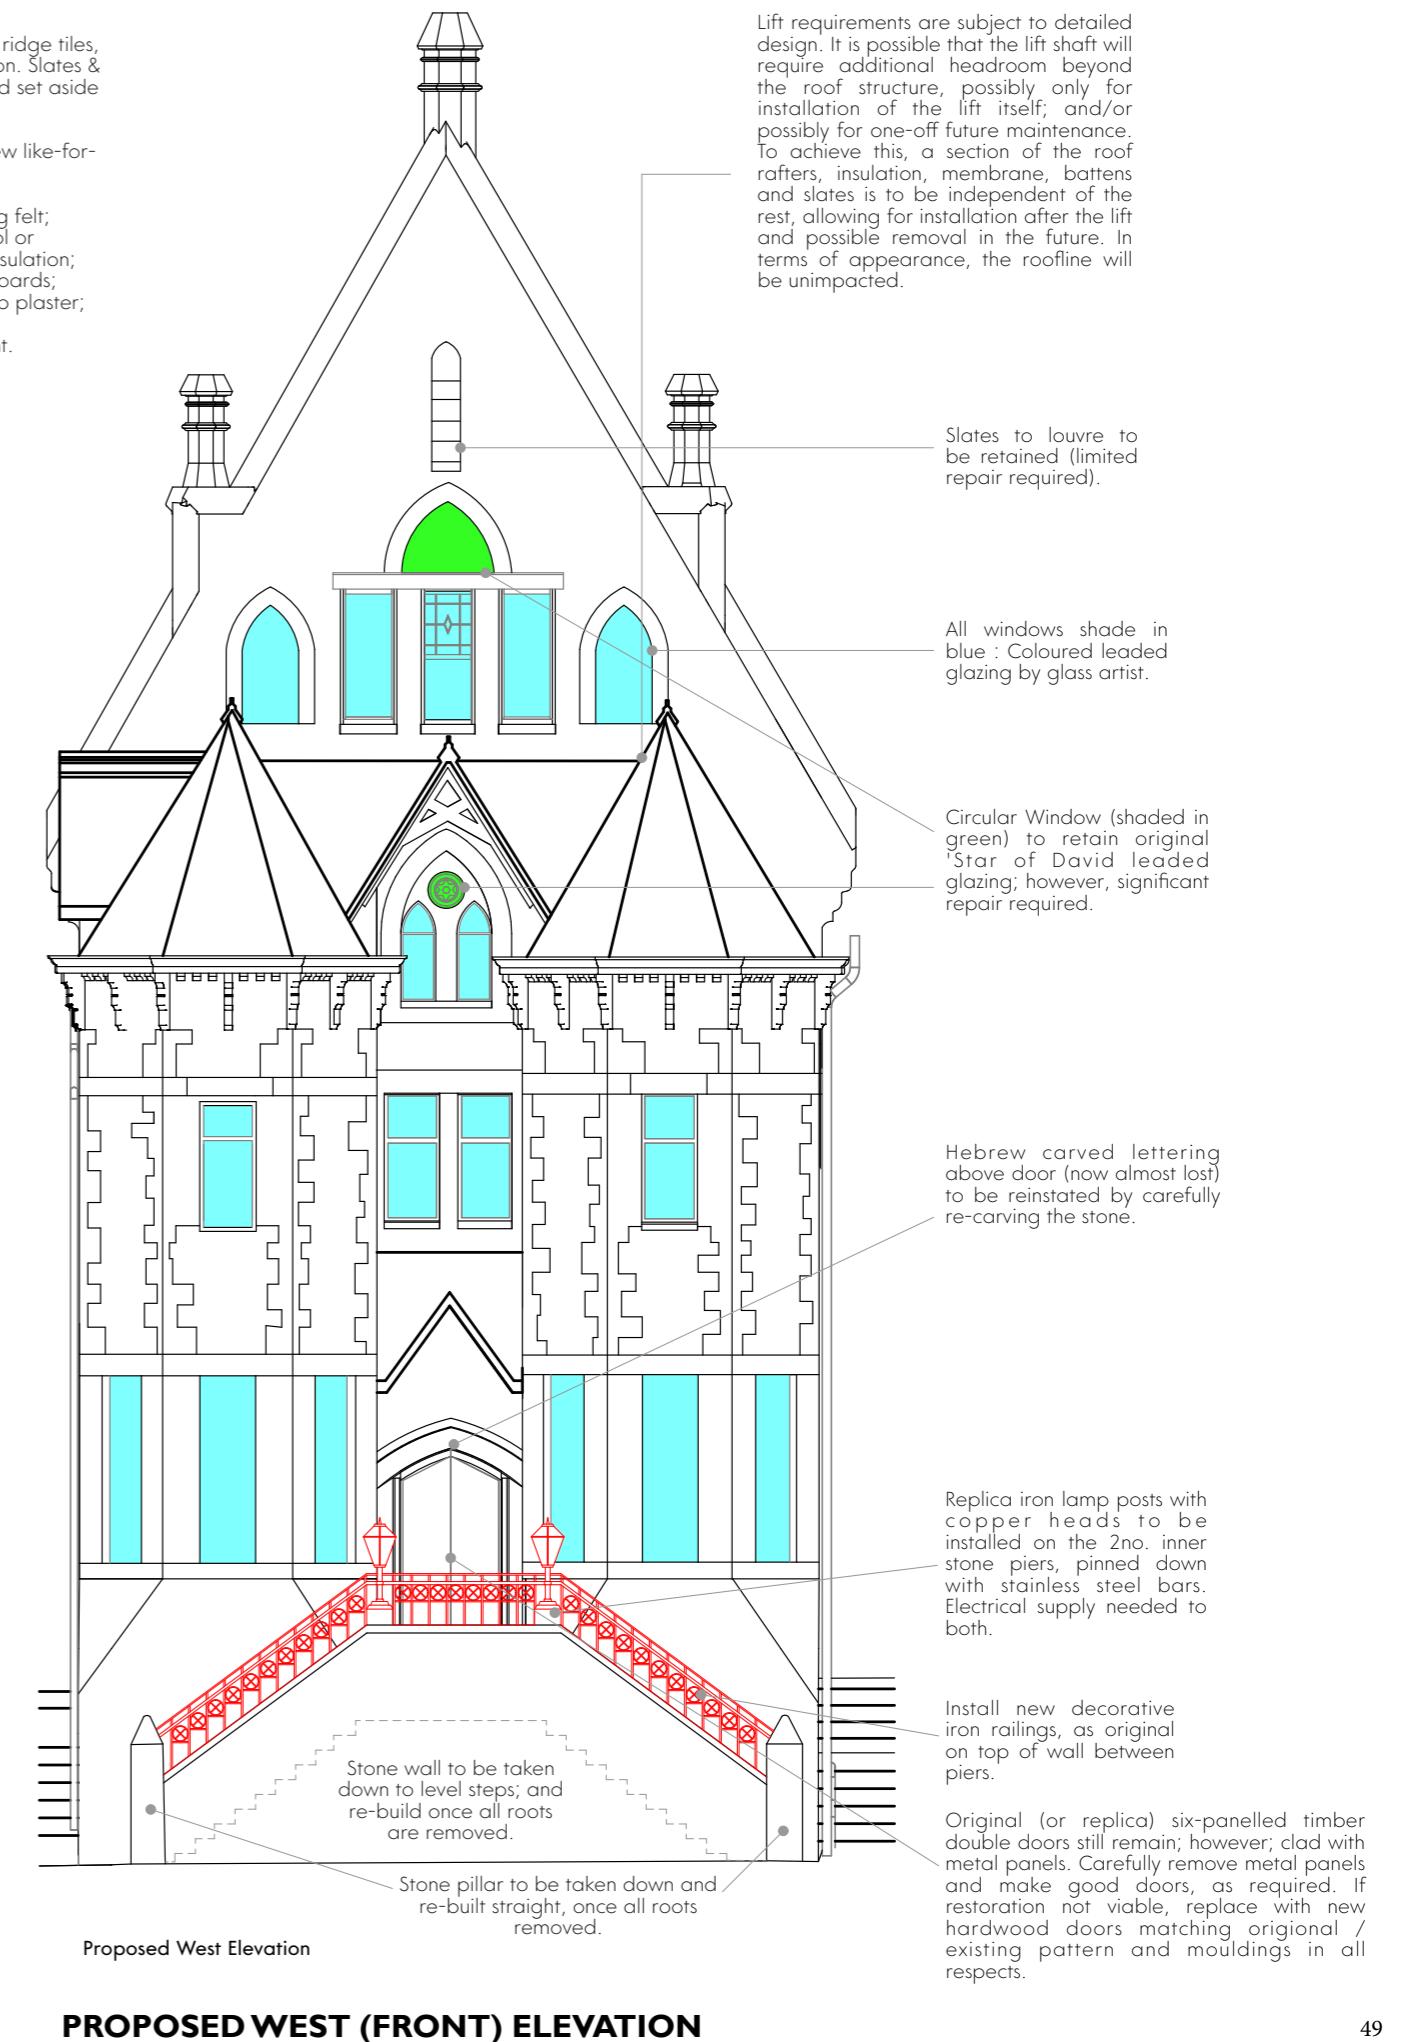
6.6.7 Existing & Proposed West (Front) Elevation

All roof to be stripped of slates, ridge tiles, leadwork, membrane & insulation. Slates & tiles to be carefully removed and set aside for re-use.

New roof build-up to comprise:
Re-used slates and tiles, plus new like-for-like, where extras required;
New 50x25mm timber battens;
New vapour-permeable roofing felt;
Between rafters, insert earthwool or glasswool vapour-permeable insulation;
Apply 25mm thick woodwool boards;
Apply 2no coats 6mm lime hemp plaster;
Apply 3mm lime top coat;
Paint in vapour-permeable paint.

All plastic rainwater gutters and downpipes to be replaced with cast iron goods, to match the original, like-for-like; and all existing cast iron items to be repaired and repainted, or where too badly damaged, replaced.

All cement pointing to masonry to be carefully removed, where possible. Once done, all pointing to be assessed; and any lost, friable or recessed joints to be re-pointing in lime mortar.

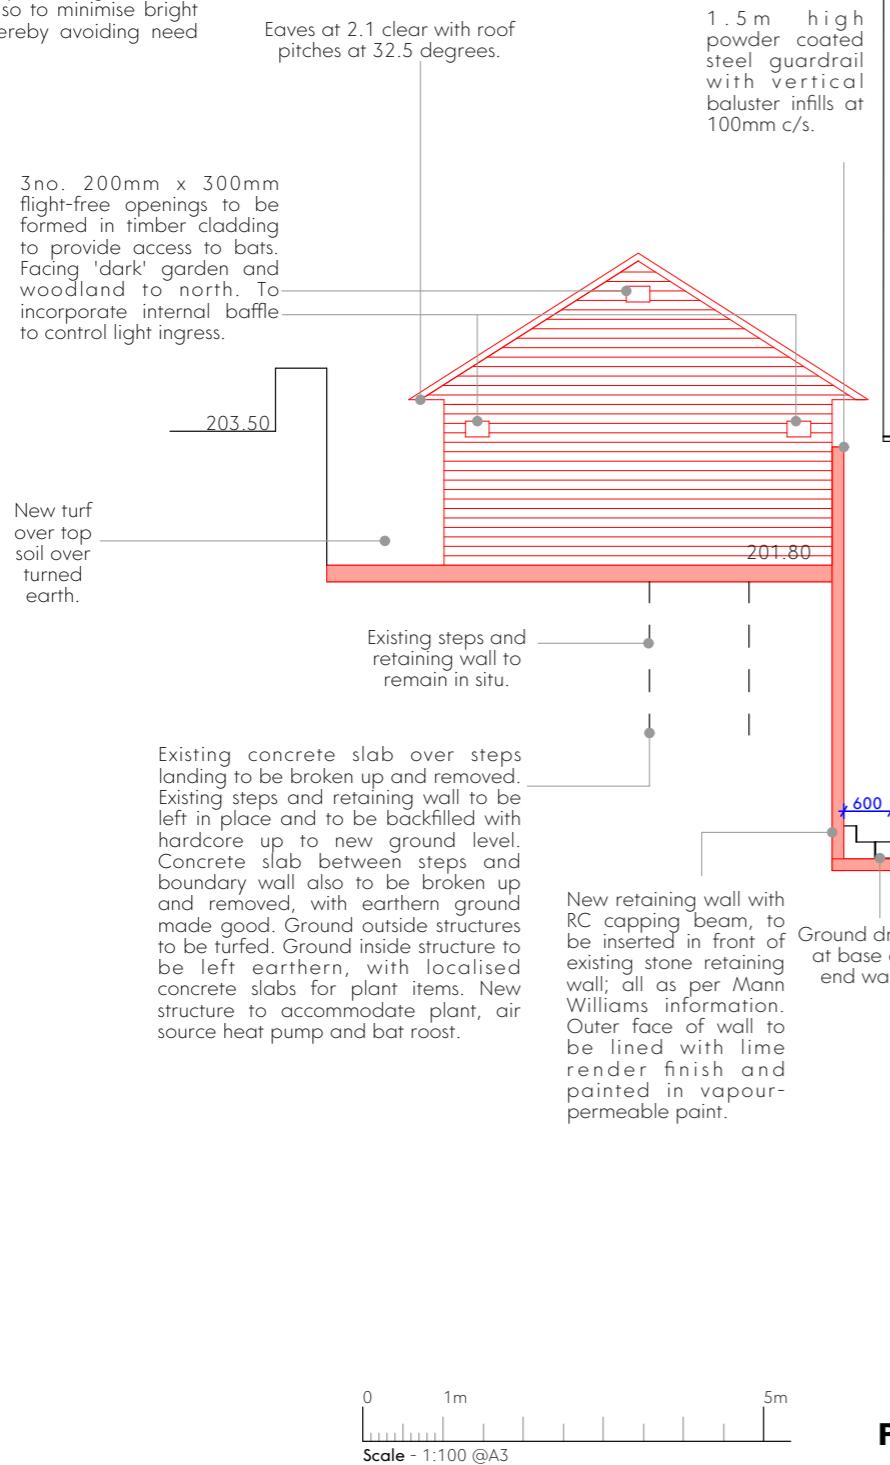
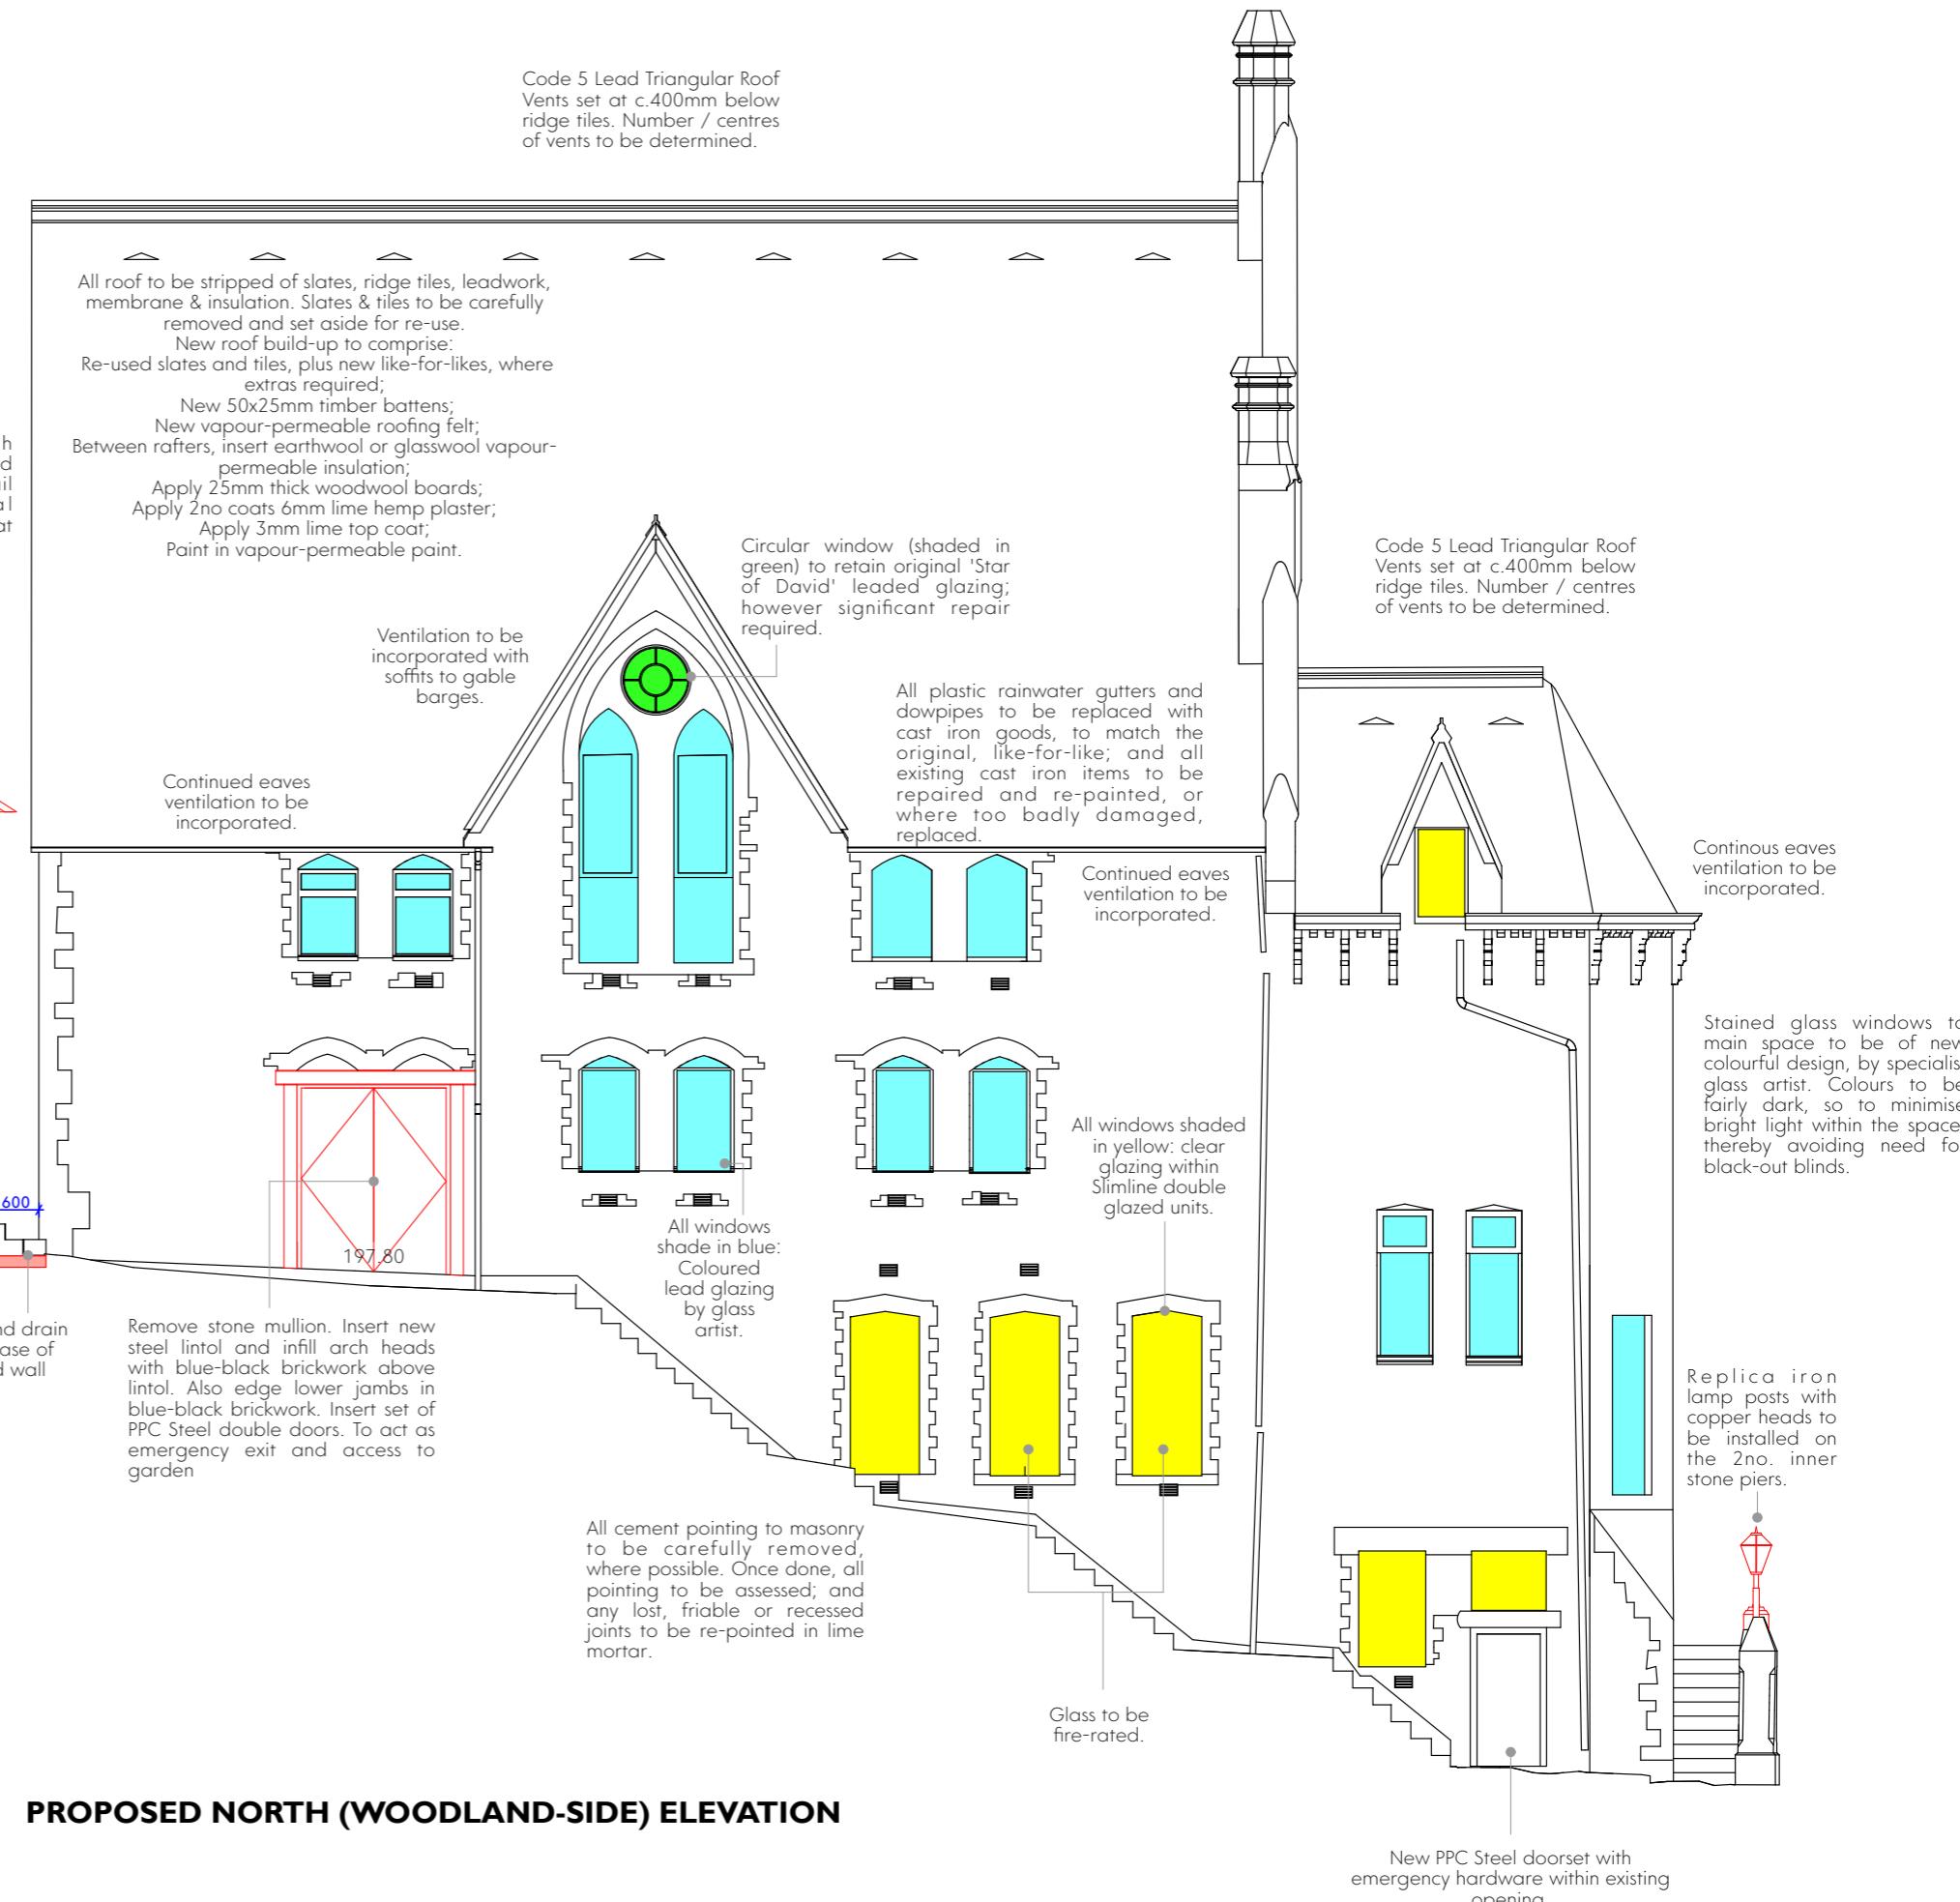
PROPOSED NORTH (WOODLAND-SIDE) ELEVATION

All new glazing to front range windows and upper ground floor to be clear Slimline double-glazed units.

Stained glass windows to main space to be of new colourful design, by specialist glass artist. Colours to be fairly dark, so to minimise bright light within the space, thereby avoiding need for black-out blinds.
