THE FORMER SYNAGOGUE

THE PROPOSALS

.....
(449)2503-GWP-A-HIS-P02

6.0 SECTION FOUR - EXPLANATION OF THE PROPOSALS

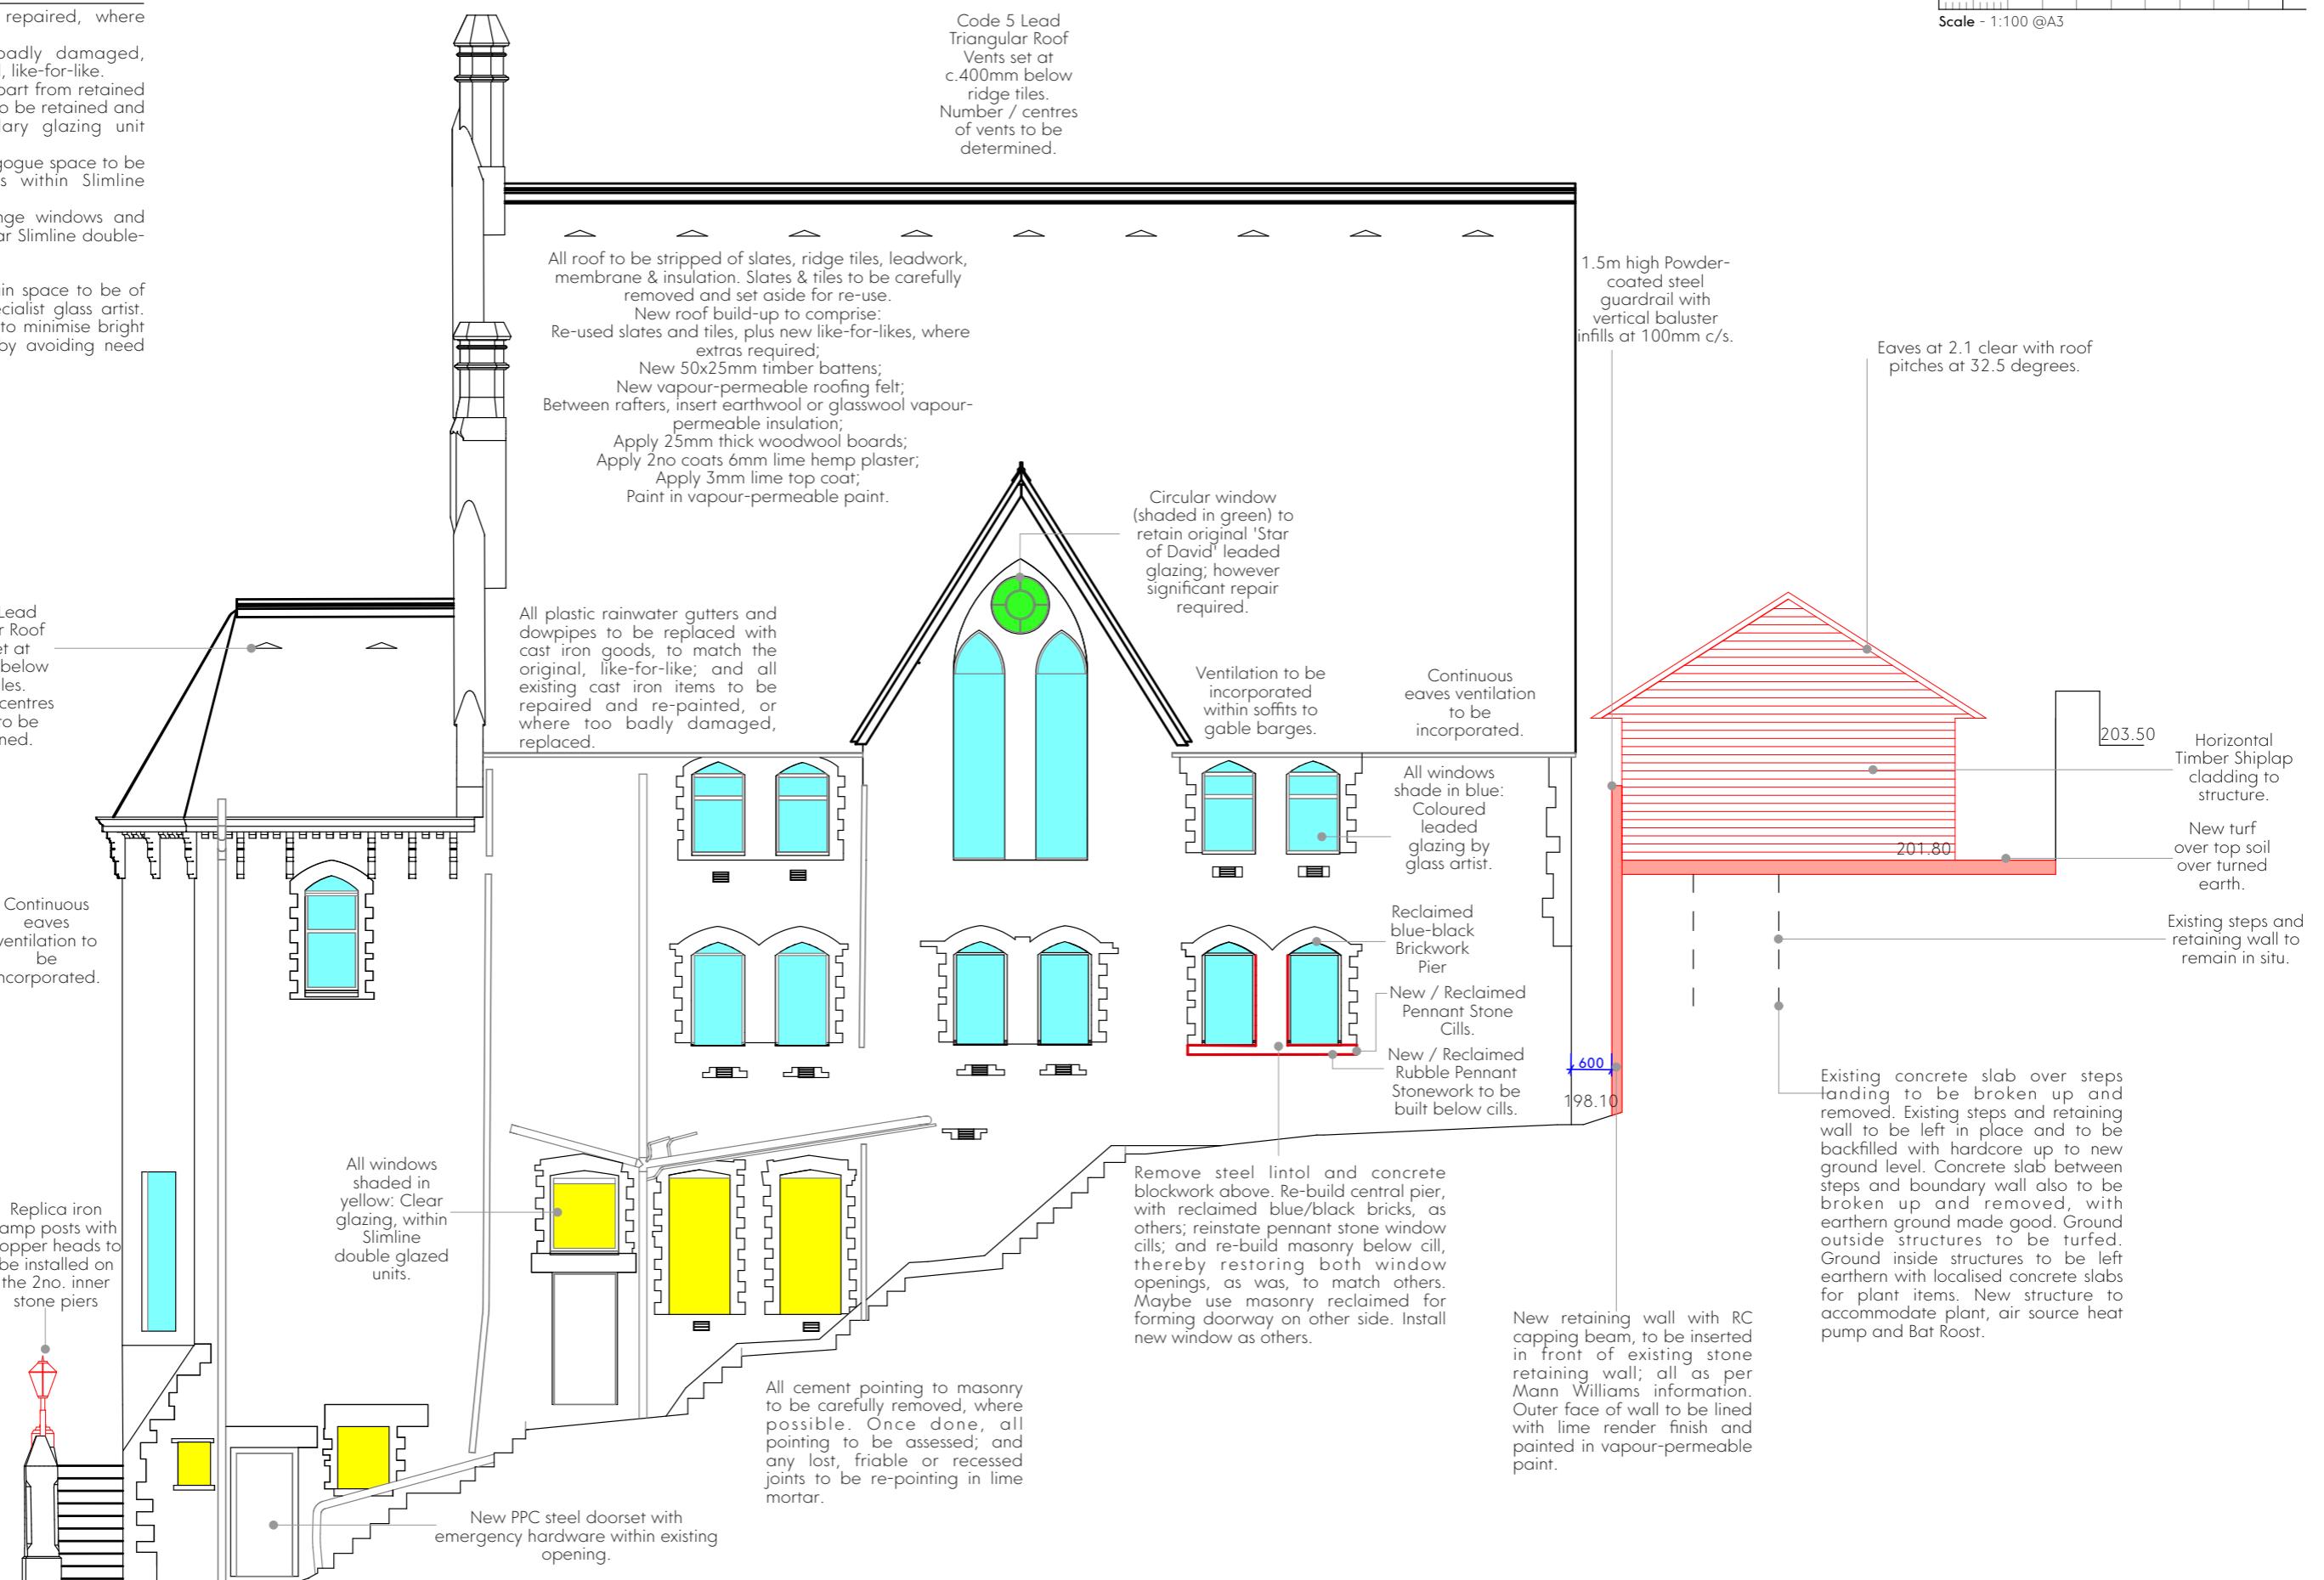
PROPOSED SOUTH ELEVATION

All new glazing to front range windows and upper ground floor to be clear Slimline double-glazed units.

Stained glass windows to main space to be of new colourful design, by specialist glass artist. Colours to be fairly dark, so to minimise bright light within the space, thereby avoiding need for black-out blinds.

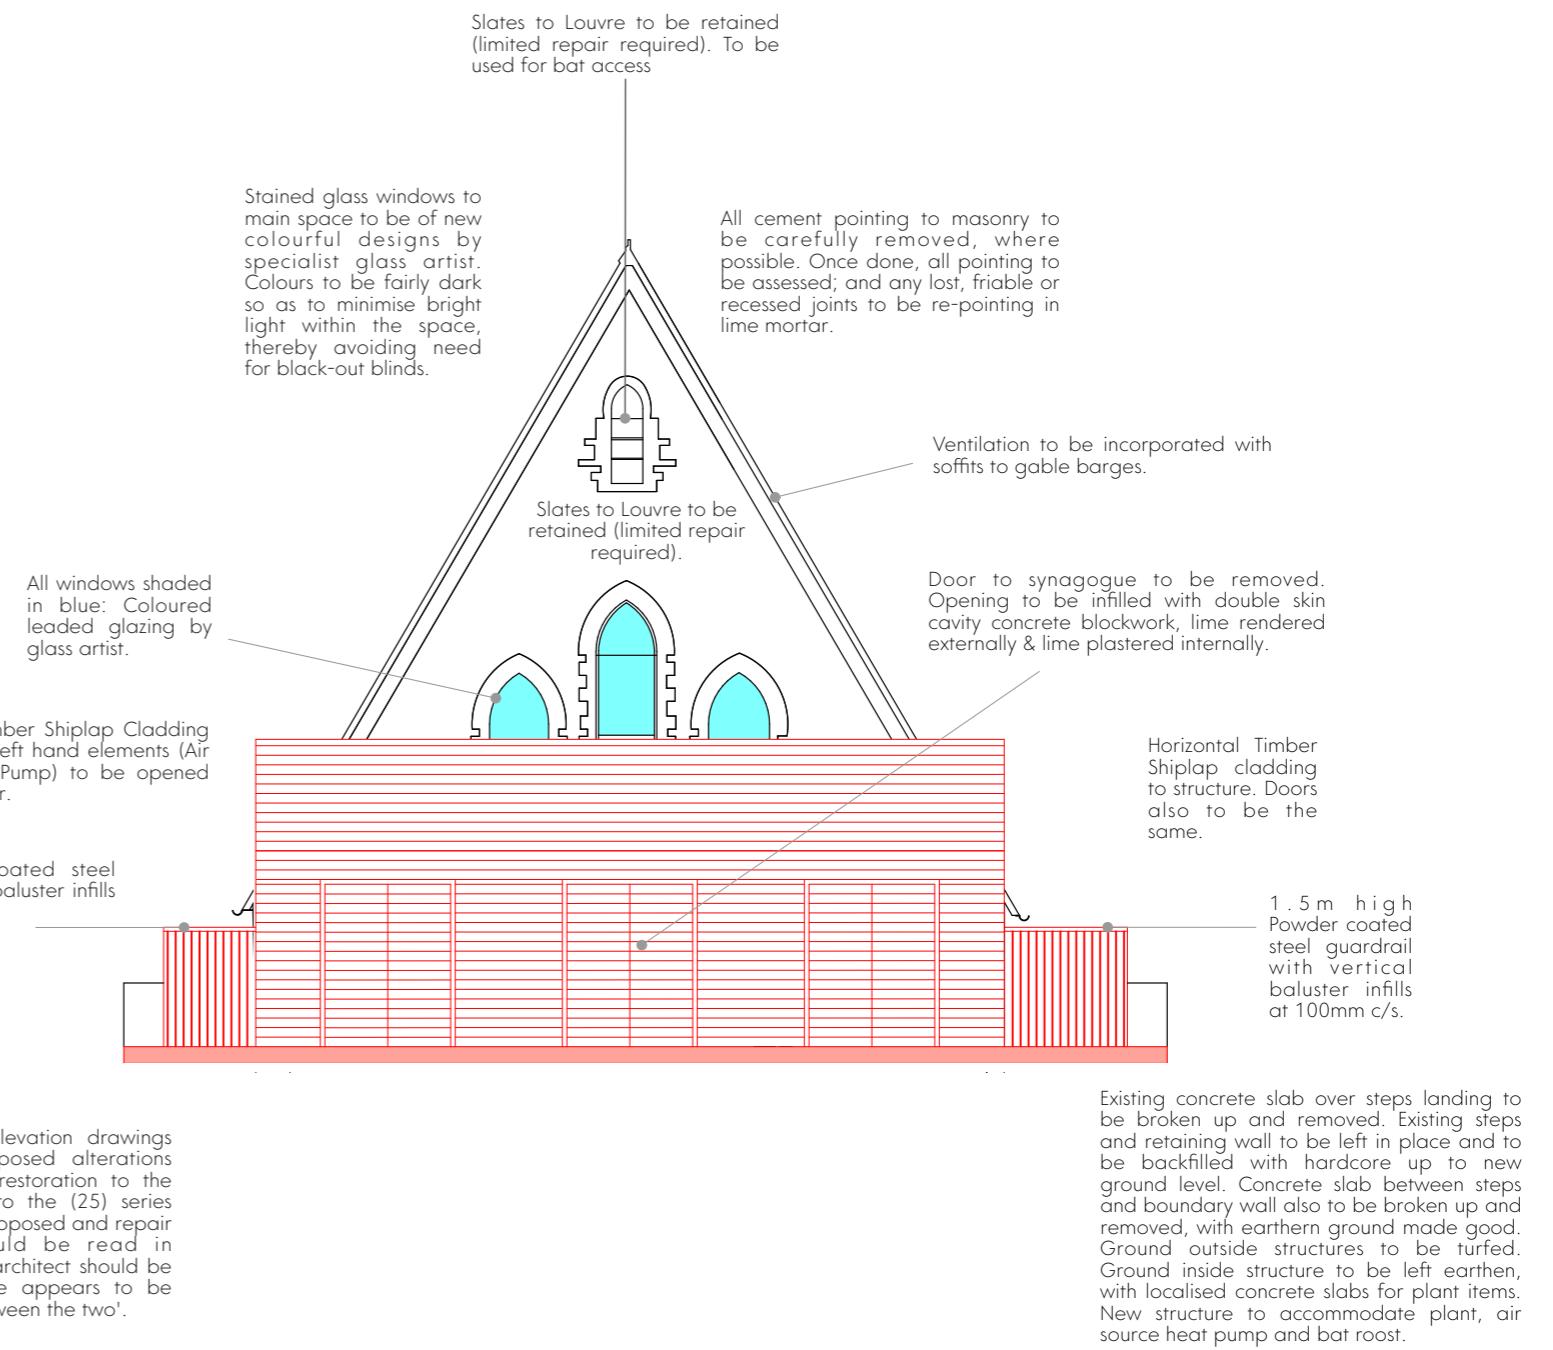
PROPOSED EAST (REAR) ELEVATION

'The proposed elevation drawings identify the proposed alterations and matters of restoration to the envelope, refer to the (25) series drawings. Both proposed and repair elevations should be read in conjunction. The architect should be consulted if there appears to be contradiction between the two'.

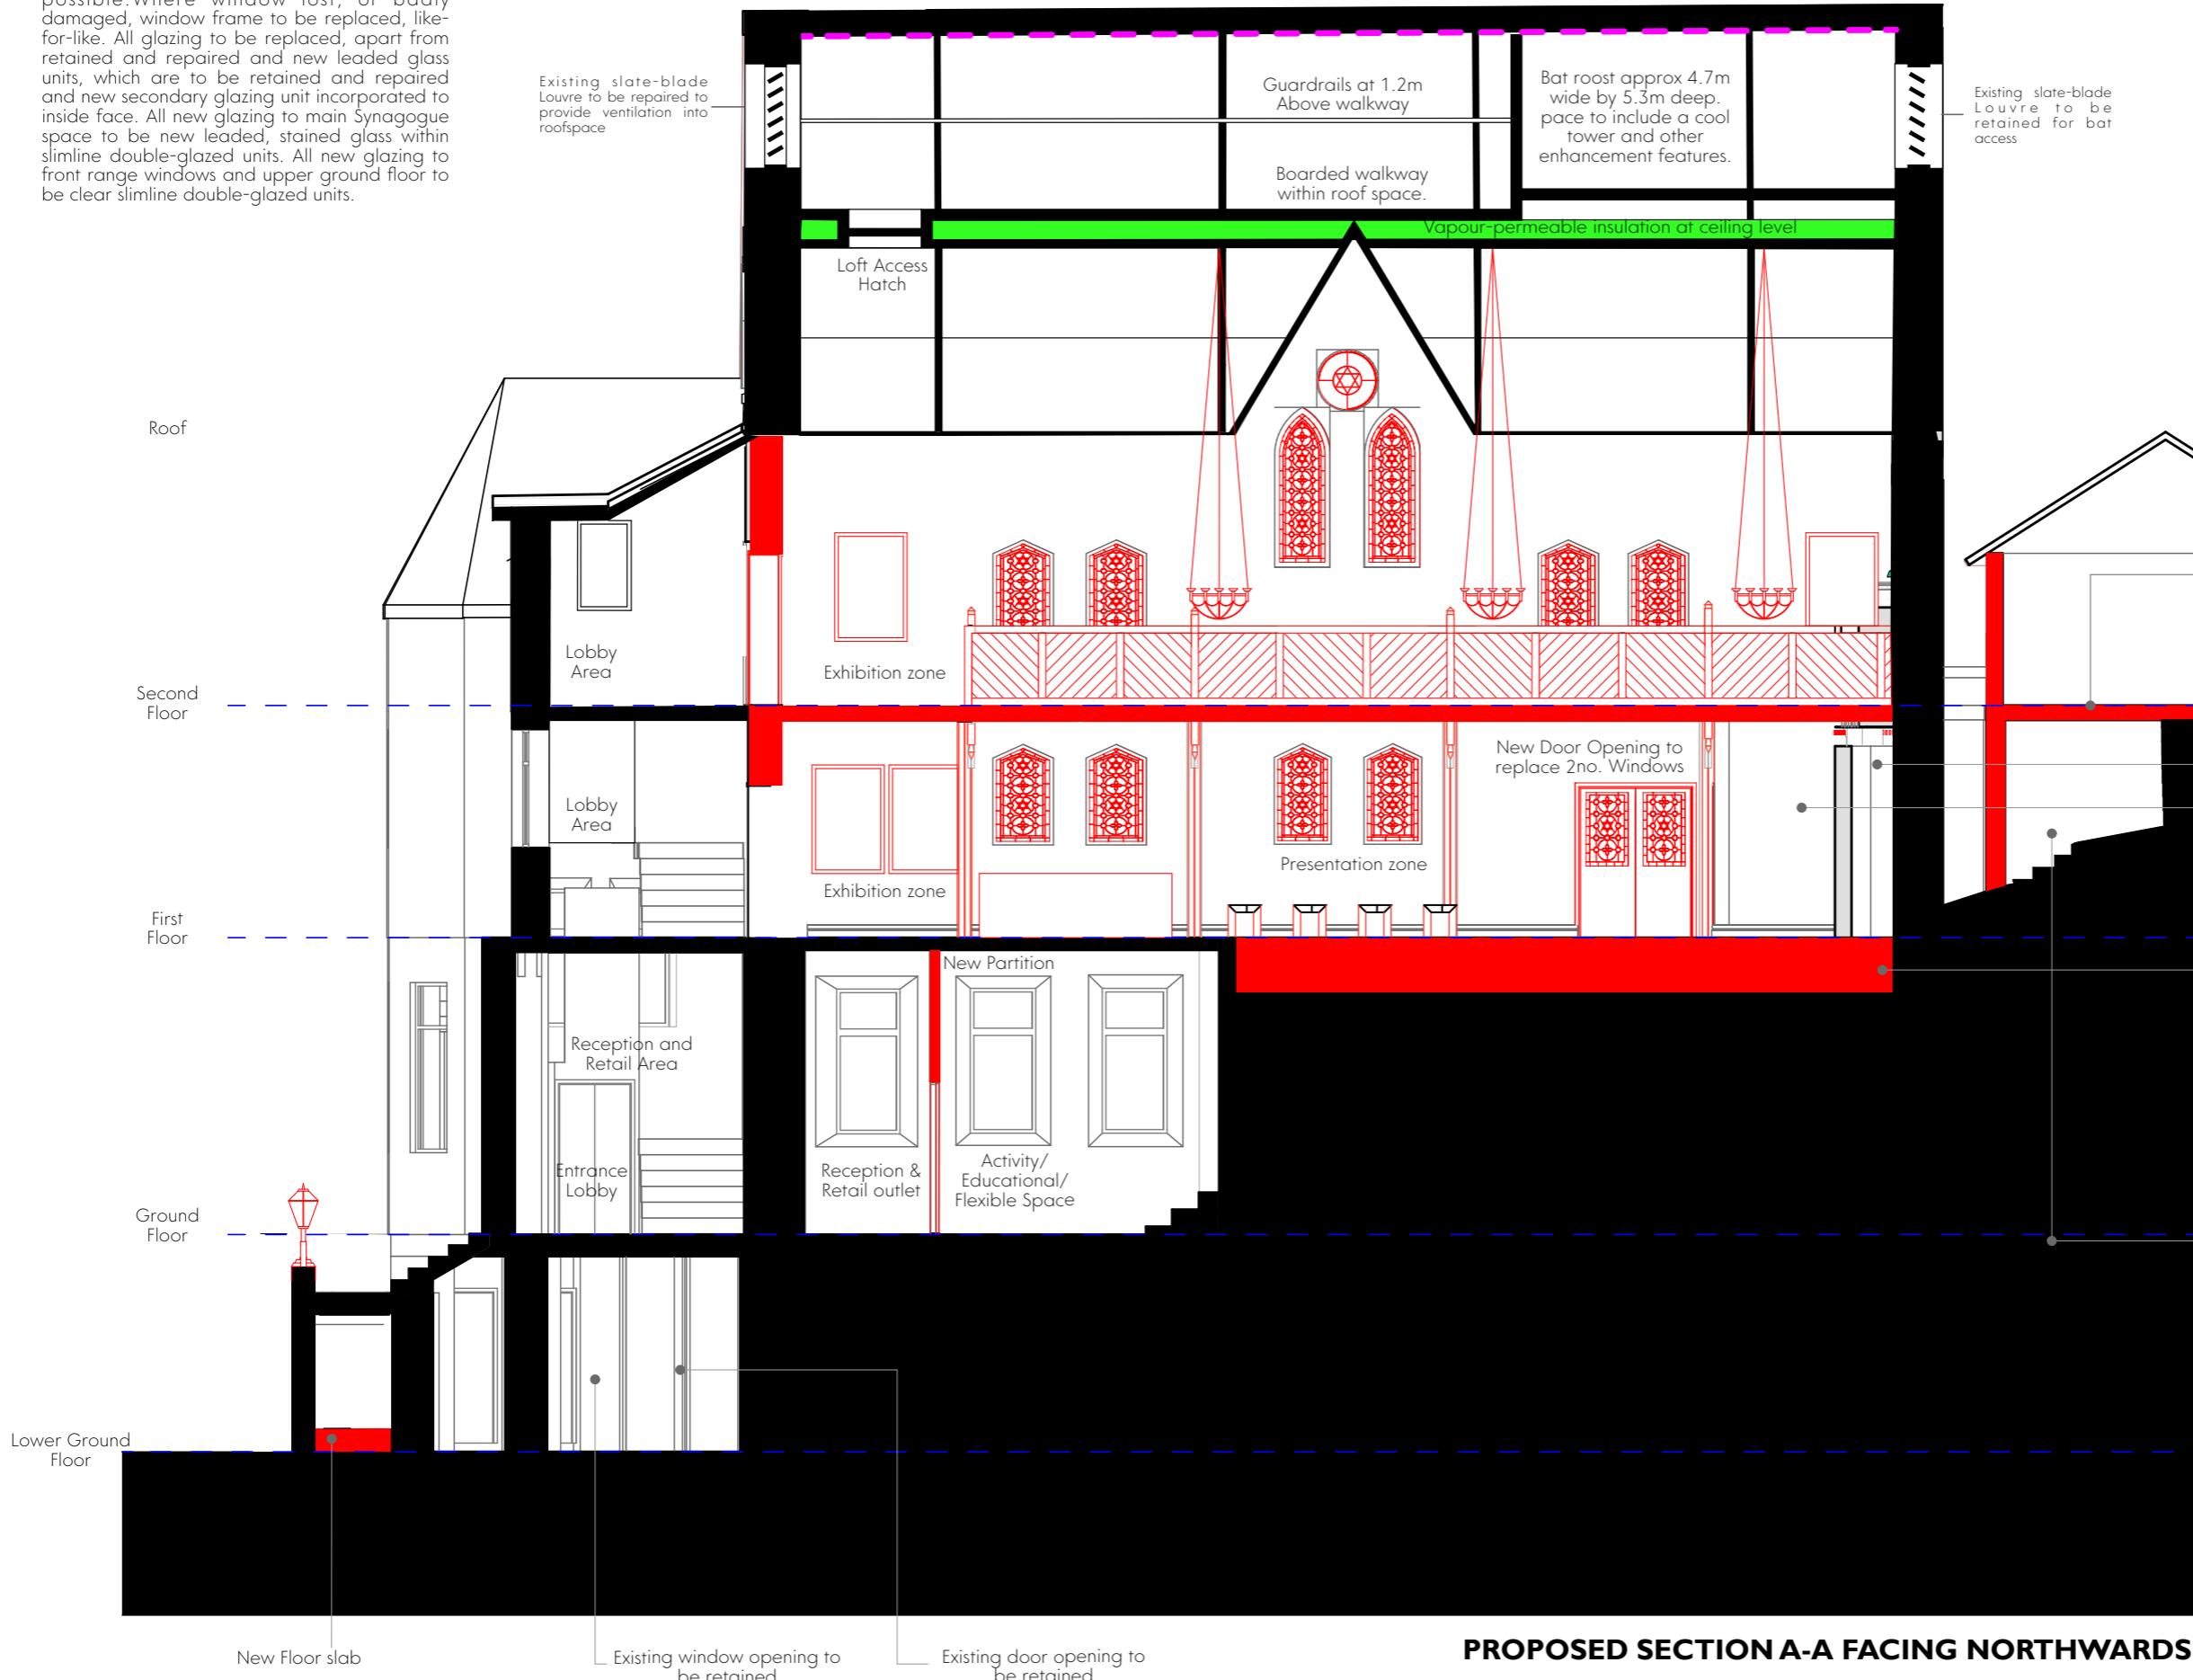
PROPOSED SECTION A-A FACING NORTHWARDS

Externally, all cement pointing to masonry to be carefully removed, where possible. Once done, all pointing to be assessed; and any lost, friable or recessed joints to be re-pointing in lime mortar. Internally, all cement/gypsum plaster to be removed; and all existing walls to be re-plastered in a 3-coat lime plaster and finished in a vapour-permeable paint.

Roof membrane to be laid under slates and battens for entire bat roost, membrane to be 'TXL Batsafe' or 'Siga Majcoat 350'. May be the same to rest of roof; however, may also be different, more vapour-permeable membrane, such as Procter Roofshield. Ensure general membrane does not extend to bat roost.

Lockable service hatch in partition for monitoring purposes by a licensed bat worker

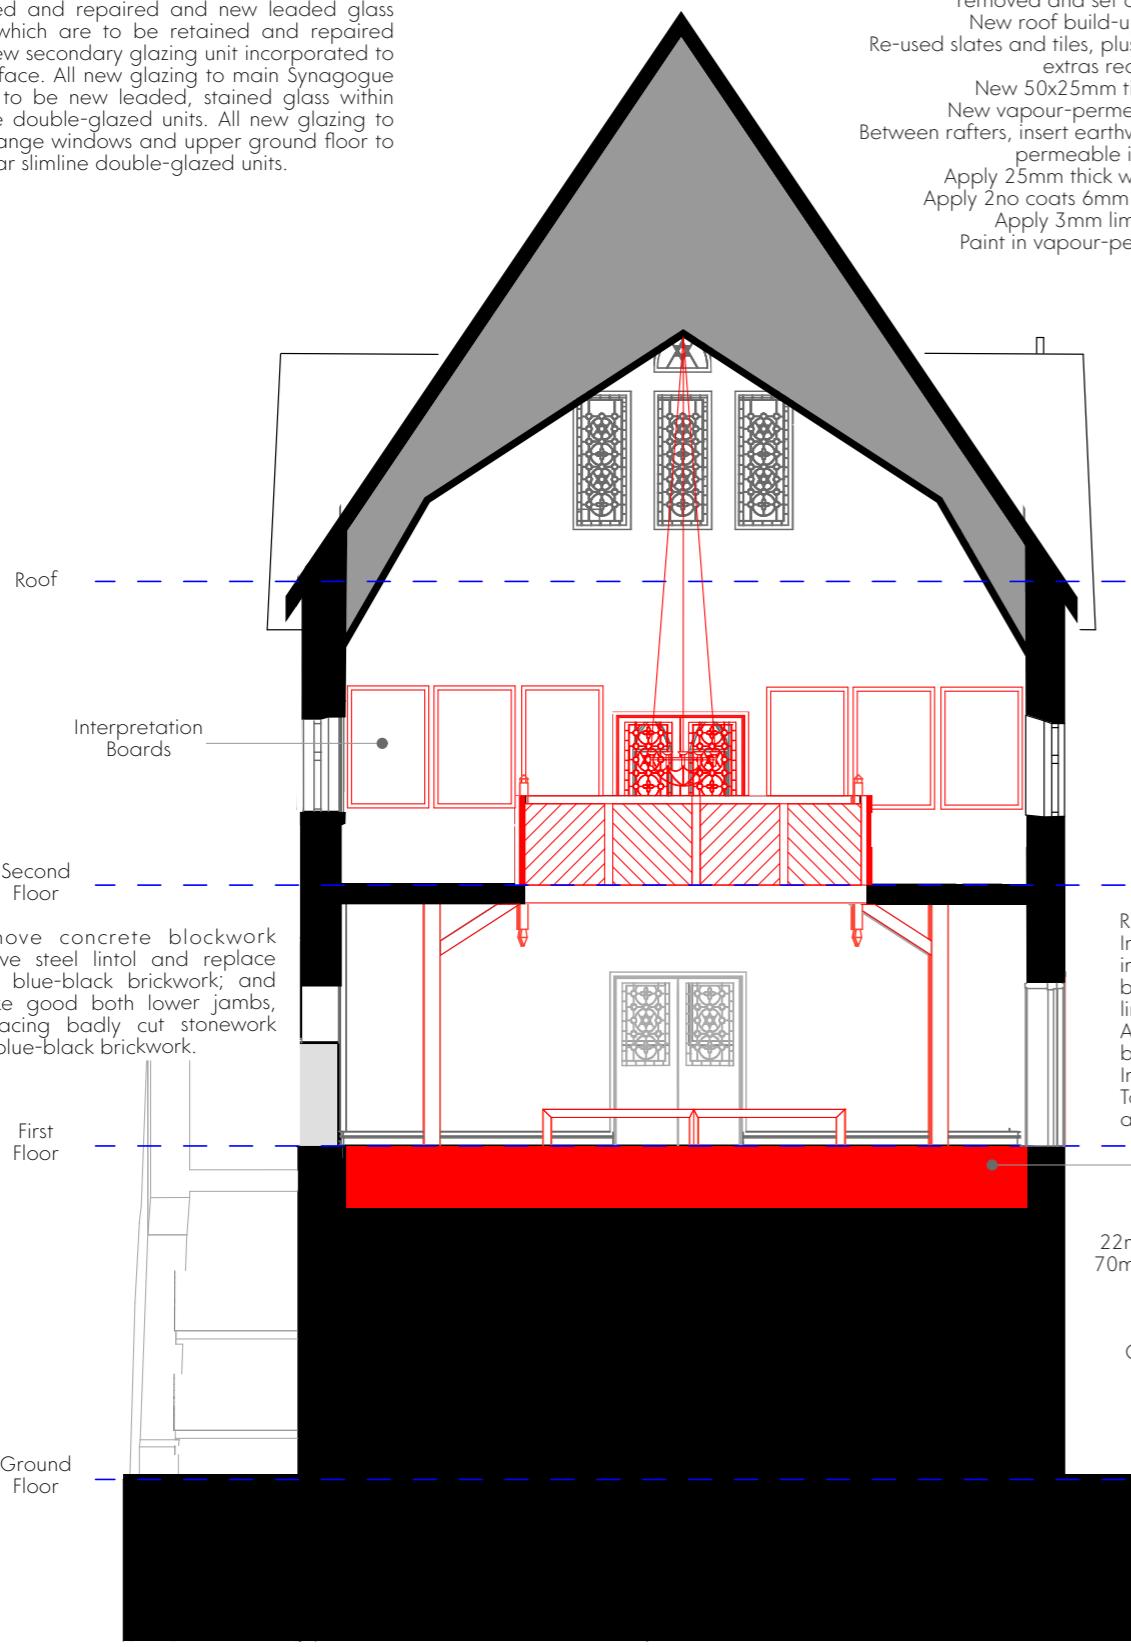
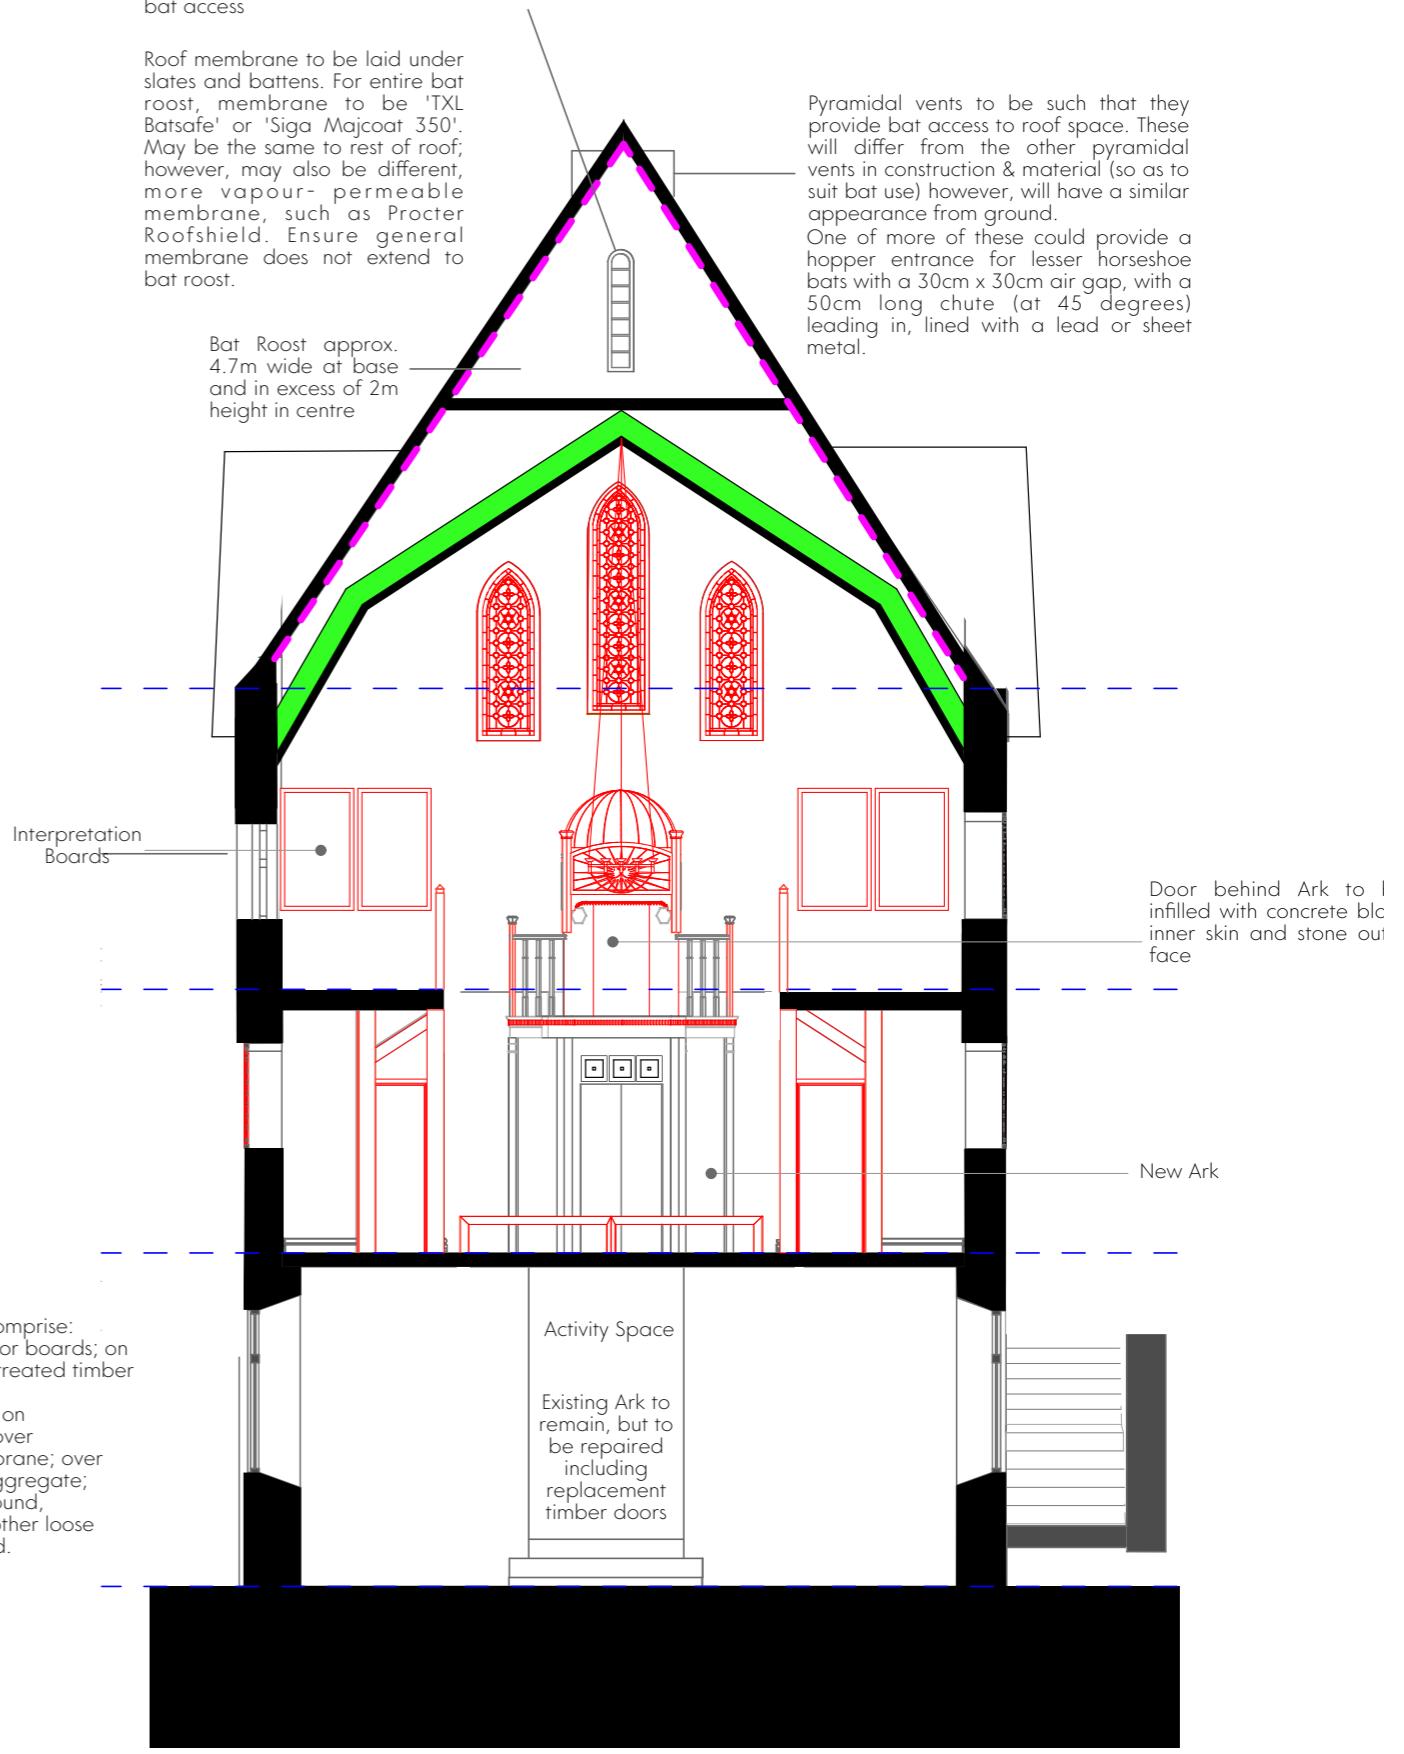
6.6.19 Proposed Cross Sections Through Main Space

Externally, all cement pointing to masonry to be carefully removed, where possible. Once done, all pointing to be assessed; and any lost, friable or recessed joints to be re-pointing in lime mortar. Internally, all cement/gypsum plaster to be removed; and all existing walls to be re-plastered in a 3-coat lime plaster and finished in a vapour-permeable paint.

All window frames to be repaired, where possible. Where window lost, or badly damaged, window frame to be replaced, like-for-like. All glazing to be replaced, apart from retained and repaired and new leaded glass units, which are to be retained and repaired and new secondary glazing unit incorporated to inside face. All new glazing to main Synagogue space to be new leaded, stained glass within slimline double-glazed units. All new glazing to front range windows and upper ground floor to be clear slimline double-glazed units.

All roof to be stripped of slates, ridge tiles, leadwork, membrane & insulation. Slates & tiles to be carefully removed and set aside for re-use.
New roof build-up to comprise:
Re-used slates and tiles, plus new like-for-likes, where extras required;
New 50x25mm timber battens;
New vapour-permeable roofing felt;
Between rafters, insert earthwool or glasswool vapour-permeable insulation;
Apply 25mm thick woodwool boards;
Apply 2no coats 6mm lime hemp plaster;
Apply 3mm lime top coat;
Paint in vapour-permeable paint.

Within roof plane over bat roost, there will be further access tiles and modified ridge tiles to provide dedicated access into the roof for crevice-dwelling species present onsite. Access will also be created under some of the standard roof slates, by cutting a notch from the new slate, which will lead to the narrow space between membrane, timbers and slates. Notches will also be cut out of the battens in some areas to enable the bats to move more easily up and down the roof under the slates.

Roof membrane to be laid under slates and battens. For entire bat roost, membrane to be 'TXL Batsafe' or 'Siga Majcoat 350'. May be the same to rest of roof; however, may also be different, more vapour-permeable membrane, such as Procter Roofshield. Ensure general membrane does not extend to bat roost.

Bat Roost approx. 4.7m wide at base and in excess of 2m height in centre

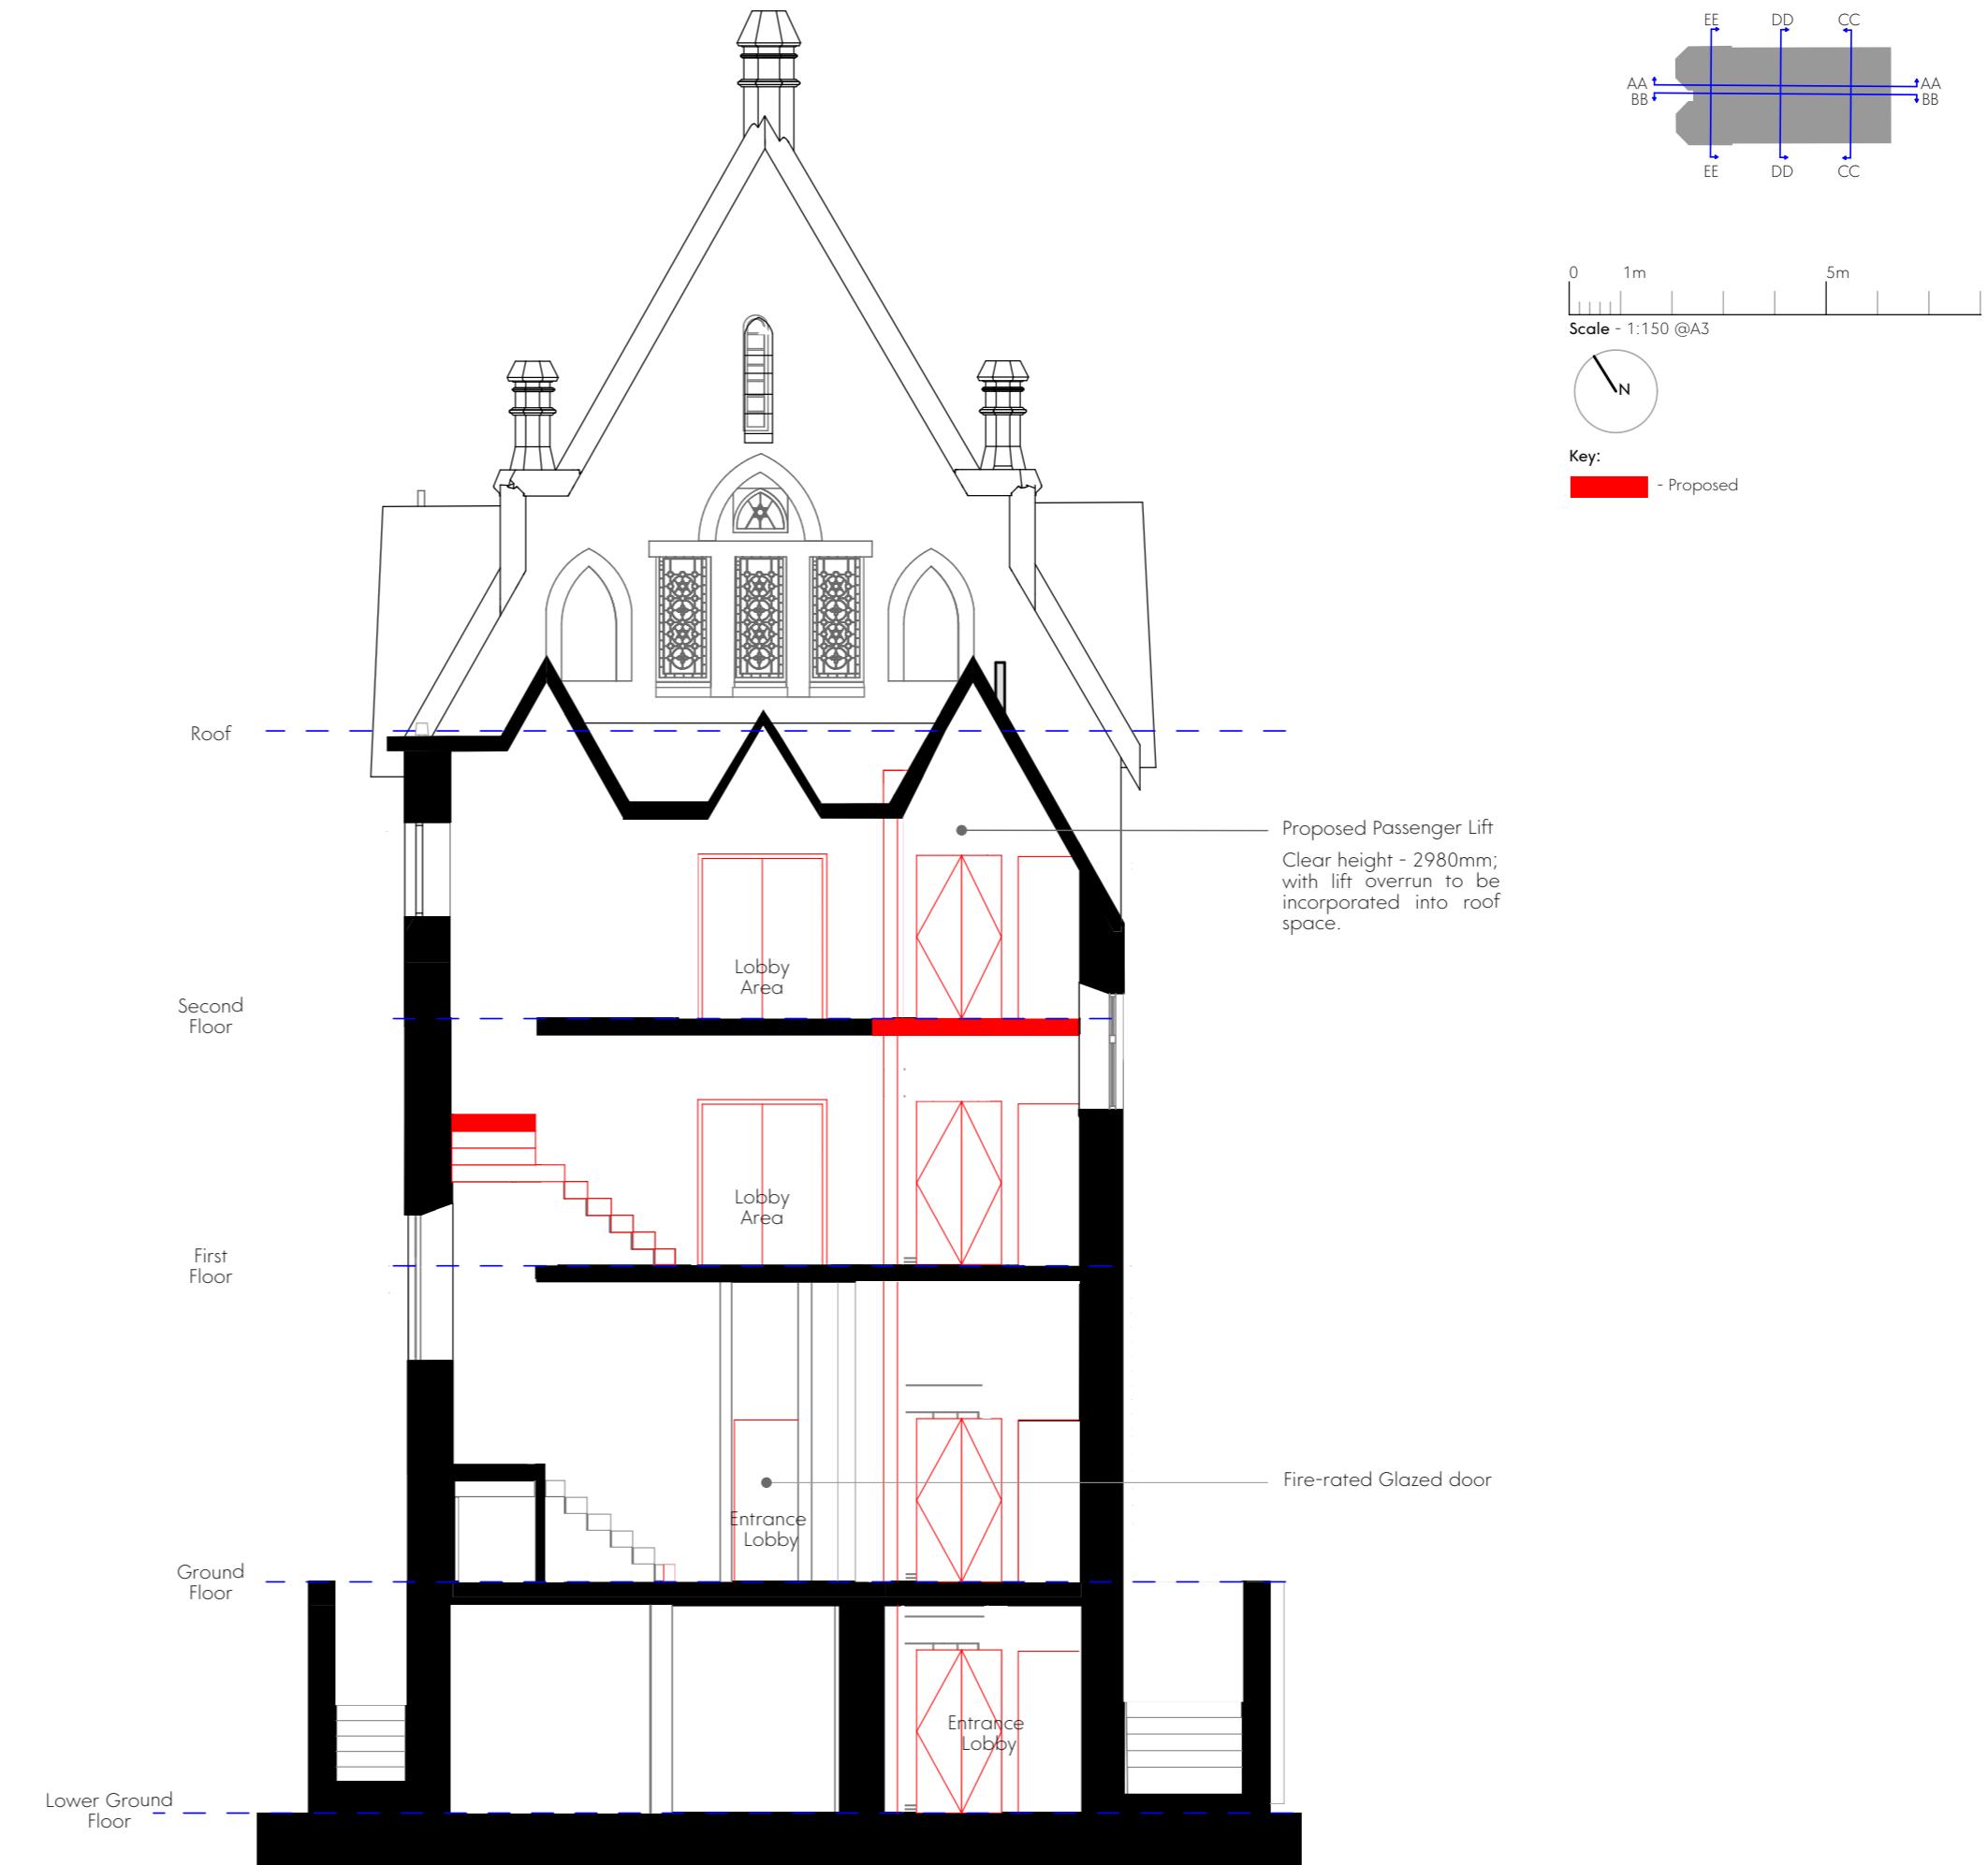
6.6.20 Proposed Cross Sections Through Front Range

Externally, all cement pointing to masonry to be carefully removed, where possible. Once done, all pointing to be assessed; and any lost, friable or recessed joints to be re-pointing in lime mortar. Internally, all cement/gypsum plaster to be removed; and all existing walls to be replastered in a 3-coat lime plaster and finished in a vapour-permeable paint.

All window frames to be repaired, where possible. Where window lost, or badly damaged, window frame to be replaced, like-for-like. All glazing to be replaced, apart from retained and repaired and new leaded glass units, which are to be retained and repaired and new secondary glazing unit incorporated to inside face. All new glazing to main Synagogue space to be new leaded, stained glass within slimline double-glazed units. All new glazing to front range windows and upper ground floor to be clear slimline double-glazed units.

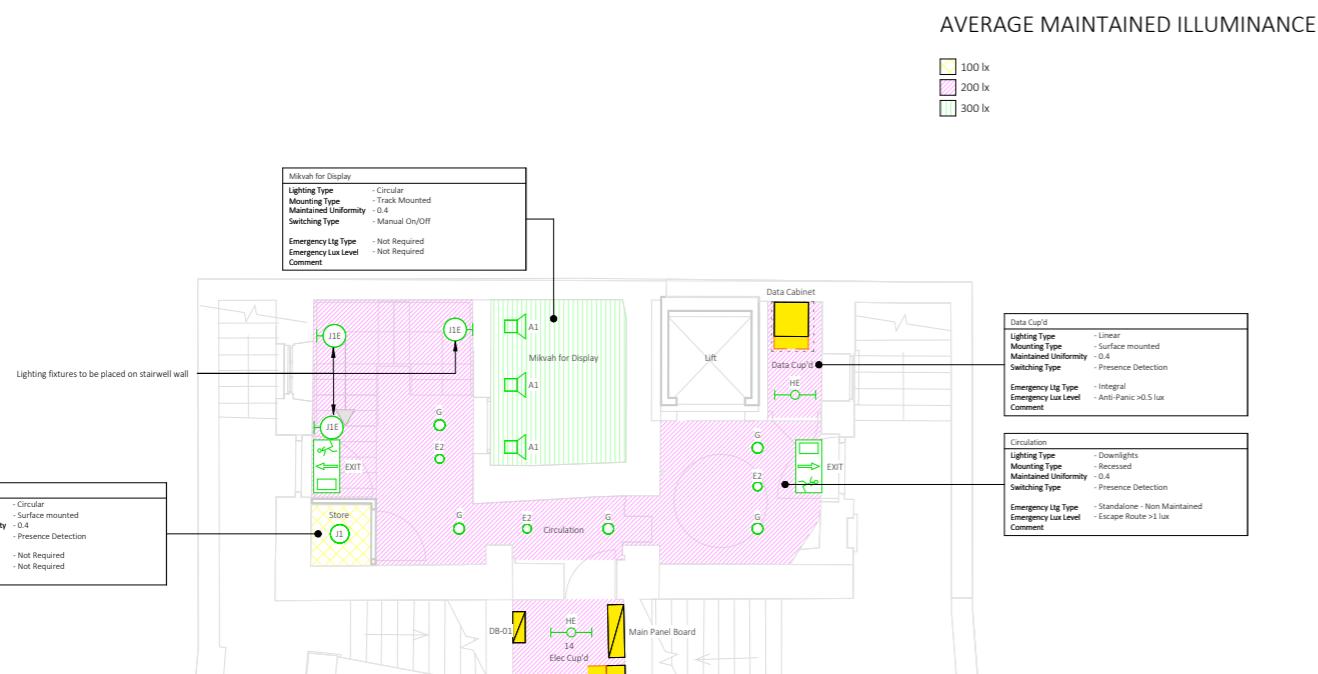
PROPOSED LOWER GROUND FLOOR PLAN

6.6.23 Proposed Lighting Layouts - Lower Ground & Upper Ground Floors, produced by Hydrock (now Stantec)
