THE FORMER SYNAGOGUE

THE PROPOSALS

.....
(449)2503-GWP-A-HIS-P02

6.0 SECTION FOUR - EXPLANATION OF THE PROPOSALS

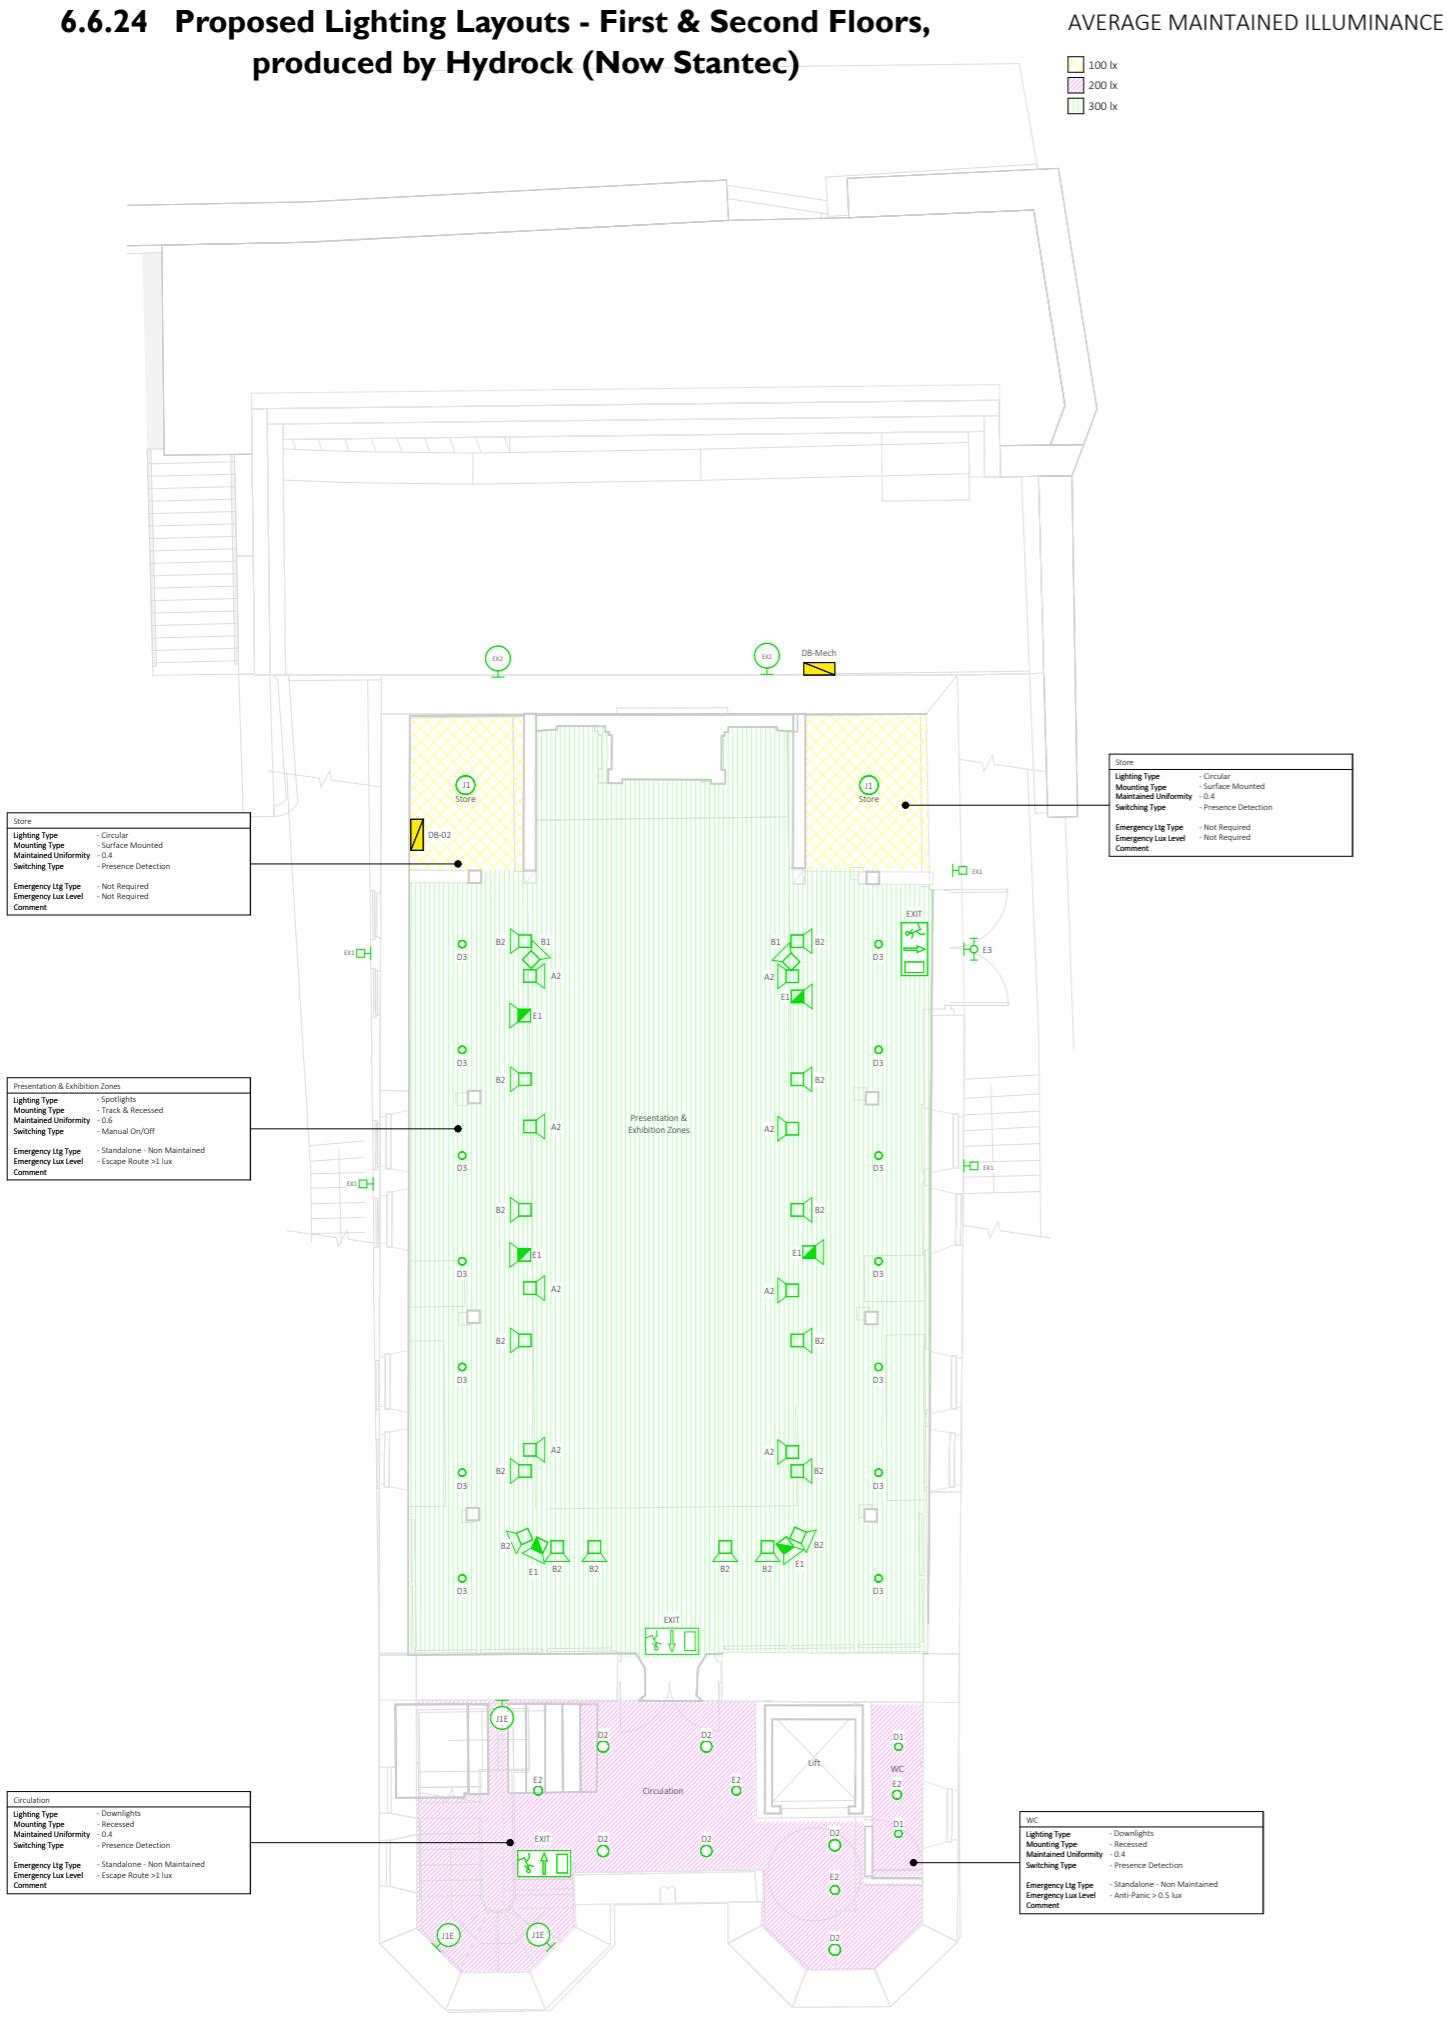
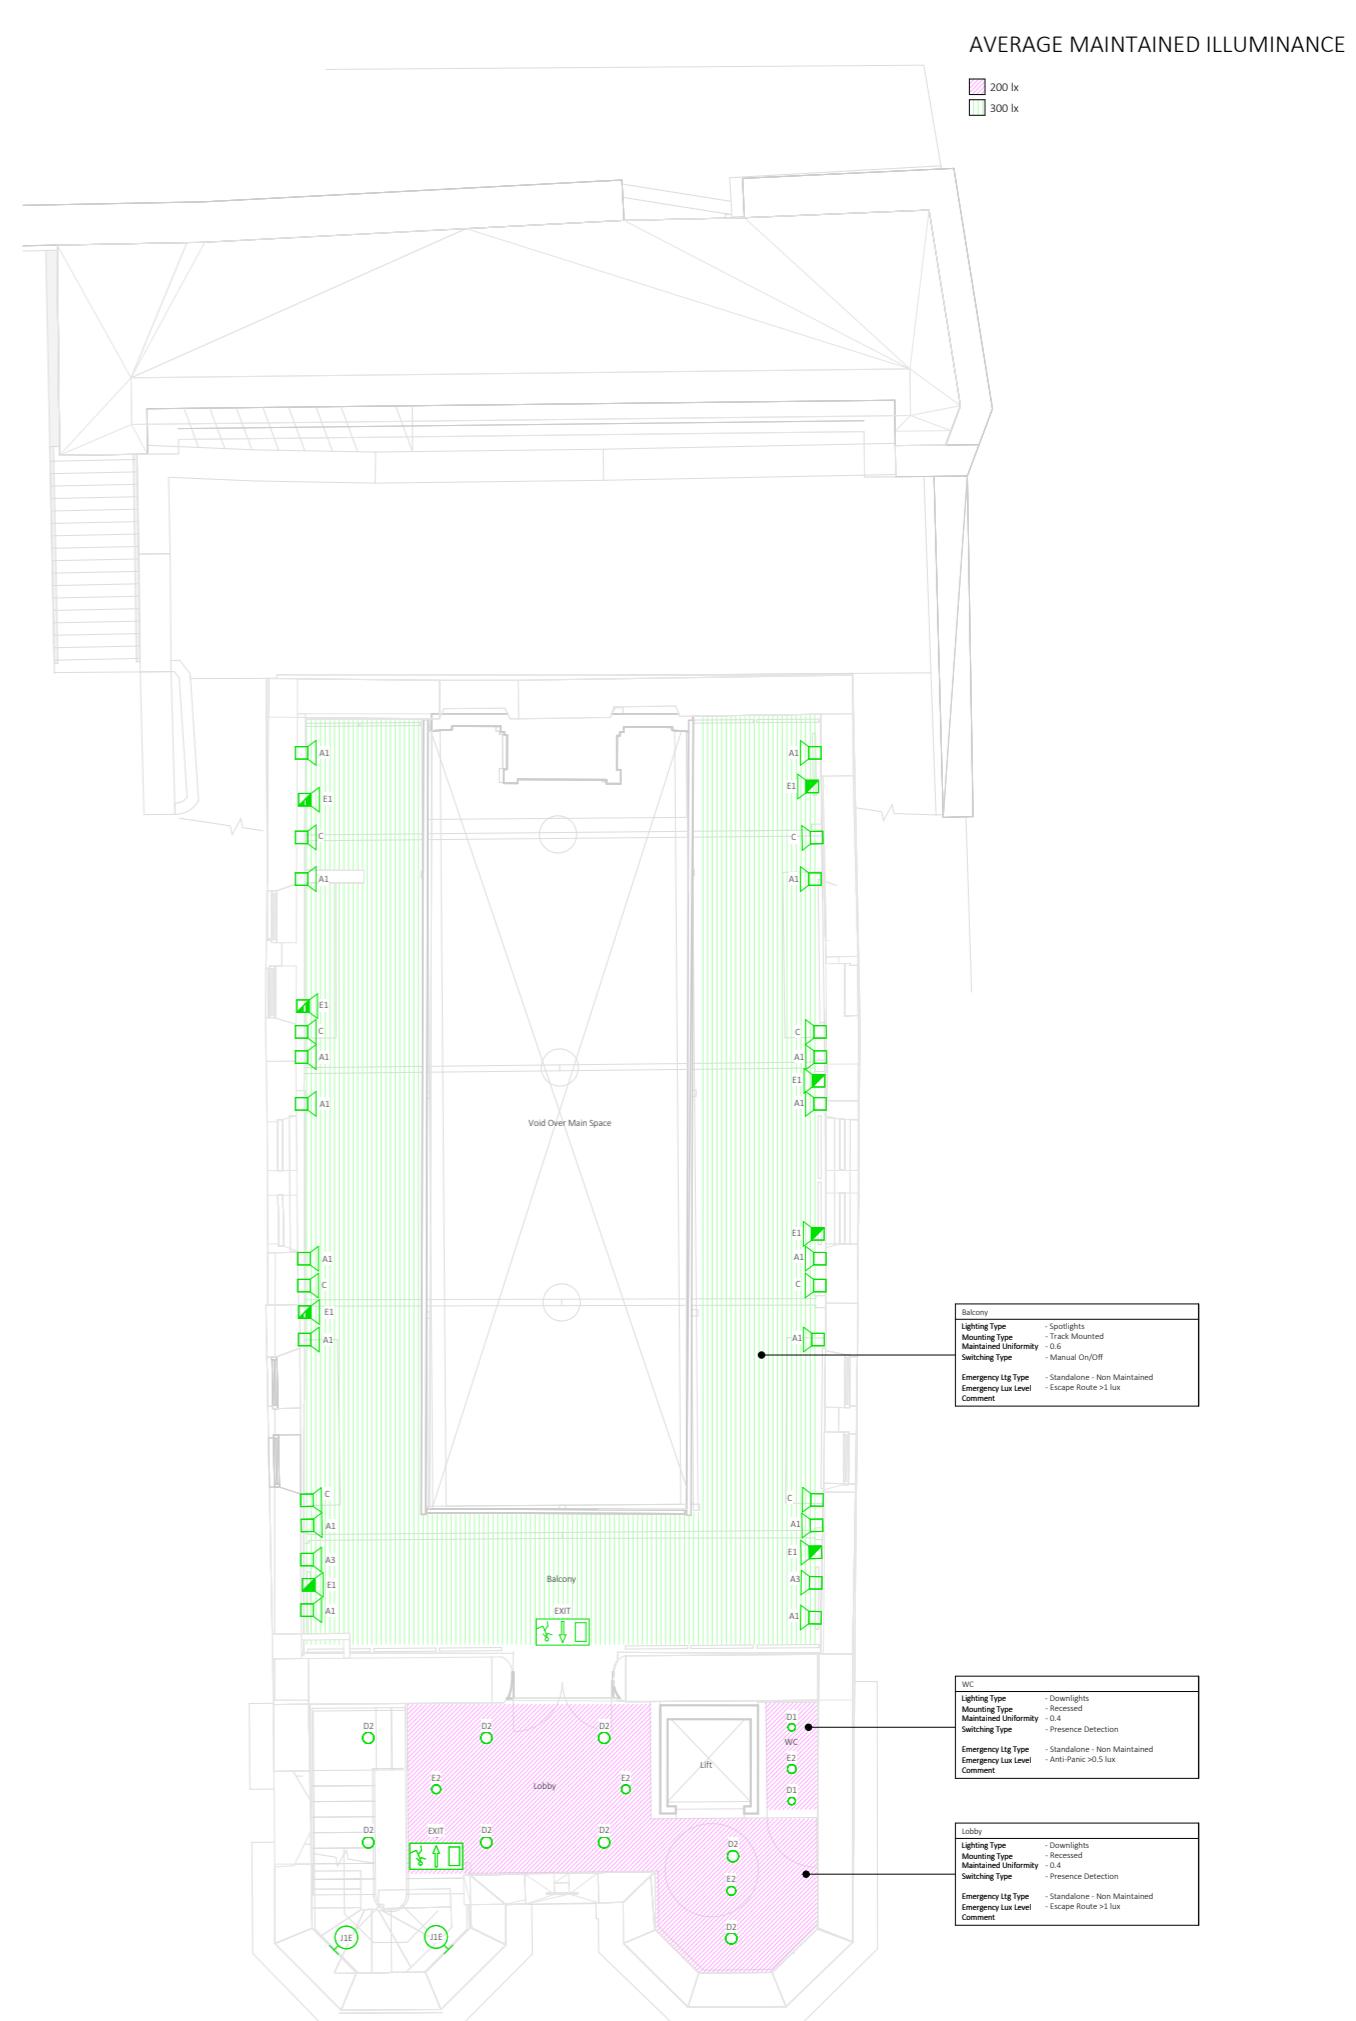
6.6.24 Proposed Lighting Layouts - First & Second Floors, produced by Hydrock (Now Stantec)

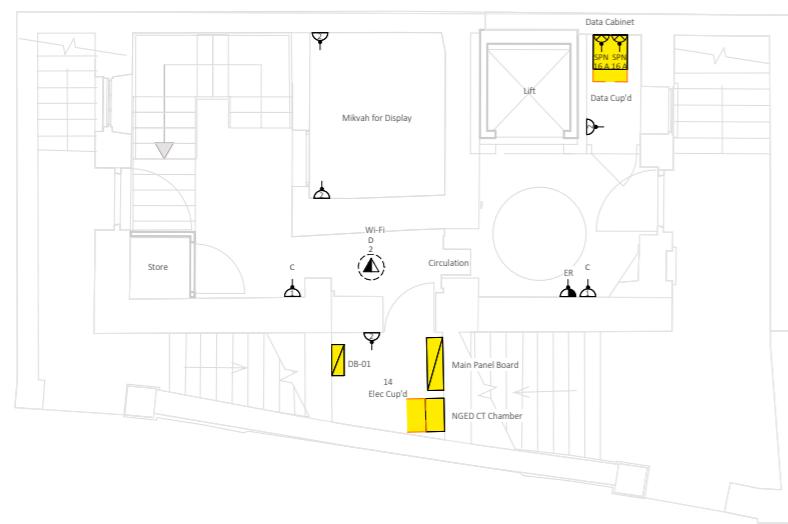
PROPOSED LOWER GROUND FLOOR PLAN

**6.6.25 Proposed Small Power Layouts - Lower Ground & Upper Ground Floors,
produced by Hydrock (now Stantec)**

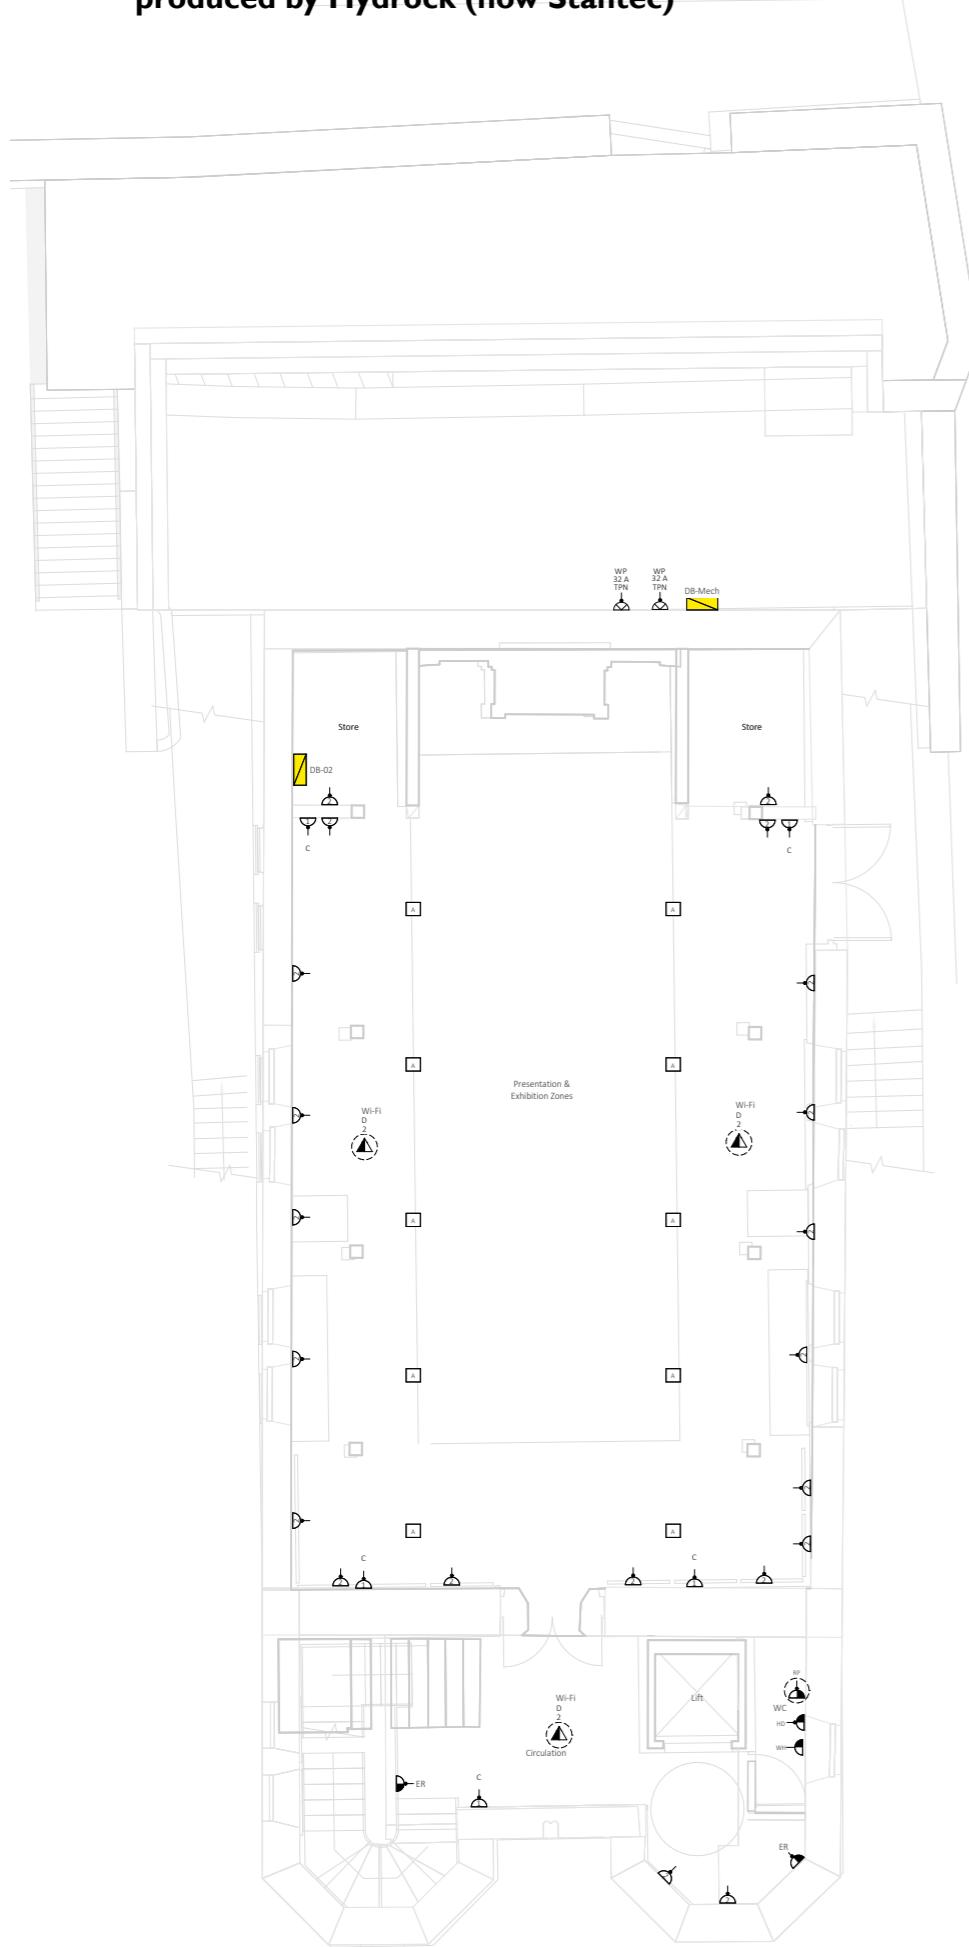
PROPOSED FIRST FLOOR PLAN

**6.6.26 Proposed Small Power Layouts - First & Second Floors,
produced by Hydrock (now Stantec)**

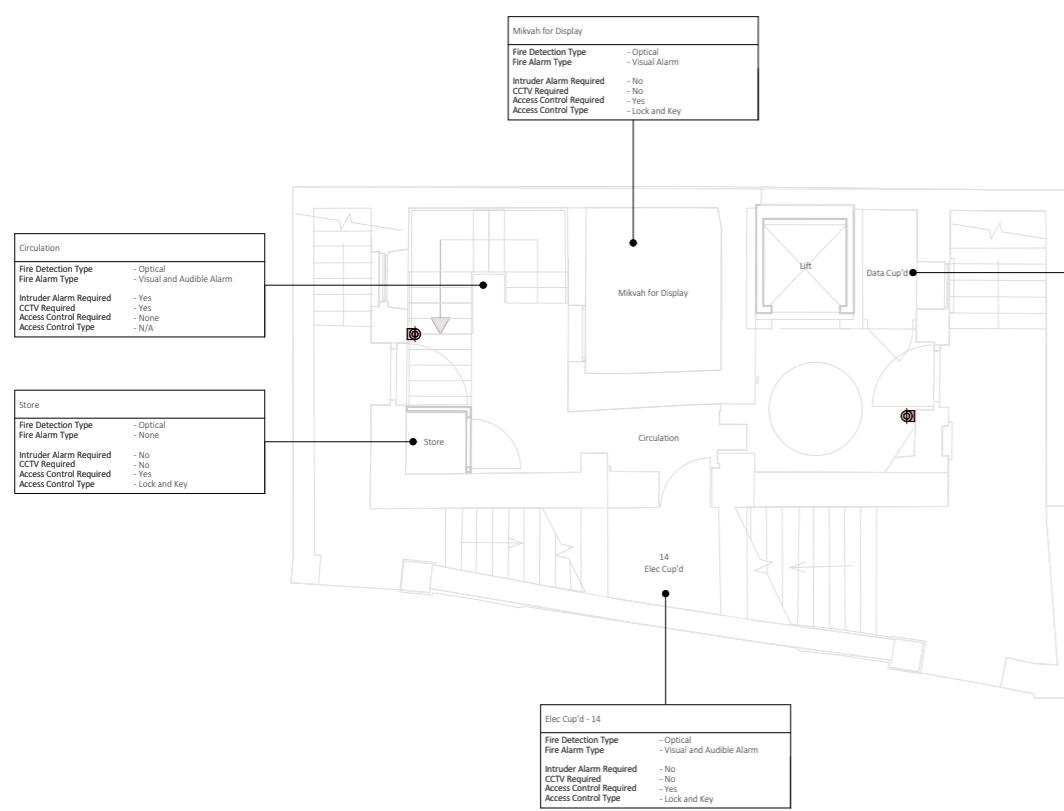
PROPOSED LOWER GROUND FLOOR PLAN

6.6.27 Proposed Protective Services Layouts - Lower Ground & Upper Ground Floors, produced by Hydrock (now Stantec)

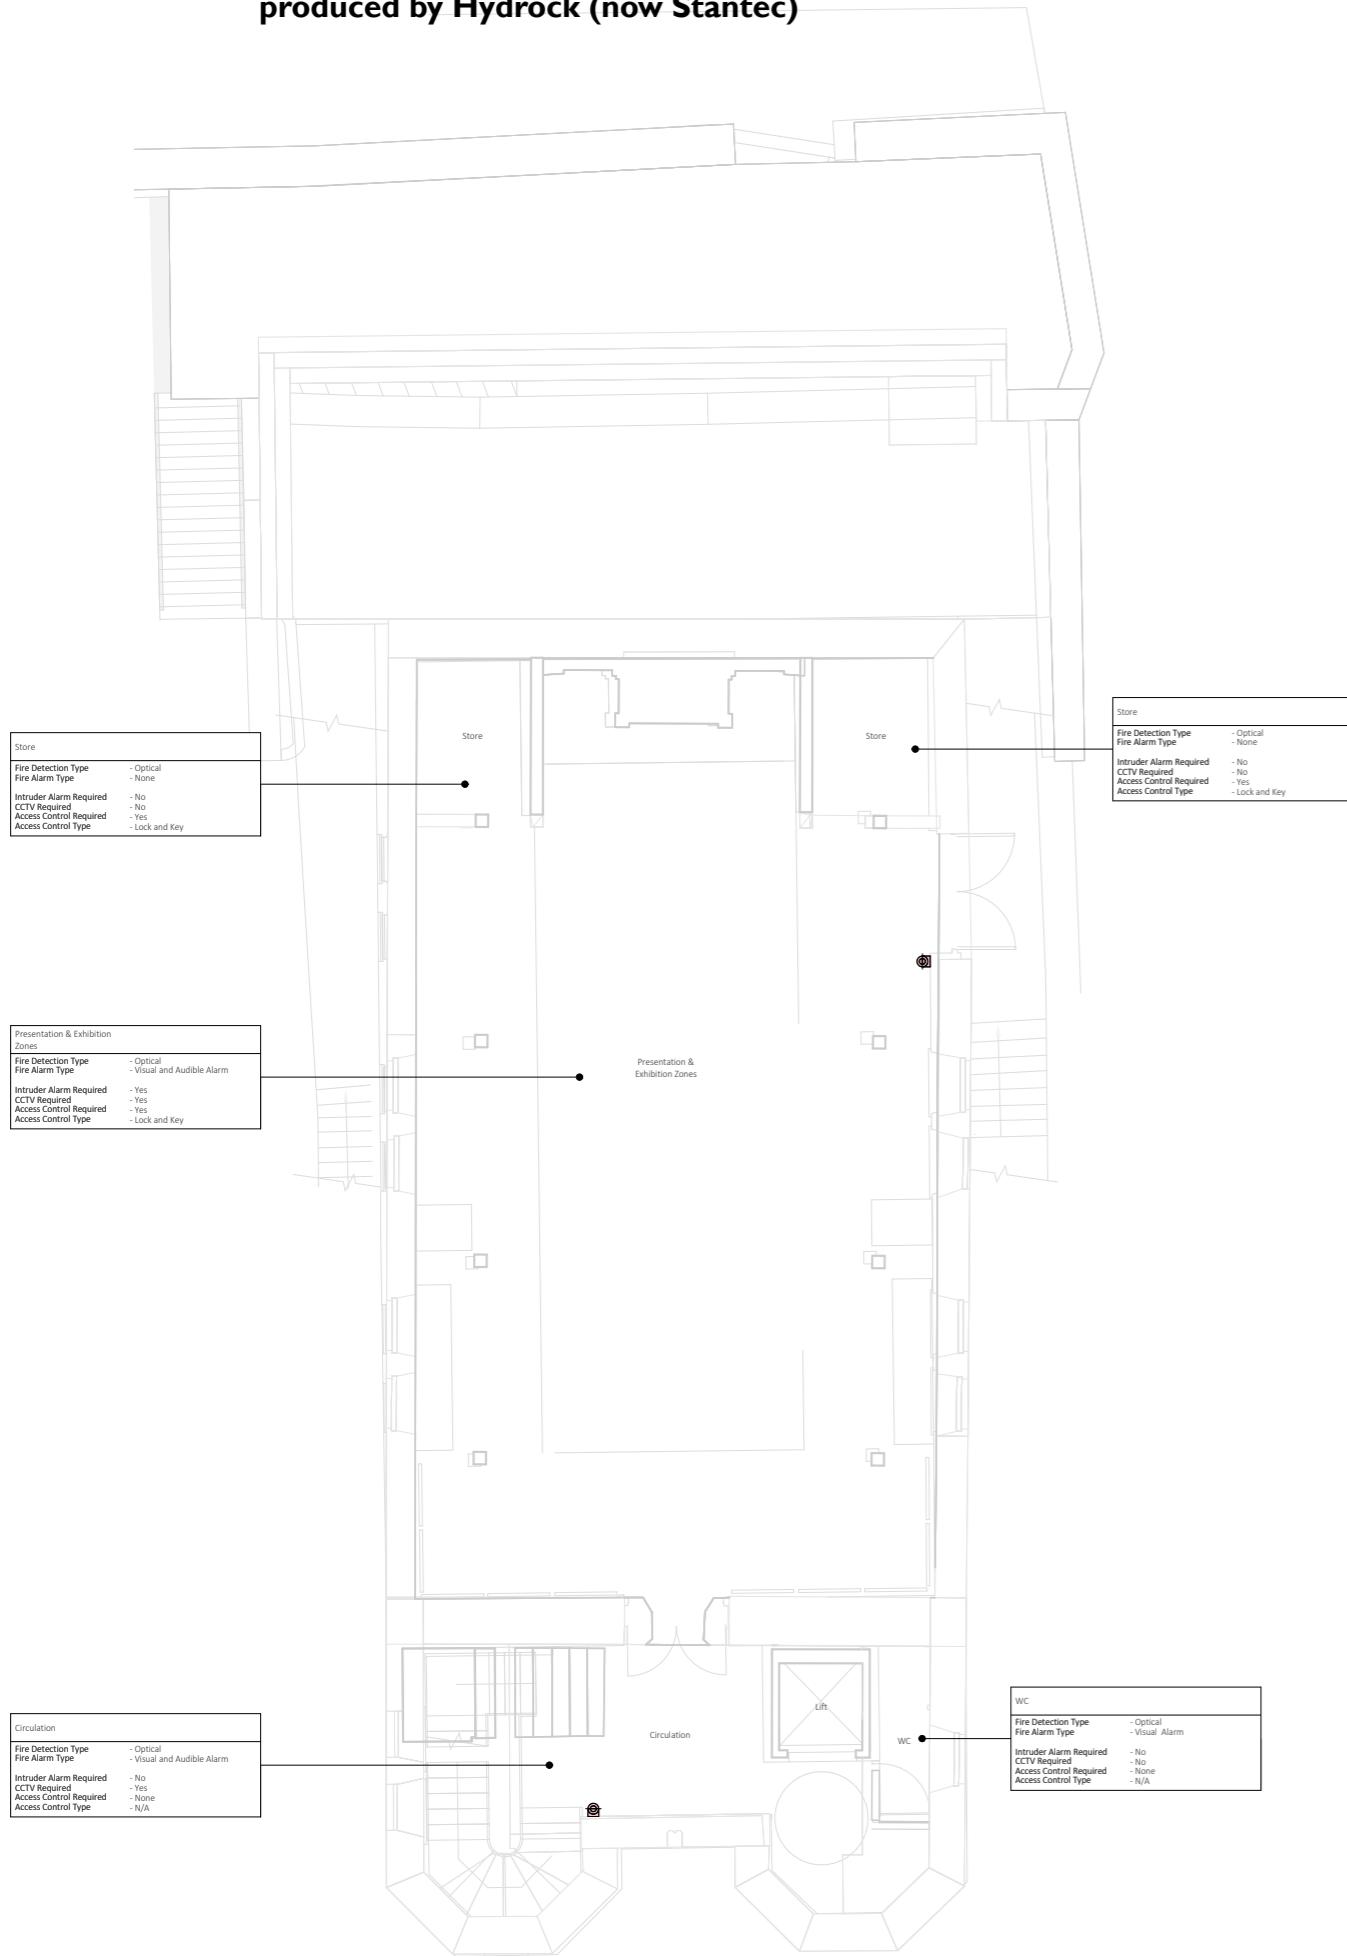
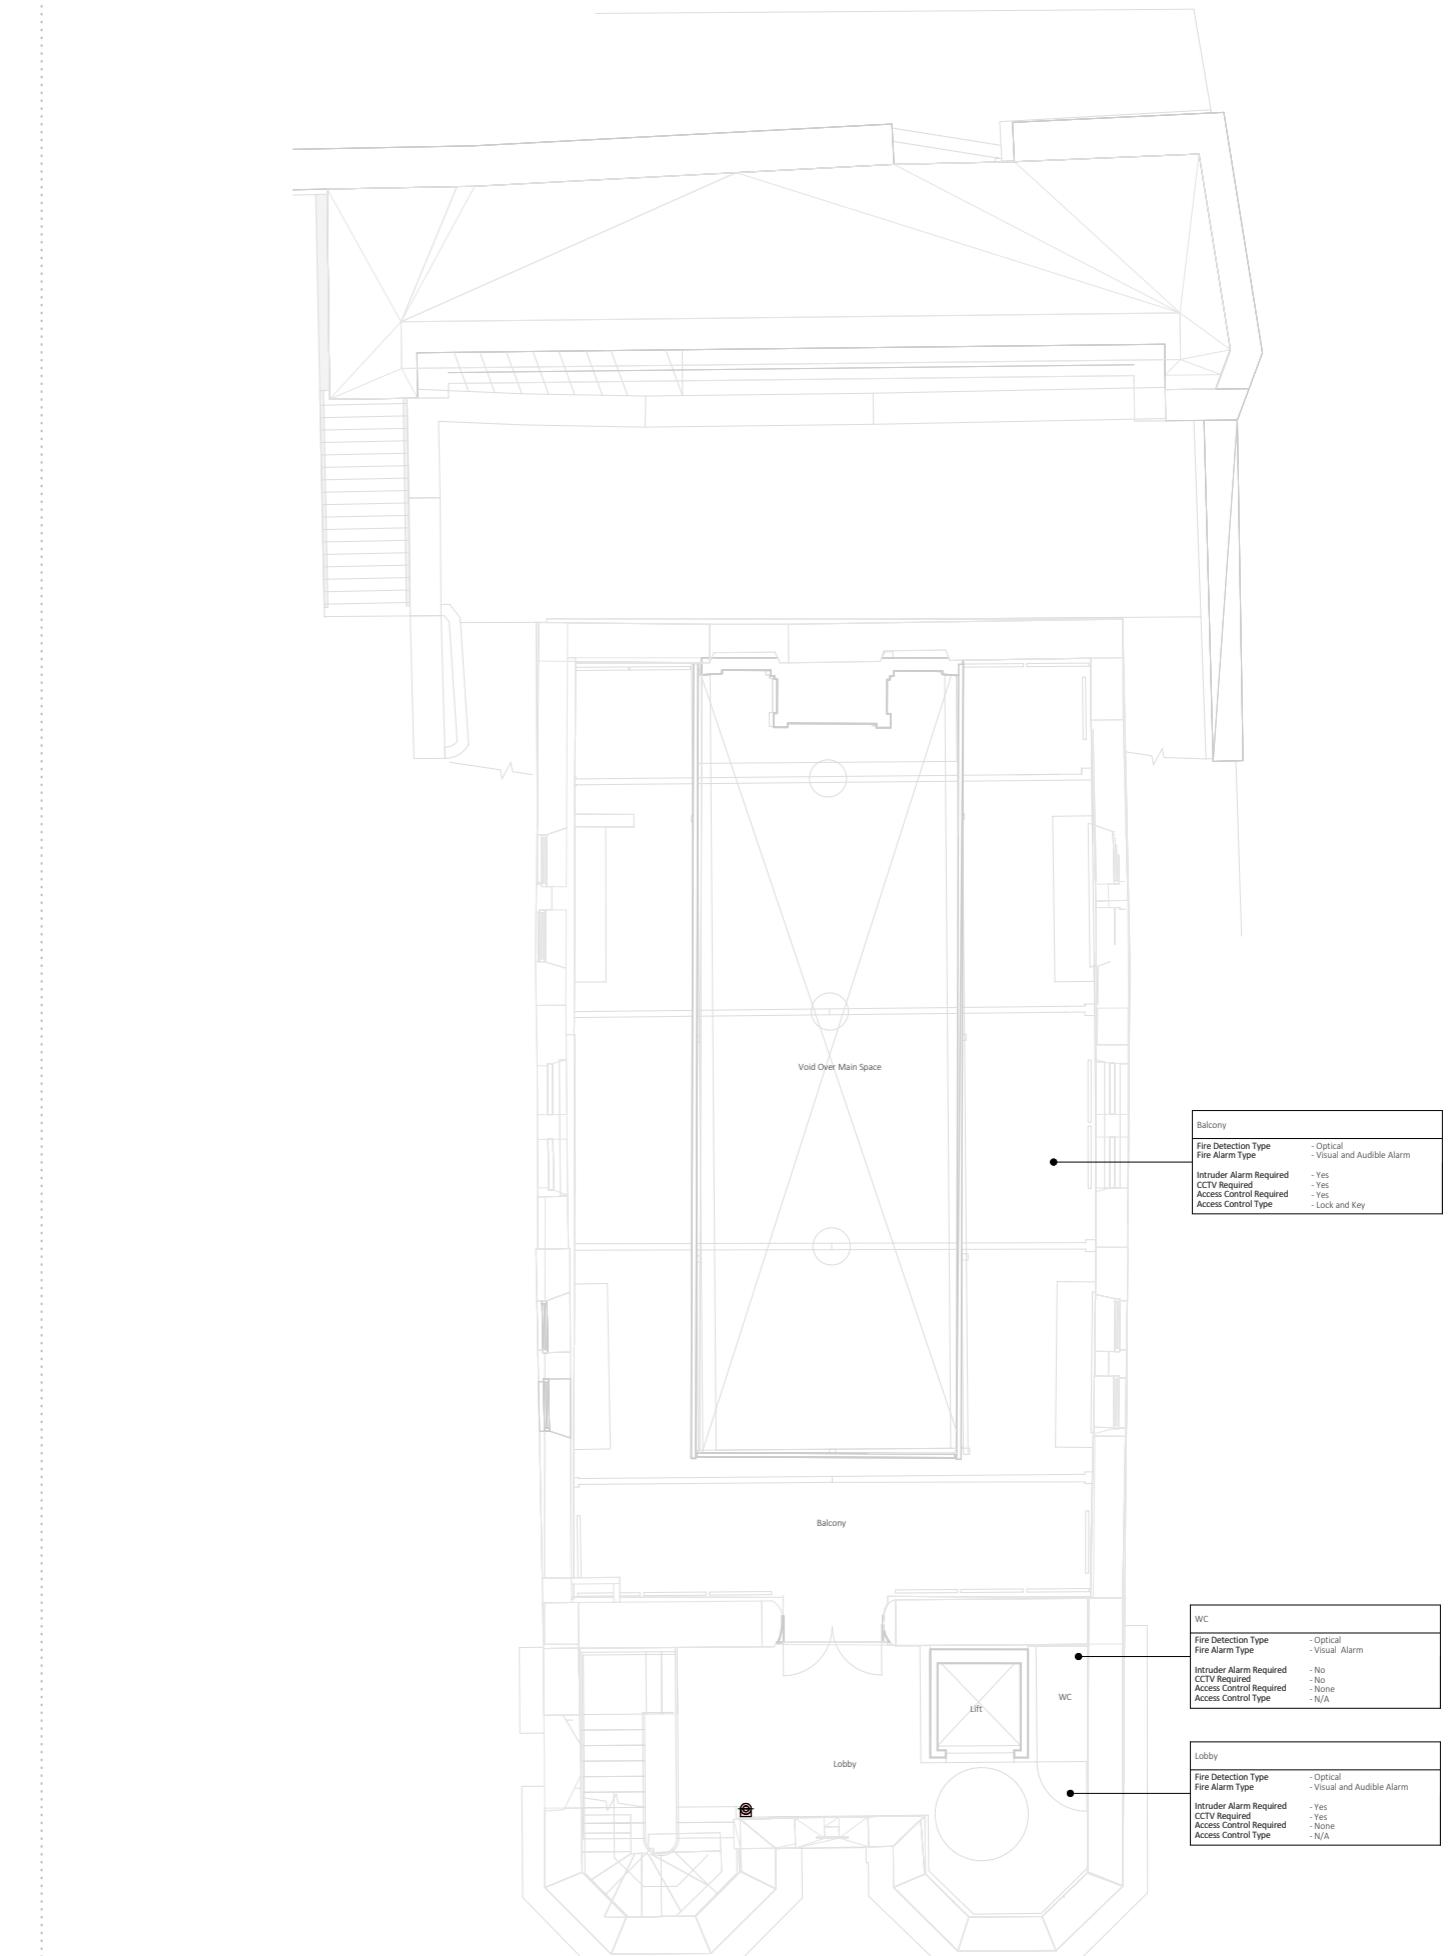
6.6.28 Proposed Protective Services Layouts - First & Second Floors, produced by Hydrock (now Stantec)

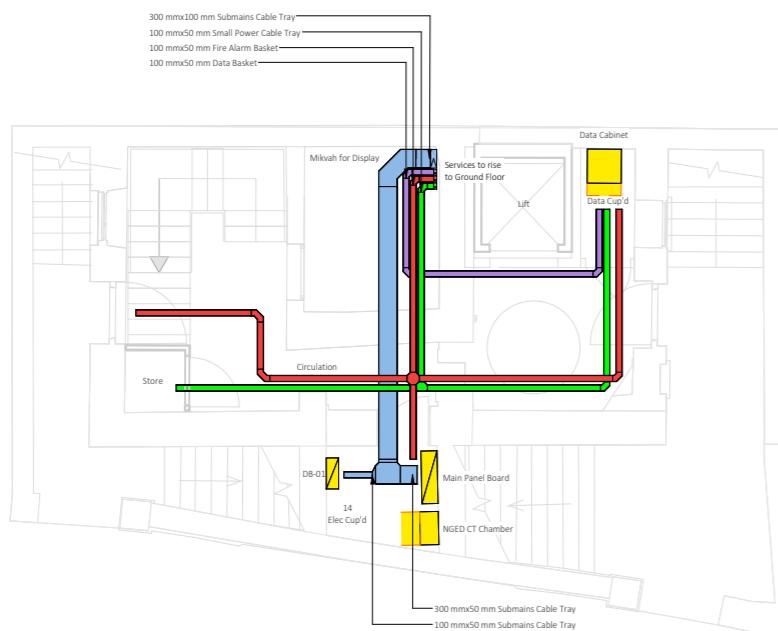
PROPOSED LOWER GROUND FLOOR PLAN

**6.6.29 Proposed Containment Layouts - Lower Ground & Upper Ground Floors,
produced by Hydrock (now Stantec)**

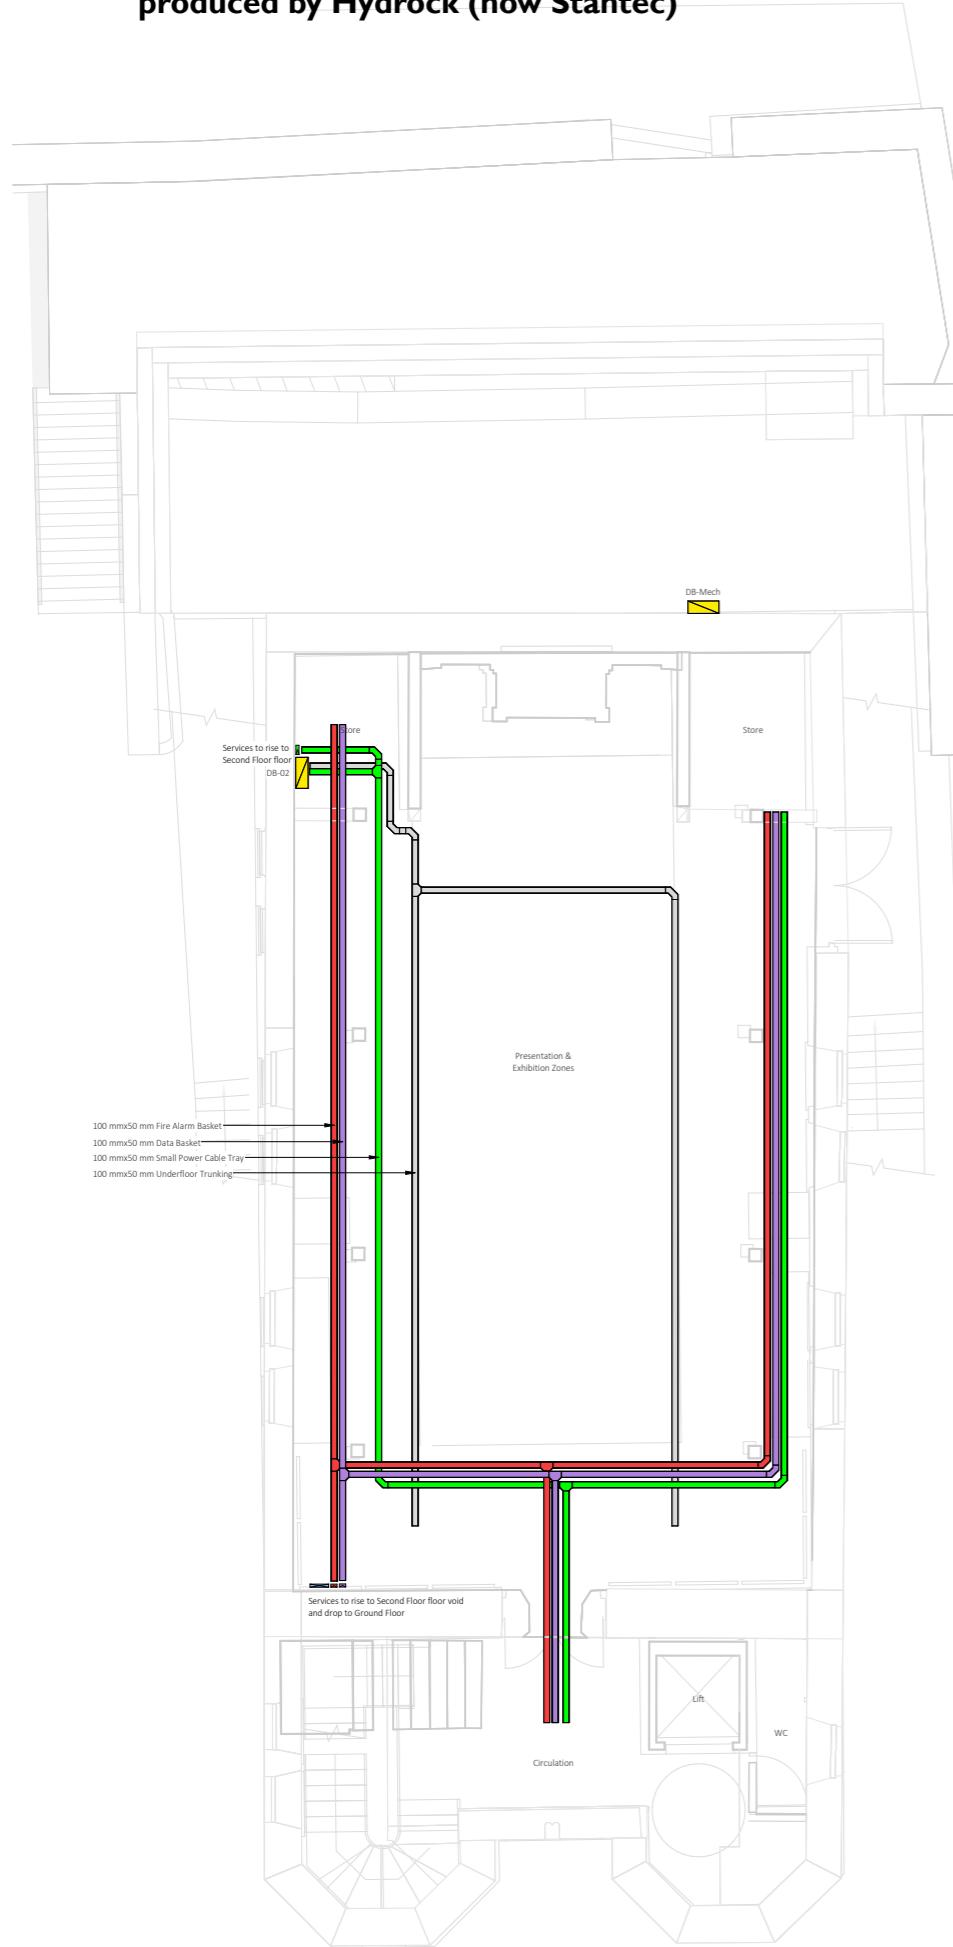
PROPOSED FIRST FLOOR PLAN

**6.6.30 Proposed Containment Layouts - First & Second Floors,
produced by Hydrock (now Stantec)**

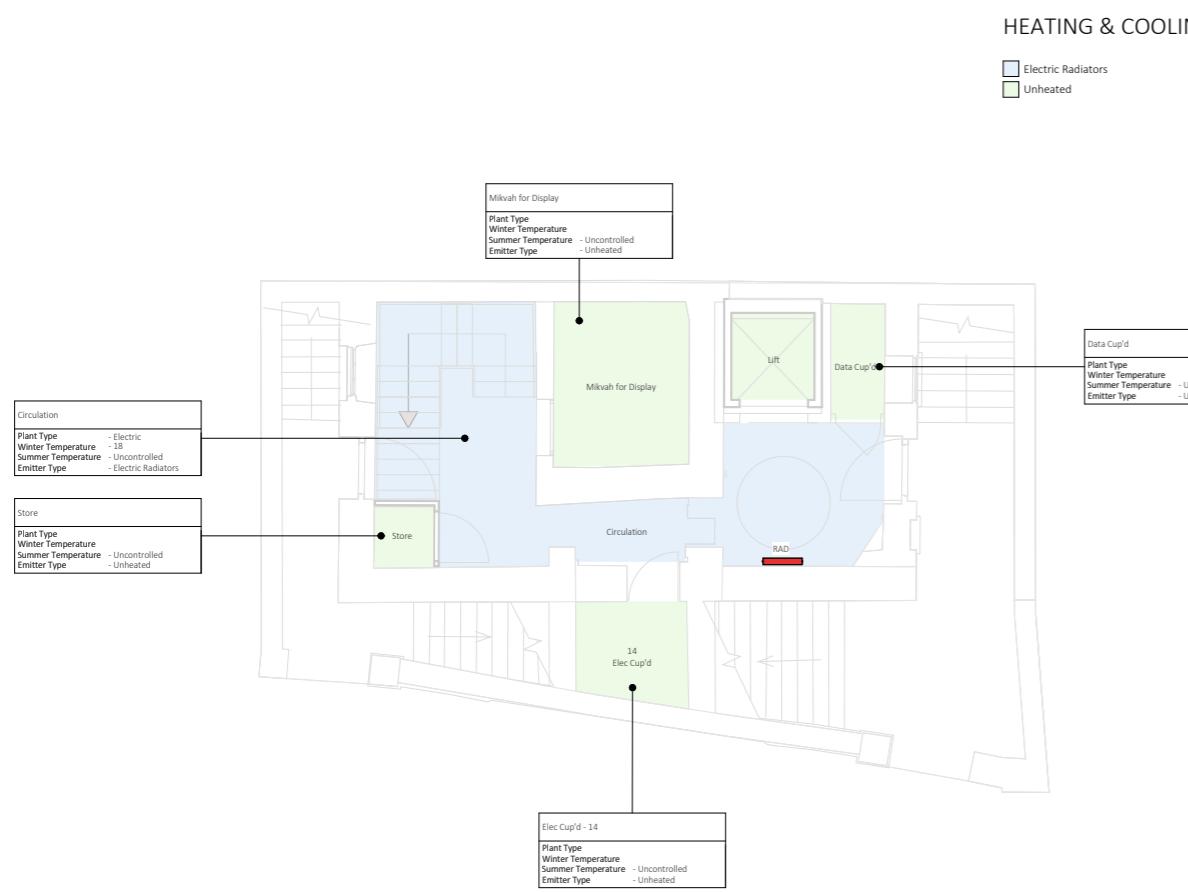
PROPOSED LOWER GROUND FLOOR PLAN

6.6.31 Proposed Heating & Cooling Layouts - Lower Ground & Upper Ground Floors, produced by Hydrock (now Stantec)

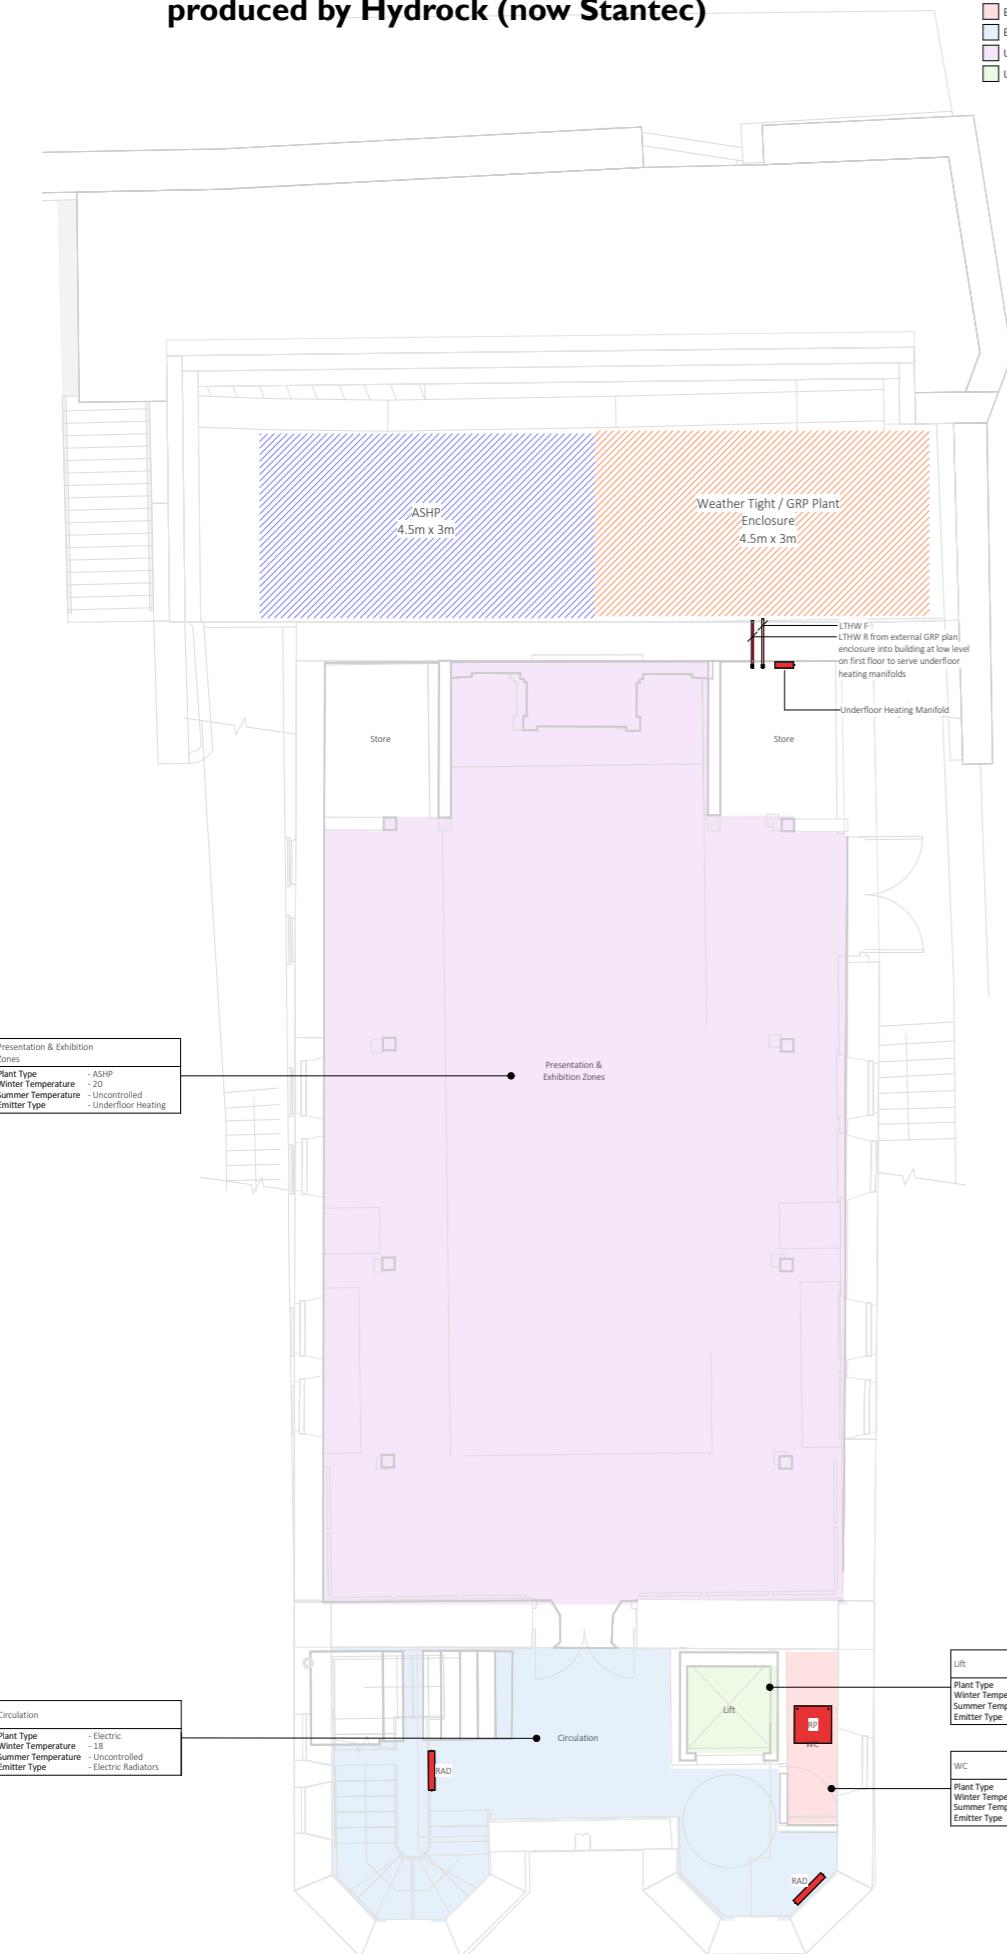
PROPOSED FIRST FLOOR PLAN

6.6.32 Proposed Heating & Cooling Layouts - First & Second Floors, produced by Hydrock (now Stantec)

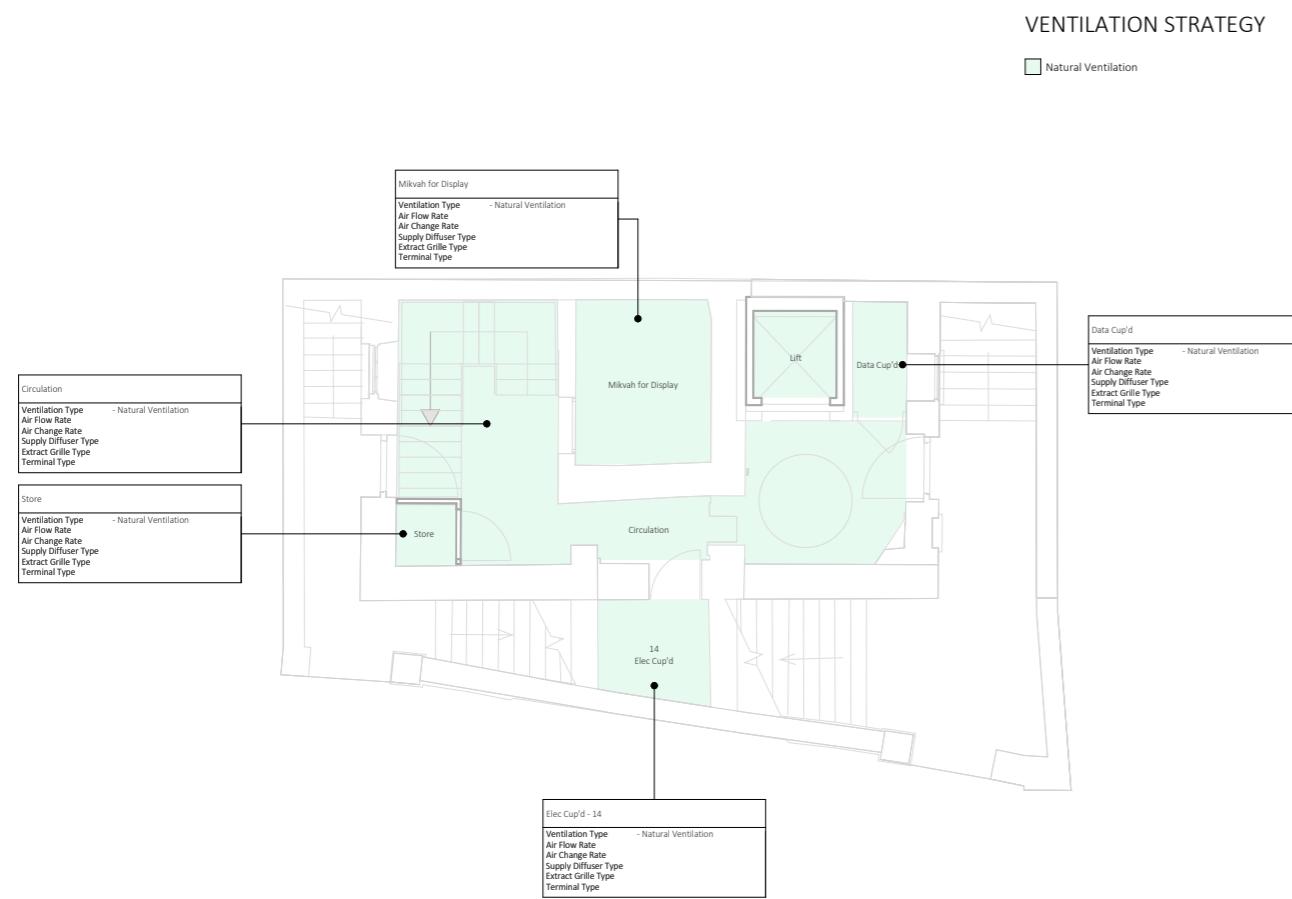
PROPOSED LOWER GROUND FLOOR PLAN

6.6.33 Proposed Ventilation Layouts - Lower Ground & Upper Ground Floors, produced by Hydrock (now Stantec)

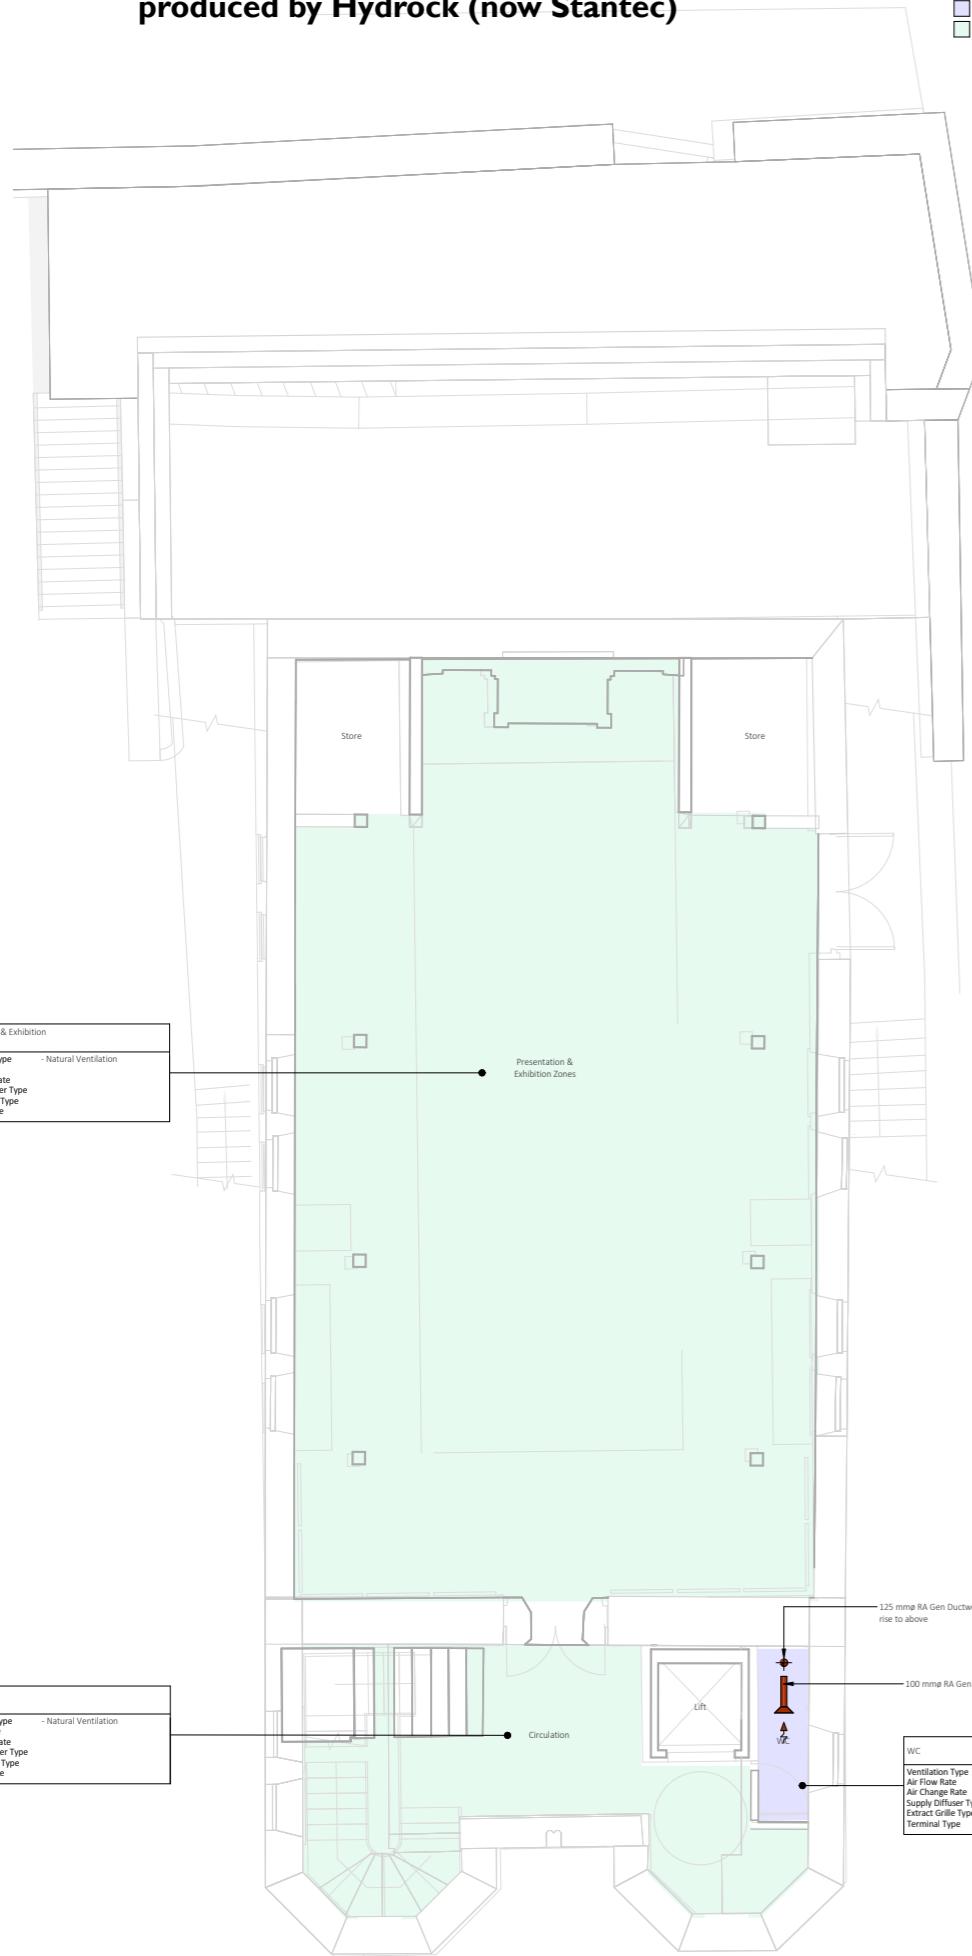
PROPOSED FIRST FLOOR PLAN

VENTILATION STRATEGY

- Extract Only
- Natural Ventilation
