THE FORMER SYNAGOGUE

THE PROPOSALS

.....
(449)2503-GWP-A-HIS-P02

6.0 SECTION FOUR - EXPLANATION OF THE PROPOSALS

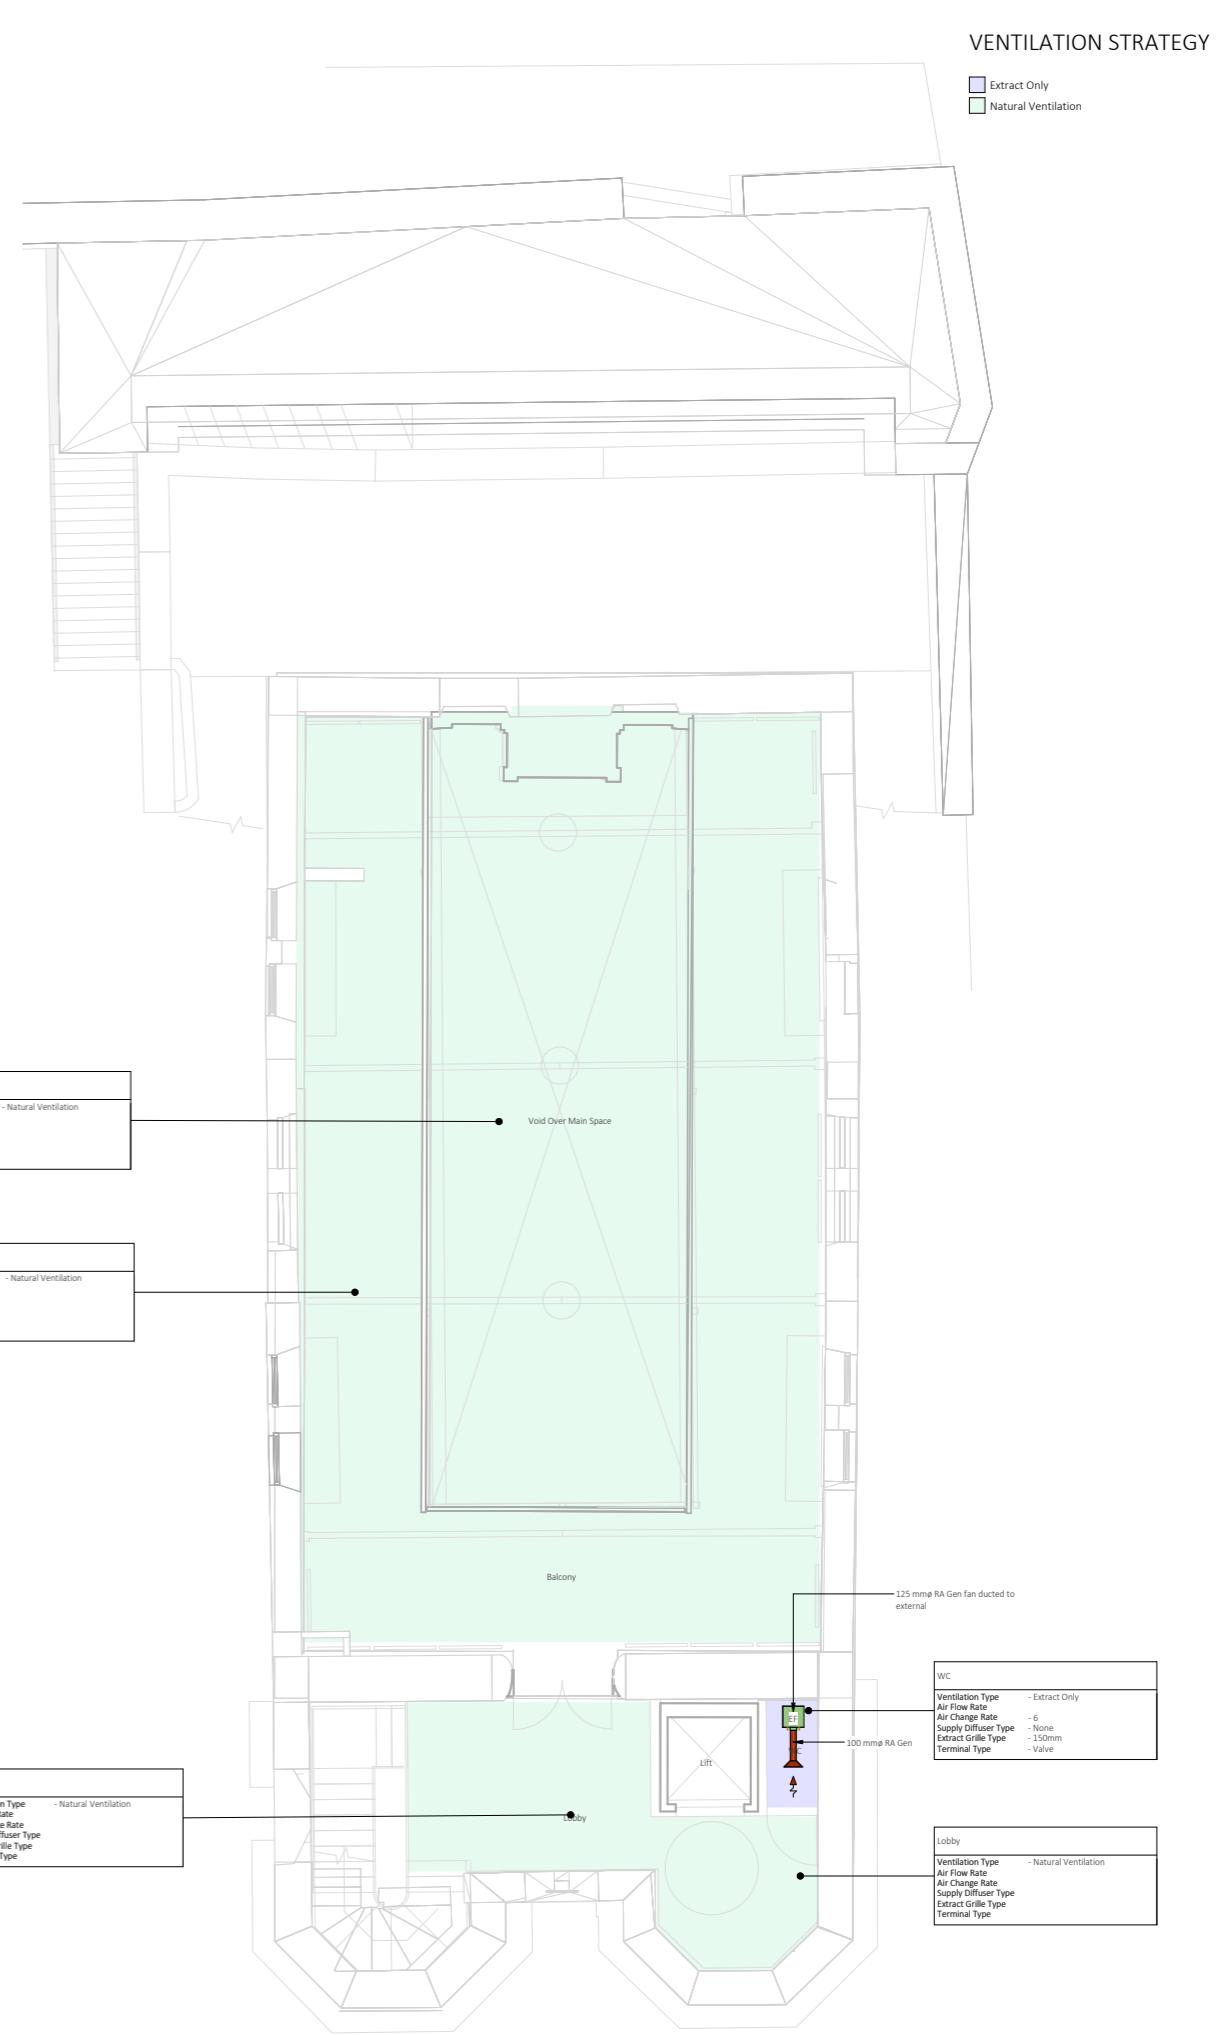
PROPOSED SECOND FLOOR PLAN

VENTILATION STRATEGY

- Extract Only
- Natural Ventilation

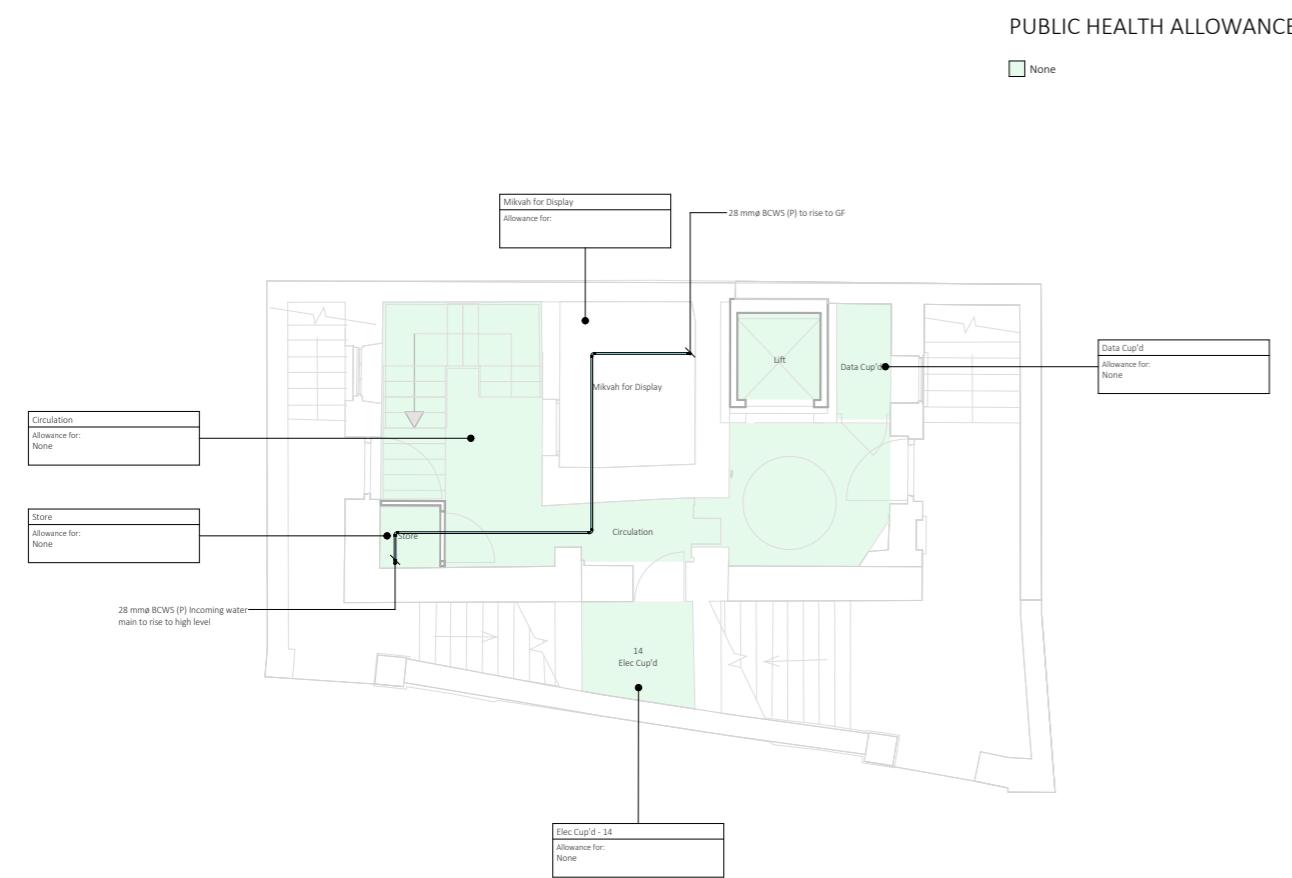
PROPOSED LOWER GROUND FLOOR PLAN

6.6.35 Proposed Public Health Layouts - Lower Ground & Upper Ground Floors, produced by Hydrock (now Stantec)

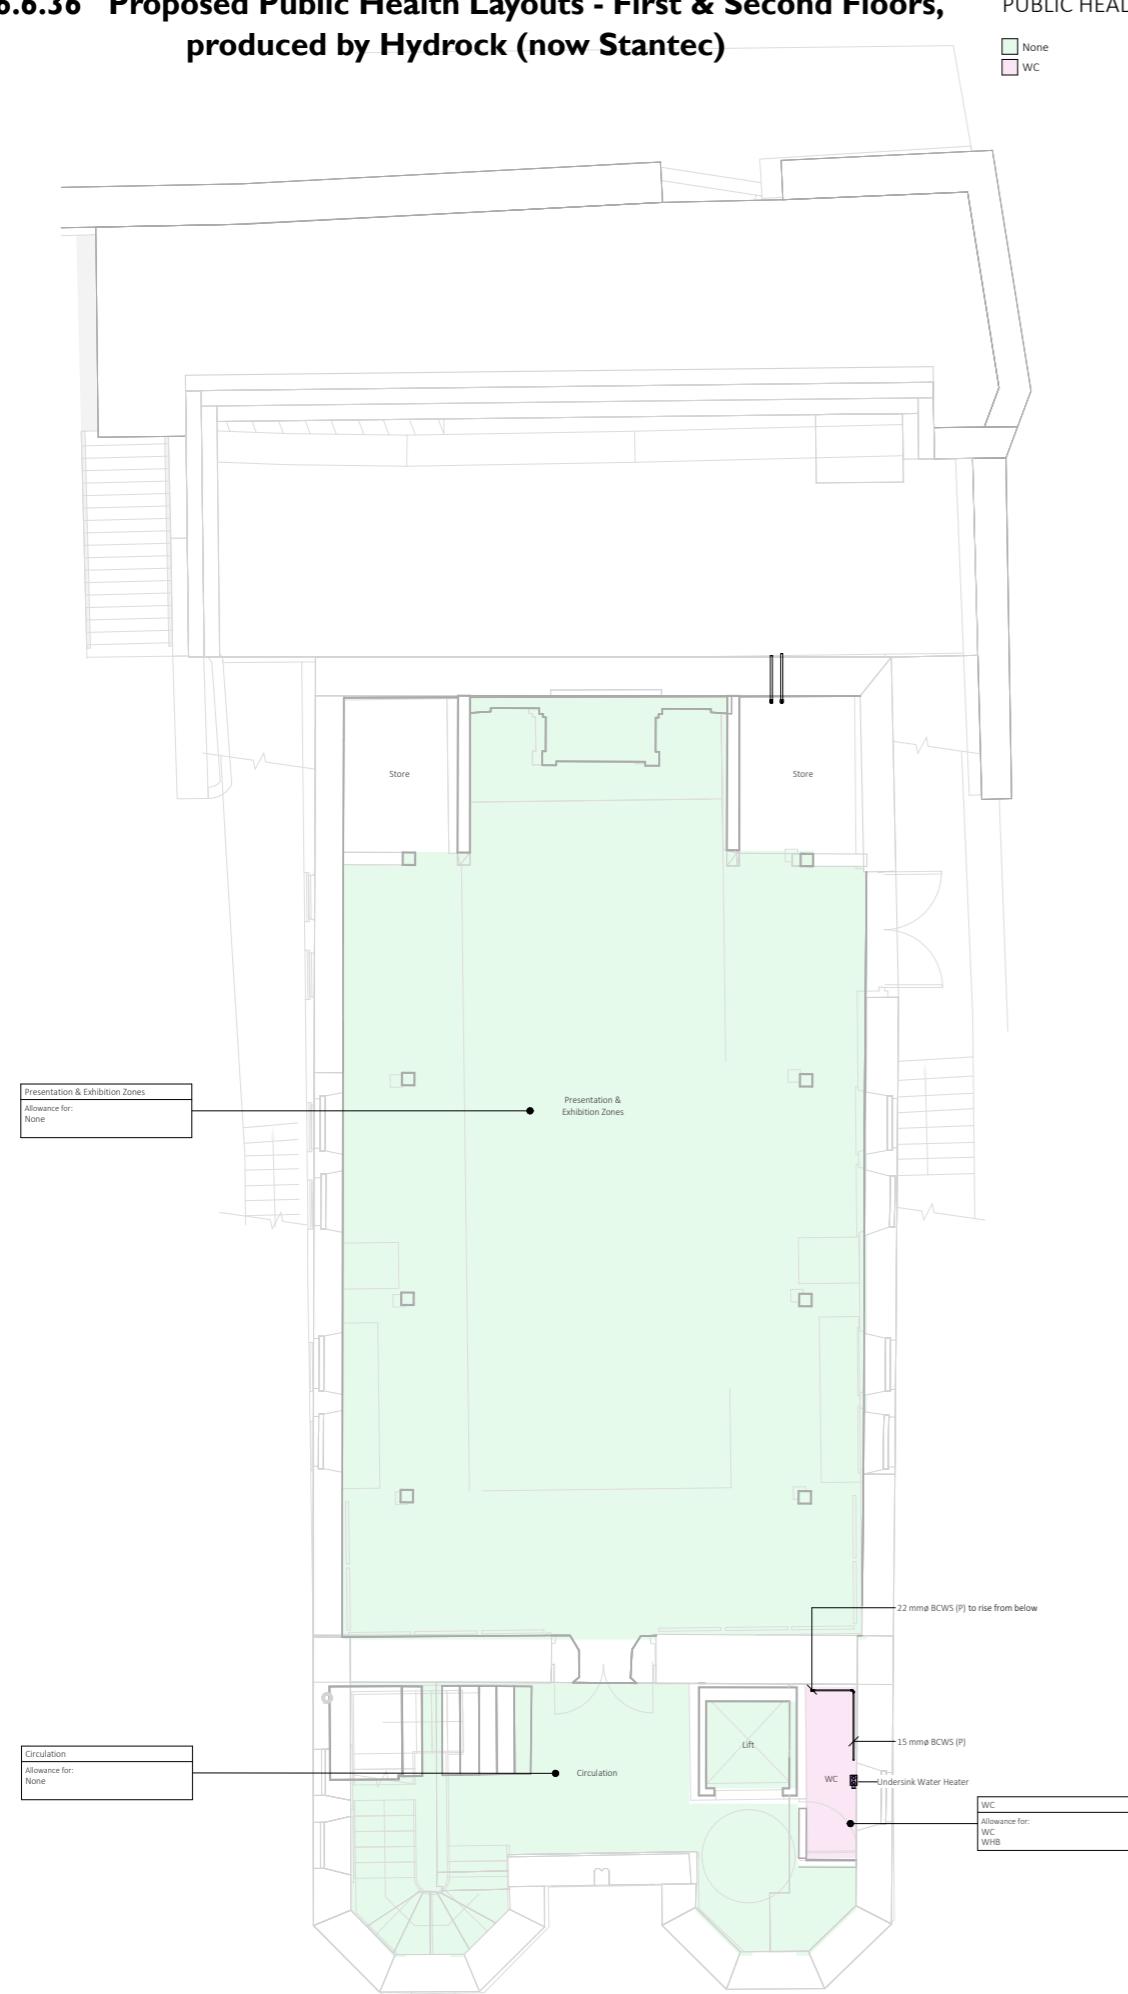
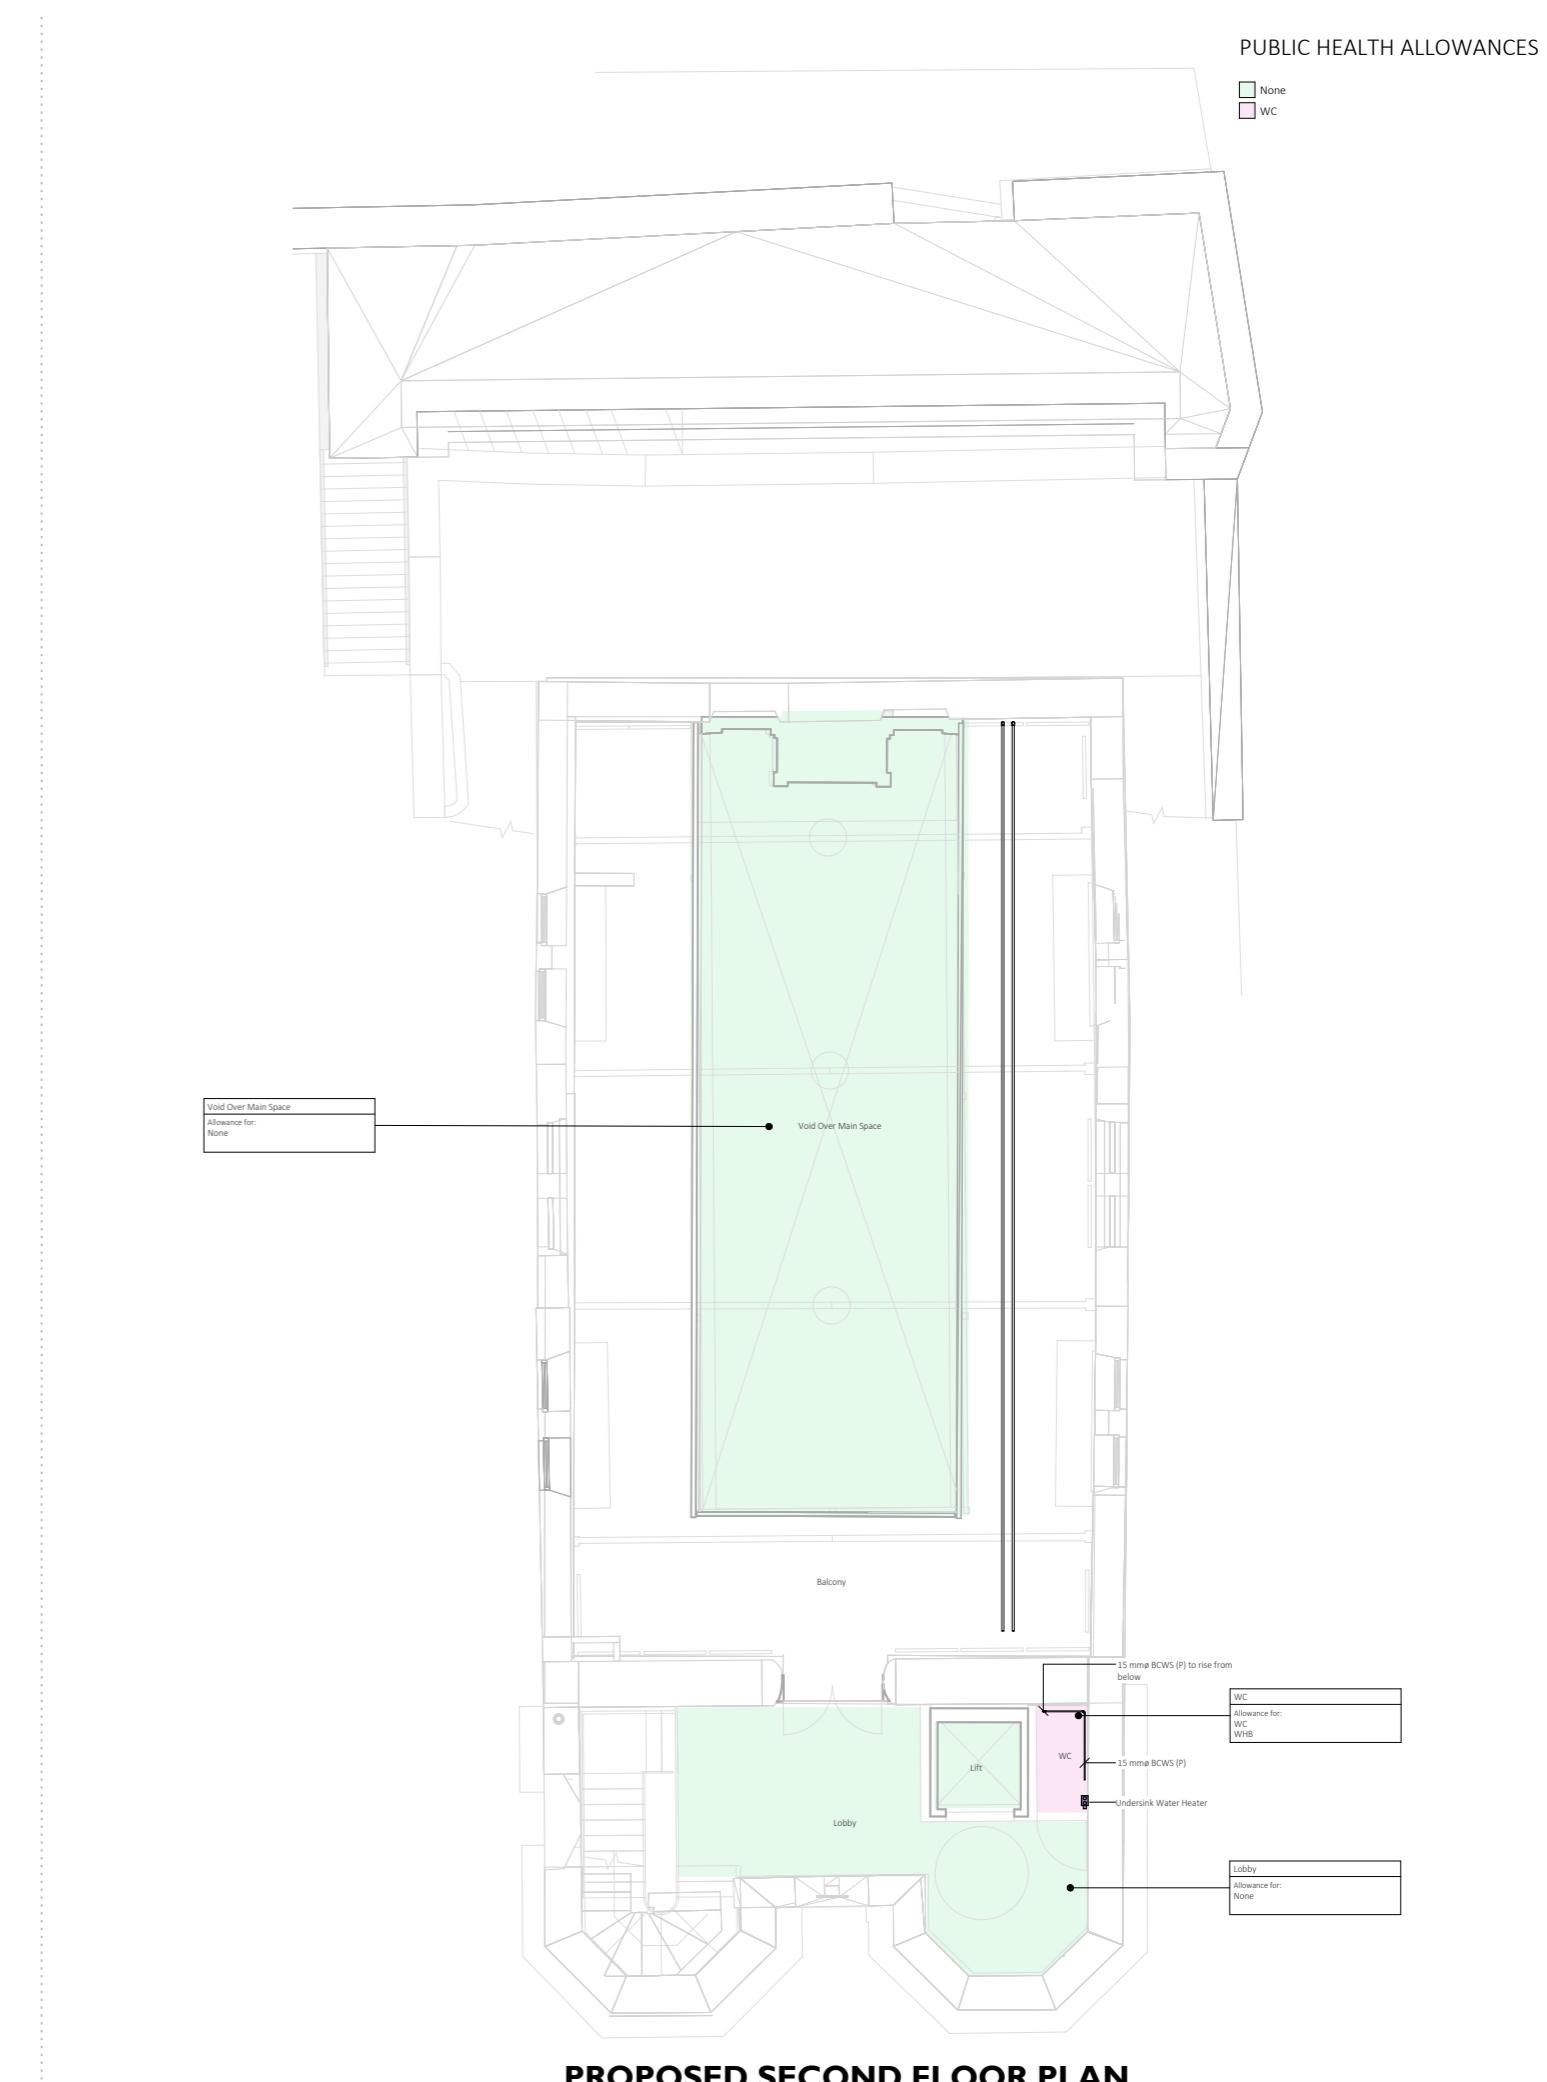
6.6.36 Proposed Public Health Layouts - First & Second Floors, produced by Hydrock (now Stantec)
