**FFOS-Y-FRAN  
FINAL RESTORATION STRATEGY**

**Supplementary Environmental Information (SEI)  
SEI Appendices**

**MERTHYR  
(SOUTH WALES) LTD**

A report for Miller Argent Ltd  
by Richard Roberts BA and  
Martin Lawler BA MIFA

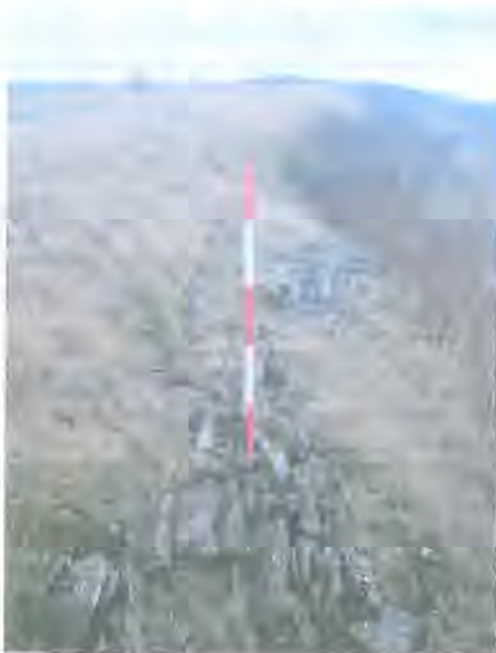
*Plate 1: Pond 85523, showing detail of stone revetment on inner south wall, looking SW*

The dam measures almost 200m northeast to southwest, and 130m northwest to southeast; the dam walls are stone-revetted on their inner edge, most noticeably on the long south side. The two sluice positions on the west side of the dam lead to Leat 88014 (north sluice) and Leat 88020 (south sluice).

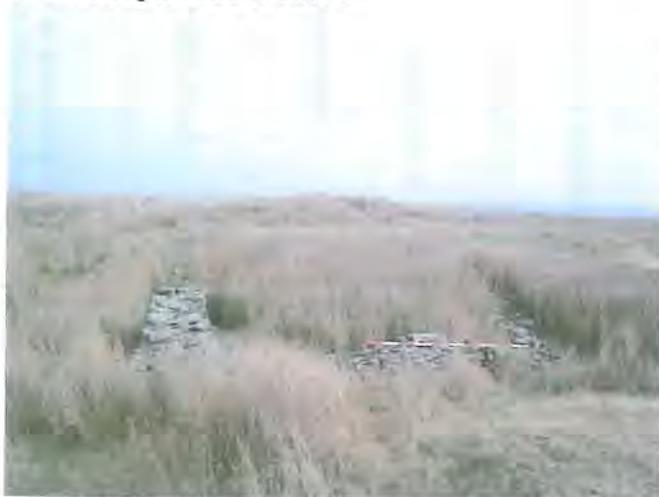
*Plate 3: Rectangular structure 88021 with Pond 85523 in background, looking NW*

This site lies to the southwest of the dam, at the junction of Leats 88020 and 88014. The pit is an oval shaft (88022), 17.5m x 13.4m, now filled with water, with some rough stonework visible on its northeast and southeast sides. A channel extends from the shaft southwest to Leat 88014, and seems to be respected by the adjacent tips. Occupying a platform on the northwest side of the shaft is a rectangular structure of drystone walling (88021), open on its southeast side, but with an enclosed room in one corner. This is presumably a balance pit, with a general arrangement similar to that of Pit 85558 near Soap Vein Pond. The small scale of the tips, notably close to the shaft itself, suggests that it may have been a short-lived operation.

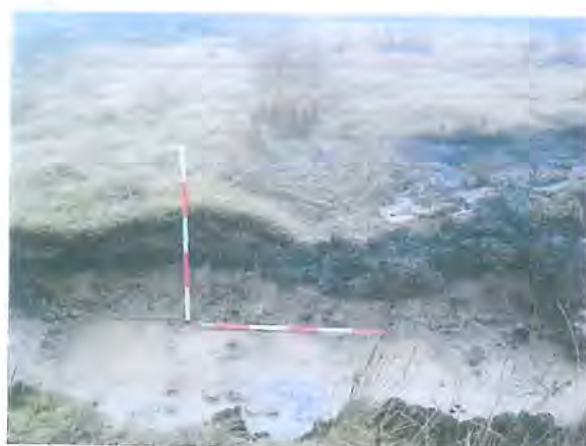
Plate 4: Machine-cut section of Leat 88023, looking W

RECORD: The line of the leat was traced from GPS spot co-ordinates and the air photograph. A drawn profile of the leat was recorded near its west end at SO 08634 07096. A machine excavation through the leat was undertaken at approximately SO 08654 07092. See Appendix 1 for details of photographs.

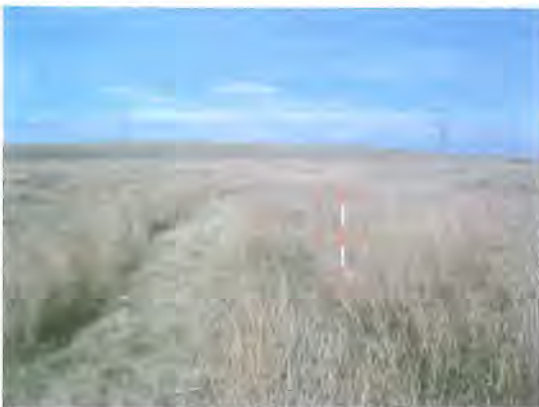
Plate 5: Leat 88014, at position of profile shown in Figure 8, looking NW

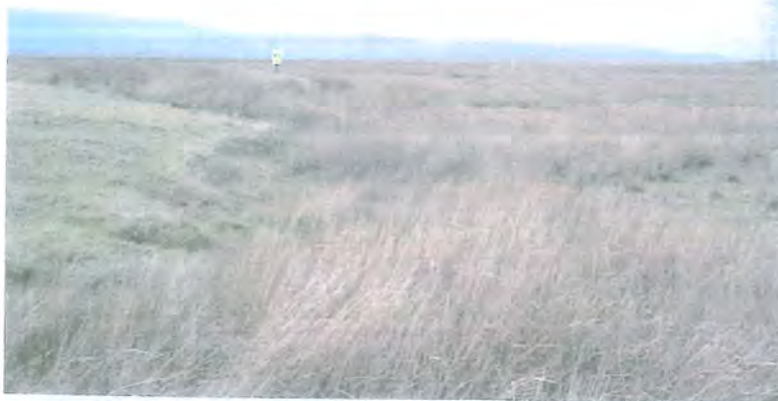
*Plate 6: Leat 88020, looking SW from Pond 85523. Figure is standing on platform for Pit structure 88021*

This is a short section of leat extending southwest from the southwest corner of Pond 85523 to a junction with Leats 88014 and 88025. It may be regarded as the eastern section of Leat 88025.

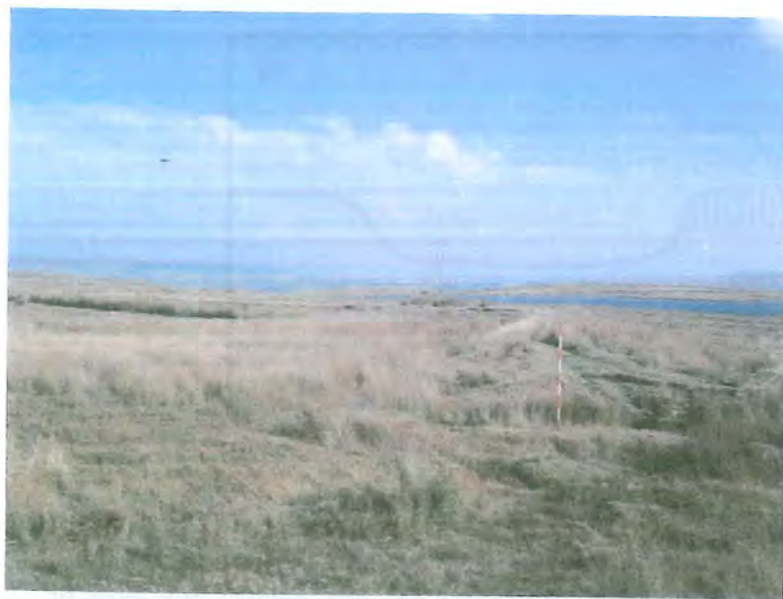
*Plate 7: Pond 85524, S end, with Leat 88014 on right, looking NE towards Rhaslas Pond*

The southern of the two Twynywaun ponds lies adjacent to the present road. It will not be affected by the proposed scheme, and was not included in the present survey. The pond is an extensive feature, with earthen dam walls on its east and south-east sides and an open west (upslope) side. It is fed by leat 88014 from its south corner.

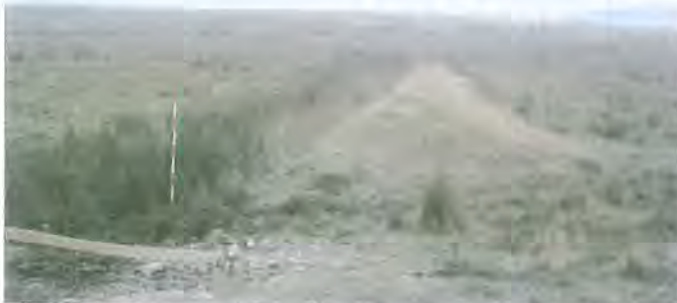
*Plate 8: Leat 88015, showing crossing point for trackway shown on 1<sup>st</sup> ed OS plan, looking E*

At SO 08656 06674 the leat is crossed by a trackway shown on the 1<sup>st</sup> ed OS sheet. This is one of the most impressive of the trackway crossing points. The bank on its south side rises to 2m in height, and becomes a prominent, broad earthwork for several metres on each side of the crossing point. The crossing itself was over a stone causeway, now culverted. The raised embankment seems to be a way of funnelling stock to the causewayed part of the crossing, rather than as some form of water catchment. A smaller ditch has been cut on the lower (south) side of the bank. Slightly to west of the crossing point, leat 88015 is joined by a second leat, 88029; the latter feature is, in turn, fed by a secondary ditch further upstream to the west. Between the causeway and the major natural stream course marked by Pond 85526, the leat

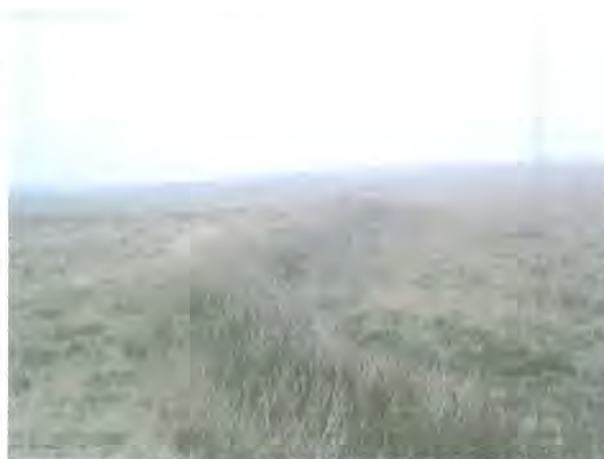
*Plate 9: Junction of Leats 88015 (foreground) and 88029 (left), looking SW*

This feature follows an east-bound course parallel with 88015 and on the south (downslope) side of it, reaching a junction with the latter at SO 08629 206682. A secondary leat feeds into 88029 from the north at SO 08472 206787. Thus, to the west of this point, there are three east-bound leats running roughly parallel with one another: Leat 88015, a central leat and Leat 88029. Leat 88029 is crossed by the line of a trackway shown on the 1<sup>st</sup> ed OS plan. This area is marshy and overgrown by reeds, and it was not possible to examine the crossing point in the field. At the same point there is also a junction with a lower line of leats (described here as 'Area F Leats'), which feed into Pond 85525.

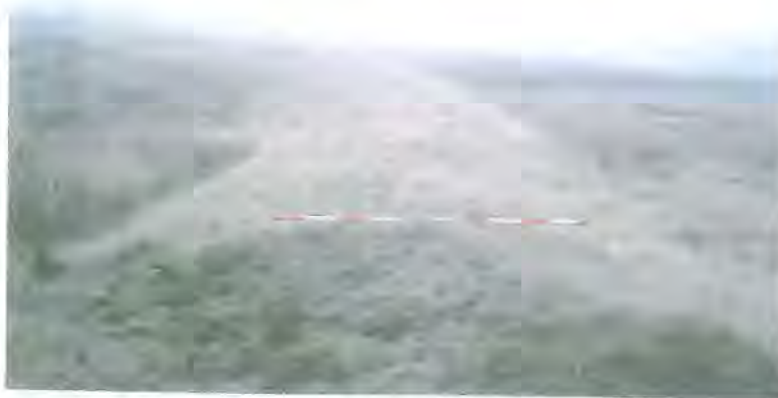
*Plate 11: Pond 85526, SW embankment, looking SE. Stone sluice at base of dam on left edge of photograph*

The pond is an approximate rectangle in plan, aligned on a northwest – southeast axis across the line of the natural channel, and measuring 74.8m x 37.3m in area. The southwest side of the dam is a broad embankment. Unusually, there are also substantial earthen banks on the upslope northeast, northwest and east sides, which allow leats to be carried around the pond. The pond is fed from the northeast by Leat 88015. A stone-walled sluice is located at the base of the main southwest embankment, draining to a dogleg outfall channel to the southwest, which forms the first part of Leat 88027. At the southeast corner of the dam is an opening to an overflow course which curves to the southeast

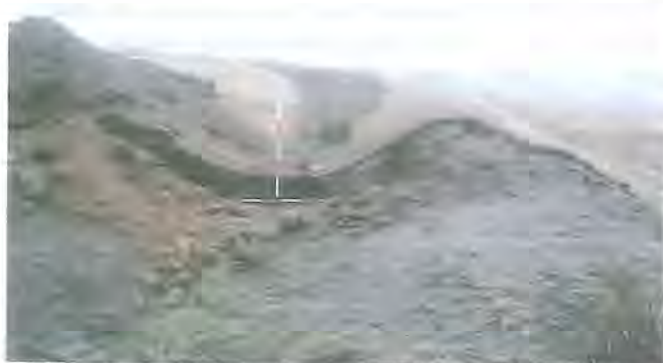
Plate 12: Machine-cut section across Leat 85575 at SO 08871 06581 (as Figure 23 above), looking E

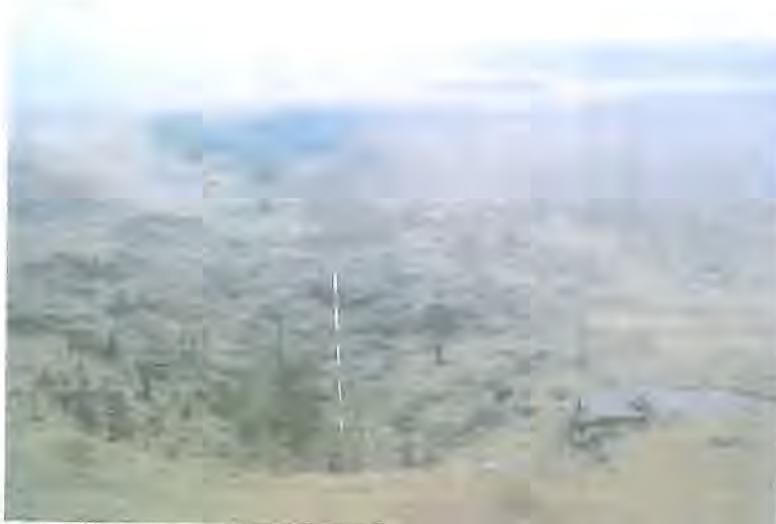
*Plate 14: Pit 85558, looking NW towards tramroad terrace. Note stone lining at back and right of shaft*

The pit is set within a level hollow, 43m x 23m in area, surrounded by levelled tips and embanked leats. The shaft is oval, 6.7m x 5.15m, with lining stonework on its northwest and northeast sides. An aperture in the stonework on the northwest side is in line with the position of a track shown on the 1<sup>st</sup> ed OS plan. Holding-down bolts mark the position of part of the superstructure, probably for the frame of a balance wheel.

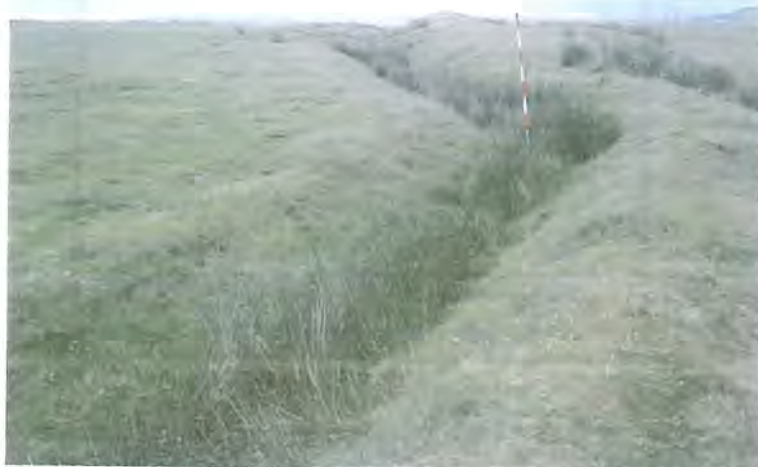
*Plate 16: Leat 85575, near trackway junction (in background), looking W*

This leat is the eastwards continuation of Leat 88015; it extends from Pond 85526 towards Rhaslas Pond, downslope of Leat 88017. The western part of this course has been described above as part of the features surrounding Pond 85526 (Area 4). The leat is shown essentially in its present form on the 1<sup>st</sup> ed OS plan, though it has been joined by Leat 88016. The ditch varies along its length, but is an average of 2m in width and 0.8m in depth.

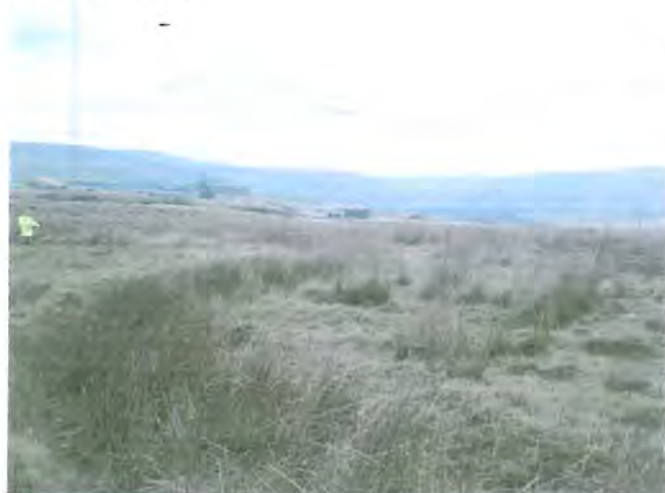
*Plate 17: Junction of Leat 88017 (foreground) with Leat 88016 (background), looking SE*

This feature is part of a group of leats in this area which do not appear on the 1<sup>st</sup> ed OS plan. In its original role, as shown in the 2<sup>nd</sup> ed OS plan of 1905, it formed the east end of the shorter Leat 88017, joining this leat to Leat 85575. By the 3<sup>rd</sup> ed OS plan of 1915, Leat 88017 had been extended directly to Rhaslas Pond, and Leat 88016 became a secondary course.

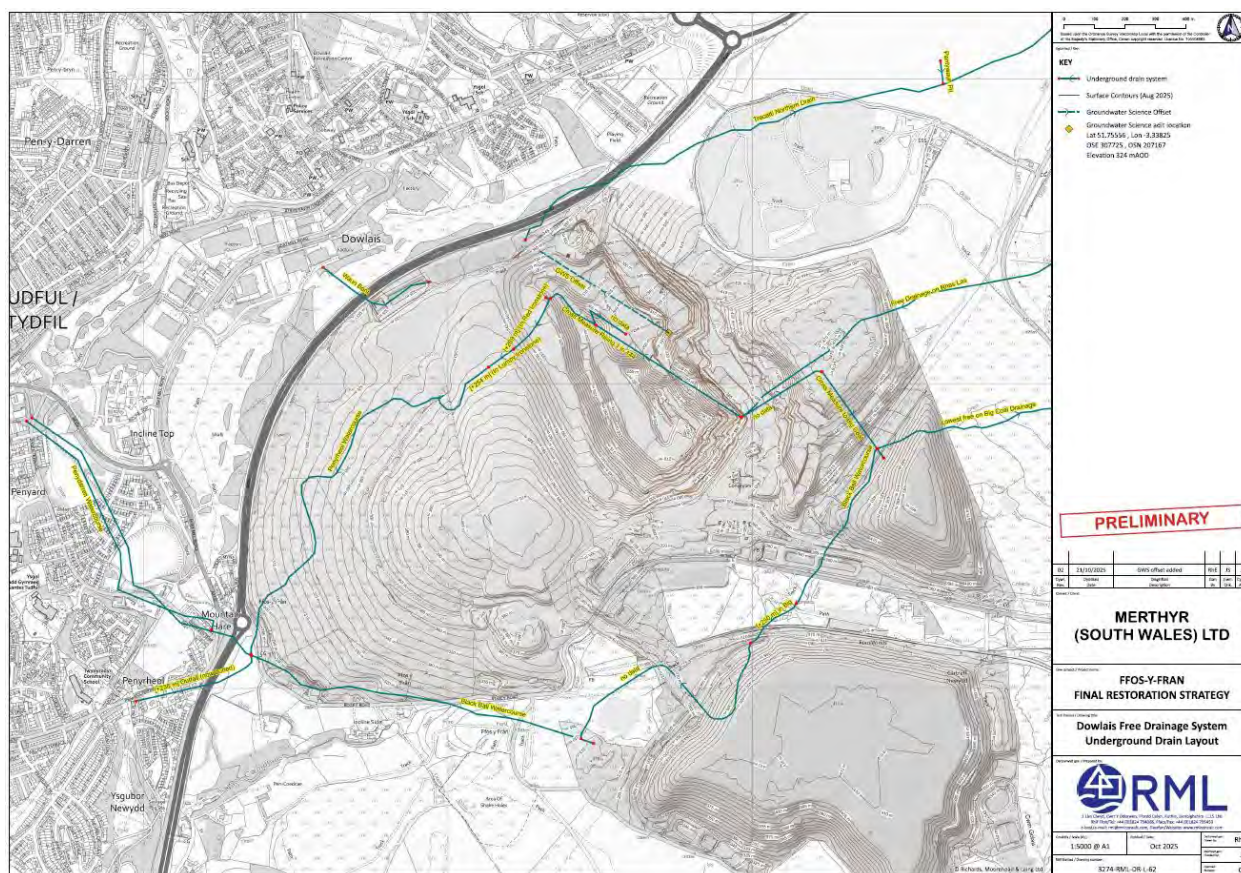
Figure 2: Layout of the known DFDS network in the pit void area.

The question of potential connectivity between the pit lake water body and the DFDS was considered in detail by James Associates (James Associates, 2025) in a geotechnical assessment. The study concluded that the current and future configuration of the pit void would be unlikely to provide any means for water to flow directly from the lake into the DFDS. It is instead more likely that groundwater would continue to percolate through the backfill material and find its way to the DFDS and other existing mine workings in a controlled manner similar to the pre-mining conditions.

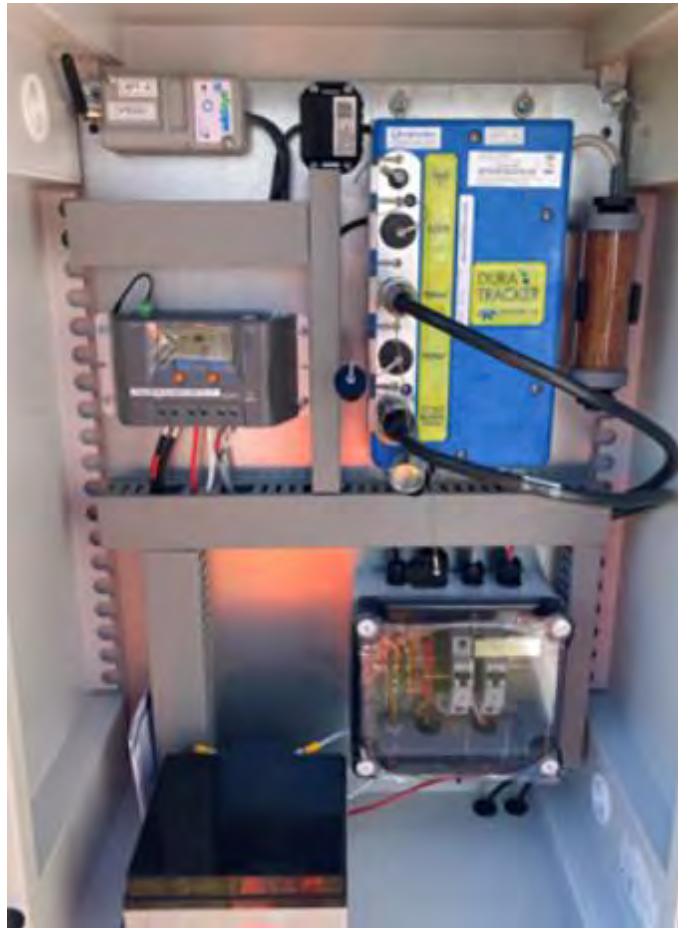
*Figure 4: ISCO DuraTracker area-velocity flowmeter and Wildeye 4G Telemetry Datalogger assembly*

Ratings curves would be generated for each site using a temporary installation, consisting of a **Duratracker** portable logger unit (Figure 4) and **AV (Area Velocity) meter** (Figure 5). These will be kept in place sufficiently long to characterise the rating curve over the full stream flow regime. The length of time required for this will depend on climatic conditions. It is recommended that monitoring for rating curve development would start during the winter period to capture high flow conditions, and continue into the spring and early summer to capture low flow conditions however this is dependent on when planning approval is received.

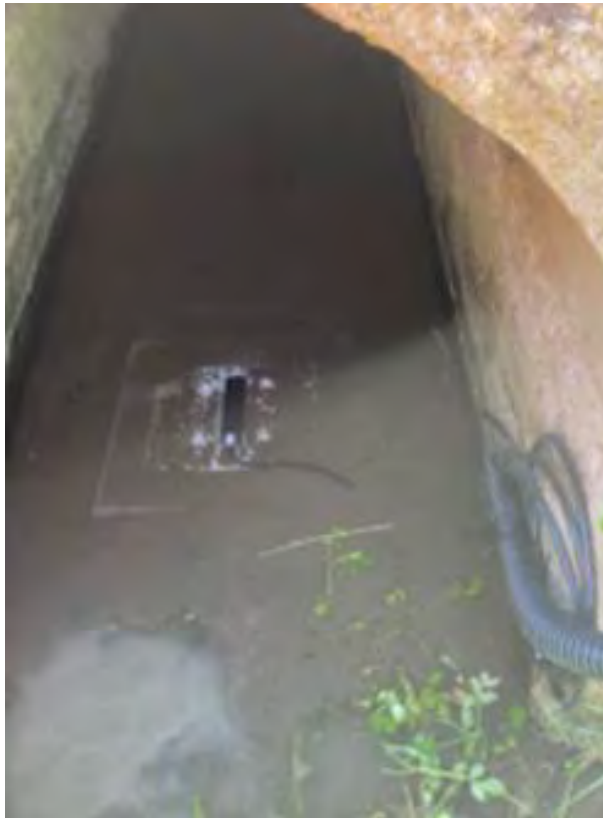
*Figure 5: ISCO Area-Velocity AV350 doppler sensor*
