*Report No. BC/MB/07.20.02.*

# **Coal Mining Risk Assessment: Land Adjacent to 22 Pant Road, Dowlais, Merthyr Tydfil.**

***MMA***

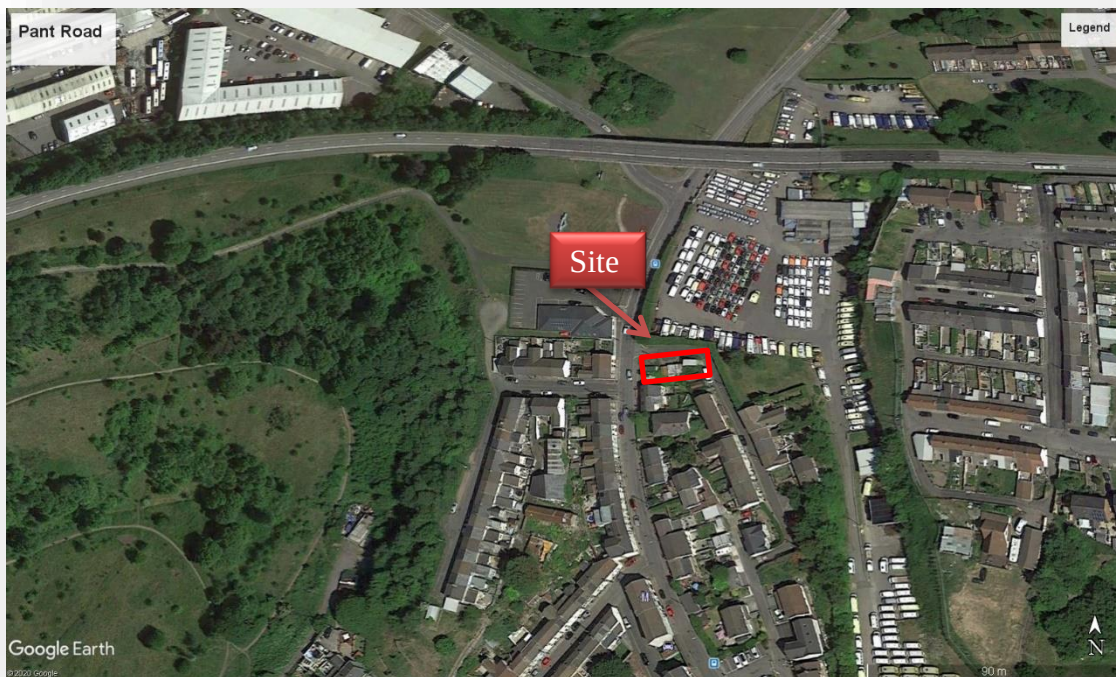
**Figure 1**  
**Aerial View of Site**

The parcel of land that is the subject of this report ('the Site') is located at the north-eastern margins of Merthyr Tydfil in the district of Dowlais and is approximately 2.6 km north-east of the centre of the town (see Figure 1 and *General Location Plan, drawing no. BC/MB/07.20.02.01*). The Site is located on south-westerly facing slopes and is at approximate elevation of between 331m and 328m aod: it is irregular in outline with approximate maximum dimensions of 30m and 15m (see *Detailed Location Plan, drawing no. BC/MB/07.20.02.03*). The Site lies within a mixed residential area where houses are primarily arranged in terraces. A motor sales auction site is present immediately to the north of the Site, beyond Llewellyn Street.

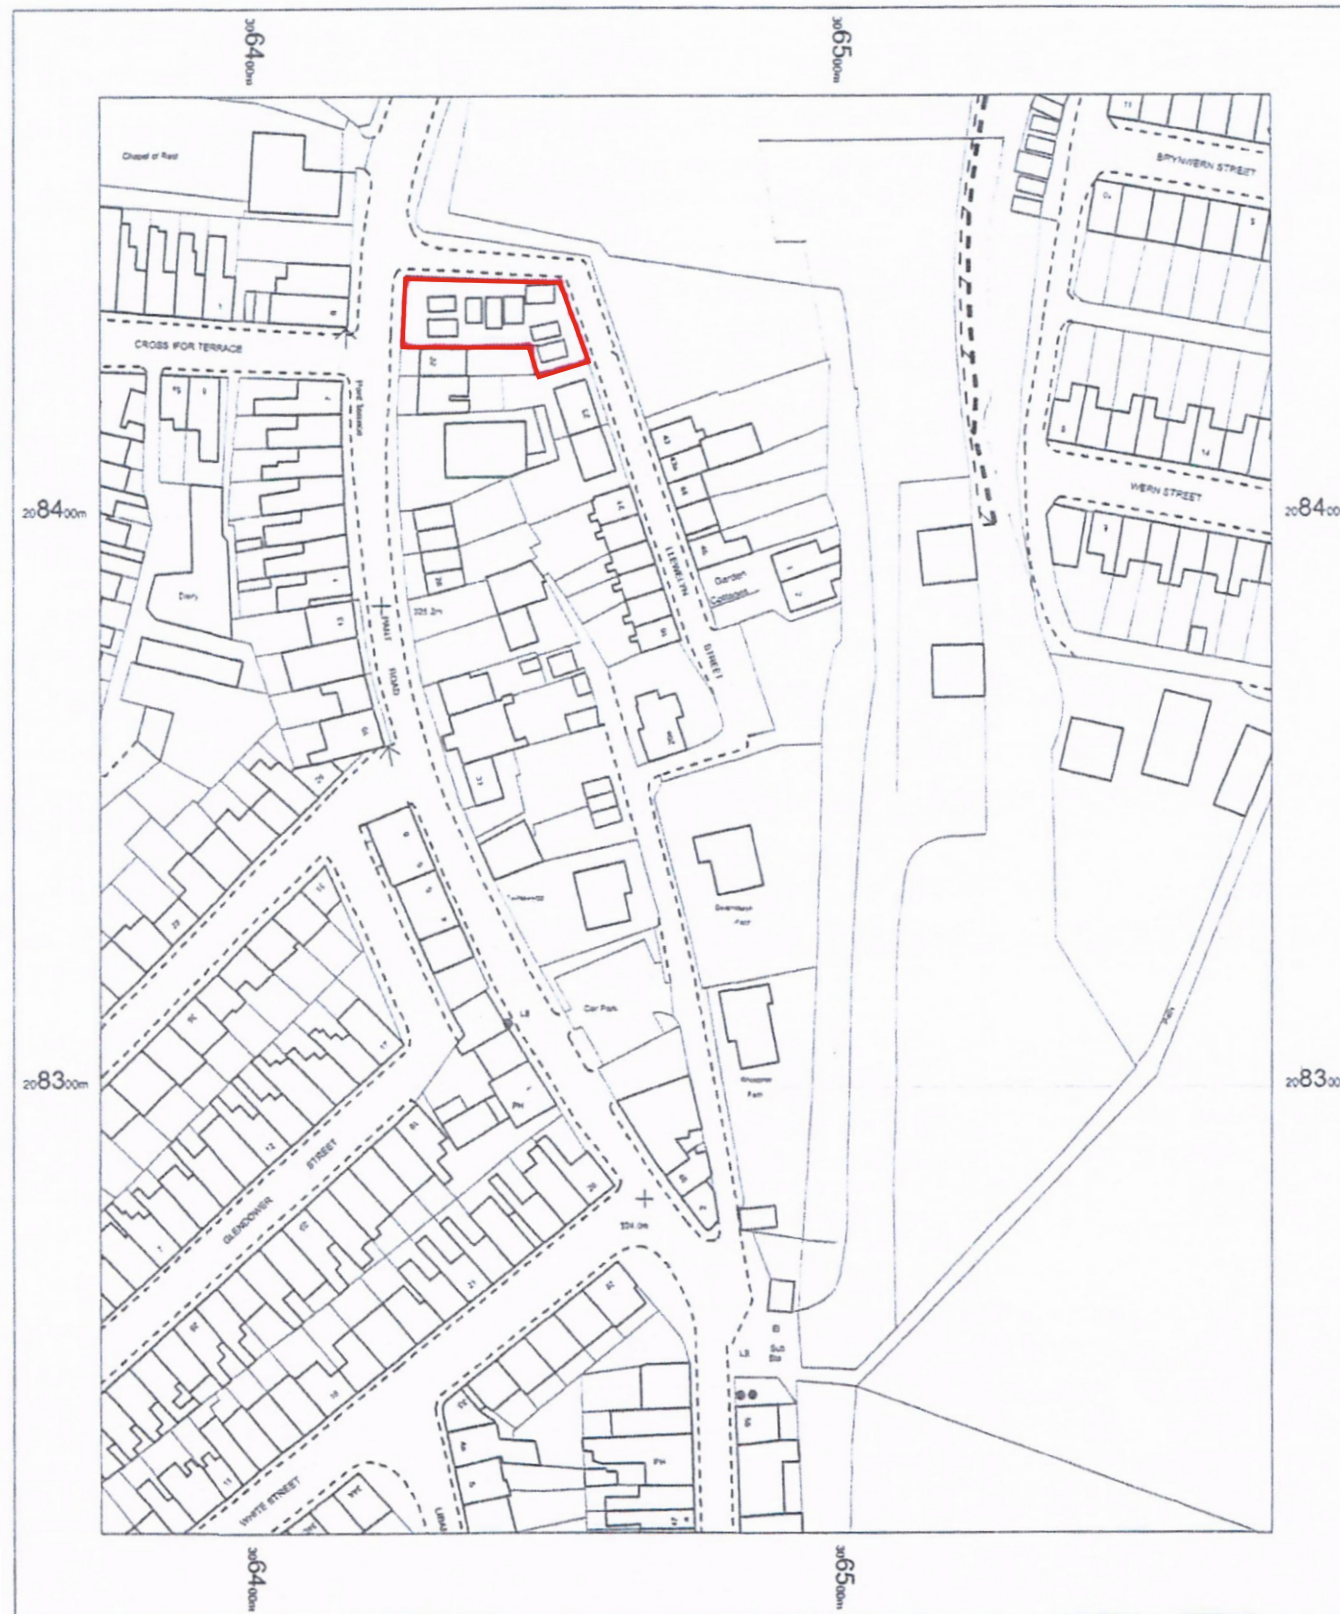
Drawing No: BC/MB/07.20.02.03.

## *Detailed Location Plan.*
