*Report No. BC/MB/10.19.01.*

# **Coal Mining Risk Assessment: Land at Willows House, Abercanaid.**

## **Coal Mining Risk Assessment: Land at Willows House, Abercanaid, Merthyr Tydfil.**

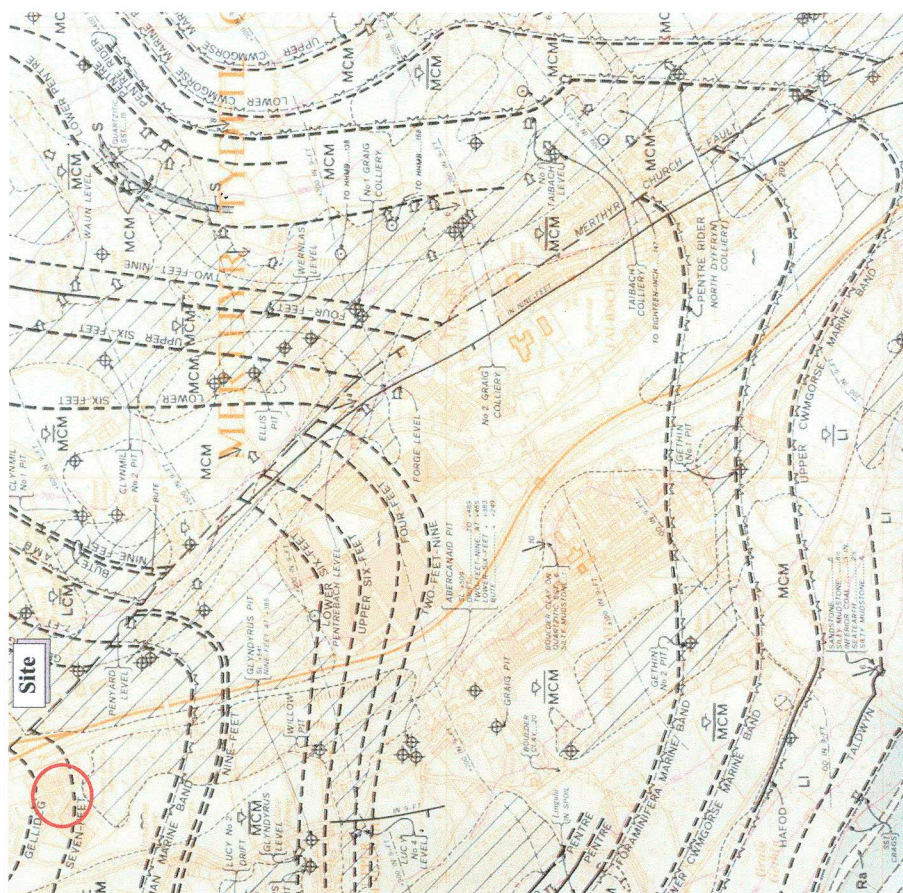
Drawing No: BC/MB/10.19.01.02.

The Site is situated fairly centrally towards the northern margin of the South Wales Coalfield so that it is underlain at shallow depths by strata assigned to the Middle Coal Measures (see *Geology Plan, drawing no. BC/MB/10.19.01.02*). The most recently published geological

sheet (SO 00 SE at 1:10,560 scale) shows the inferred position of the outcrop of the Seven Feet Seam to pass through the Site and the outcrop of the Gellideg Seam to be present approximately 50m north of the Site. The outcrops follow an open "V- shape" as they cross the valley floor (see *Geology Plan*, drawing no. BC/MB/10.19.01.02).

The measures of the South Wales Coalfield have been affected by large normal faults often referred to as "cross-faults". In the Abercanaid area such faults tend to have a slightly sinuous trace at the surface and typically trend towards the north-west. The published geological sheet shows the nearest such fault to be the Merthyr Church Fault; the inferred surface position of which is shown to be present approximately 150m north-east of the Site.
