# Former Barclays Bank 47 High Street Merthyr Tydfil

## Heritage Impact Statement

Former Barclays Bank  
47 High Street  
Merthyr Tydfil

Heritage Impact Statement

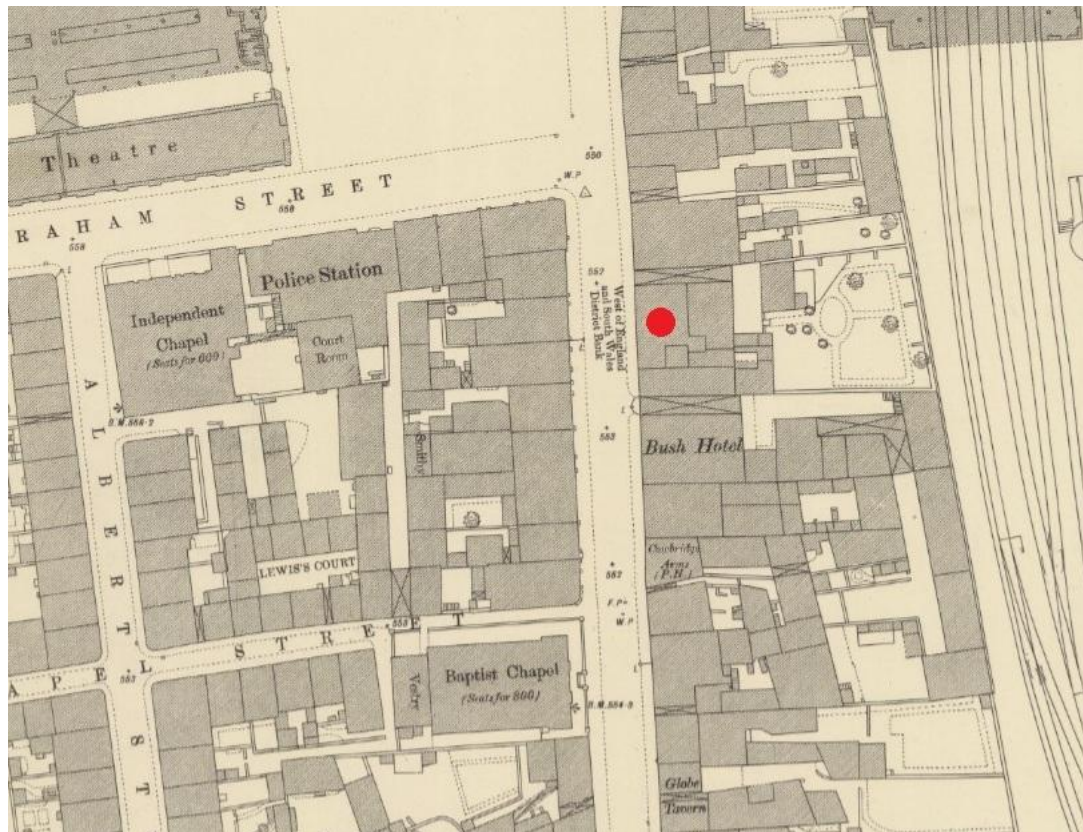
Figure 2. Merthyr Tydfil town plan, 1873.

The 1873 Ordnance Survey Merthyr Tydfil town plan shows the plot of 47 High Street occupied by the West of England and South Wales District Bank (fig 2). The map indicates a separate rear range, suggesting the separation of commercial and residential parts of the property. Much of the fabric of the previous building was probably incorporated when the existing building was built in 1901-2 for the London and Provincial Bank, by P.J. Thomas, architect of Bridgend. Thomas also appears to have extended the previous building by additions at the rear, on ground depicted as a garden in 1873. An early-twentieth century

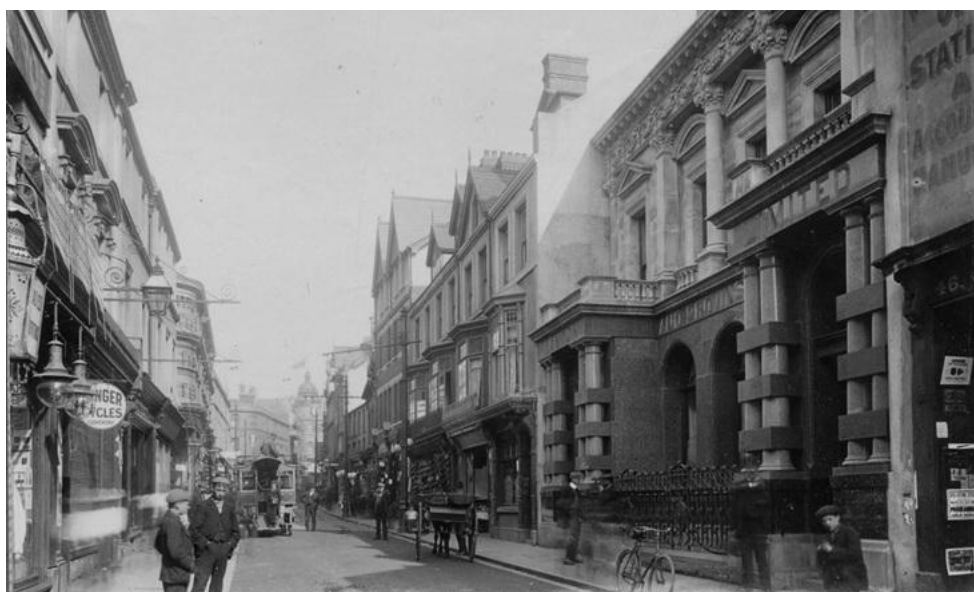
Figure 3. Early twentieth-century view of High Street, with the bank on the right..

view of the High Street shows the bank with railings fronting the street, which have since been removed, and an inscription across the front of the building, which is discussed below (fig 3). Evidence for the existence of an even earlier building or buildings on the site, which stands on the main thoroughfare of pre-industrial and early-industrial Merthyr, is found in the basement, which is also discussed below.

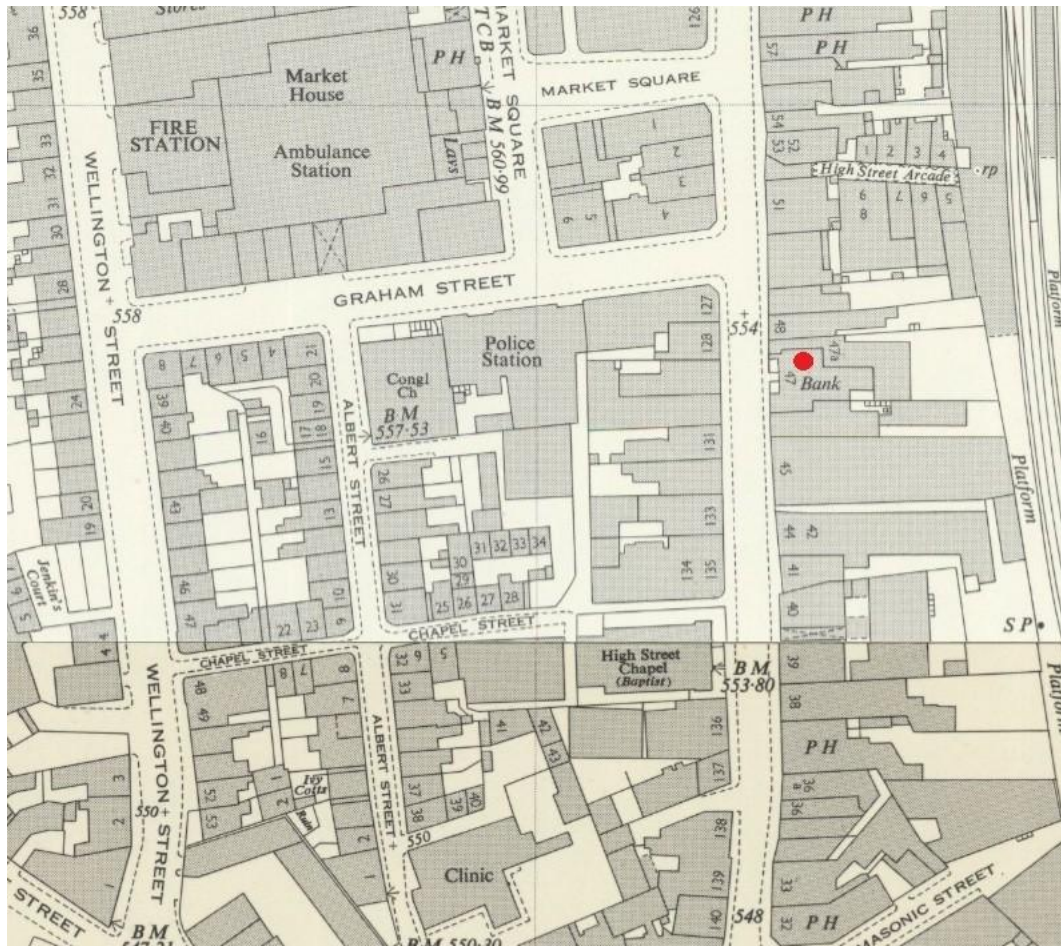
Figure 4. Ordnance Survey map, 1956.

In 1918 the London and Provincial Bank was acquired by Barclays Bank. The 1956 Ordnance Survey map marks the building as two properties, 47 and 47a High Street, presumably for the commercial and residential parts of the building respectively (fig 4). Number 47a is entered from the left-hand side of the High Street front, suggesting that the left-hand doorway to High Street was always residential and not an entry to the banking hall. Barclays Bank closed for business in Merthyr in June 2023, since when the premises has been unoccupied.

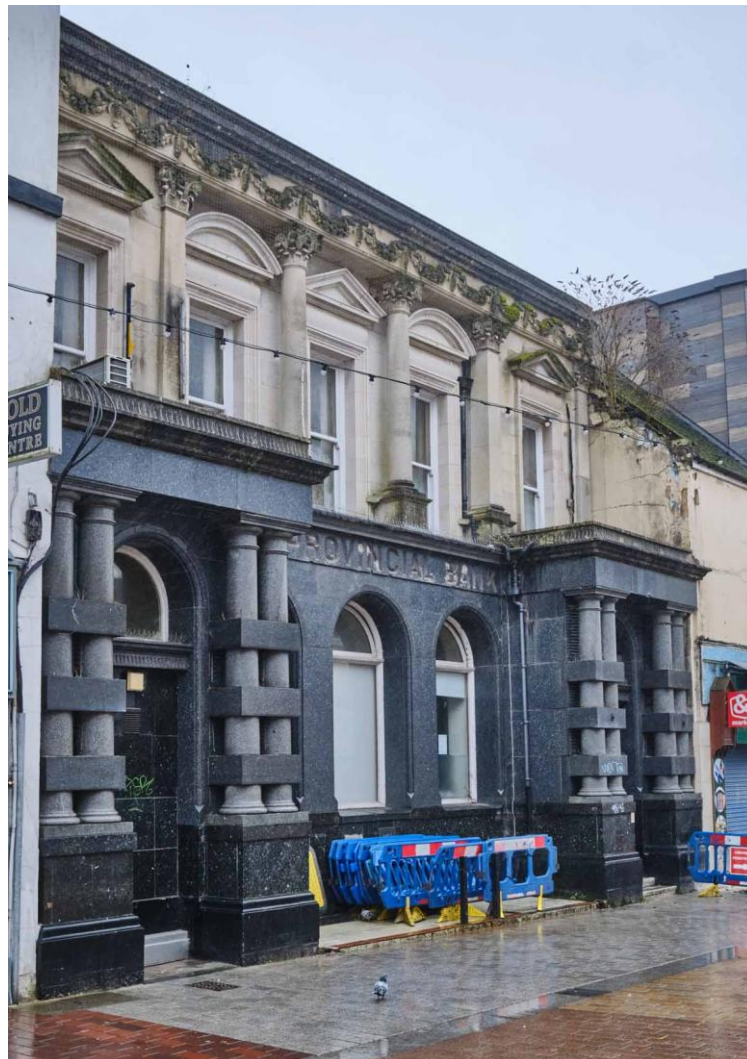
The bank has a five-bay monumental classical-style street frontage (fig 5). The lower storey is polished black granite and has outer doorways brought forward and framed by blocked paired Doric columns. The right-hand entrance retains its fielded-panel door under a round-headed overlight, whereas the left-hand entrance retains its overlight, but the doorway was blocked when a cash machine was inserted there, since removed (fig 6). Between the doorways are tall round-headed windows. The entablature reads 'AND PROVINCIAL BANK' in deeply cut letters in the centre, whereas above the doorways the words 'LONDON' and 'LIMITED' are concealed behind added fascia panels resembling black granite.

The upper storey is of Portland stone. Tall two-pane sash windows are beneath pulvinated friezes and alternating triangular and segmental pediments, below a rich garlanded frieze and Modillion eaves cornice. Outer windows are set slightly forward and framed by Corinthian pilasters, whereas the three central windows are framed by detached Corinthian columns.

*Figure 5. Entrance front on High Street.*

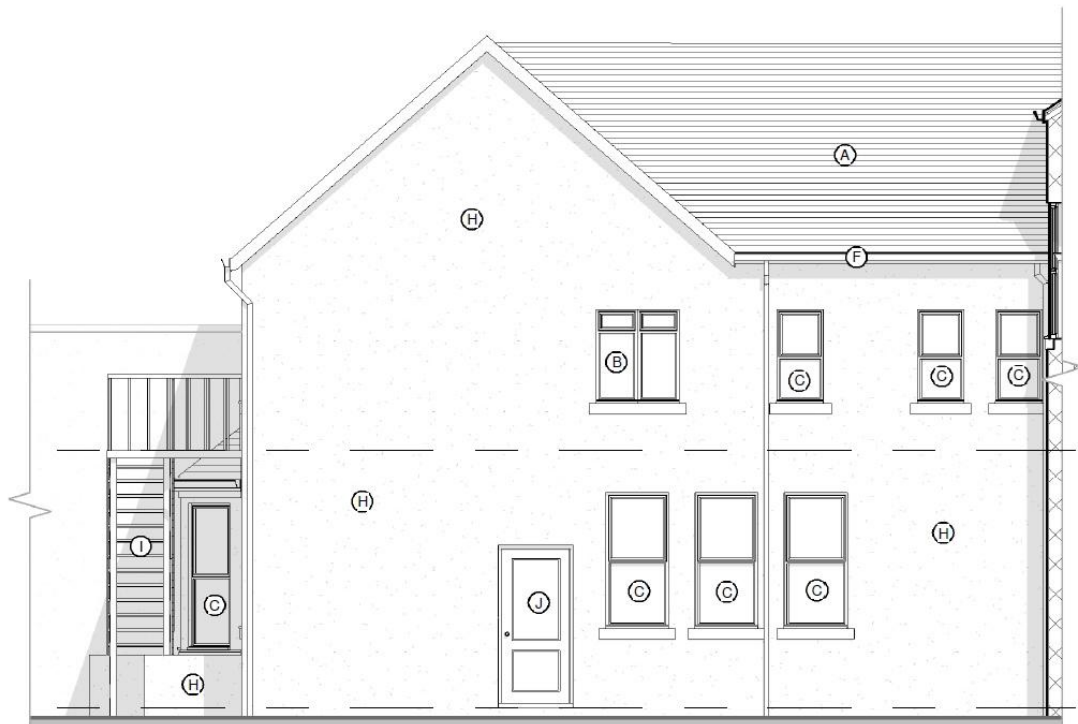
At the back of the building, the lower extension has, in its north wall facing number 49, three upper-storey windows with two-pane sash windows and one lower-storey window (fig 7).

*Figure 7. Existing north elevation.*

In the right-hand (north gable end) of the rear wing is an external stack, doorway to its right, with replacement door, two sash windows further right and replacement window on the first floor (figs 7, 9).

In the north gable end of the rear range the existing first-floor window will be replaced by a two-pane sash window (fig 32). To its right the first-floor window lighting the ladies toilet will be replaced by a similar window slightly to the right (compare figs 7 and 32).

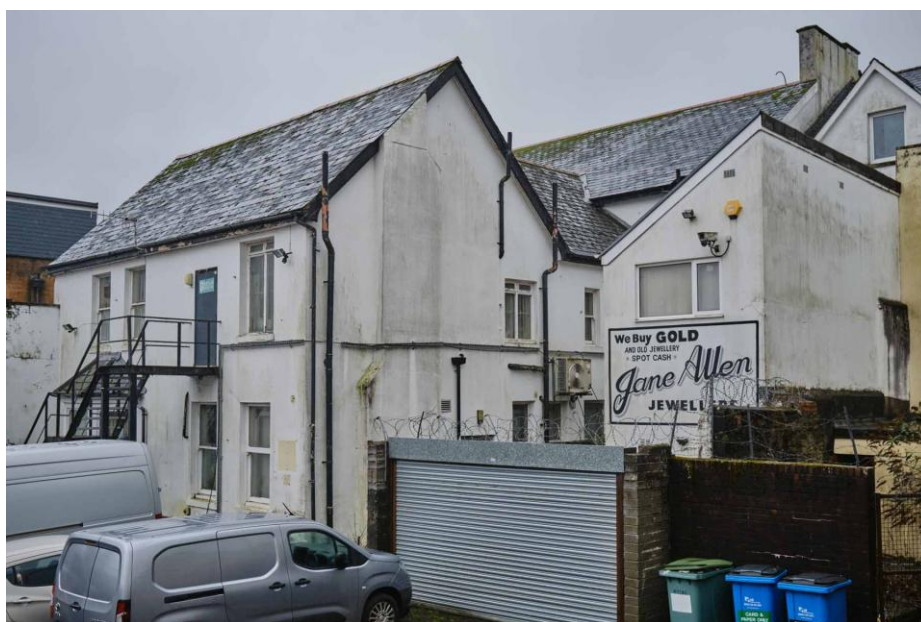
*Figure 9. Rear of the building, showing the lower link to the parallel rear range.*

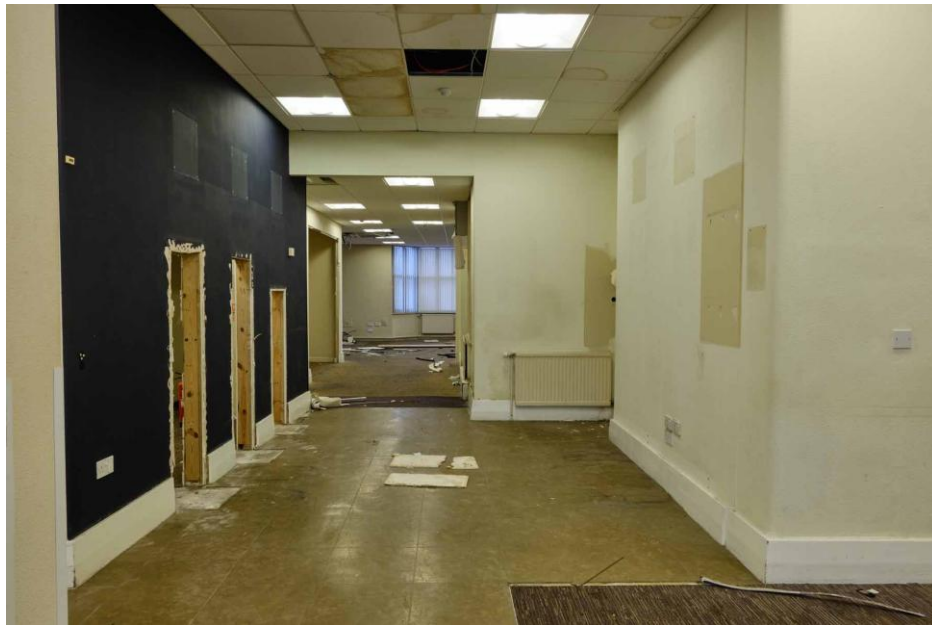
*Figure 11. Banking hall, looking to the rear of the building.*

The interior was originally part commercial and part residential, but it is difficult now to distinguish fully between them in the original (1902) use of the building. The banking hall now takes up the whole ground floor and is much modernised, but originally the rear part was probably residential (figs 10, 11). On the north side a partition has been partly removed and suggests that there was a separate corridor here reached from the left-hand main doorway, as indicated on the 1956 map (fig 12). There is a suspended ceiling of polystyrene tiles, gaps in which reveal the original ceiling, but no features of interest were visible within it. The existing doorway has inner, double half-glazed doors, a twentieth-century insertion, in a surround with fluted pilasters (fig 13).

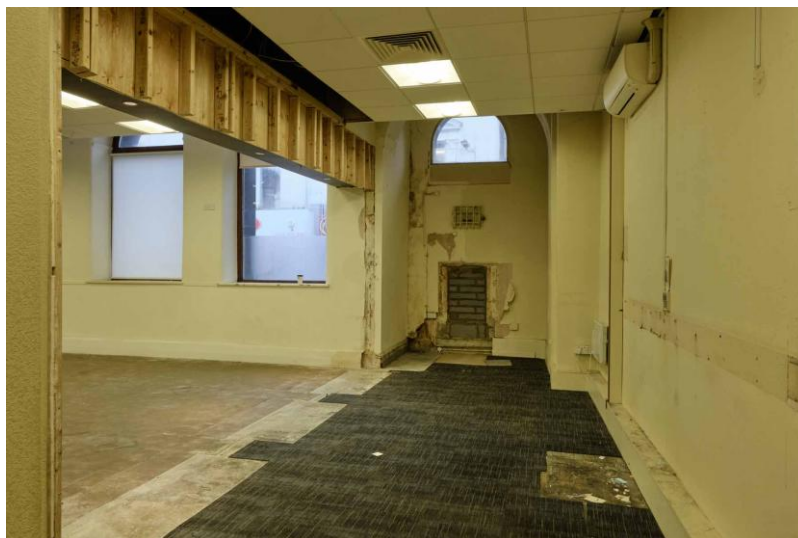
*Figure 12. View to the blocked former entrance, with evidence of a former corridor separate from the banking hall.*

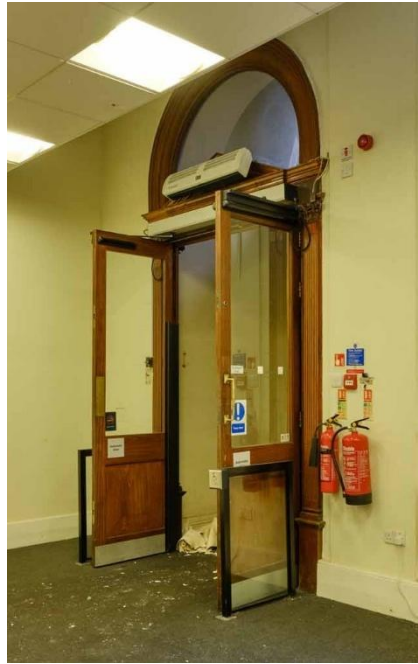
*Figure 13. Inner doorway of main entrance.*

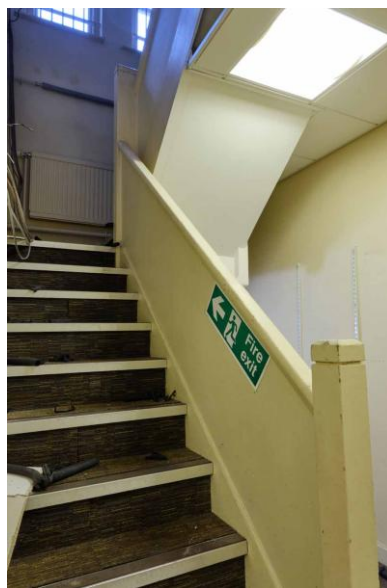
A plain open-well stair leads to the upper storey (fig 16). It has simple square newels and boarding in place of balusters. The upper storey is on two levels, indicating the different dates between the front range and the rear extensions (fig 17). From the top of the stairs there are doorways right and left. On the right side there are steps up to the doorway, which has a moulded round-headed surround, but modern door. It opens to a landing where there are doorways to the two rooms at the front, a small store, a room behind in the front range (Room 4), and the lift. They have doorcases with moulded surrounds and pediments (except for room 1 which has lost its pediment), but modern doors (fig 18). Within Room 4 there is a similar doorway to a small storage area, which retains an original fielded-panel door (fig 19). Within this store the rubble-stone fabric of the external wall is visible.

*Figure 16. Stairway.*

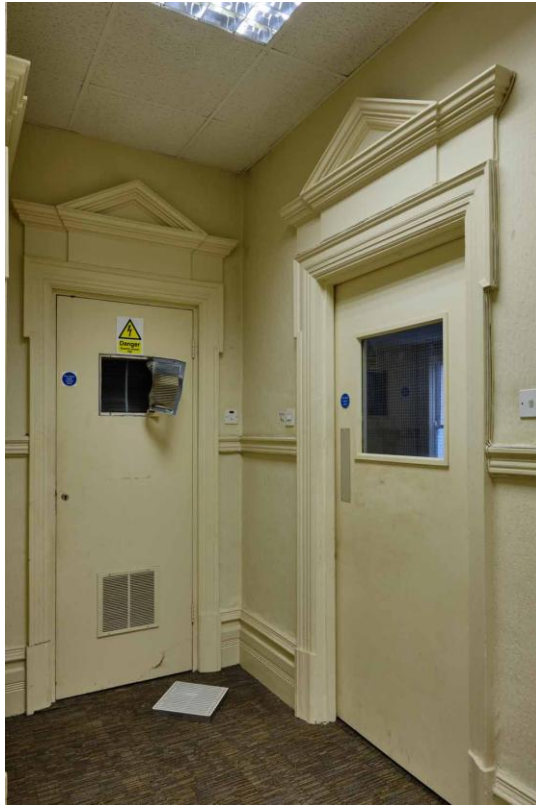
*Figure 18. Doorcases to Room 2 and a store.*

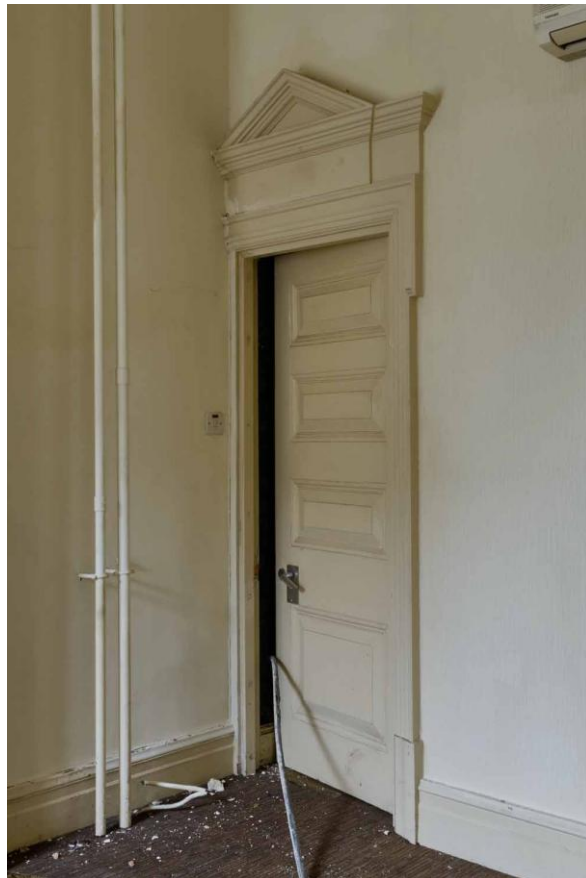
*Figure 19. Doorcase and panel door to store in Room 4.*

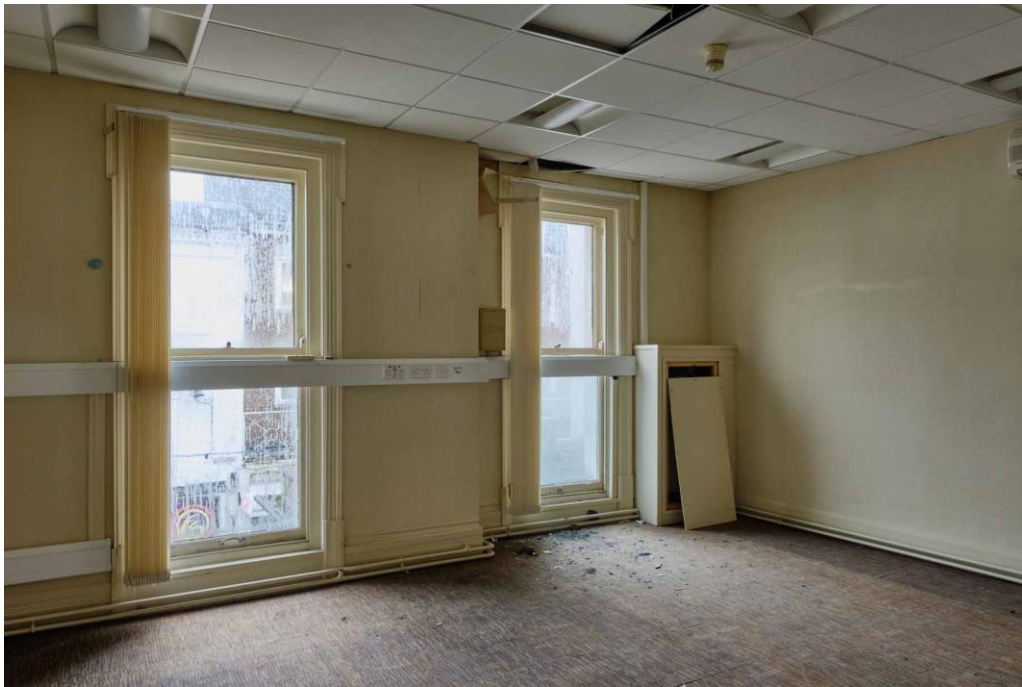
Rooms 1 and 2 in the main range retain windows with moulded surrounds, as well as a moulded skirting board (fig 20). There is no evidence of former fireplaces in these rooms, but there is a blocked fireplace and chimney in Room 4 (fig 21). Rooms in the rear range are at a lower level. Windows all have steel bars internally (fig 22). The kitchen (Room 6) includes a picture rail and was evidently originally residential (fig 23). The female toilets retain an original panelled door (fig 24). The corridor is partly a later addition, since it leads to the escape door in the back wall, which is not an original feature.

*Figure 20. Architraves to windows in Room 1.*

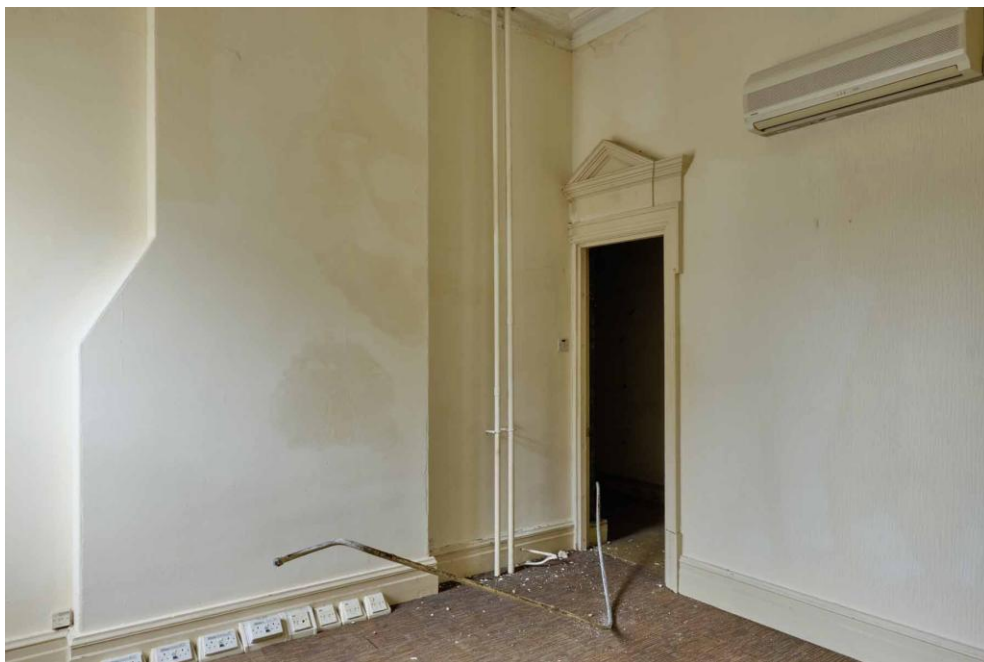
*Figure 21. Blocked fireplace in Room 4.*

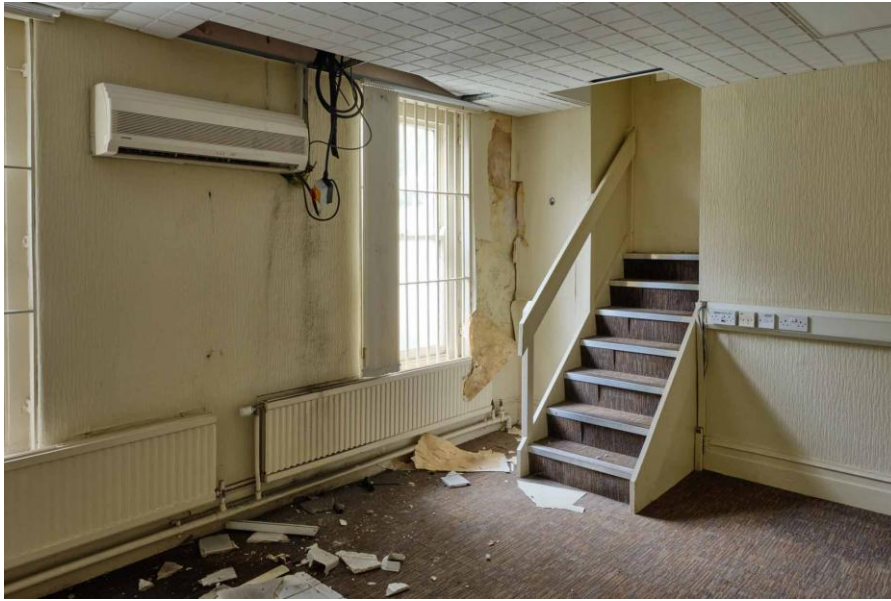
*Figure 22. Modern steps in Room 5, and barred window.*

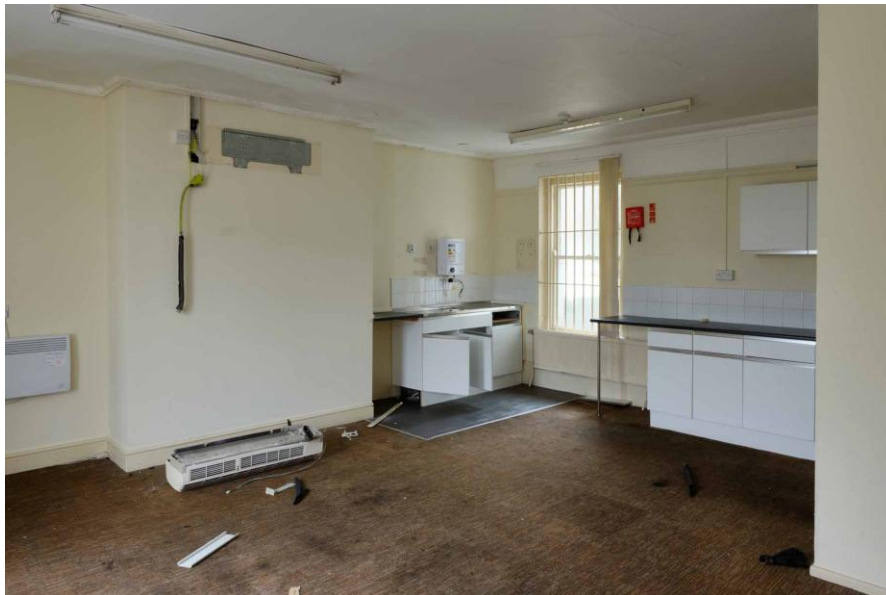
*Figure 23. Room 6, with blocked fireplace.*

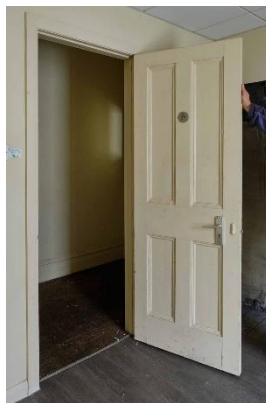
*Figure 24. Panel door to ladies toilet.*

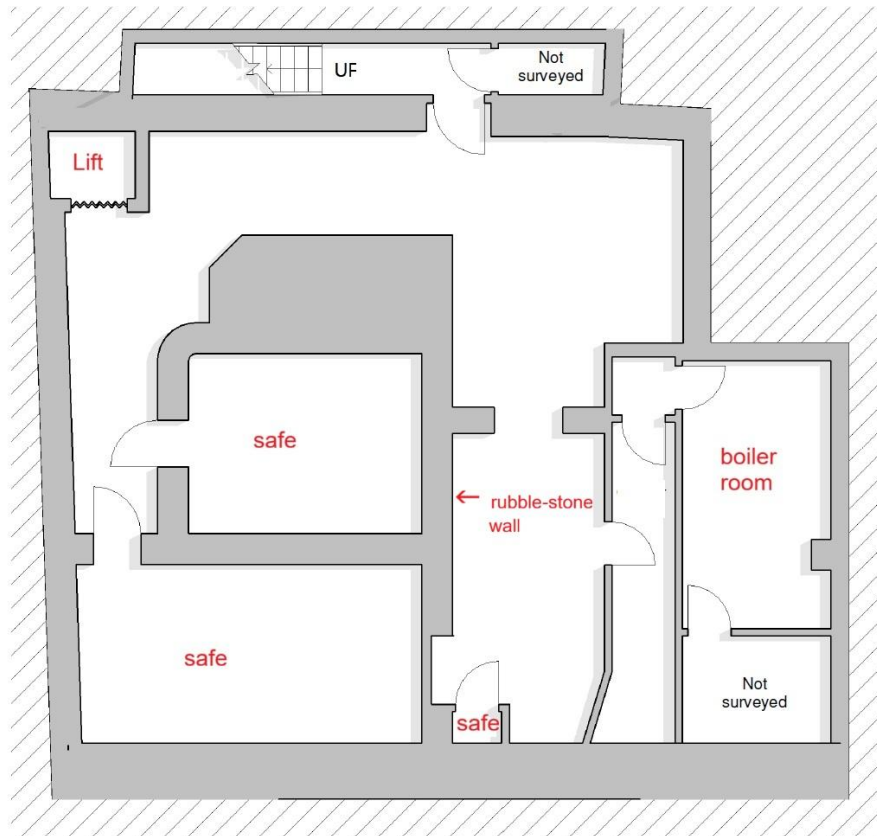
*Figure 25. Basement plan.*

A closed-string stair, beneath the main stair, descends to the basement (figs 25, 26). A rubble-stone cross wall belongs to a much earlier phase, probably when there were two buildings on the plot (fig 27). Flagstones are visible in part of the basement. There are two large safe rooms. One of them was specially constructed as such, whereas the other uses the existing basement walls (fig 28). Both of them retain heavy reinforced steel doors made by Chubb (fig 29).

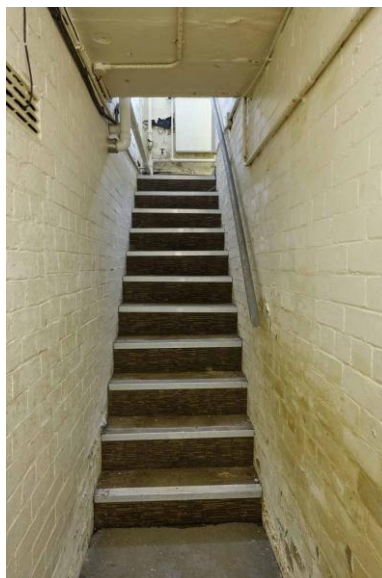
*Figure 26. Basement stair.*

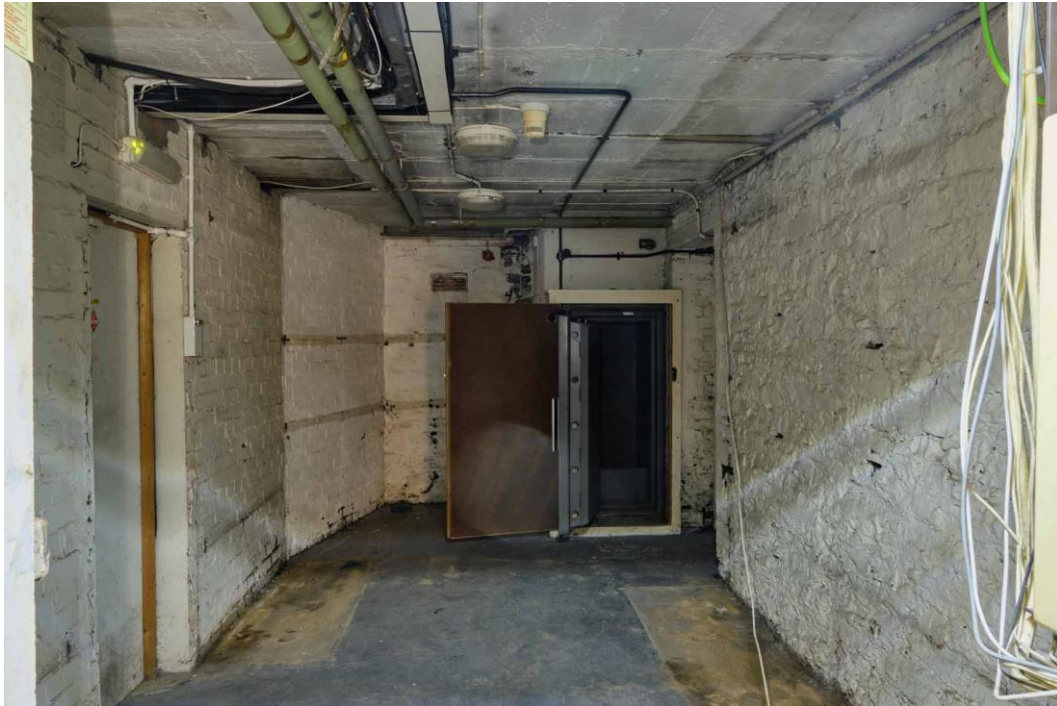
*Figure 27. Basement, with small modern safe, and dividing wall on the right, probably pre-dating the first bank on the plot.*

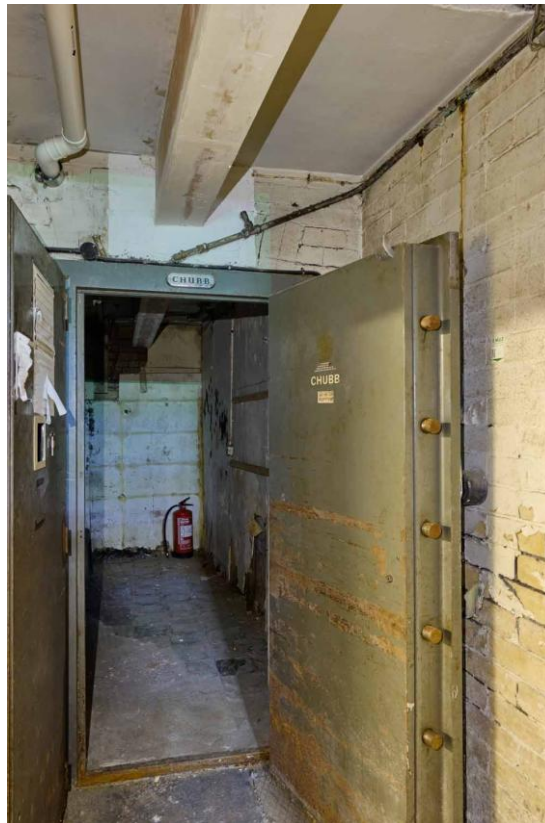
*Figure 29. Safe door.*

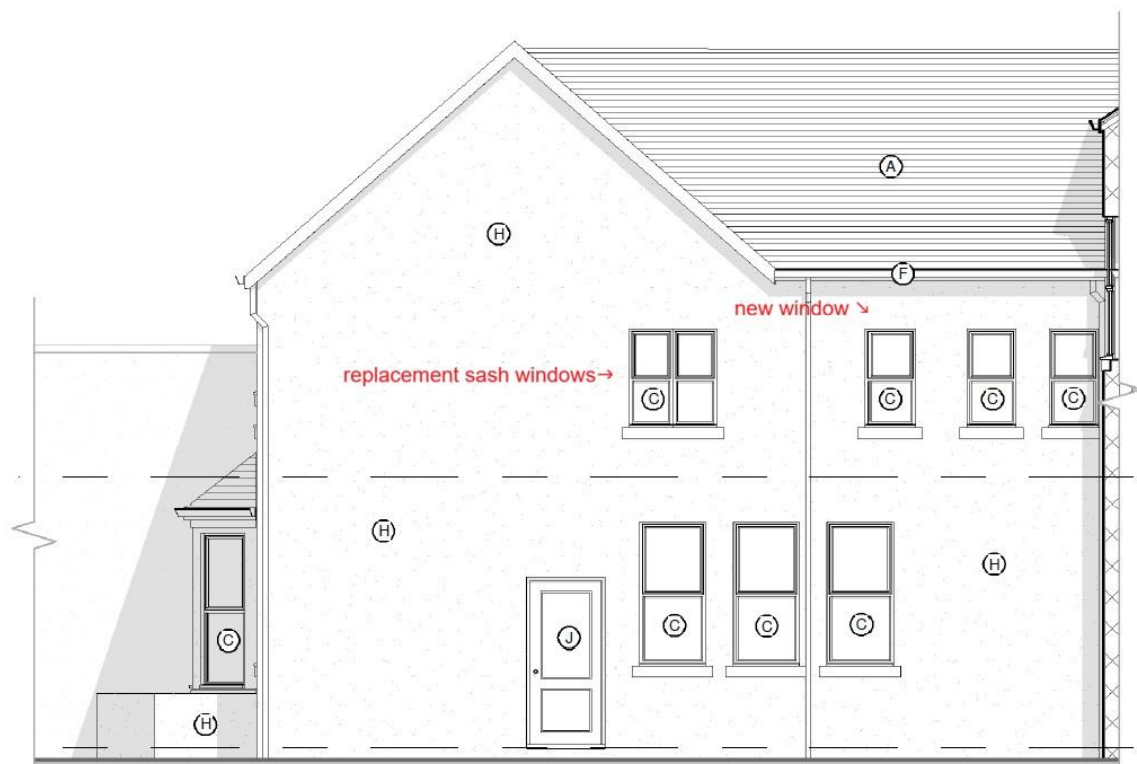
Figure 32. Proposed north elevation.
