# INTERNAL MEMORANDUM

**SUBJECT: P/22/0083 | Proposed barn conversion to form a residential dwelling | Tyla-Glas Farm Craig Y Hendre Bedlinog Treharris CF46 6SN**

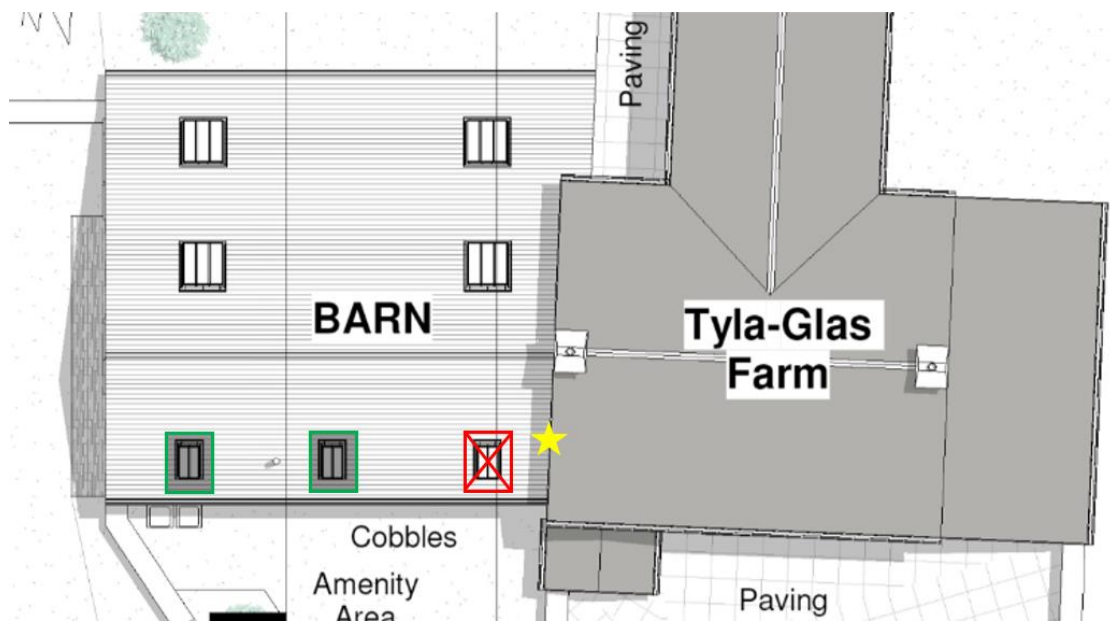
electric blinds that close at dusk. Electric blinds with no other mitigation will not be acceptable as these can fail or can be overridden. The common pipistrelle roost entrance on the south western gable end of the farmhouse is shown on the drawing below (yellow star). The best solution therefore, would be to remove the roof light on the south eastern pitch closest to the roost entrance (crossed in red). Low transmission glazing treatments will then be used for the remaining roof lights on the south eastern pitch (green boxes). NB light transmission through 'tinted' glass can be reduced with specially coated materials, similar to blackout glass or tinted windows, which can reduce visible light transmittance.

- o A change in design regarding the roof lights is required. Document 1 suggests relocation of the roof lights on the south eastern elevation or the addition of
