## Arboricultural Report

To the British Standard 5837:2012  
*(Trees in relation to design, demolition  
and construction. Recommendations)*

Site – Goetre Primary School, Merthyr

Project Reference – ArbTS\_1751.2\_Goetre Primary School

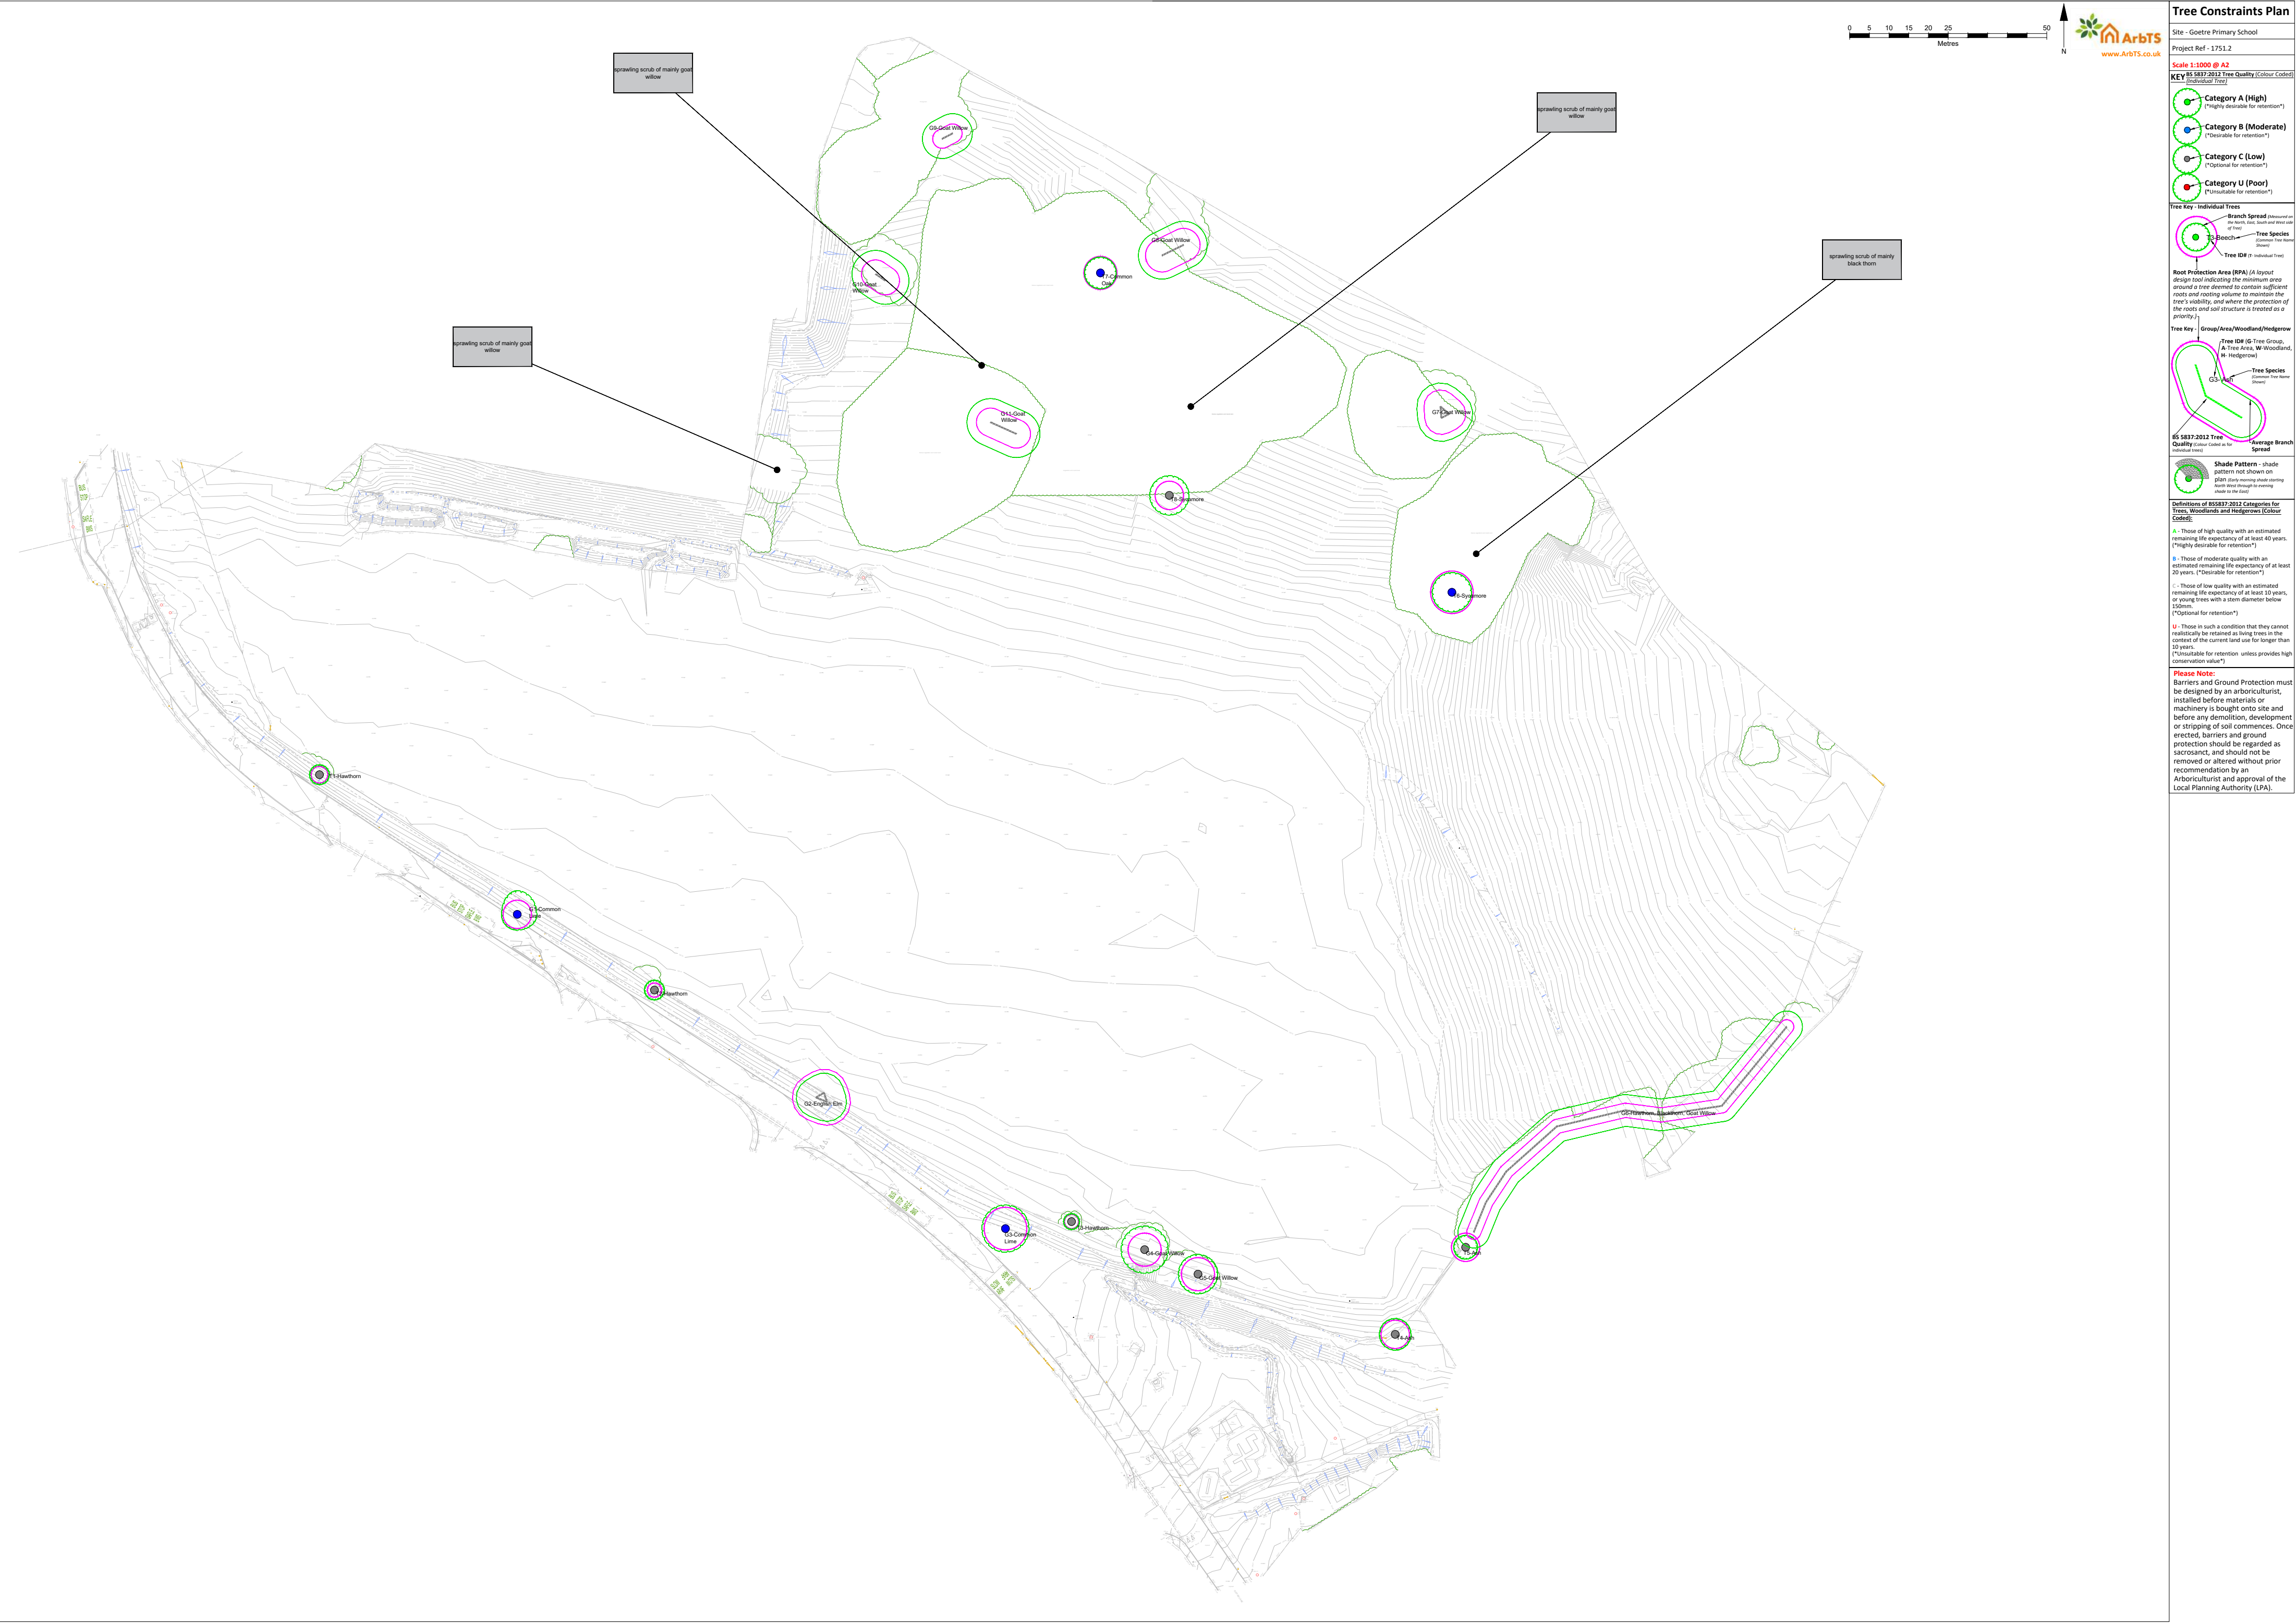
### Tree Constraints Plan

- **Root Protection Area** – The magenta circle on the TCP sets out the root protection area (RPA). No construction work in this area, ground-level alteration or site traffic (machinery or persons) should occur. This prevents damage to tree roots and soil compaction. (Where possible, an Arboriculturist can design suitable tree protection methods to facilitate construction work/site traffic within these areas).

- **Tree Canopy** - The green circle/oval on the TCP sets out the above-ground constraints of tree canopy spread. Within this area, no construction work or site traffic (machinery or persons) should occur if the tree is to be retained. This prevents damage to the tree branches and trunk. (Where possible, an Arboriculturist can design suitable tree protection methods to facilitate construction work/site traffic within these areas).

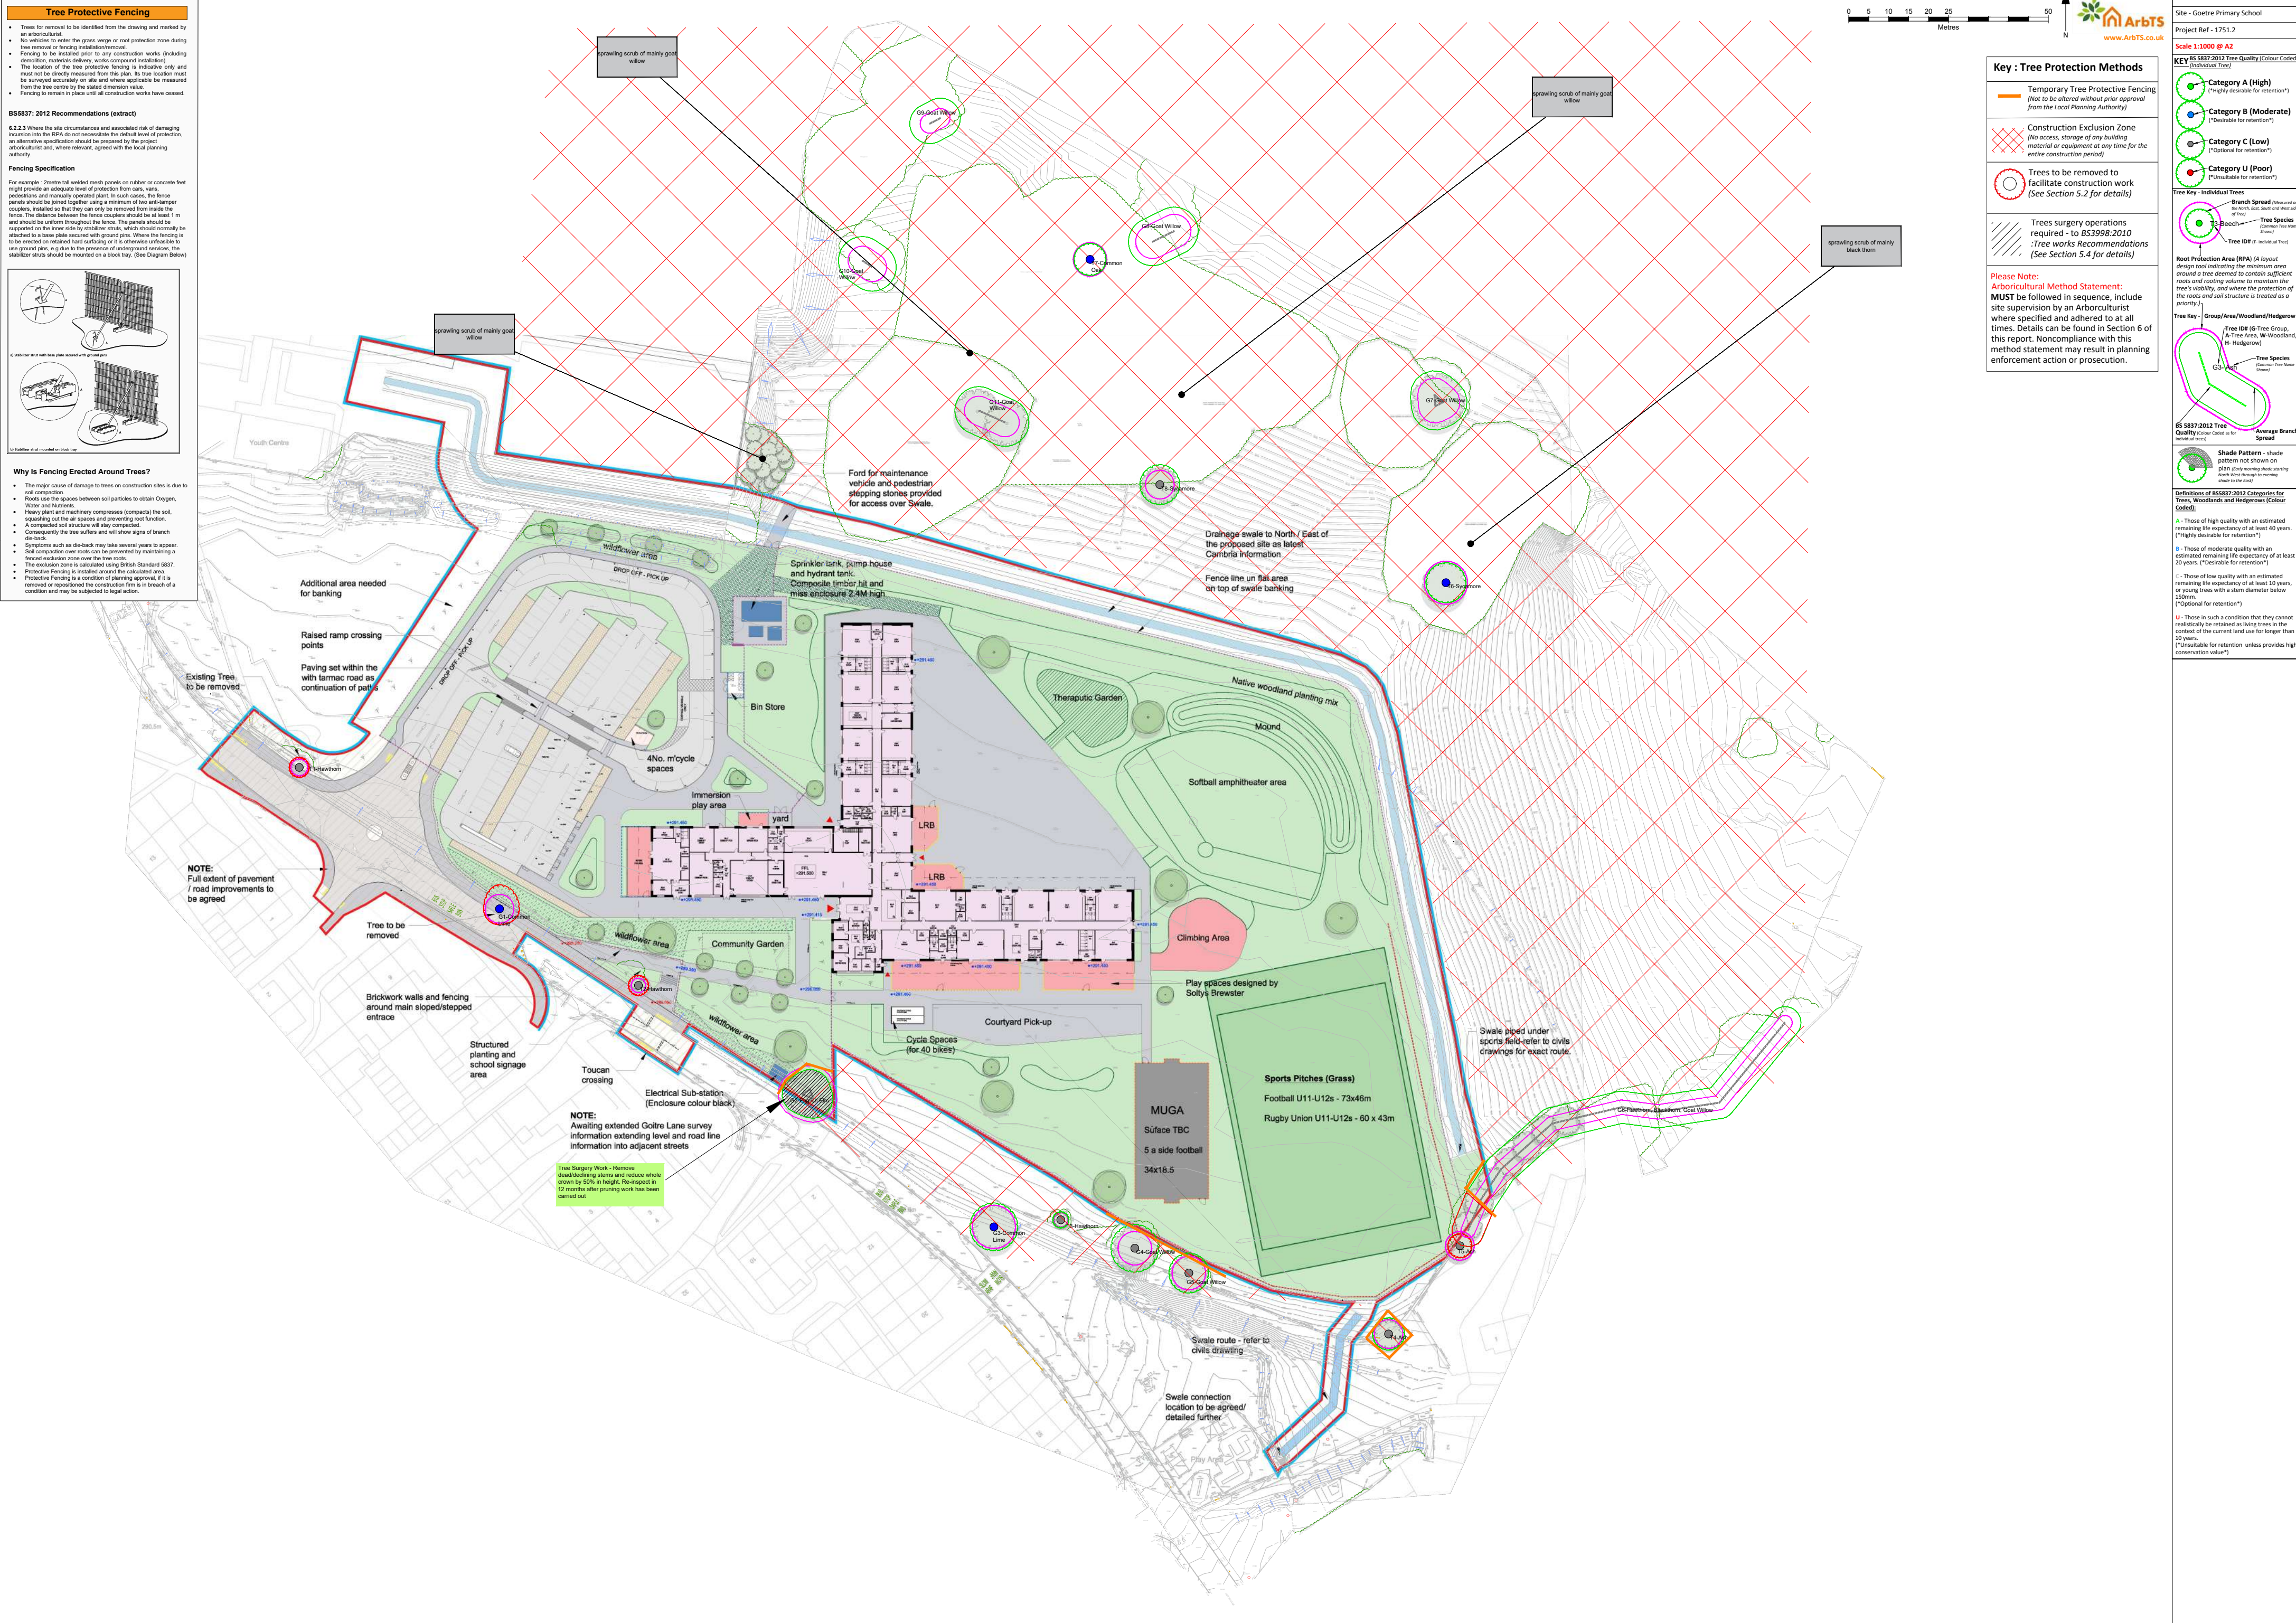
## **10.0 Appendix 4 – Tree Protection Plan**

**Tree Protective Fencing**

- Trees for removal to be identified from the drawing and marked by an arboriculturist.
- No vehicles to enter the grass verge or root protection zone during tree removal or fencing installation/removal.
- Fencing to be installed prior to any construction works (including demolition, materials delivery, works compound installation).
- The location of the tree protective fencing is indicative only and must not be directly measured from this plan. Its true location must be surveyed accurately on site and where applicable be measured from the tree centre by the stated dimension value.
- Fencing to remain in place until all construction works have ceased.

**Arboricultural Method Statement:**  
MUST be followed in sequence, include site supervision by an Arboriculturist where specified and adhered to at all times. Details can be found in Section 6 of this report. Noncompliance with this method statement may result in planning enforcement action or prosecution.

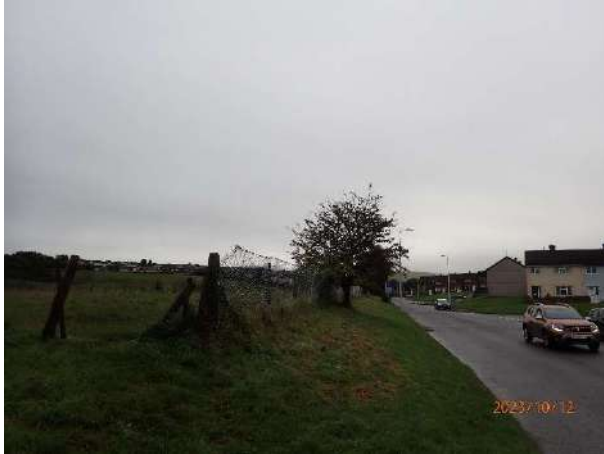
Tree ID#T1

| Tree ID # | Tree Species | Age | Stems | Stem Diam (mm) | Cat | Height + (Lower Branch Height) | Nrth | Est | Sth | Wst | Phys Cond | Struc Cond | Est. Remain Contrib | Comments | Preliminary Management Recommendations | Work Priority | RPR (m) | RPA (m2) |
|---|---|---|---|---|---|---|---|---|---|---|---|---|---|---|---|---|---|---|
| T1 | Crataegus monogyna (Hawthorn) | M | 2 | 125 | C2 | 3(1) | 2.5 | 2.5 | 2.5 | 2.5 | G/F | F | 10+ | small hawthorn | | | 2.12 | 14.12 |

- T1 – Hawthorn – Low quality (C category)
- T2 – Hawthorn – Low quality (C category)
- T5 – Ash – Low quality (C category)

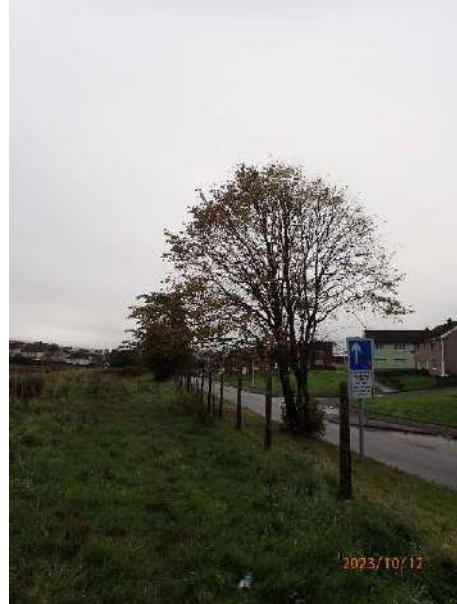
Tree ID#G1

| Tree ID # | Tree Species | Age | Stems | Stem Diam (mm) | Cat | Height + (Lower Branch Height) | Nrth | Est | Sth | Wst | Phys Cond | Struc Cond | Est. Remain Contrib | Comments | Preliminary Management Recommendations | Work Priority | RPR (m) | RPA (m2) |
|---|---|---|---|---|---|---|---|---|---|---|---|---|---|---|---|---|---|---|
| G1 | Tilia X europaea (Common Lime) | EM | 1 | 300 | B2 | 9(3) | 6 | 5 | 4 | 4 | G/F | G/F | 20+ | low B category. multistemmed trees forming a whole of fair form | | | 3.6 | 40.72 |

- Tree Group – G1 – Lime - Moderate quality (B category)
- Small end part of Tree Group – G6 – Sprawling scrub – Low quality (C category)

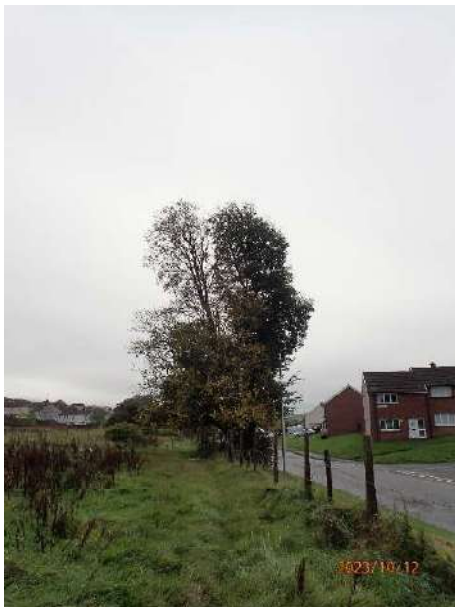
Tree ID#G2

| Tree ID # | Tree Species | Age | Stems | Stem Diam (mm) | Cat | Height + (Lower Branch Height) | Nrth | Est | Sth | Wst | Phys Cond | Struc Cond | Est. Remain Contrib | Comments | Preliminary Management Recommendations | Work Priority | RPR (m) | RPA (m2) |
|---|---|---|---|---|---|---|---|---|---|---|---|---|---|---|---|---|---|---|
| G2 | Ulmus procera (English Elm) | M | 1 | 500 | C2 | 14(4) | 5 | 5 | 5 | 5 | F/P | F | 10+ | Suckers around stem base. Unbalanced crown shape. Surrounding vegetation prevented close inspection of the tree therefore all observations and measurements are estimated. a number of trees forming a whole, one tree dead and other declining, as a whole likely to succumb to Dutch elm disease in the near future | remove dead and declining stems and reduce remaining stems by 50 percent in height to create a compact crown | H/M | 6 | 113.1 |

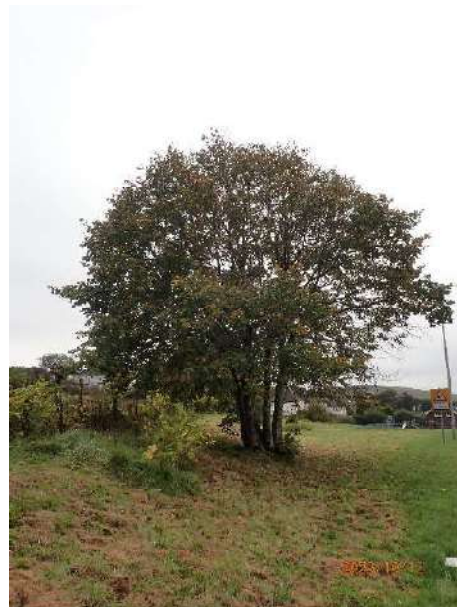
Tree ID#G3

| Tree ID # | Tree Species | Age | Stems | Stem Diam (mm) | Cat | Height + (Lower Branch Height) | Nrth | Est | Sth | Wst | Phys Cond | Struc Cond | Est. Remain Contrib | Comments | Preliminary Management Recommendations | Work Priority | RPR (m) | RPA (m2) |
|---|---|---|---|---|---|---|---|---|---|---|---|---|---|---|---|---|---|---|
| G3 | Tilia X europaea (Common Lime) | EM | 1 | 450 | B2 | 9(3) | 6 | 6 | 6 | 6 | G/F | G/F | 20+ | multistemmed trees forming a whole of fair form | | | 5.4 | 91.62 |
