# Ecological Impact Assessment

Project: Land at Dragon Parc, Merthyr Tydfil

Instructed by: Huntley Wood Investments Ltd

Reported by: Ecological Services Ltd  
10 Mount Pleasant, Llanelly Hill, Abergavenny, Monmouth NP7 0NT  
Reported by

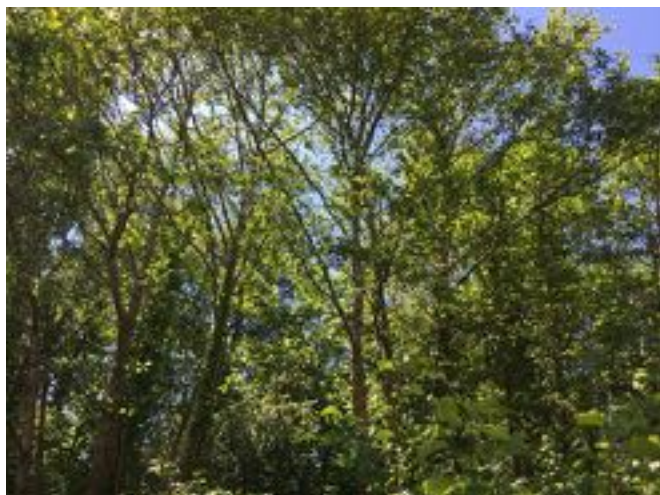
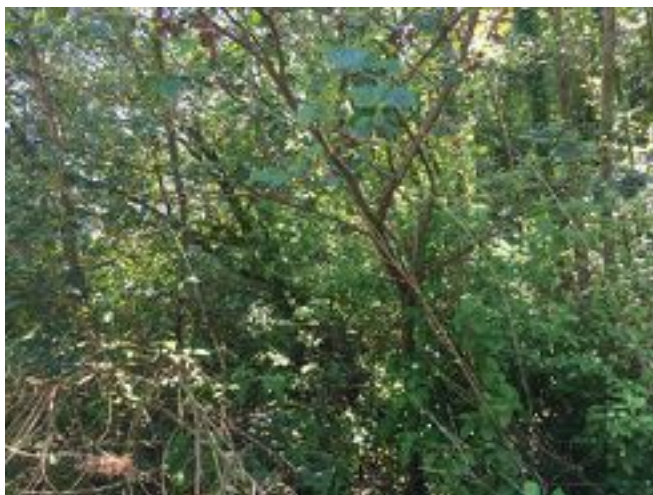
View of trees in G2 to be lost by pond

| Tree | Potential Roost Features | Potential for Bat Use |
|---|---|---|
| Group of trees around pond to the west of site - forms part of G2 as detailed in tree report | None observed. All observed trees were young with no gaps or cracks noted | Negligible |

- The location of the pond will be marked out under supervision of the ecologist prior to any clearance work in this area starting. The trees surrounding the pond will be cut down in two stages. The trees will be cut down to 0.5m high in the first stage with all cuttings removed to an agreed storage location on the hardstanding. The pond will remain undisturbed as far as possible during the first stage of clearance.

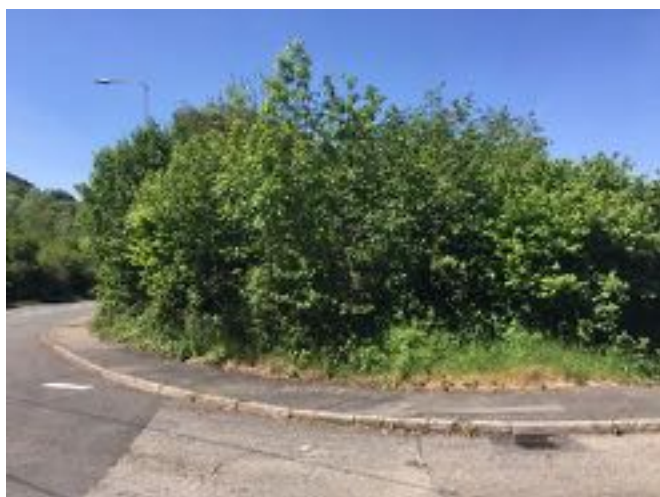
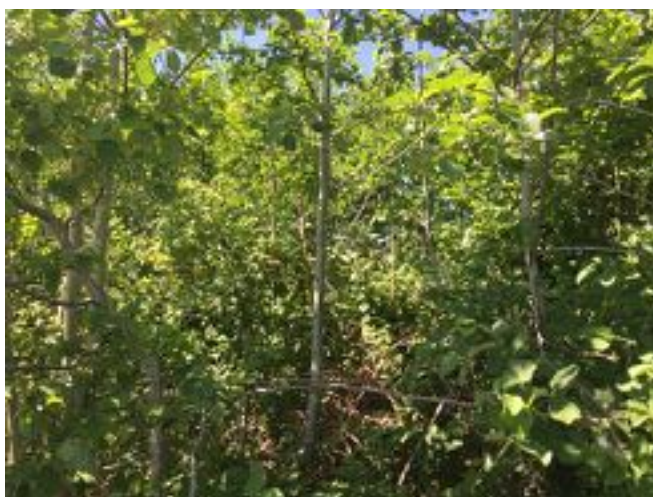
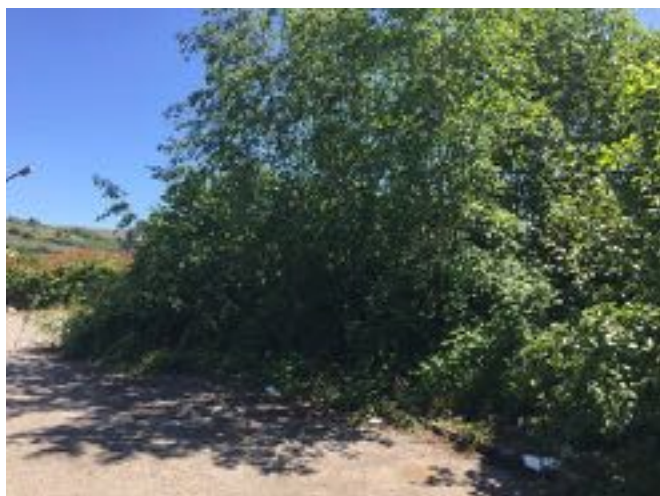
View of trees in G4 to be lost by entrance road

| Tree | Potential Roost Features | Potential for Bat Use |
|---|---|---|
| Group of trees by current access gates into the site - forms part of G4 as detailed in tree report | None observed. All observed trees were young with no gaps or cracks noted | Negligible |

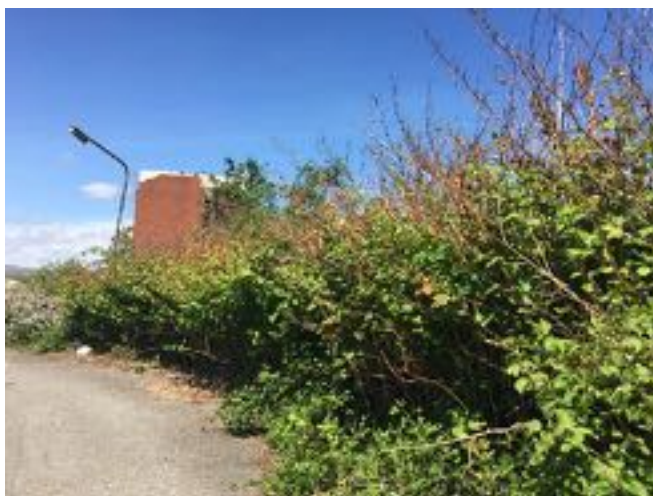
Japanese knotweed along entrance road

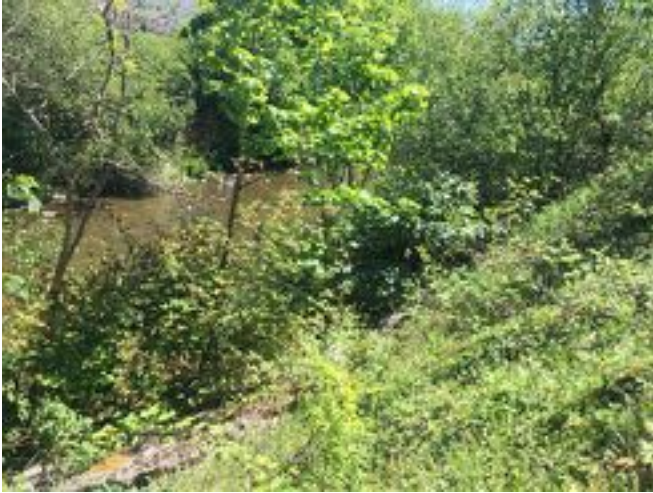
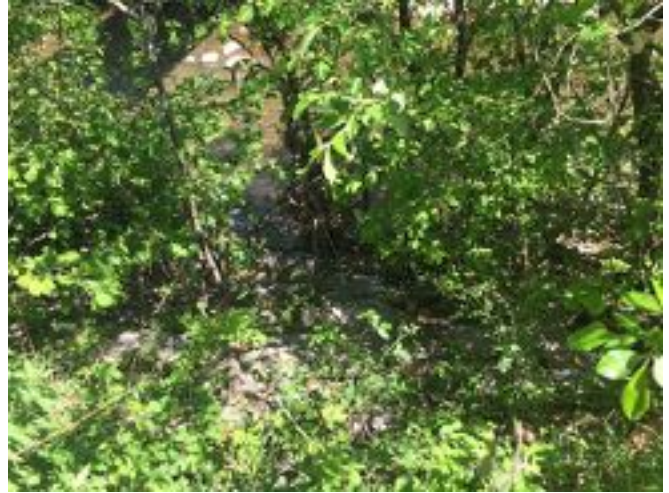
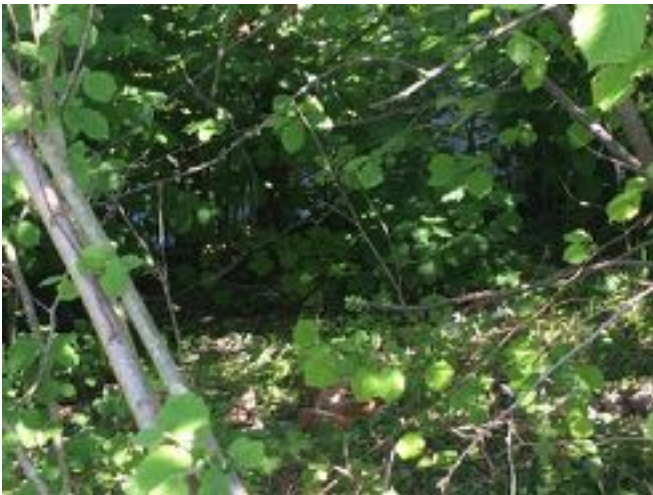
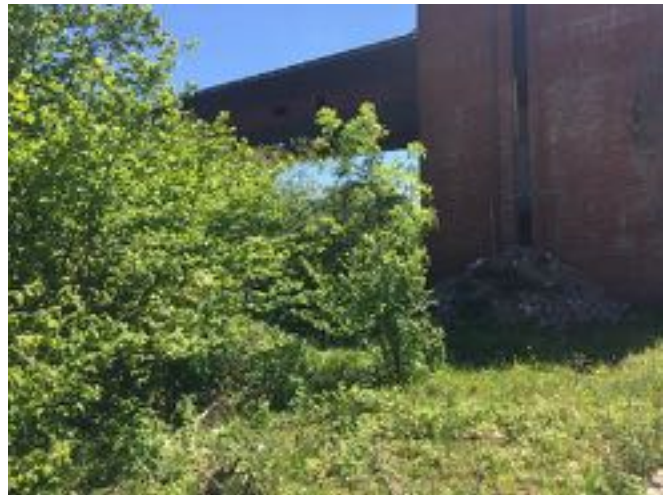
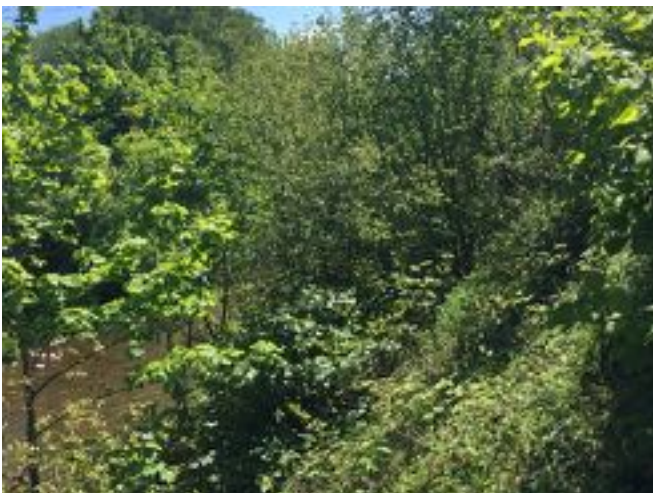
Vegetation along river at new outfall

| Tree | Potential Roost Features | Potential for Bat Use |
|---|---|---|
| 12m of tree line along bank of River Taff | None observed. All observed trees were young with no gaps or cracks noted | Negligible |

The River Taff flows directly adjacent to the proposed development site. 12m of river bank will be disturbed by the proposed development works to create a new discharge point for the drainage swale into the river. To create the new discharge point engineering work along the river bank will be required. The river bank is currently steep sloping and approximately 4m in height. It is covered in a mixture of bramble scrub, young trees and patches of Japanese knotweed.

- Only 12m of vegetation will be cleared along the river bank to facilitate the creation of the new outfall. The vegetation to remain along the river bank will be securely marked out and defined and no clearance or entrance into these areas will be permitted.

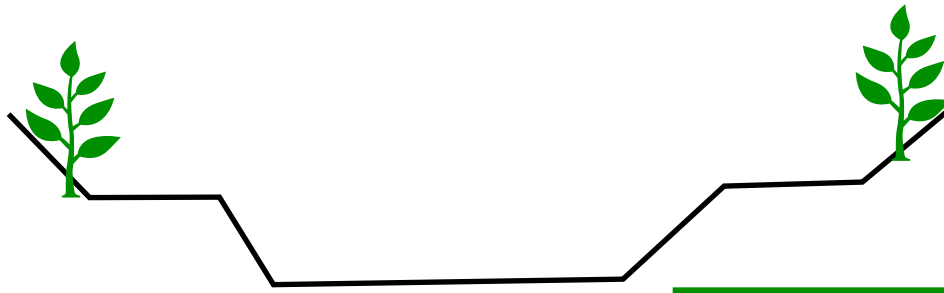
Proposed Pond Profile. Left to naturally vegetate and establish cover.

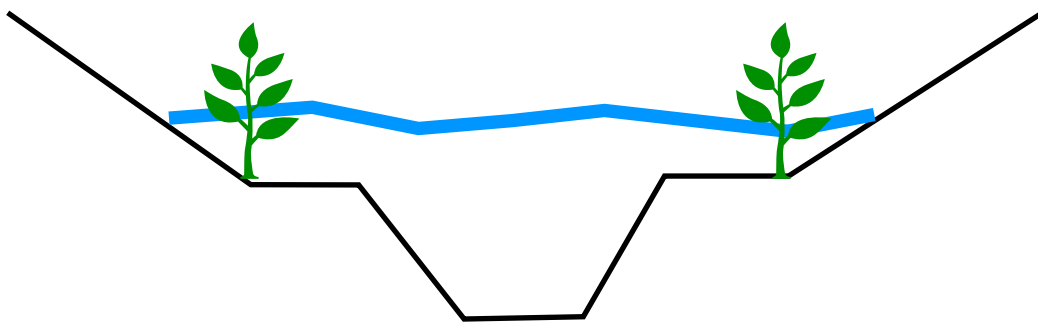
Proposed Swale Profile. Shallow banks down to water edge to allow small mammals access. Deeper profile at base to encourage a variety of vegetation and insect / animal use.
