**Drainage Strategy Report (DSR) For:**  
New Build Classrooms,  
Ty Dysgu Primary School,  
Market Street, CF48 2AJ

REF: 16691 – DSR R08

**Vale Consultancy**  
CONSULTING CIVIL & STRUCTURAL ENGINEERS

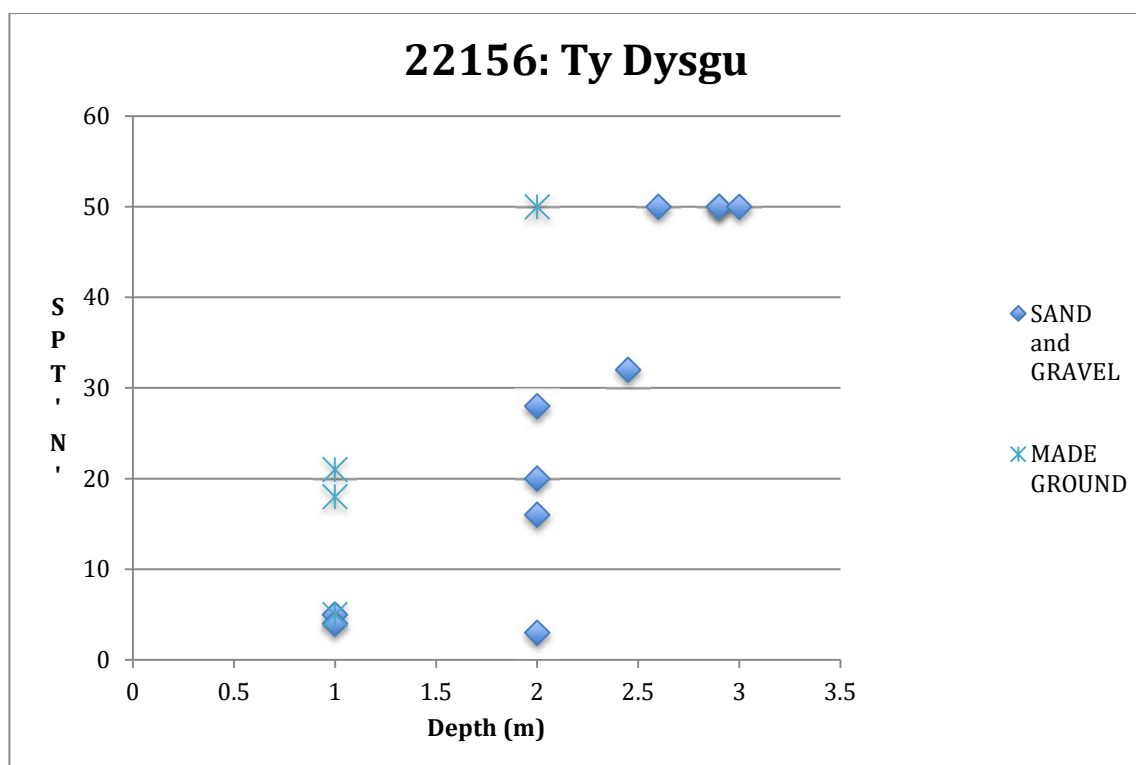
What has been described as SAND and GRAVEL, was encountered where Made Ground was penetrated. The above chart shows the relationship between uncorrected SPT N and depth.

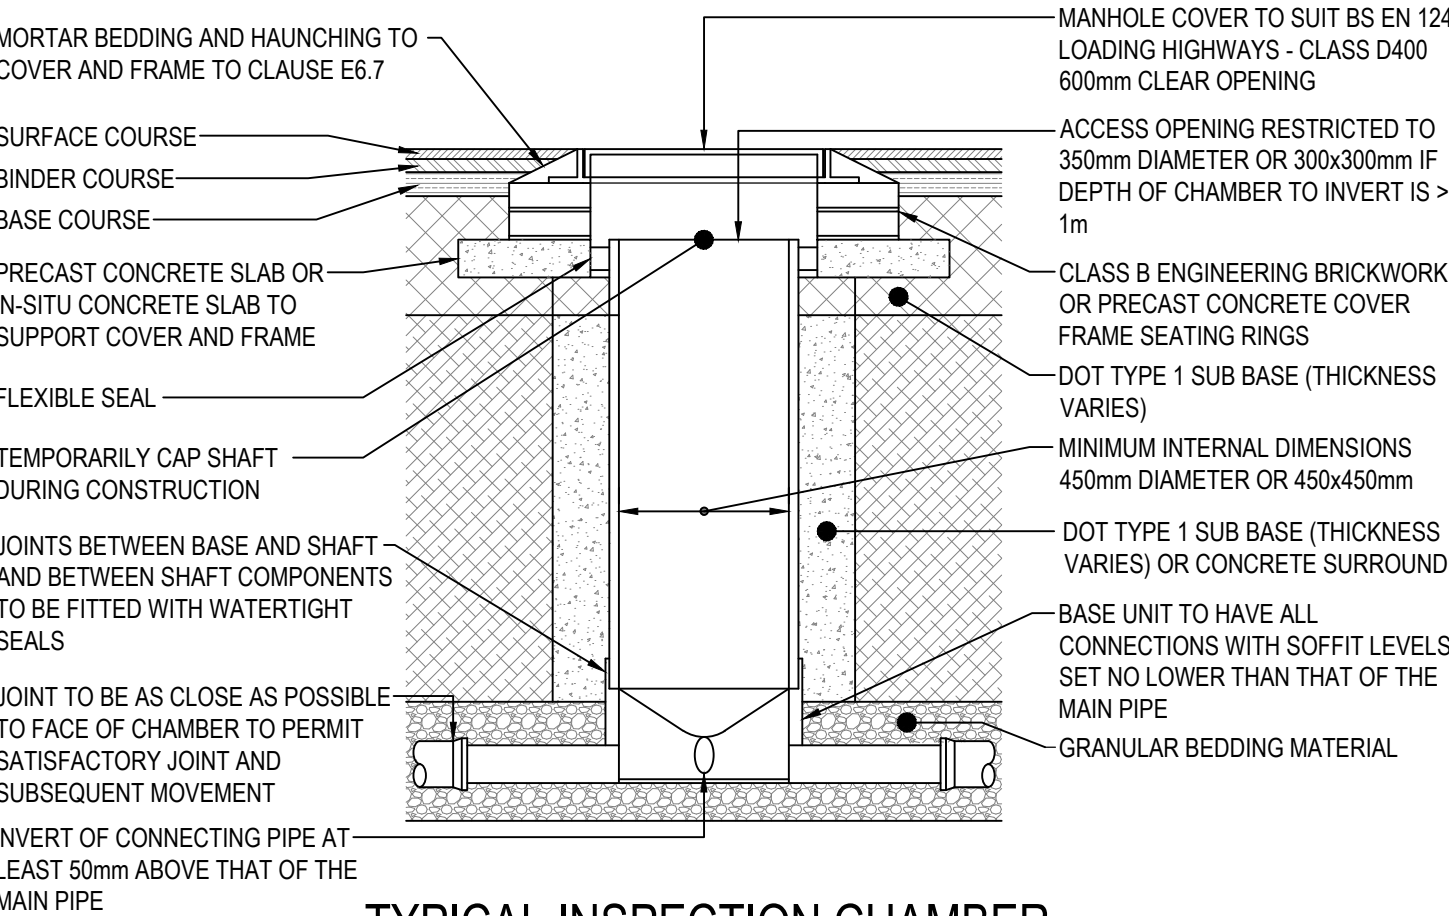
**TYPICAL INSPECTION CHAMBER  
DETAIL - TYPE 3**

(REFER TO FIG. B.16 OF SEWERS FOR ADOPTION 7th ED)  
(DEPTH FROM COVER LEVEL TO SOFFIT OF PIPE 3m)  
(FLEXIBLE MATERIAL DETAIL)

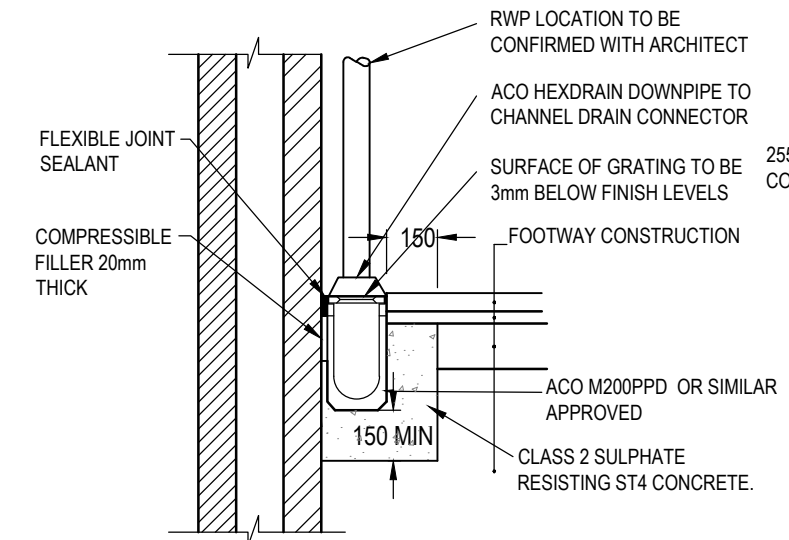
- NOTES:
1. DRAINAGE CHANNELS TO BE ACO M200PPD OR SIMILAR APPROVED
  2. FOUNDATION FOR CHANNELS TO BE LAID ON A ROLLED SUB-BASE OF 150mm MINIMUM THICKNESS.
  3. GRATING LOAD CLASSIFICATION TO BE C250/D400
  4. RWPS TO HAVE ACO HEX DRAIN CONNECTORS TO CHANNEL GRATINGS - REFER TO MANUFACTURERS GUIDELINES

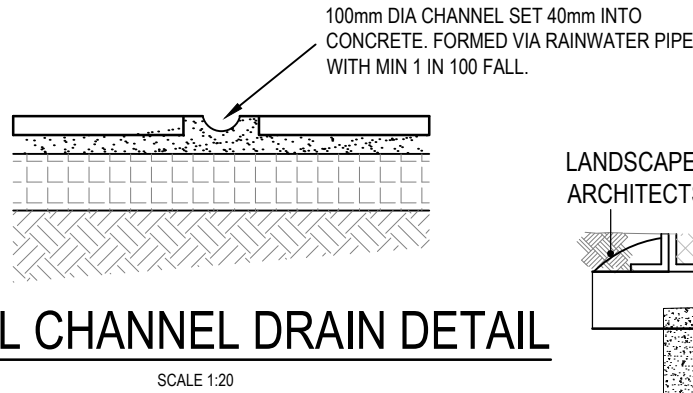
1. DRAINAGE CHANNELS TO BE ACO QMAX LINEAR DRAINAGE AS SUPPLIED BY ACO POLYMER PRODUCTS LTD, EQUAL OR SIMILAR APPROVED BY JUBB TO BE INSTALLED IN ACCORDANCE WITH MANUFACTURERS INSTRUCTIONS.
2. FOUNDATION FOR CHANNELS TO BE LAID ON A ROLLED SUB-BASE LAYER OF 100mm MINIMUM THICKNESS.
3. DRAINAGE CHANNELS ARE TO BE INSTALLED WITH SPECIFIC MANUFACTURERS INSTALLATION GUIDE FOR UNIT SPECIFIED. ANY DISCREPANCIES ARE TO BE REPORTED TO THE ENGINEER IMMEDIATELY.

**TYPICAL CHANNEL DRAIN DETAIL**

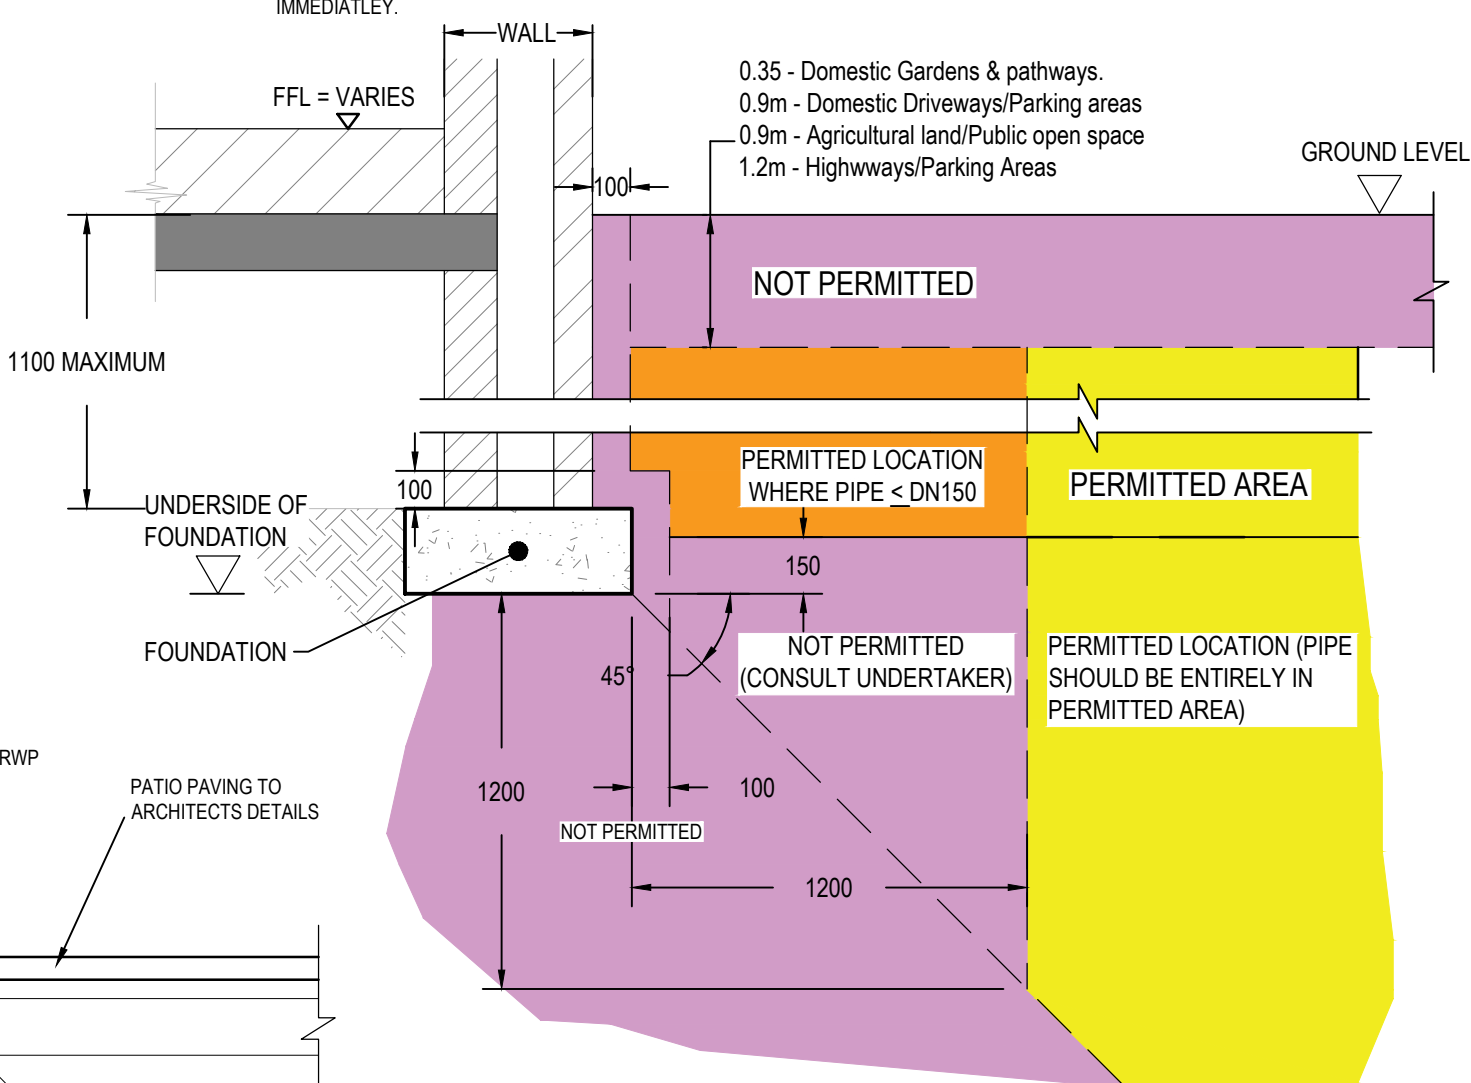
**DRAINAGE DETAIL IN CLOSE  
PROXIMITY OF FOUNDATIONS  
(DETAIL IN ACCORDANCE WITH SFA FIGURE B1)**

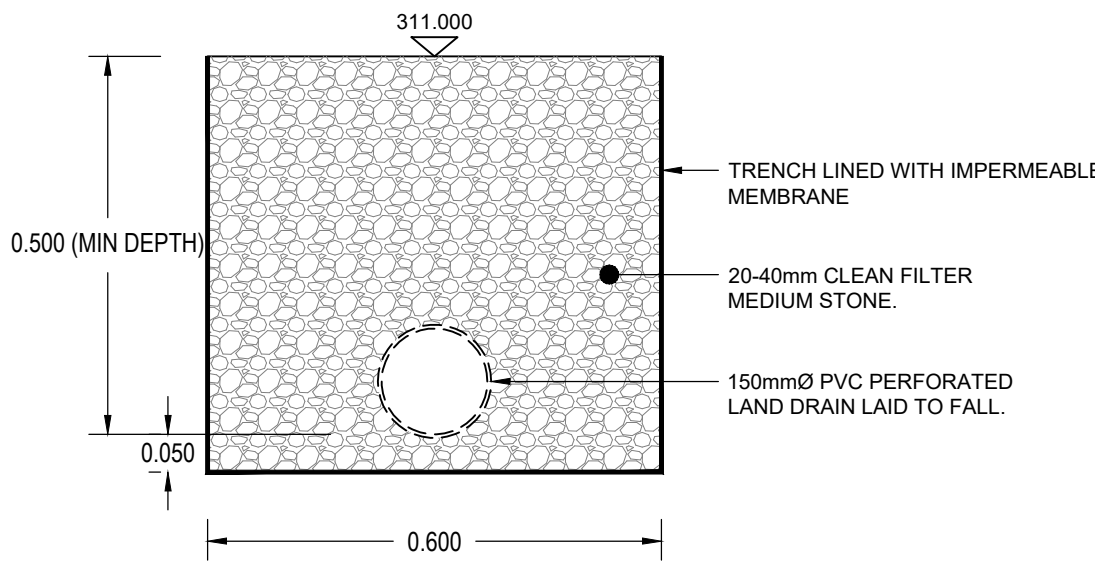
**FILTER DRAIN STANDARD  
DETAIL GFS#1**

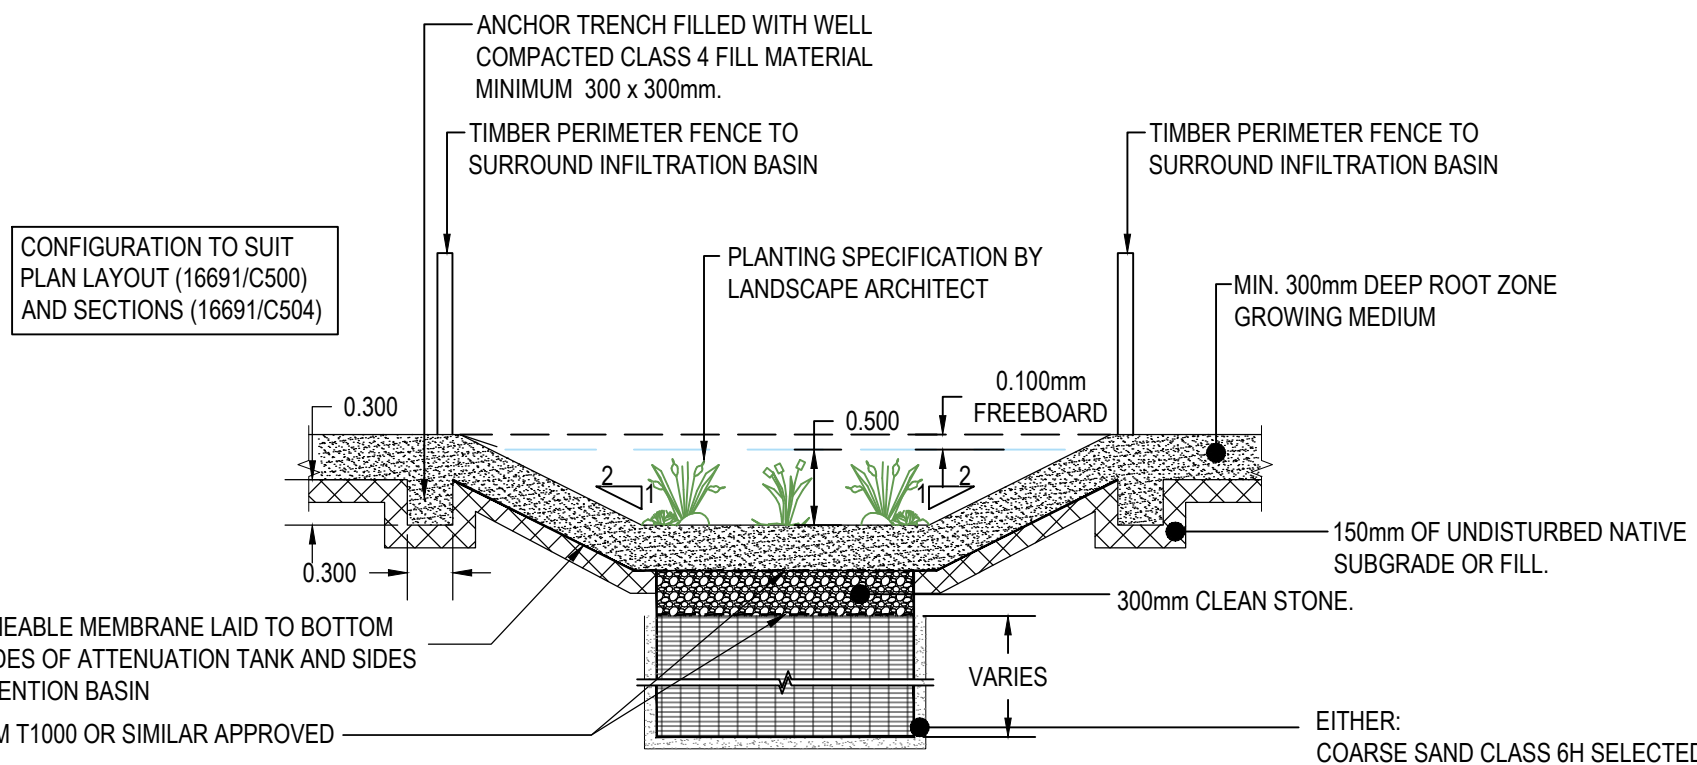
**TYPICAL SECTION THROUGH DETENTION  
BASIN WITH ATTENUATION TANK BELOW**

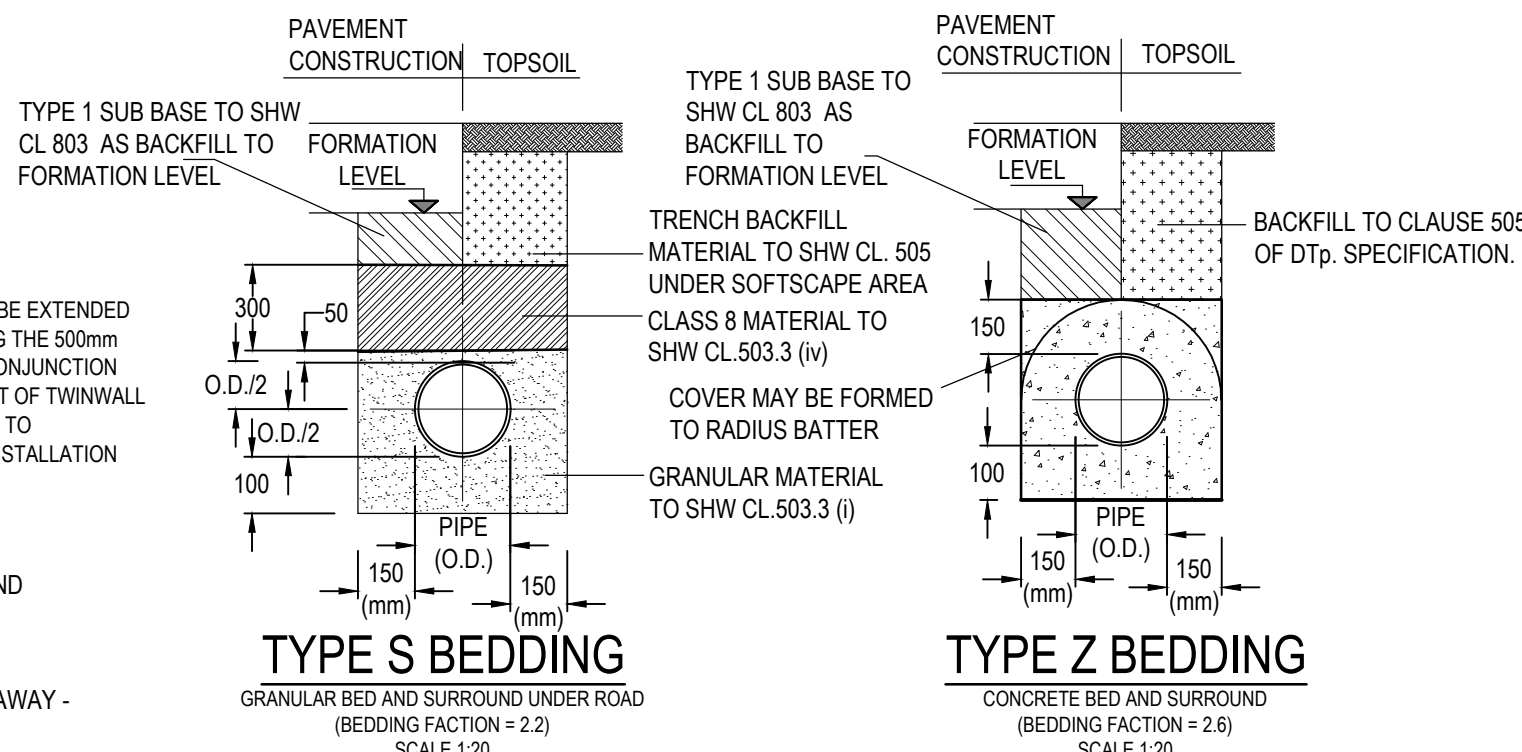
**TYPE S BEDDING**

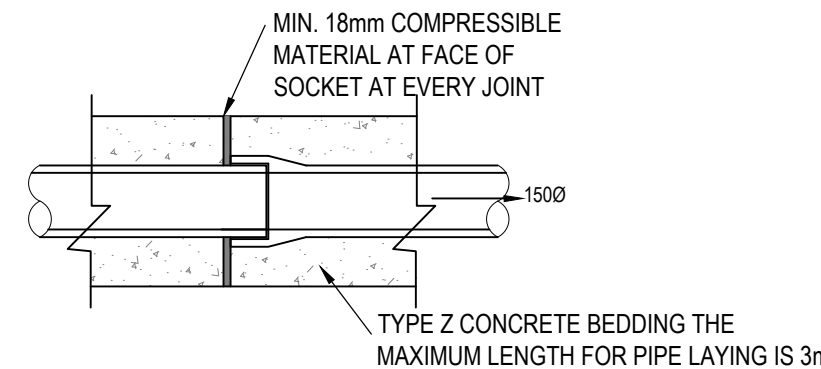
**TYPE Z BEDDING ELEVATION**

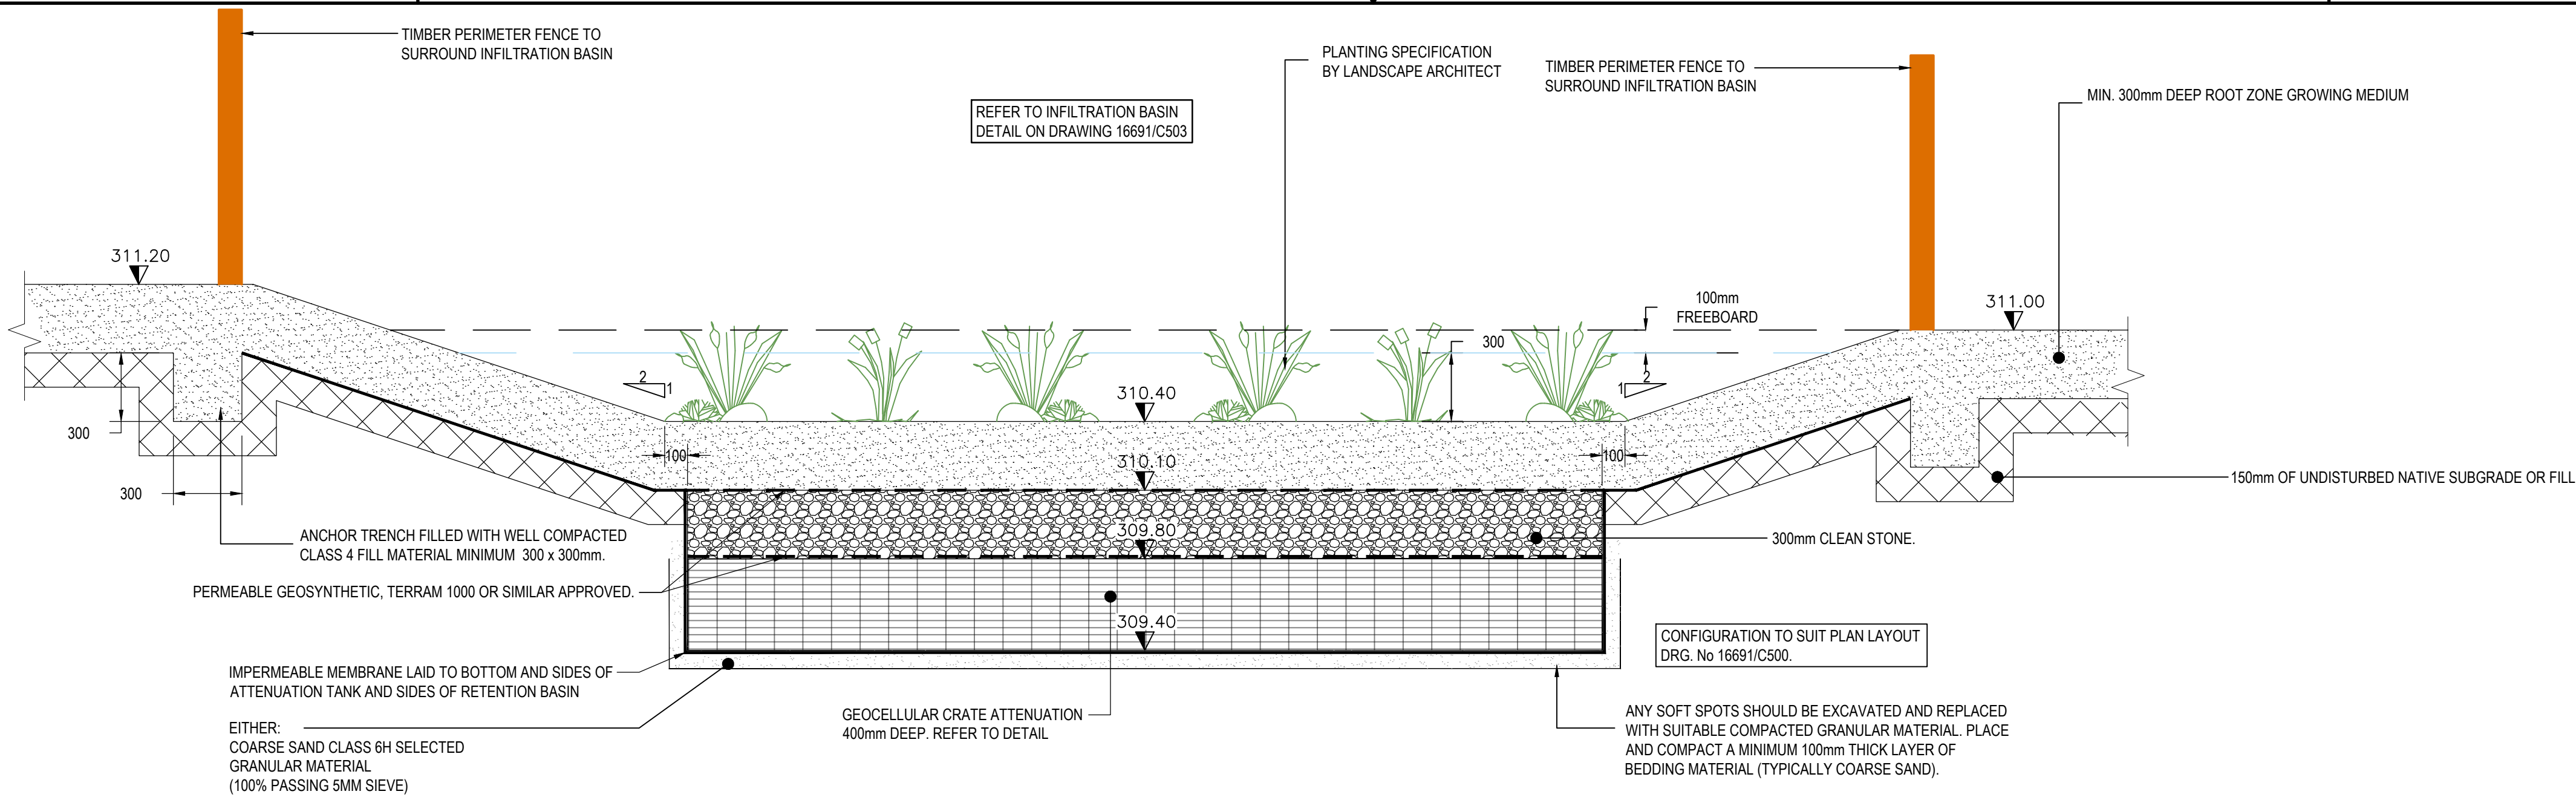
SECTION A-A THROUGH DETENTION BASIN WITH GEOCELLULAR ATTENUATION CRATES BELOW

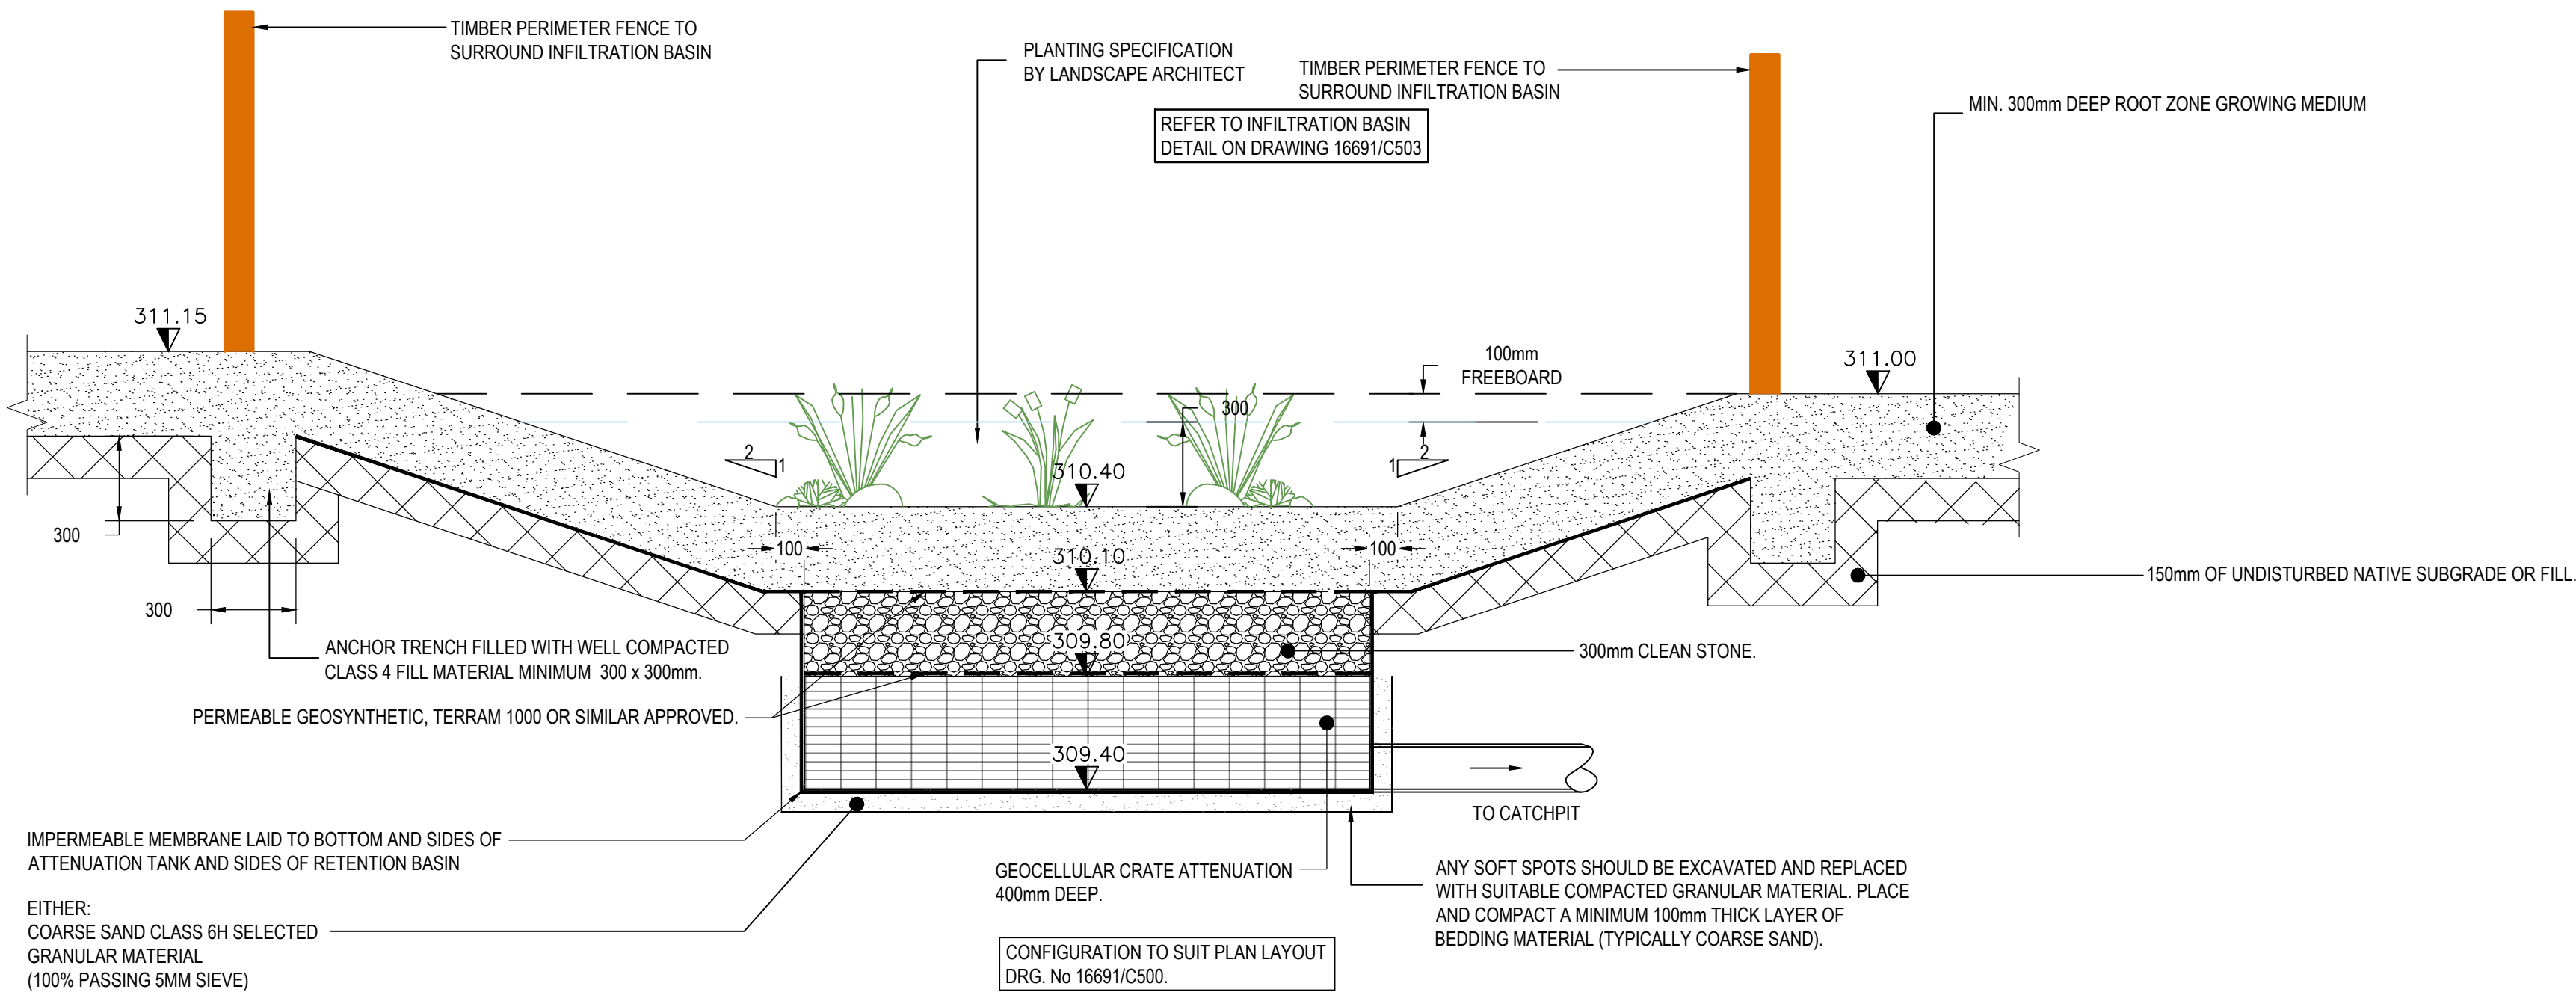
SECTION B-B THROUGH DETENTION BASIN WITH GEOCELLULAR ATTENUATION CRATES BELOW

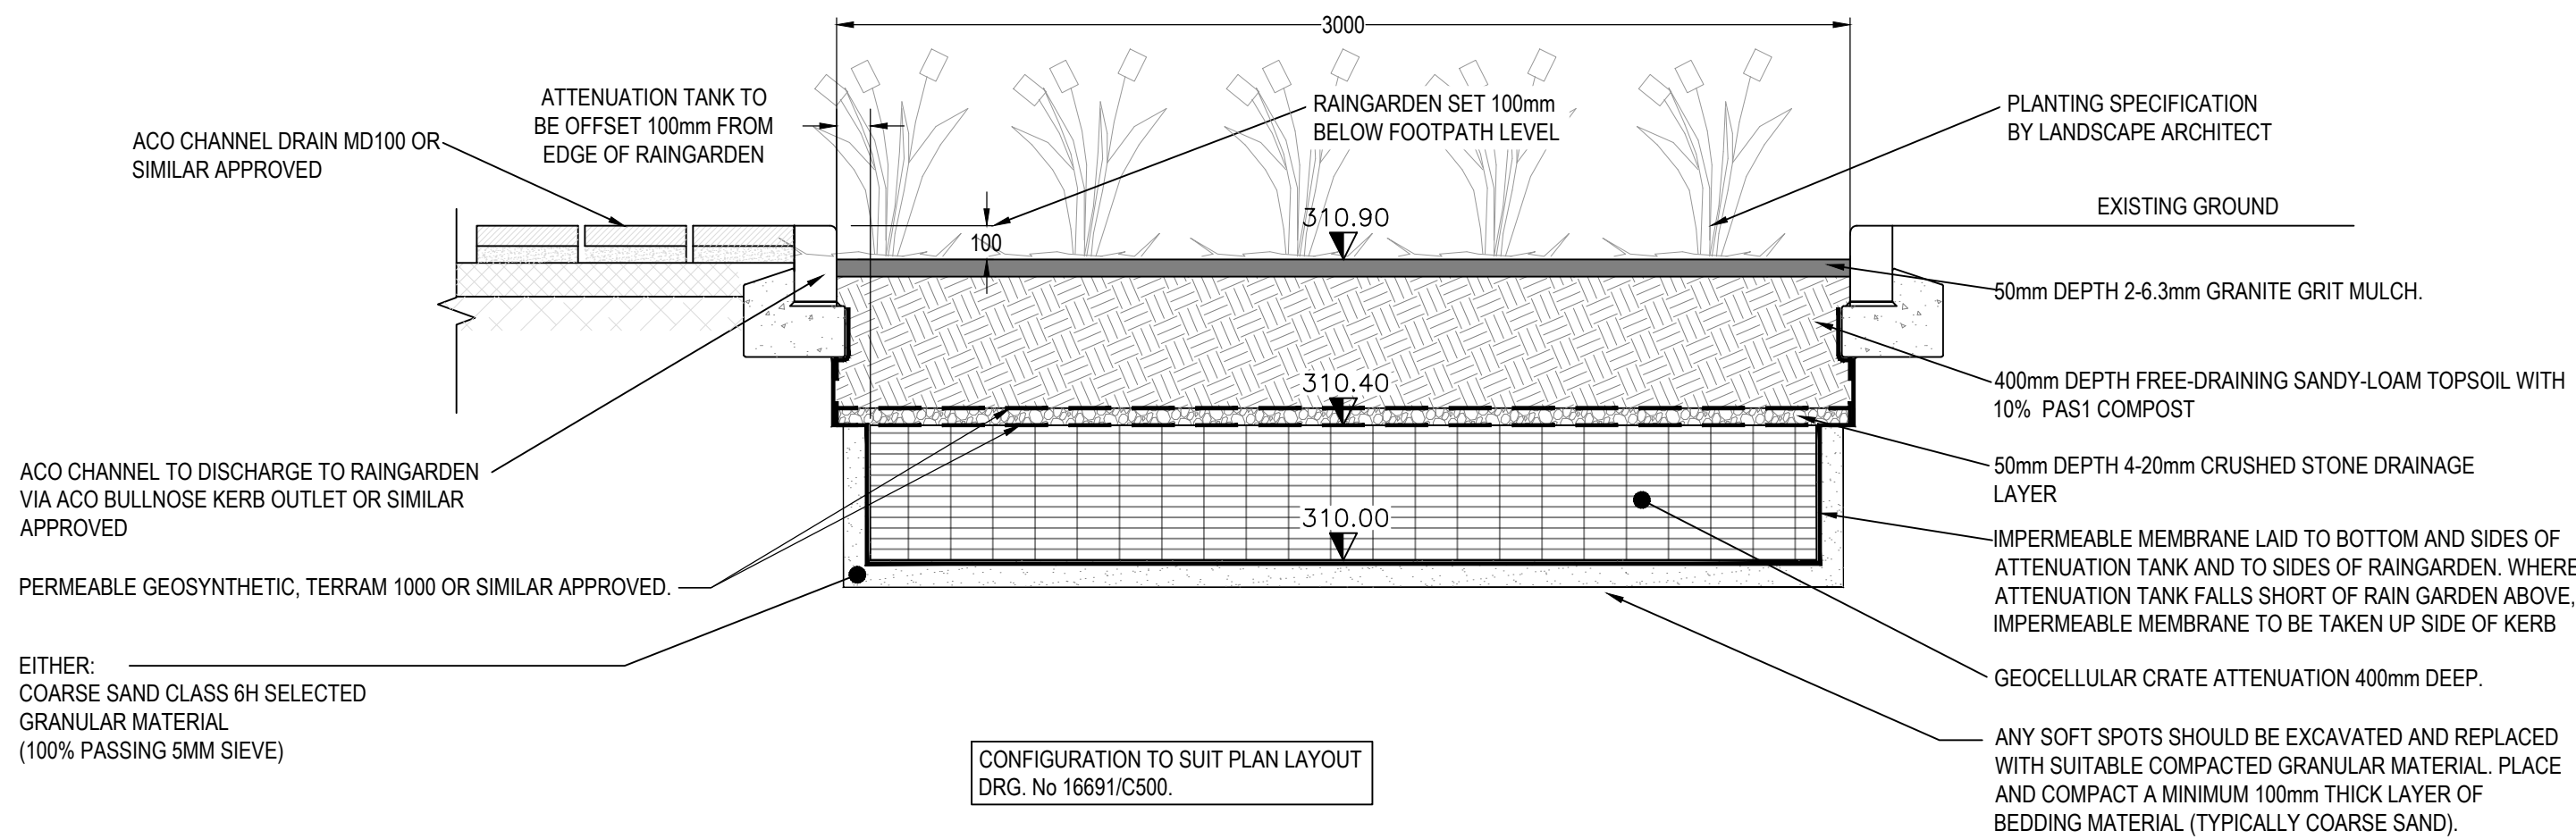
SECTION C-C THROUGH RAINGARDEN WITH GEOCELLULAR CRATE ATTENUATION BELOW

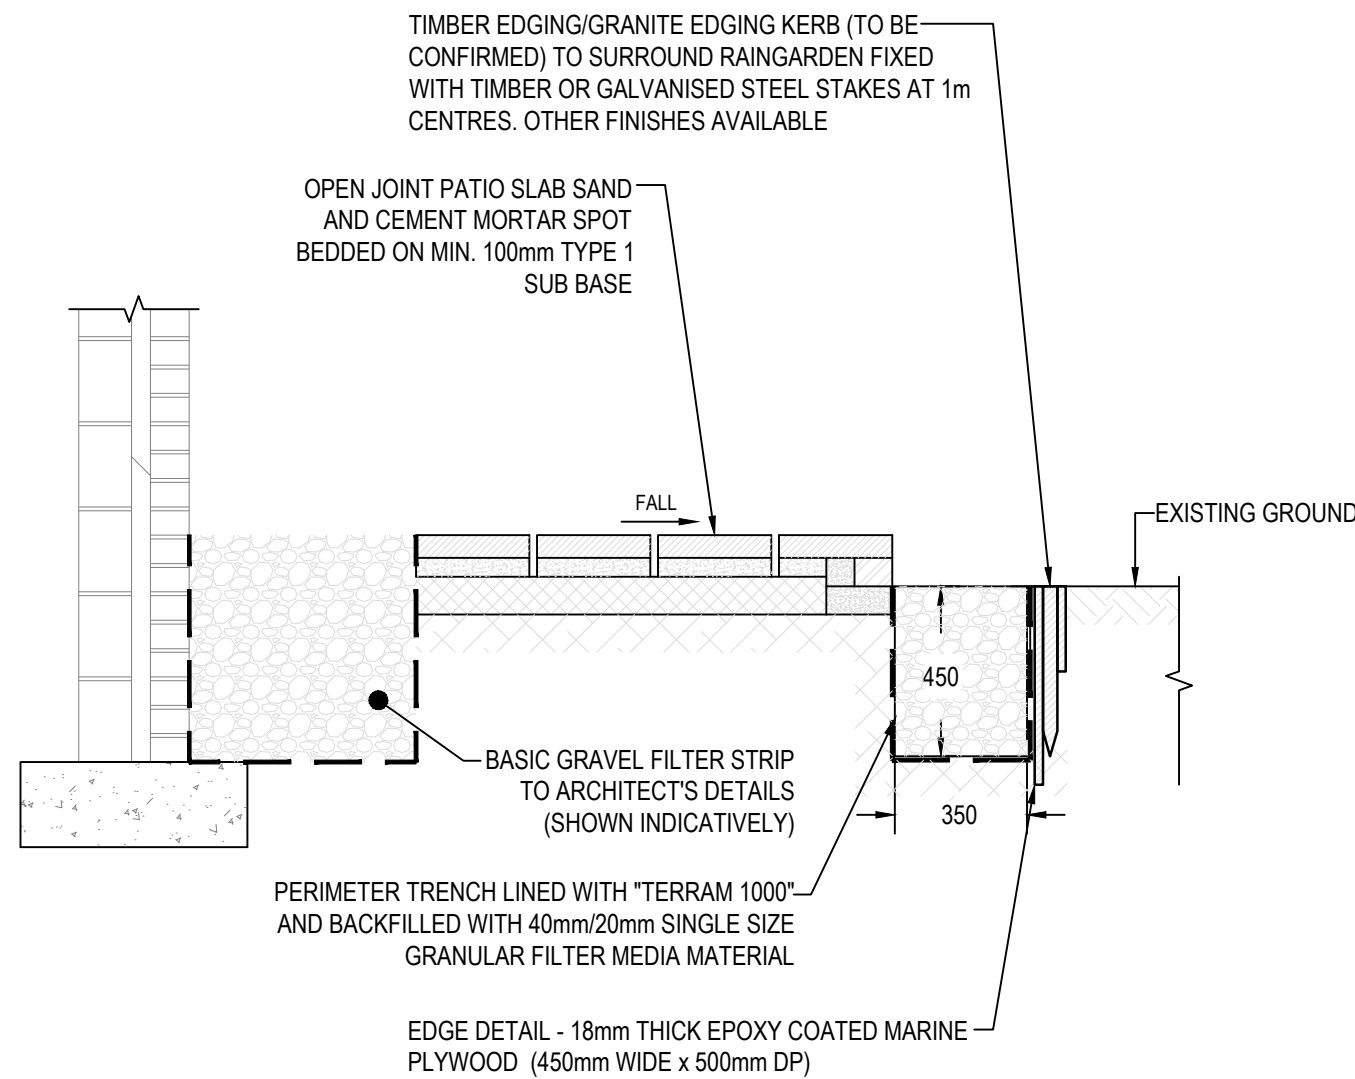
SECTION D-D THROUGH PAVED FOOTPATH AND OVEREDGE DRAIN
