FLOODLIGHTING EQUIPMENT:

HORIZONTAL ILLUMINANCE LEVELS

Obtrusive Light - Compliance Report

CIE 150/2017, E3-Medium District Brightness, Pre-Cut-off  
Filename: UKS18059\_b - VYG Rugby Pitch  
15/09/2021 10:57:51

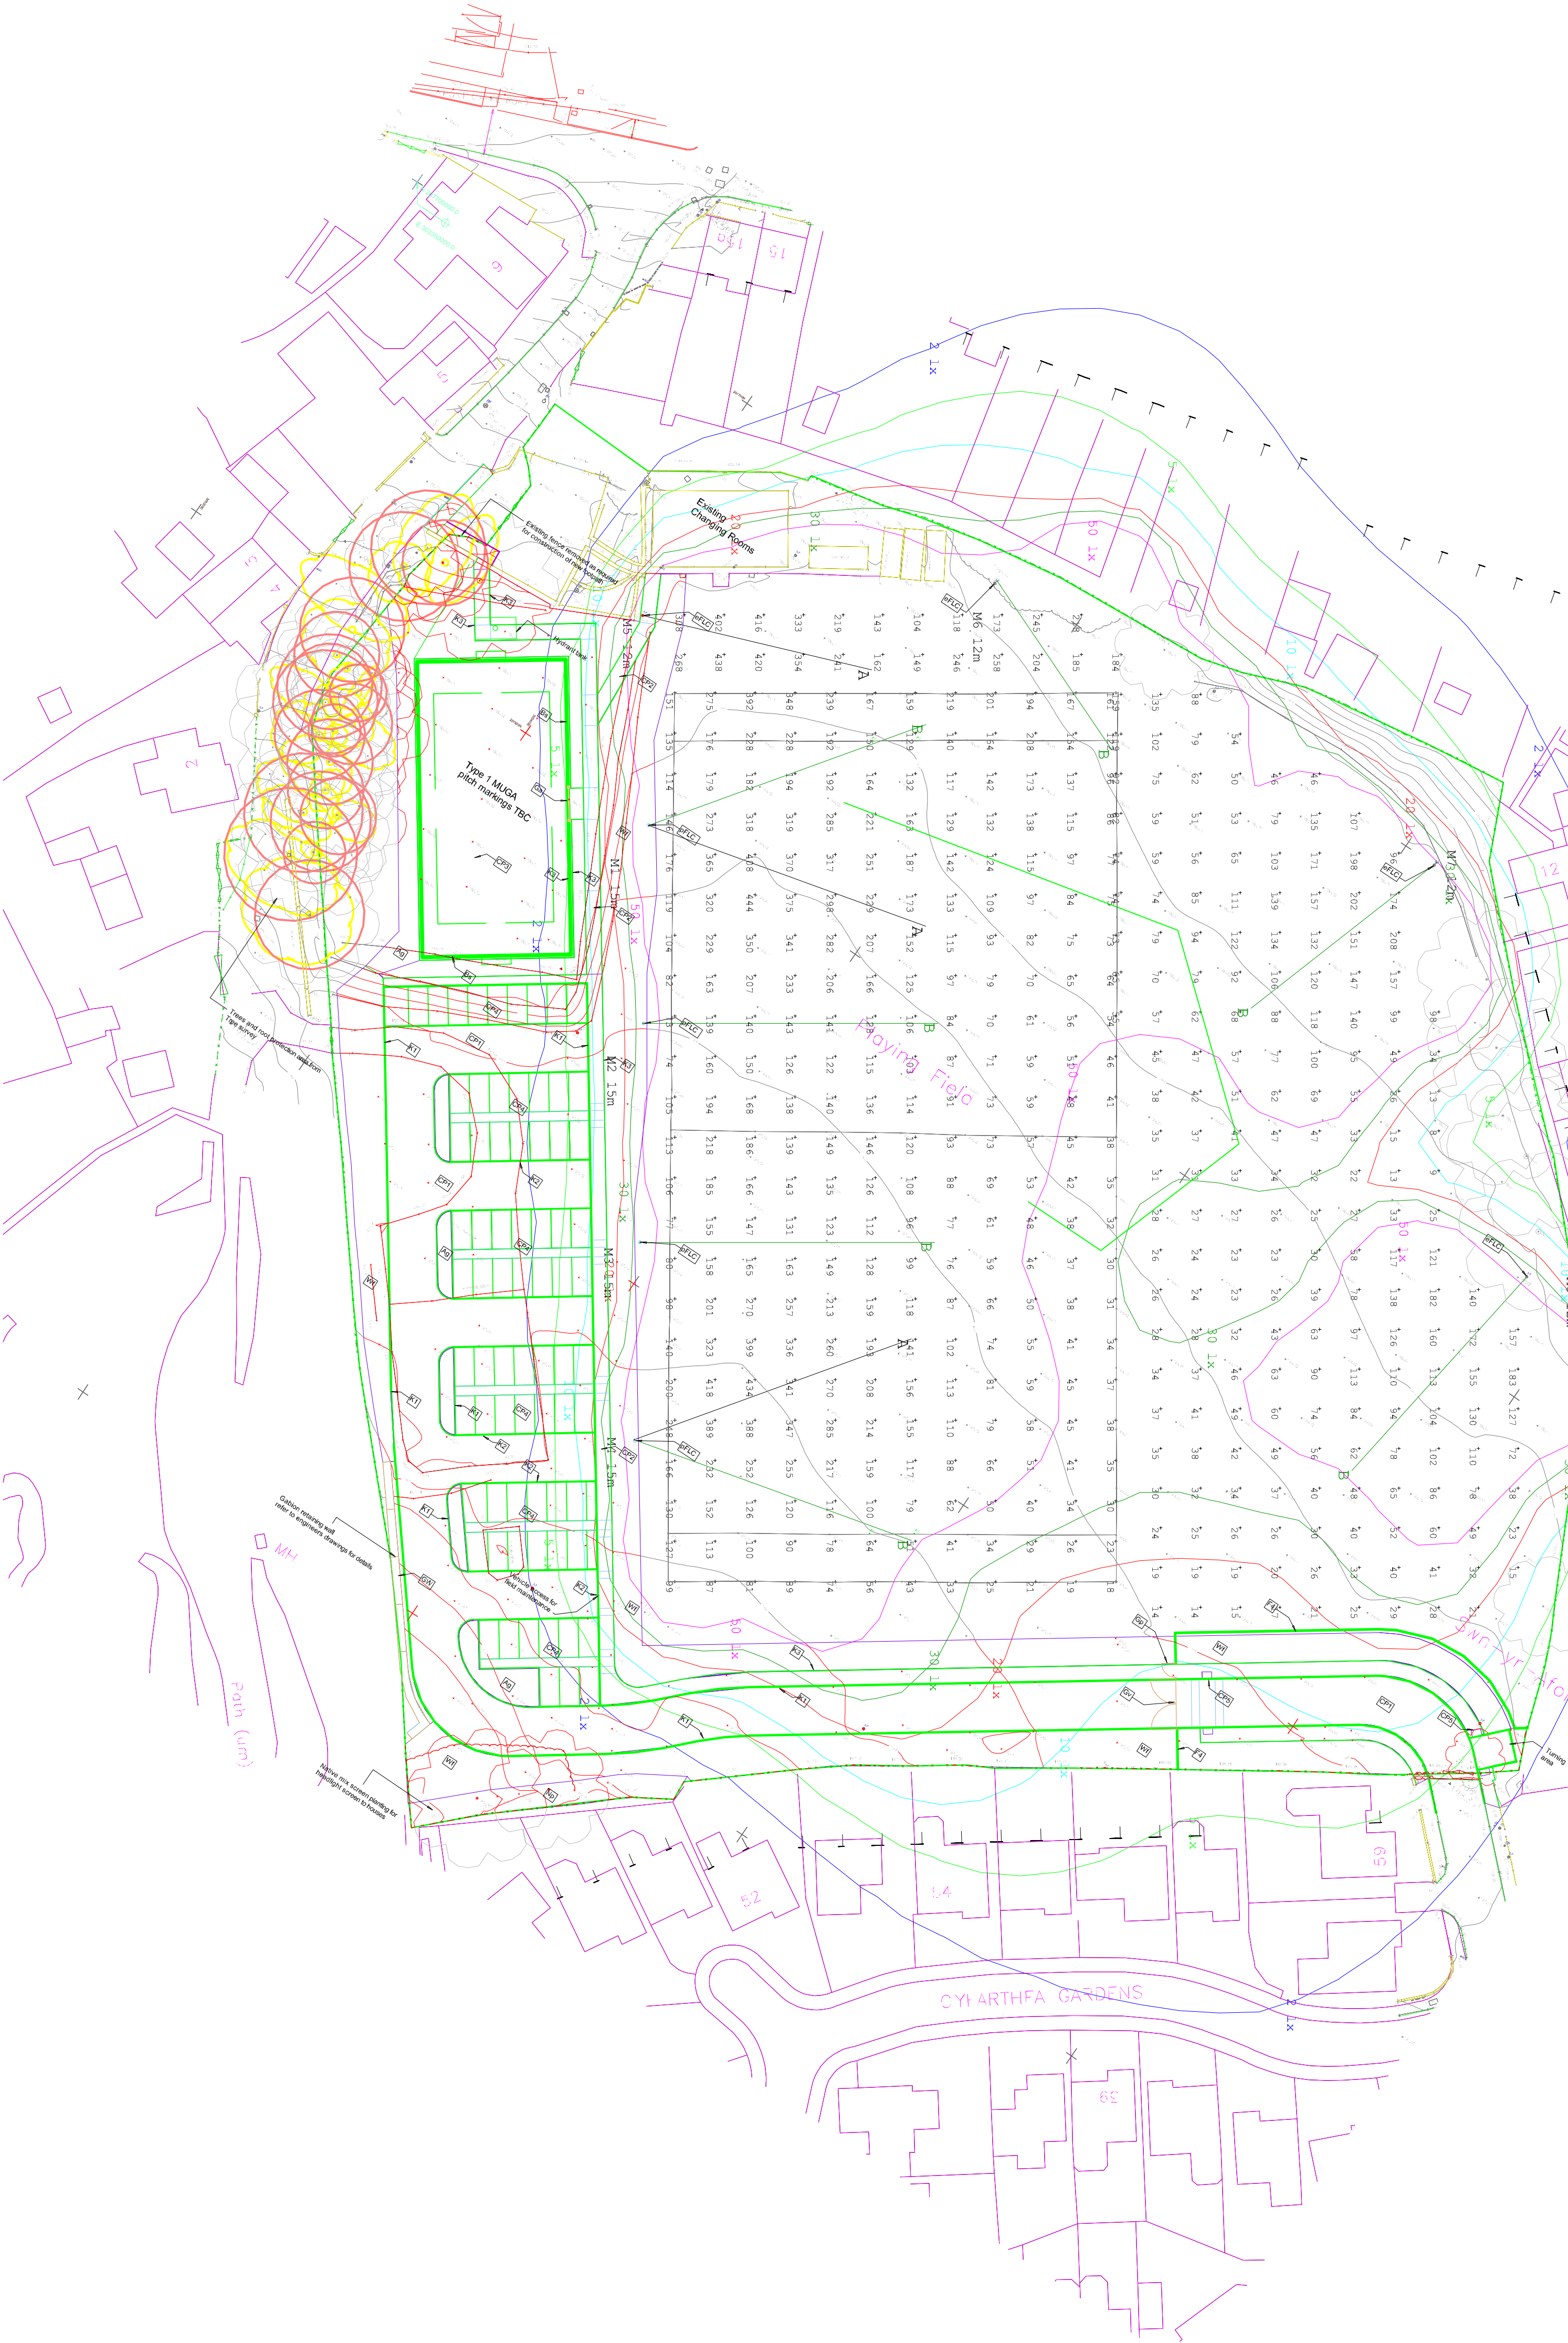
4 x NEW 15m MASTS Carrying the following AAA-Lux Luminaires  
M1 & M4.....A     1 x WS250 LS / 1550W/ GEN 7.0.1  
                              B     1 x WS290 LS / 1550W/ GEN 7.0.1  
M2 & M3.....B     1 x WS290 LS / 1550W/ GEN 7.0.1

4 x EXISTING 12m MASTS Carrying the following AAA-Lux Luminaires  
M5.....A     1 x WS250 LS / 1550W/ GEN 7.0.1  
M6-M8.....B     1 x WS290 LS / 1550W/ GEN 7.0.1

Maximum Elevation 68°

Training Pitch (specified level)  
Average Maintained Horizontal Illuminance (Eh.m): 100 lx  
Uniformity Ratio (E.min / E.av): 0.5

Training Pitch (Calculated level)  
(Calculated when floodlights on existing columns are switched OFF)  
Average Initial Horizontal Illuminance (Ei.m): 120 lx  
Average Maintained Horizontal Illuminance (Eh.m): 108 lx  
Uniformity Ratio (E.min / E.av): 0.09

Surrounding Area (Calculated level)  
Average Initial Horizontal Illuminance (Ei.m): 87 lx  
Average Maintained Horizontal Illuminance (Eh.m): 78 lx  
Uniformity Ratio (E.min / E.av): 0.09

GR<sub>new</sub> = 52

Grid Intervals 6x6m  
Maintenance Factor: 0.9

Initial Levels Shown

- Figures taken with no over spill from adjacent lighting
- Mast location and pitch scale provided by customer. Please check prior to ordering

Illuminance  
Maximum Allowable Value: 10 Lux
