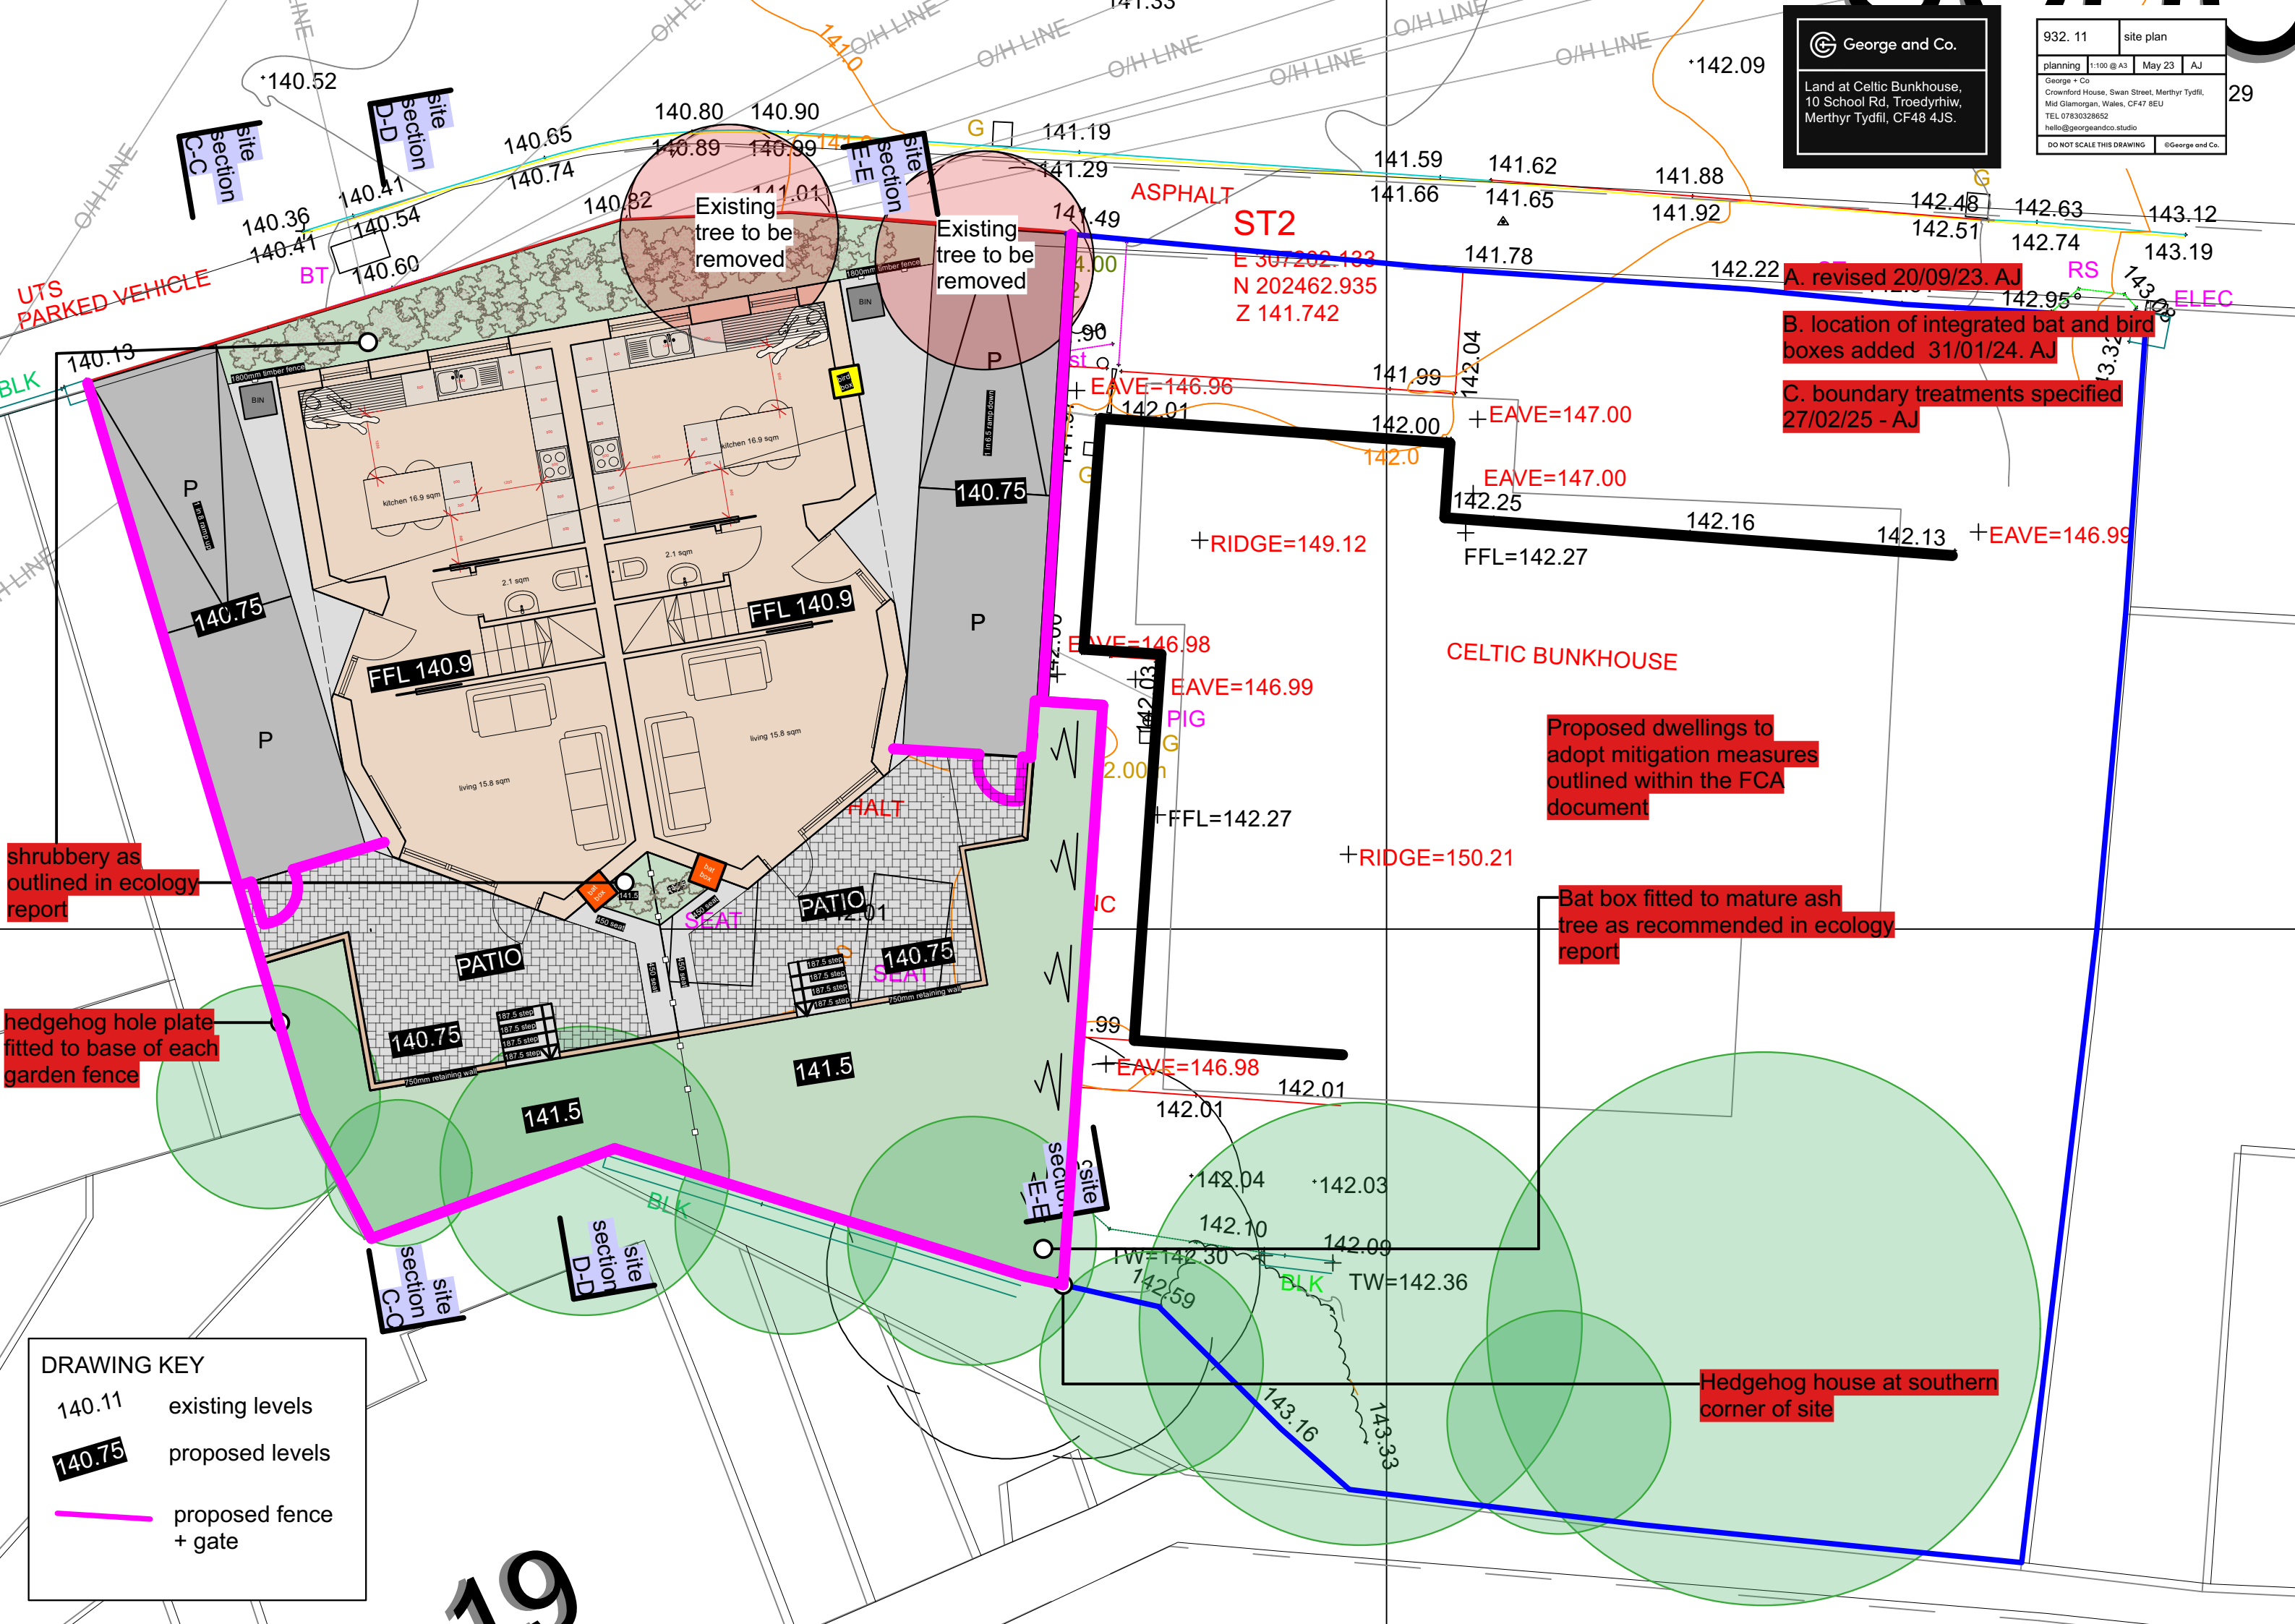
shrubbery as outlined in ecology report

hedgehog hole plate fitted to base of each garden fence

Proposed dwellings to adopt mitigation measures outlined within the FCA document

Bat box fitted to mature ash tree as recommended in ecology report

Hedgehog house at southern corner of site
