*Report No. BC/MB/06.19.09.*

# **Site Investigation Report on Land at Tynycoedcae Farm, Merthyr Tydfil**

# **Site Investigation Report: Land at Tyncoedcae Farm, Merthyr Tydfil.**

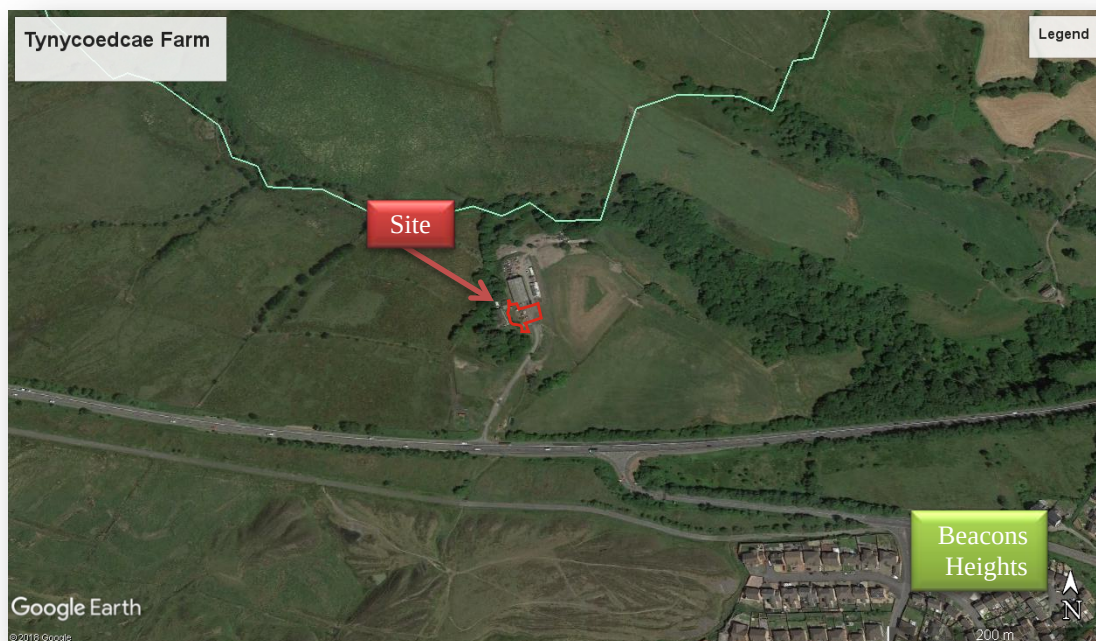
**Figure 1**  
**Aerial View of the Site**

The parcel of land that is the subject of this report, 'the Site' is located at Tyncoedcae Farm, situated immediately north of the A465 (T) Heads of the Valleys Road near Swansea Road in Merthyr Tydfil. It is located in the countryside, outside the settlement boundary, approximately 4km north-west of the centre of Merthyr Tydfil, on north-easterly slopes of Cwm Ffrwd (see Figure 1 and *General Location Plan*, drawing no. BC/MB/06.19.11.01). The Site is an enclosure on the farm that is unoccupied; it is irregular in outline and occupies an area of approximately 0.1 hectares (see *Site Investigation Plan*, drawing no. BC/MB/06.19.09.03). The Site is almost level at an approximate elevation of 300m aod.

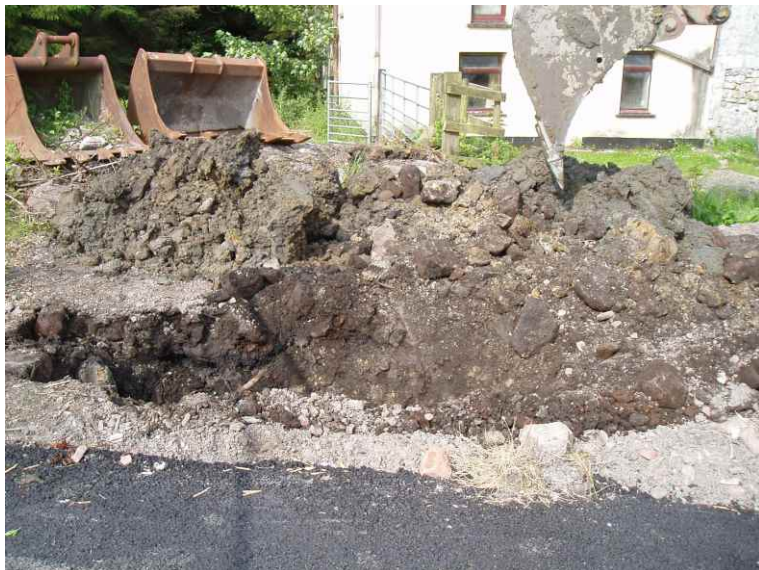
## Photo Plate 1, Trial Pit 1

| Depth | Description | Legend | Backfill/<br>Installations | | | |
|---|---|---|---|--|--|--|
| 0.40m | <b>MADE GROUND:</b> Compact, dark brown, sandy slightly clayey gravel cobble and boulder of sub-rounded to rounded sandstone and angular brick. Short length of rebar. | | 0.40m | | | |
| 0.85m | Soft to very stiff, yellow mottled brown gravelly <b>CLAY</b> with cobble and boulders. Gravel is fine to medium and coarse, sub-rounded to rounded sandstone. Cobble and boulder are sub-rounded to rounded sandstone. (Boulder Clay). | | 0.45m | | | |
| 1.30m | Soft, light grey, slightly sandy gravelly <b>CLAY</b> . Gravel is fine to medium and coarse, sub-rounded to rounded sandstone. Sub-rounded to rounded cobble also present. (Boulder Clay). | | 0.45m | | | |
| 2.90m | Very stiff, light grey, slightly sandy gravelly <b>CLAY</b> . Gravel is fine to medium and coarse, sub-rounded to rounded sandstone. Sub-rounded to rounded cobble and boulder also present. (Boulder Clay). | | >1.60m | | | |

**Stability:** No shoring installed. Stable.

**Groundwater:** Damp at 1.30m.

The Made Ground encountered is not suitable for founding on. The underlying Boulder Clay encountered in all four trial pits is suitable to act as a founding medium for conventional strip/trench foundations. The Boulder Clay was found to be variously 'soft', 'stiff', 'very stiff' and 'firm'. In Trial Pits 1 and 2 'soft' areas were encountered at depths down to 1.30m and 2.40m respectively. Foundations must be taken down to below the 'soft' areas and should extend a minimum of 300mm below any 'soft' areas encountered in order to ensure that the foundations are bearing on 'stiff' or 'firm' Boulder Clay.

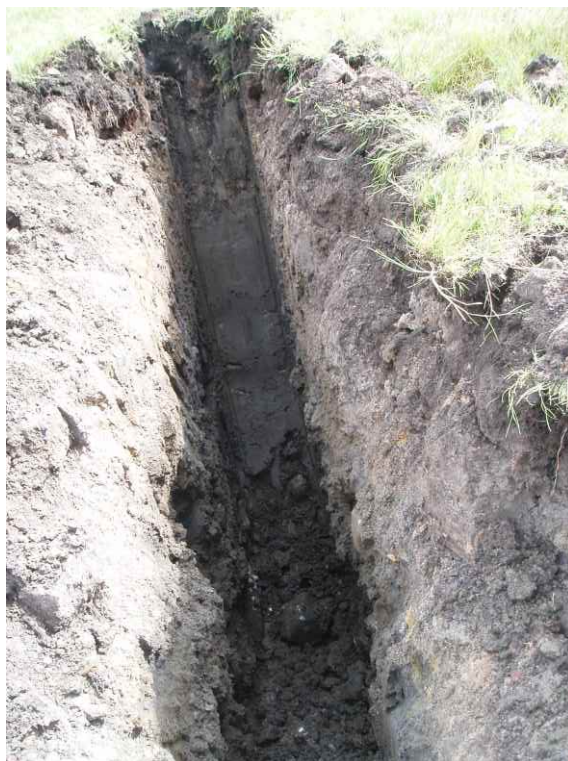
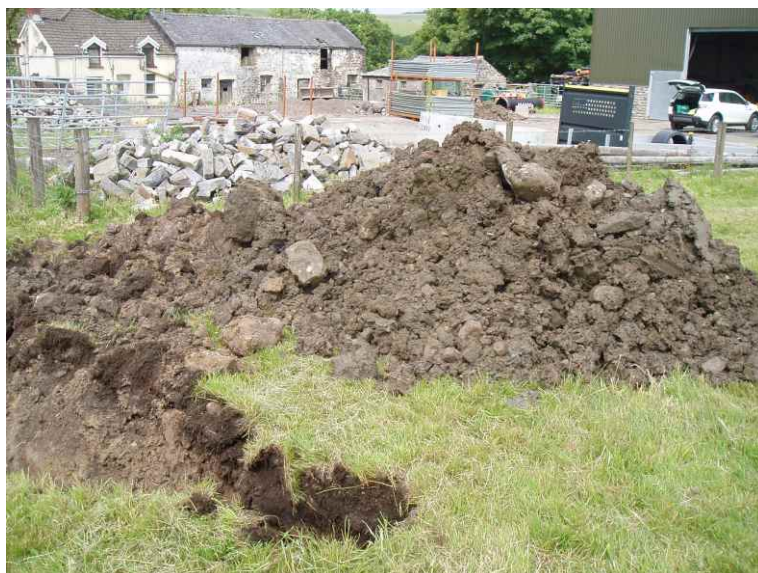
## Photo Plate 2, Trial Pit 4

| Depth | Description | Legend | Backfill/<br>Installations | | | |
|---|---|---|---|--|--|--|
| 1 | <b>TOPSOIL:</b> Loose, brown, slightly clayey sandy, many roots. | | 0.35m | | | |
| | Firm, yellow mottled grey gravelly <b>CLAY</b> with cobble and boulders. Gravel is fine to medium and coarse, sub-rounded to rounded sandstone. Cobble and boulder are sub-rounded to rounded sandstone. (Boulder Clay). | | 1.20m | | | |
| | Firm, grey mottled brown gravelly <b>CLAY</b> with cobble and boulders. Gravel is fine to medium and coarse, sub-rounded to rounded sandstone. Cobble and boulder are sub-rounded to rounded sandstone. (Boulder Clay). | | >1.60m | | | |

**Stability:** No shoring installed. Stable.

**Groundwater:** No groundwater encountered.
