Our ref:Land@SixBells

Following our survey of land designated CYM221750 (title number) at six Bells Estate, Merthyr Tydfil CF48 1TU (Subject property) we can confirm there is no evidence of live Japanese Knotweed growth however there is significant evidence of an historical and still viable Japanese Knotweed (*Fallopia japonica*) infestation within the boundaries of the subject property

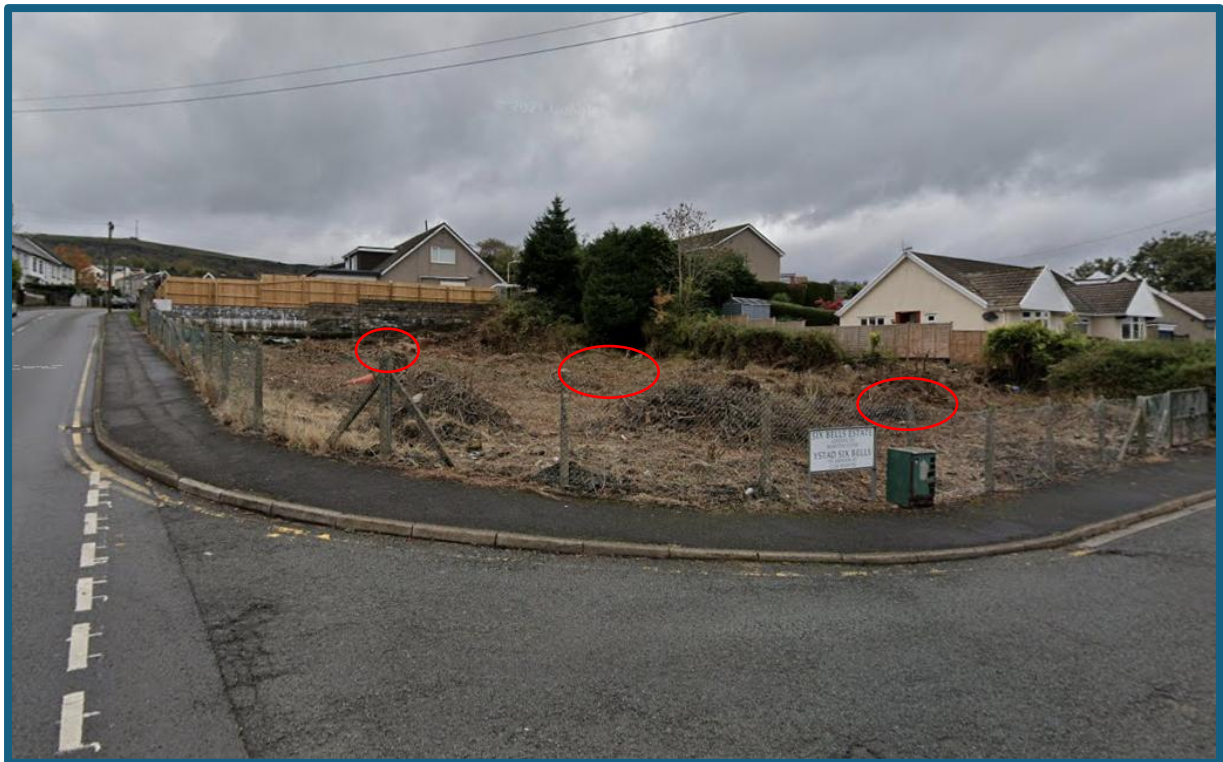
During the course of the survey 3 areas of JK were observed with more 'patches' likely in the undergrowth. All 3 areas observed appeared to have some dormancy with no live growth presenting but rhizomes being viable with bright orange colour indicating as much. The 'dead' stems in these areas appear to be last season or the seasons before growth. The growth was sporadic, weak and stunted with significant bonsai growth.

The nature of the survey and soil movements on the property make it difficult to put a figure on total ground area affected by the JK, however if based on the JK that was observed during the survey the combined coverage of the three would be approximately 30 square metres.

Roadside picture of the subject property taken by google during the winter dormancy period, JK infected areas marked in red.

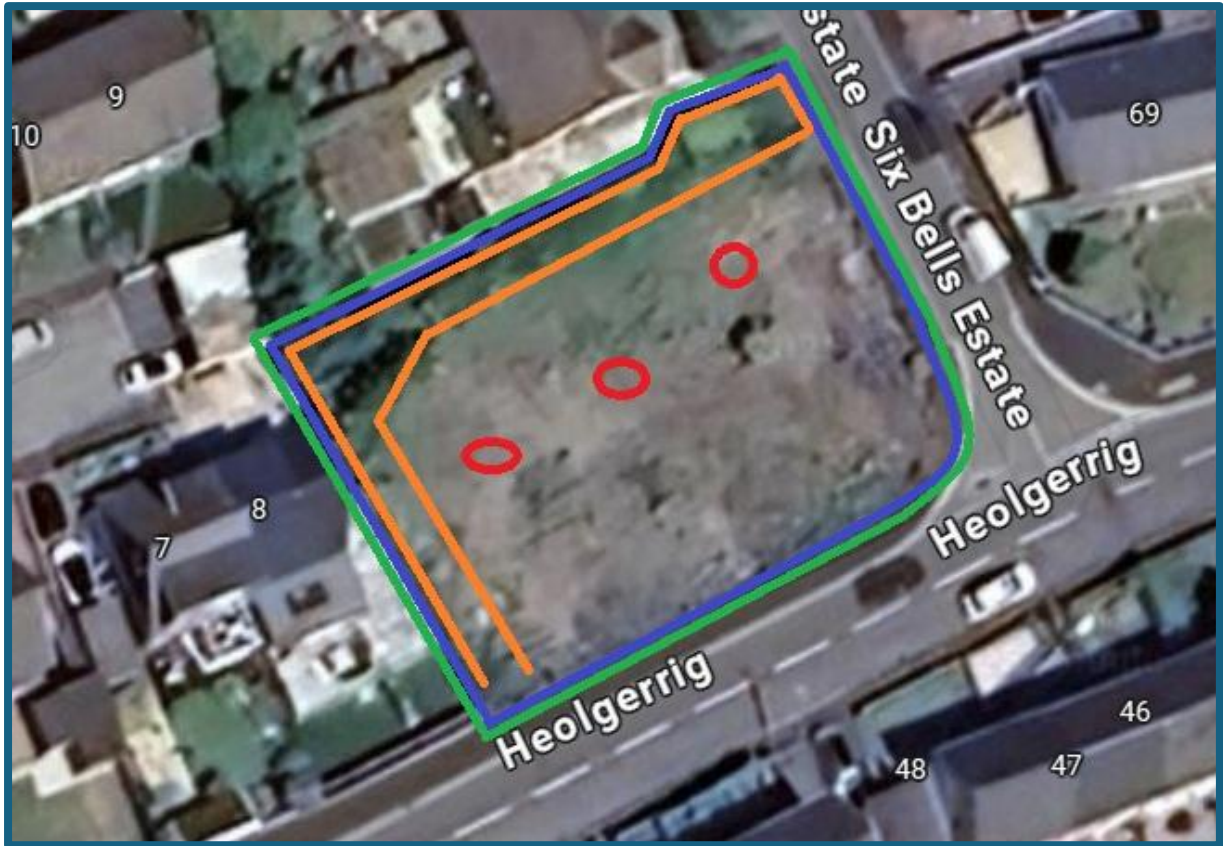
Satellite image of the subject property with boundaries marked in Blue, JK in red, Proposed soil lay down area in Orange and proposed treatment boundary in green.

To proceed with development of the site CSK recommend the JK rhizomes within the areas marked for the dwelling and immediate garden should be excavated and separated from the soils using the 'sifting' technique. All Rhizomes should then be incinerated following permission to do so from Natural Resources Wales via an 'exemption to burn' application. Soils excavated can be reused in a low-risk area on site (the likely option is that the soils be laid down on the banking at the northern and western boundaries).

To achieve this CSK recommend a 'Clerk of works' service. This would essentially mean CSK direct operations using the customers contractors and plant.

Following excavation works a 5-year Herbicide application backed up by a 10-year insurance backed guarantee policy should be implemented should the development be put on the open market for sale once development works are completed.
