**CYFARTHFA CASTLE  
ROOF REPAIRS**

**GENERAL ARRANGEMENT  
PLAN**

**FIRST FLOOR  
EAST**

**MANN WILLIAMS**  
CONSULTING CIVIL AND  
STRUCTURAL ENGINEERS

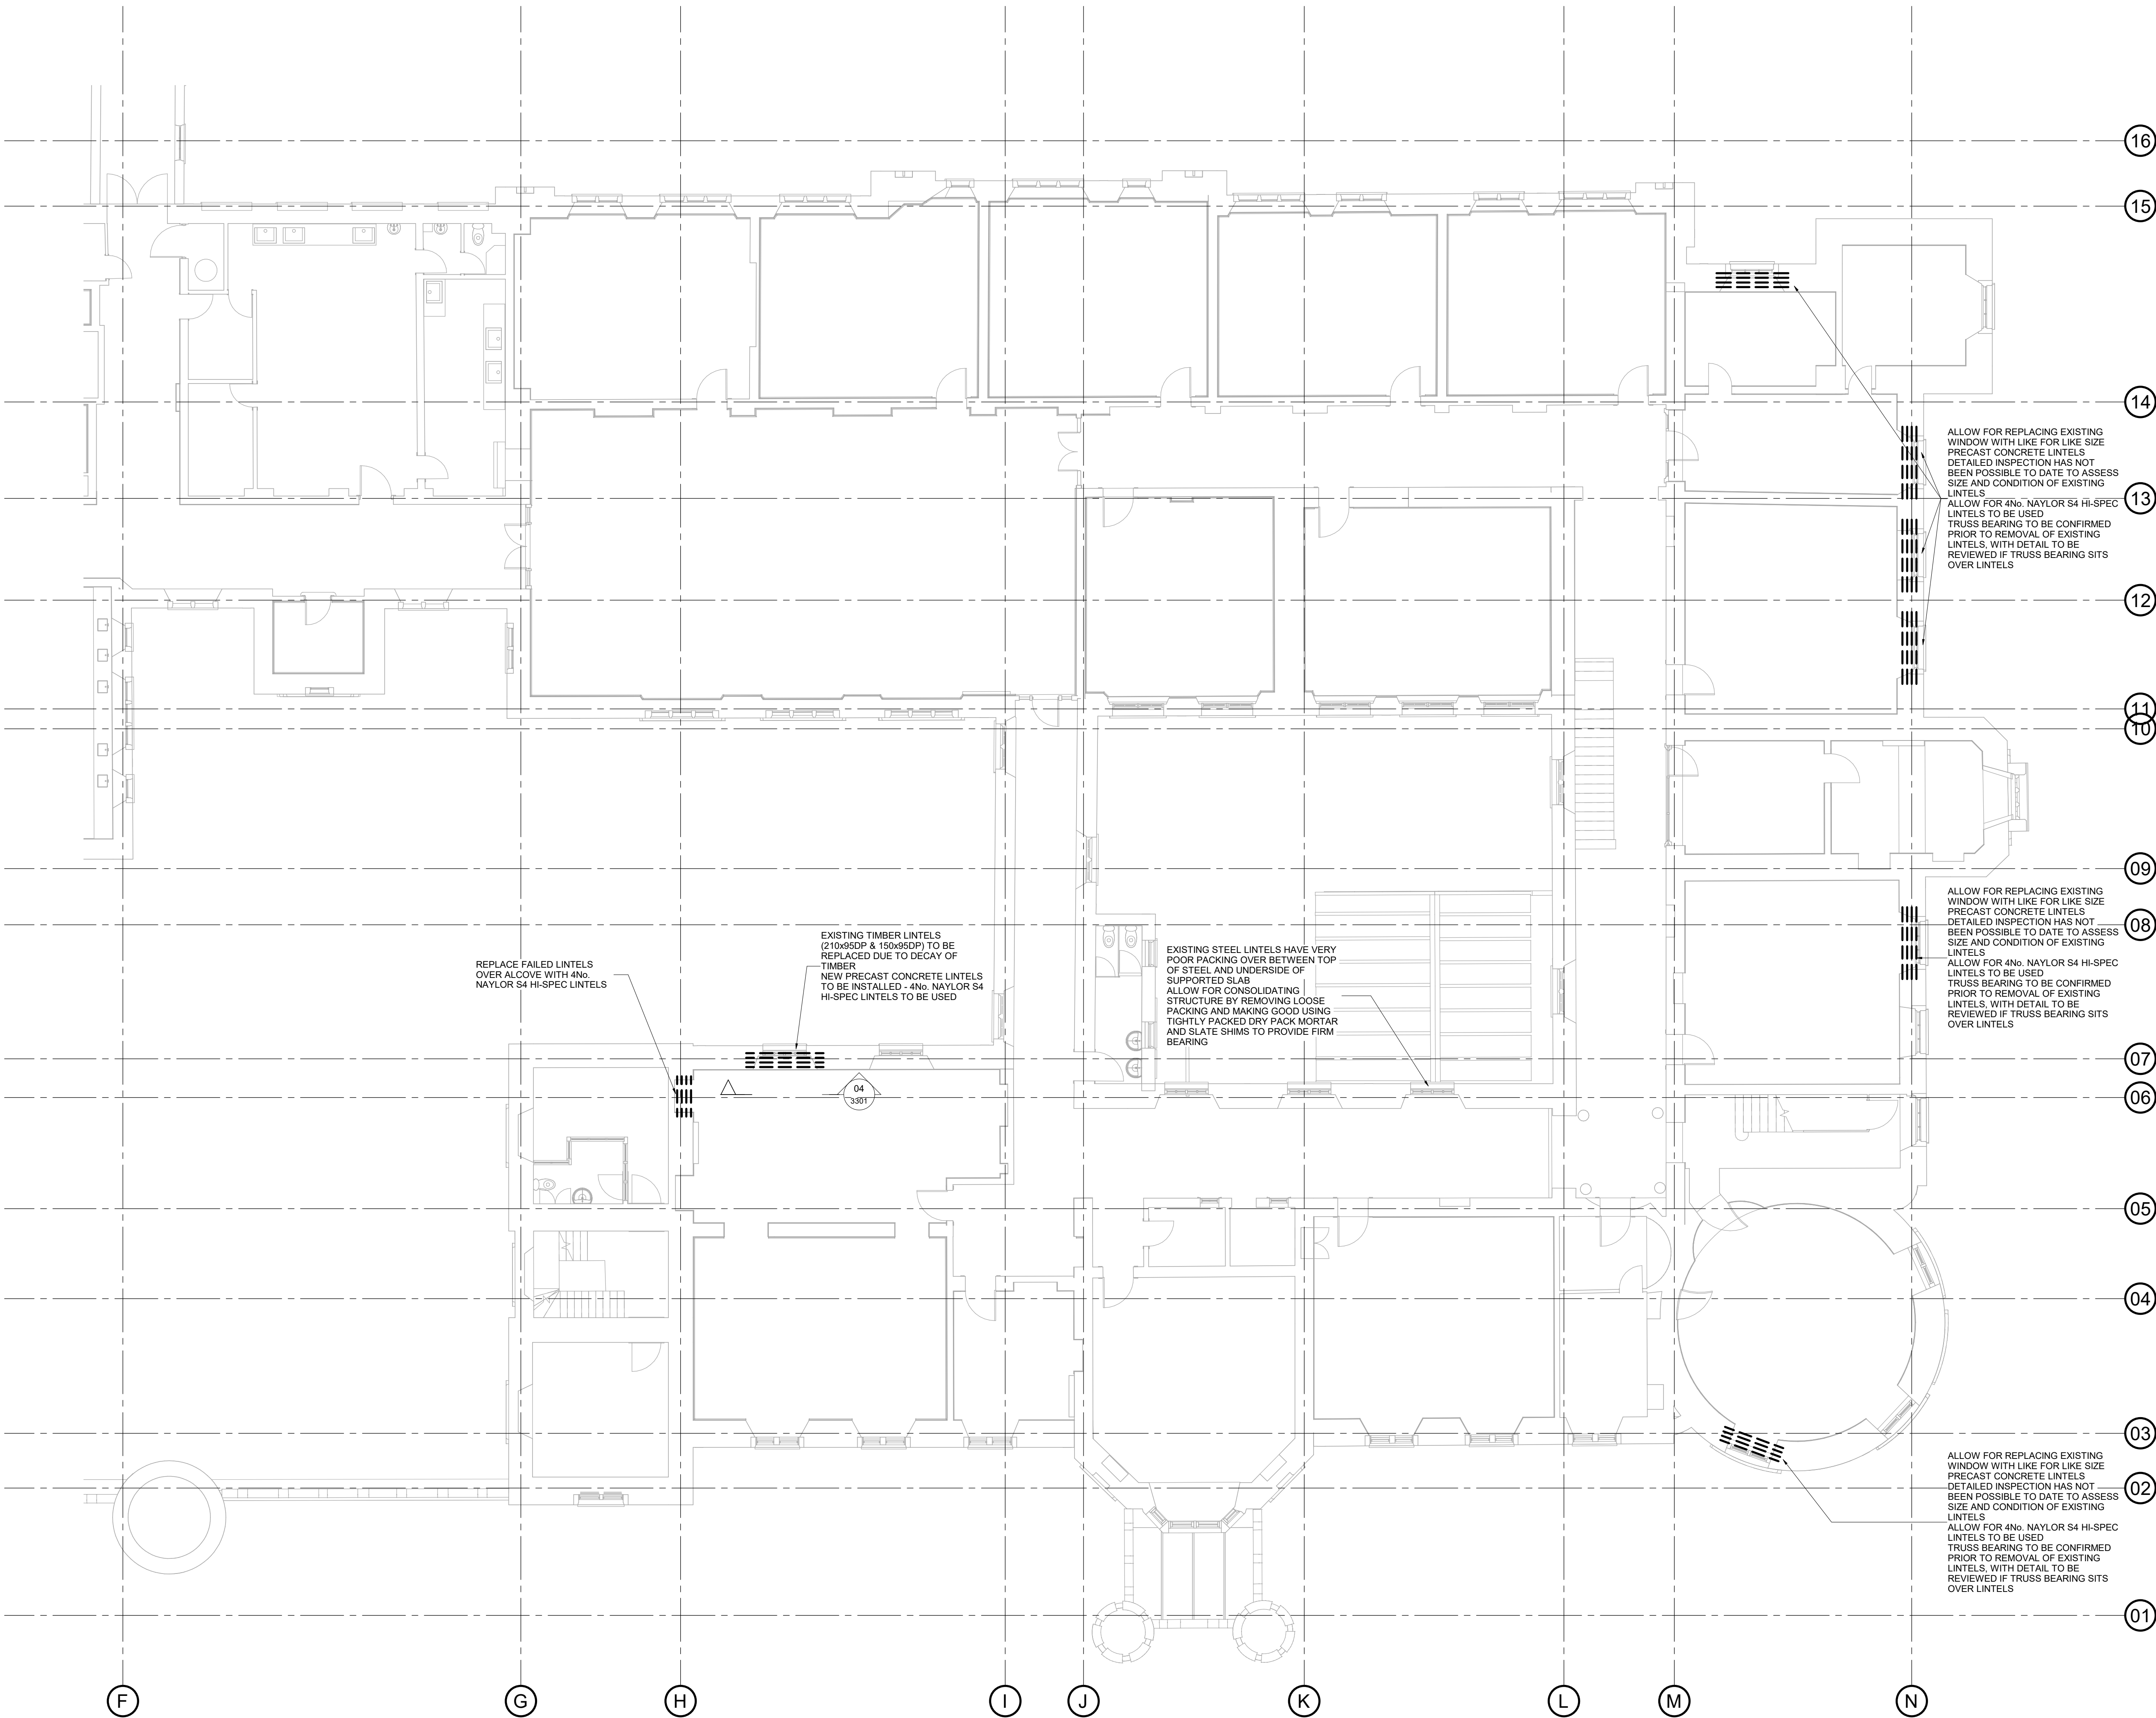
WHERE EMBEDDED STEEL OR IRONWORK HAS CORRODED AND CAUSED FRACTURING / SPALLING OF STONE WINDOW REVEALS, ALLOW FOR CUTTING OUT CORRODED STEEL AND SECTION OF SPALLED STONEMASONRY AND PINNING IN NEW STONE PIECE TO MATCH, USING 2No. M6 STAINLESS STEEL PINS - ALLOW FOR 5No. SUCH REPAIRS TO BE REVIEWED FOLLOWING ERECTION SCAFFOLDING

IN ADDITION TO THOSE NOTED ON PLAN ALLOW FOR 20% OF ALL WINDOW LINTELS TO BE REPLACED USING LIKE FOR LIKE SIZED PRE-CAST CONCRETE LINTELS (NAYLOR HI-SPEC OR EQUIVALENT APPROVED) DURING REPAIR WORKS TO WINDOW FRAMES, THE LINTELS SHOULD BE INVESTIGATED BY THE MAIN CONTRACTOR AND ANY WHICH SHOW SIGNS OF DECAY OR FAILURE SHOULD BE REPORTED TO THE STRUCTURAL ENGINEER FOR REVIEW PRIOR TO REPLACEMENT WHERE FRACTURES ARE IDENTIFIED IN EXTERNAL STONE LINTELS - ALLOW FOR STITCHING FRACTURES AS PER DETAIL 03/3301 ALLOW FOR FRACTURE STITCHING IN 10No. LOCATIONS - TO BE REVIEWED FOLLOWING ERECTION OF SCAFFOLD
