**FFOS-Y-FRAN**  
**RESTORATION STRATEGY**

**Figure 1.3 - Phase 2A Restoration and**  
**Aftercare Allocation of Work Areas**

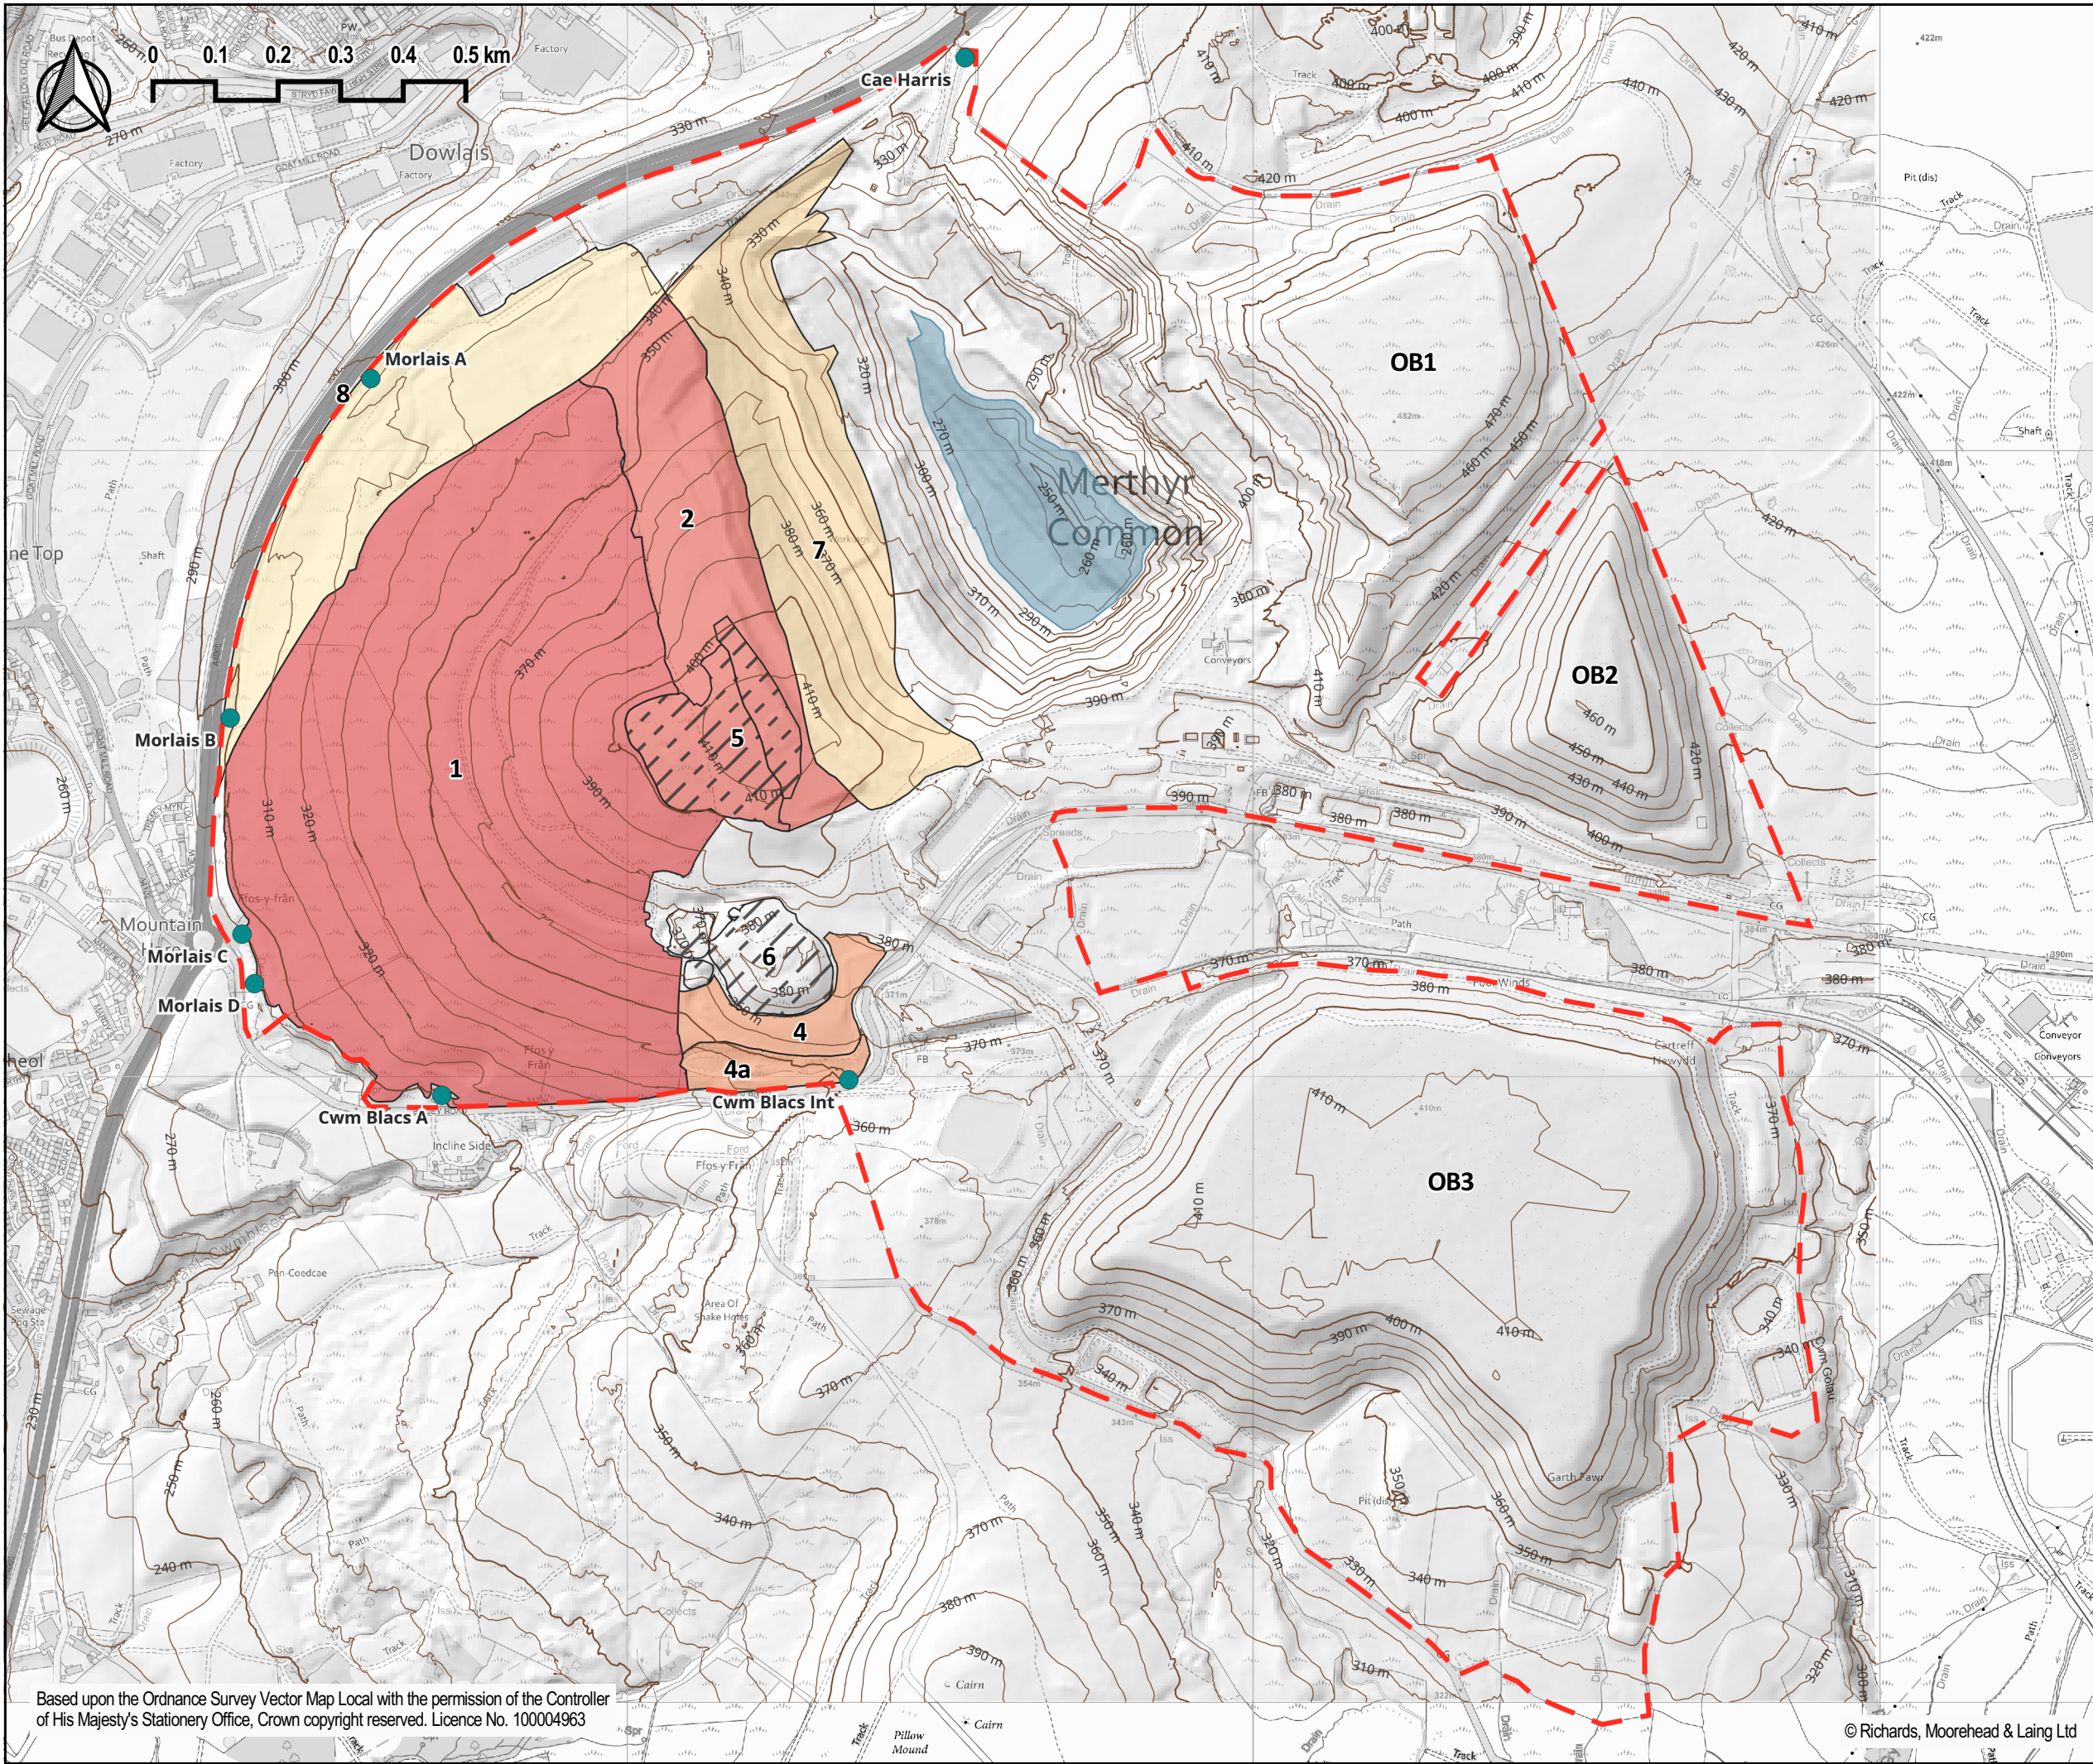
1 - Previously restored to grassland

2 - Early restoration of backfill

4 - Cultivation and seeding of graded area

4A - remediation of area around settlement pond

5 - Soil forming material storage

6 - Soil forming material storage

7 - Regrading of backfill to final profiles

8 - A4060 Corridor allocated employment site

Interim restoration surface contours (10 m interval)
