**FFOS-Y-FRAN**  
**FINAL RESTORATION STRATEGY**

**Figure 1.4 - Advance**  
**Restoration Works**

3274-RML-DR-L-32

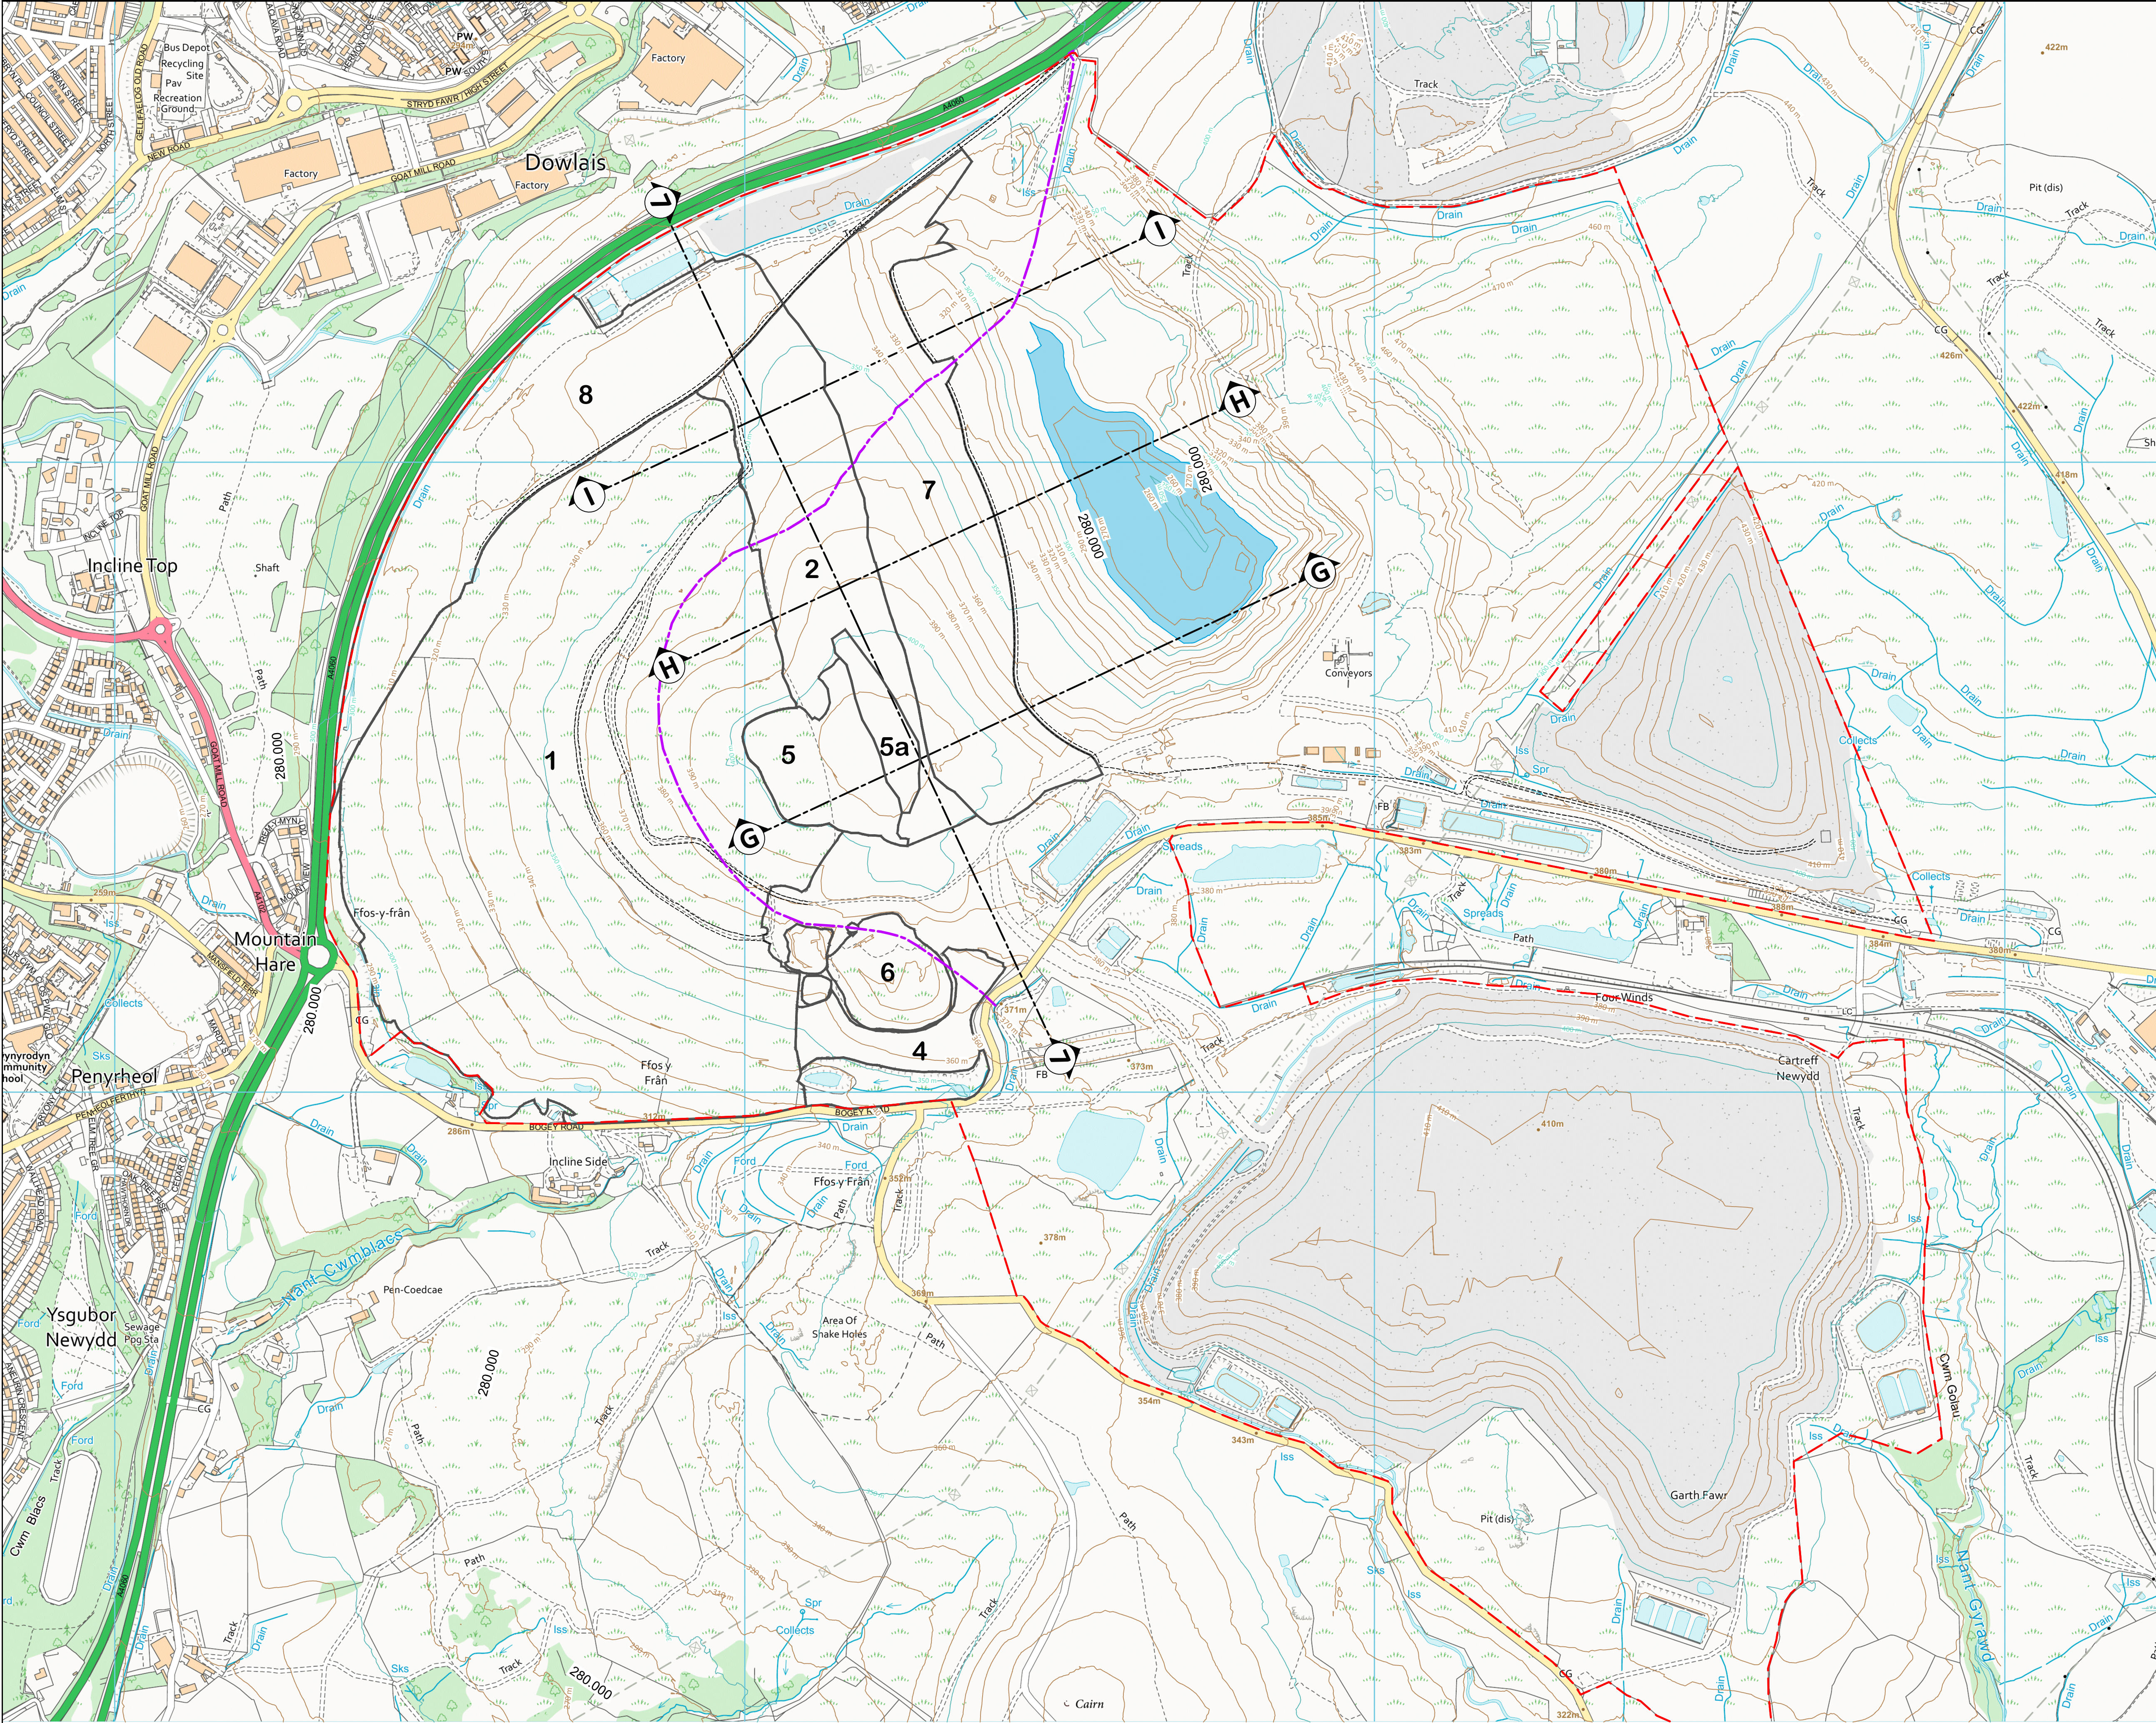
- Eglurhad / Key:
- Site boundary
  - Surface contours (interval: **major** 50 m, **minor** 10 m)
  - Alignment of BOAT (108/41)
  - Edge of track/hard standing
  - Proposed waterbody
  - Cross Section (Refer to drawing 3274-RML-DR-L-31)

- Advance restoration areas
- |    |                                                           |

| 1 | Backfill restored to pasture |
| 2 | Early restoration of backfill |
| 4 | Seeding of graded area and remediation of settlement pond |
| 5 | Soil forming material storage area |
| 5a | Soil forming material storage area |
| 6 | Soil forming material storage area |
| 7 | Grading of backfill to finished profiles |
| 8 | A4060 corridor future employment site |
