### **The Proposals & Objectives**

### **Design Note 1: Low Pitch & Long Rafter Roof over School Room & Toilets.**

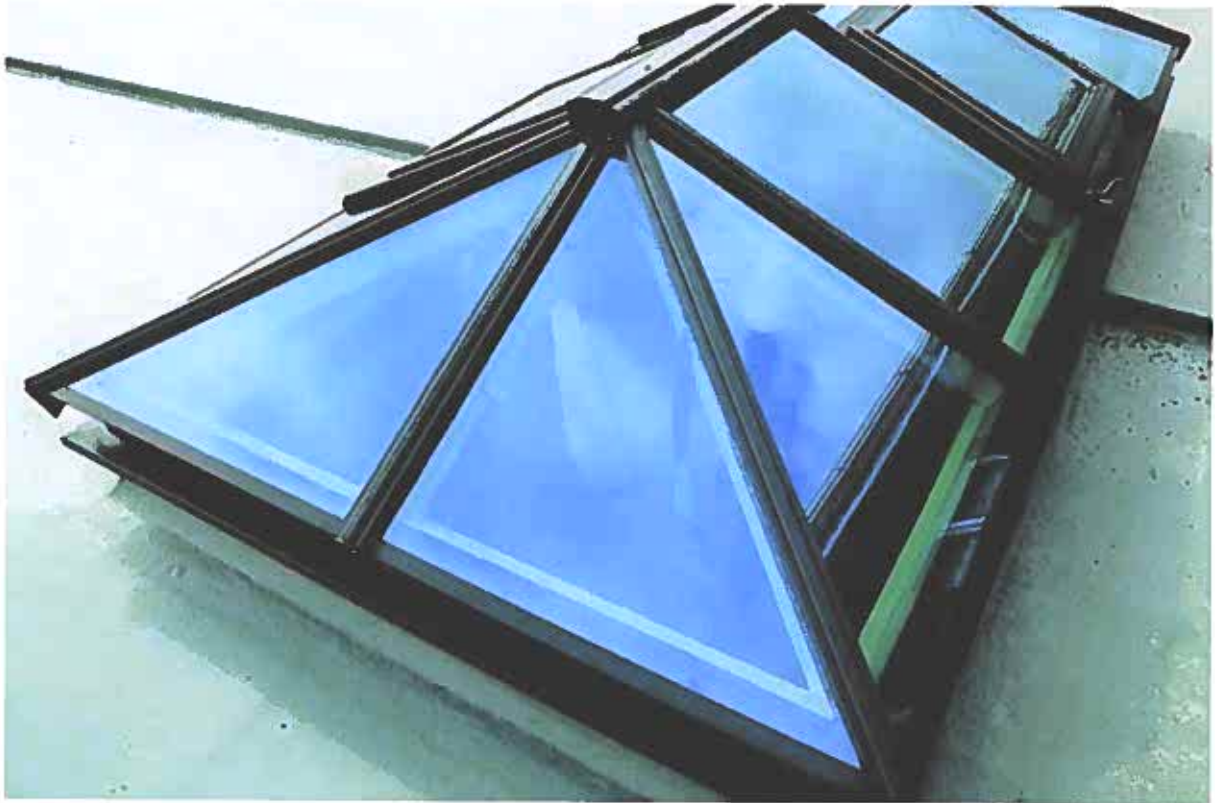
External View of Lantern Light – Typical. Not part of the current submission.

The flat roof designed with lantern rooflights having the added advantage of providing natural daylight into both male and female toilets. The design preference is a lead roll flat roof. Unfortunately lead needed to be discounted as a roof finish due to the potential of theft.

The preferred solution was to rebuild the new toilet annex as a modern 2020 era single storey flat roofed link with lantern lights, a solution which does not detract from the massing, roofscape and architectural styles of the two main pavilions. The flat roof scheme is also some 15K cheaper to build.

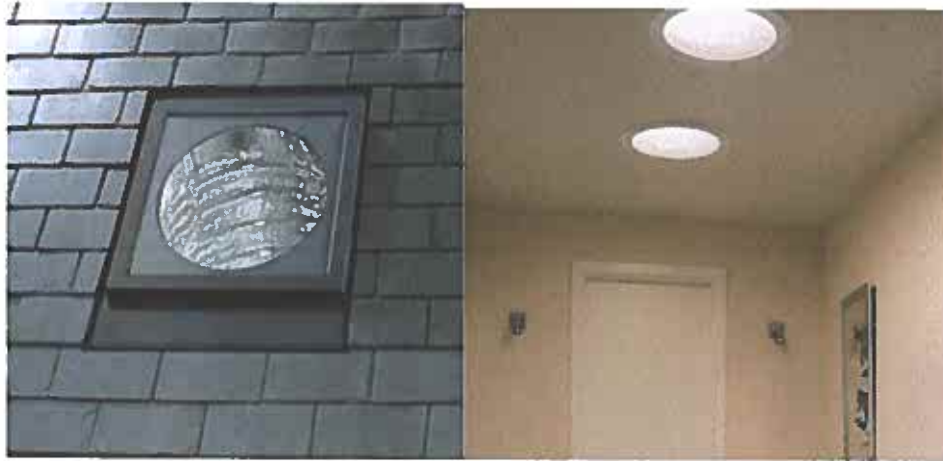
Externally the Sun Tube measuring 462 x 462 mm presents as a circular glass aperture within the square rooflight set level with the face of the slate thus minimising visual intrusion.

Sun Tunnel External View.

Sun Tunnel Internal View

Internally the sun tunnel presents as a dome or ceiling light fitting with a far less obtrusive interior compared with the vertical plasterboard shaft required to be formed from rooflight to ceiling line which also breaks and reduces the effectiveness of the insulation layer. The sun tunnel will have less impact on the building internally.
