**BLESSED CARLO ACUTIS CATHOLIC SCHOOL**

**S278 HIGHWAY DRAINAGE LAYOUT**  
(Sheet 1 of 5)

| Drawing No. | BCA | CAM | VX | XX | DR | C | 0750 |

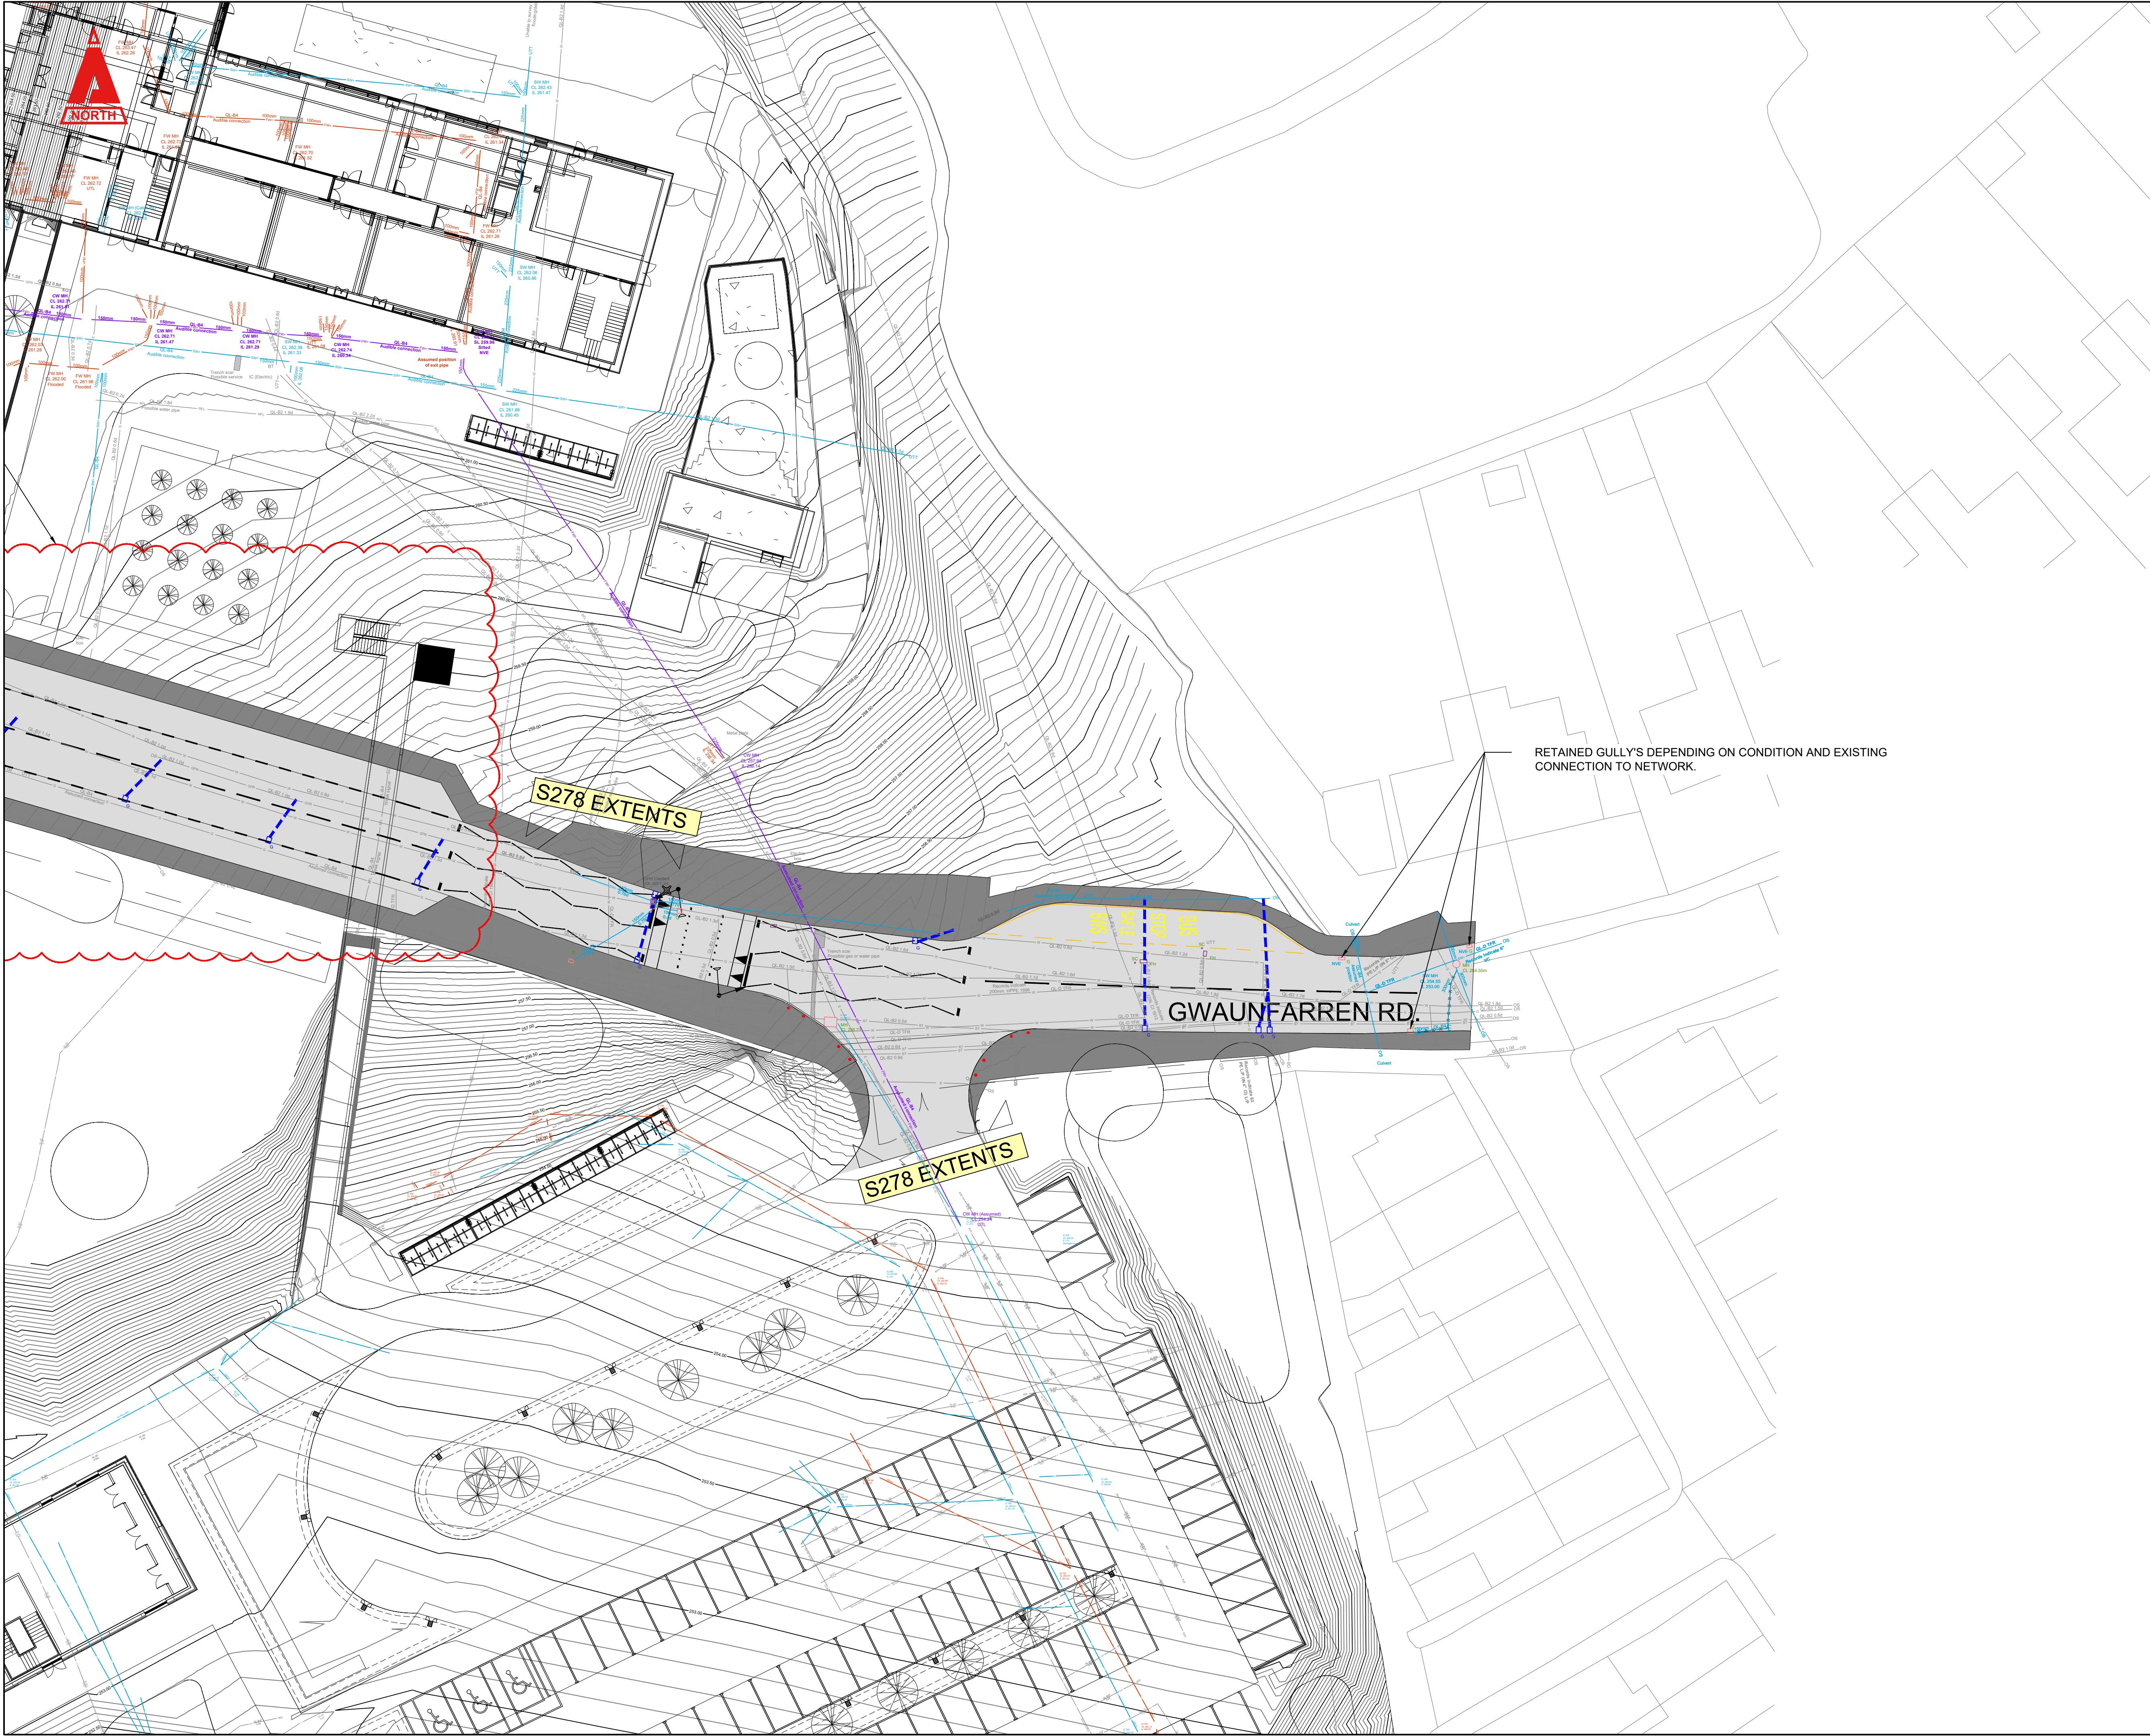
RETAINED GULLY'S DEPENDING ON CONDITION AND EXISTING CONNECTION TO NETWORK.

PCC ROAD GULLY +150mm DIAM. CONNECTION

1. CCTV DRAINAGE SURVEY REQUIRED WITHIN GWAUNFARREN ROAD AND GALON UCHAF ROAD TO REVIEW CONDITION AND LOCATION OF EXISTING HIGHWAY DRAINAGE NETWORK.
